Project No.: 209.40465

RE: LITTLE AVE – ABANDONED WELL RECONNAISSANCE

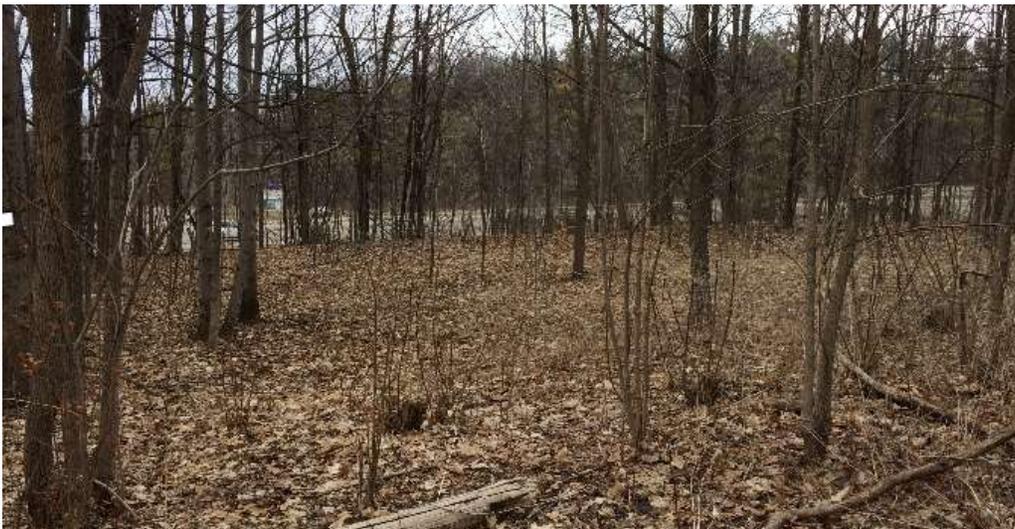
The site was walked on Wednesday, April 11, 2018 during a time of no snow cover and no vegetation growth. The small insert photo below shows the character of the site, and that visibility was good.

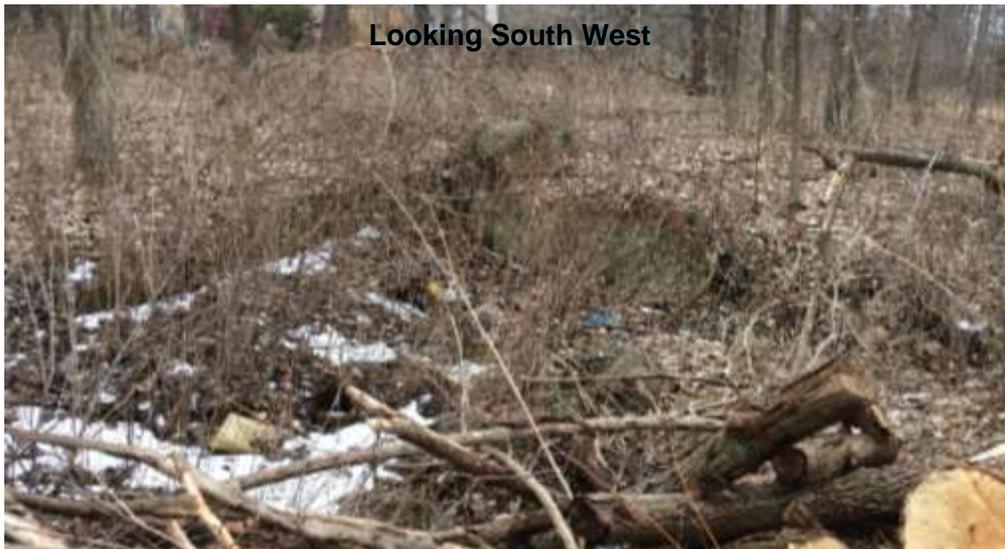
One foundation was found (at about N4913825-E606786), as captured on the photograph shown below. It was partly filled with debris (logs, broken asphalt, junk). It was not possible to see if there was an old well in the bottom, which is sometimes (but rarely the case). The foundation was circumnavigated in two concentric loops at about 10 m spacing, as wells are typically near the homes they serve. No evidence of barns or outbuildings were found.

It is anticipated that this foundation will be removed as the site is prepared for construction. Mucking out should include the removal of debris and organic matter *prior to* dismantling the foundation walls. When this is done the basement floor should be examined for signs of well or a subsurface cistern. This could take the form of a steel casing, concrete tiles, rock lined dug well, or even concrete vault. If it is found it should be plumbed and a licensed well technician retained to properly seal it.

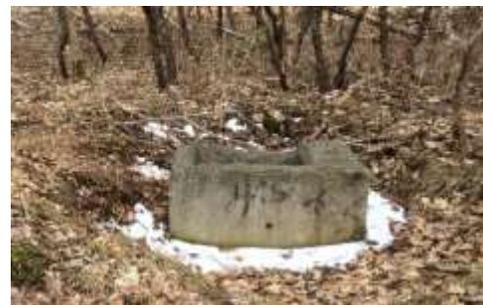
A square concrete structure measuring about 6' by 4' was found as well, perhaps an old cistern or livestock watering trough, but of indeterminate use/origin. Only 4' deep, in the shaded bottom it held debris, dirt and a thick frozen lense of ice/snow. It lay in a shallow excavation with the spoil piled around it. It does not resemble a well in our experience.

Once the weather has warmed up and the snow and ice in the base of this box has melted, the debris should be cleared by hand and the bottom examined for the presence of any wellhead structure. Safety precautions should be followed in case there is a deep open well found below the base, and the bottom sounded by a probing pole without entering the box. If one is found it should be examined and decommissioned as per O.Reg 903. If none is found then the box

would have to be removed, organic material removed, and properly compacted clean soil fill placed to bring it back to grade. (This is normal site mucking practice)
