## 2024 Sanitary Collection System Annual Report

Environmental Compliance Approval 014-W601

March 26, 2025

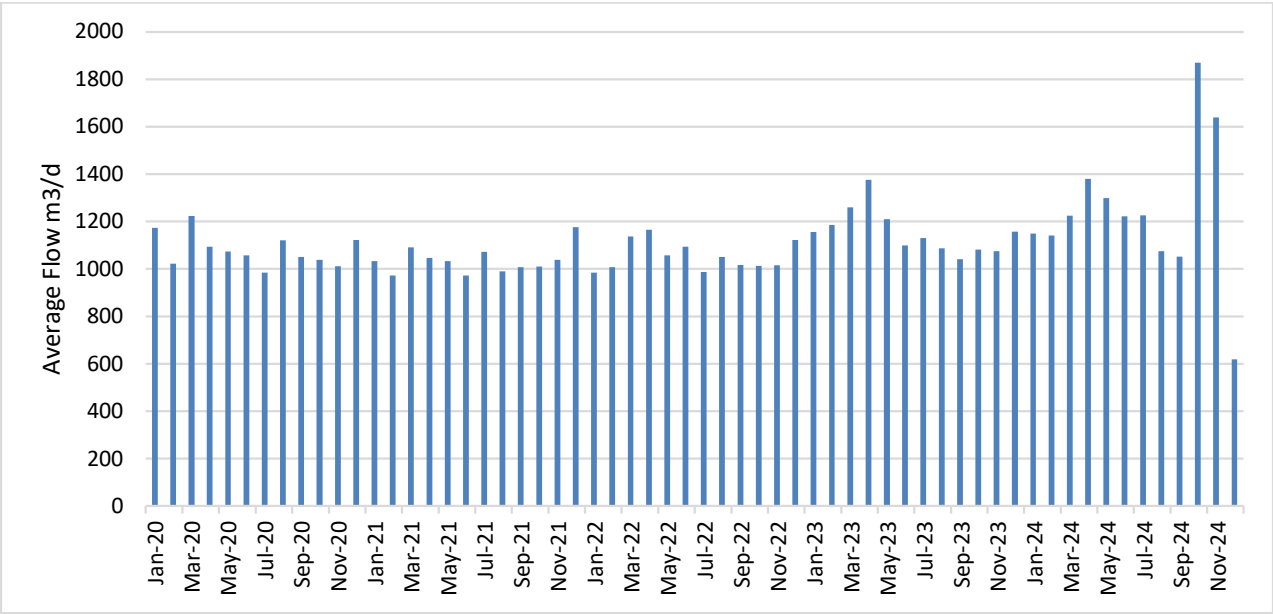
Figure 4 Little Lake SPS Monthly Average Daily Flows

During the months of October and November, the internal piping system at Little Lake SPS was upgraded by a capital construction project. The internal process piping within the wet well was replaced including a connection to the second 450mm forcemain, previously installed. During this time flows were monitored by the contractor on a weekly basis and reported to the City.

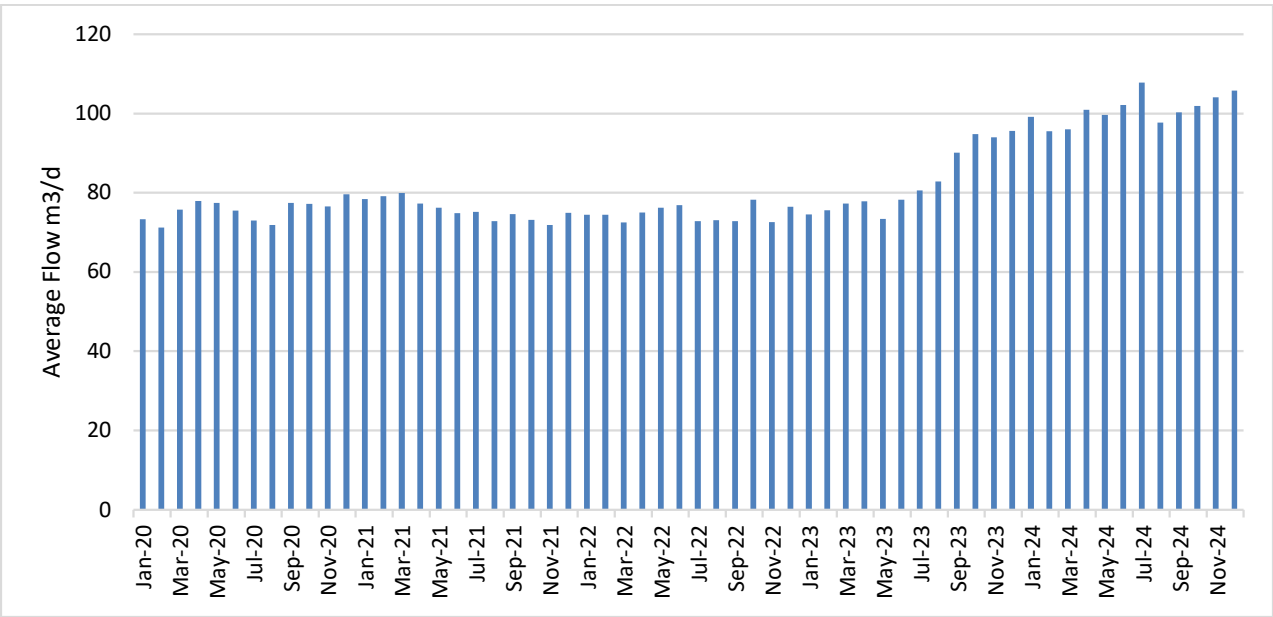
Figure 7 Mooregate SPS Monthly Average Daily Flows

The adequacy of the existing system is sufficient from a compliance standpoint, despite rising flows at some stations. Over the past five (5) years development and population growth, as well as an increase in multi-unit dwellings being built within the City, have driven the increase in flows. Mooregate SPS has experienced

a rise in flow as a result of intensified activity within the SPS collection zone driven by high-rise developments. In September, Heritage Pumping Station experienced increased flows because of transmission watermain flushing during which flows were directed into the pumping station to prevent discharge into Lake Simcoe. Lockhart SPS experienced abnormally high flows from August 26<sup>th</sup> to 31<sup>st</sup>. Despite a thorough review of system data and equipment inspections, operations were unable to determine the exact cause of the increase. Lockhart receives most of its flow from industrial facilities, and these sources may have contributed to the increased flows due to maintenance activities. Moving forward, operations staff will more closely monitor the station for any anomalies.

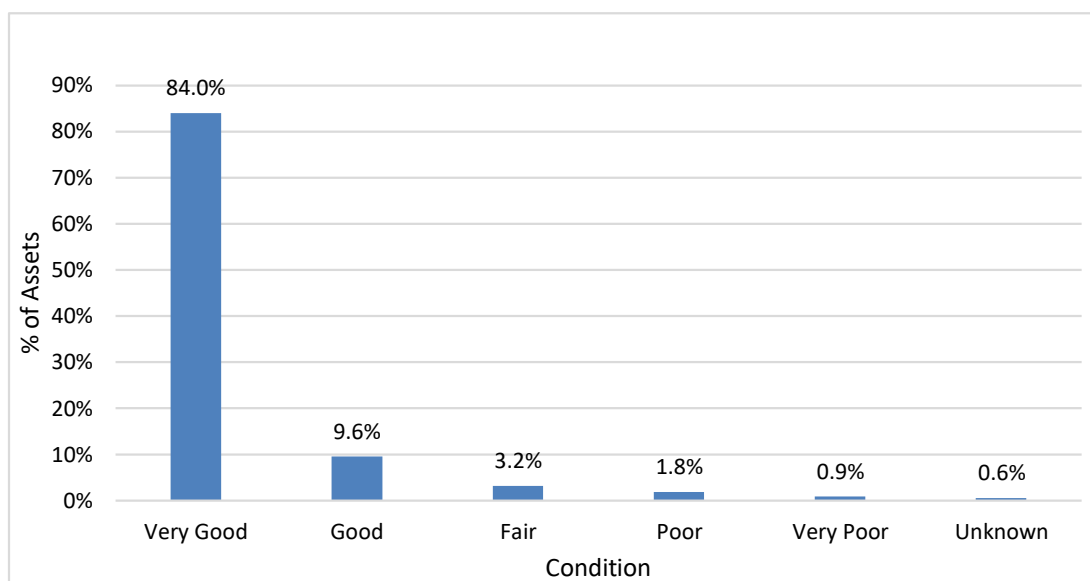
Figure 12 2024 Sanitary Sewer Condition Rating

The City administers a closed-circuit television (CCTV) sewer inspection program for sanitary sewers. The City's contractor conducted inspections on approximately 52 km of sanitary sewers. Please refer to Appendix A for a map of Sanitary Flushing and CCTV. The sanitary mains that were inspected ranged in age from 25 to 50 years old. Despite the age of the pipes, the CCTV results revealed that the pipe conditions were generally rated as very good condition. The use of CCTV technology allows a thorough examination of the sanitary collection system to ensure early and effective detection of any potential issues such as damaged pipes, inflow, infiltration and potential blockages. The information garnered from the CCTV inspections feed into the flushing and insitu repair programs described below. The inspected sewers had an 84% very good condition rating, indicating that the CCTV program has effectively provided staff with information to complete proactive and preventative maintenance within the system. These efforts have preserved the integrity of the pipes, contributing to the overall functionality and longevity of the sanitary collection system. The condition rating of the sanitary sewer collection system in its entirety is shown in the figure below:
