**20 & 22 WELLINGTON ST. EAST, BARRIE DEVELOPMENT**  
**TREE INVENTORY, ANALYSIS, AND PRESERVATION REPORT**

20-22 WELLINGTON ST. EAST,  
BARRIE, ONTARIO, COUNTY OF SIMCOE

MAY 2023

OUR FILE: LA 746-22

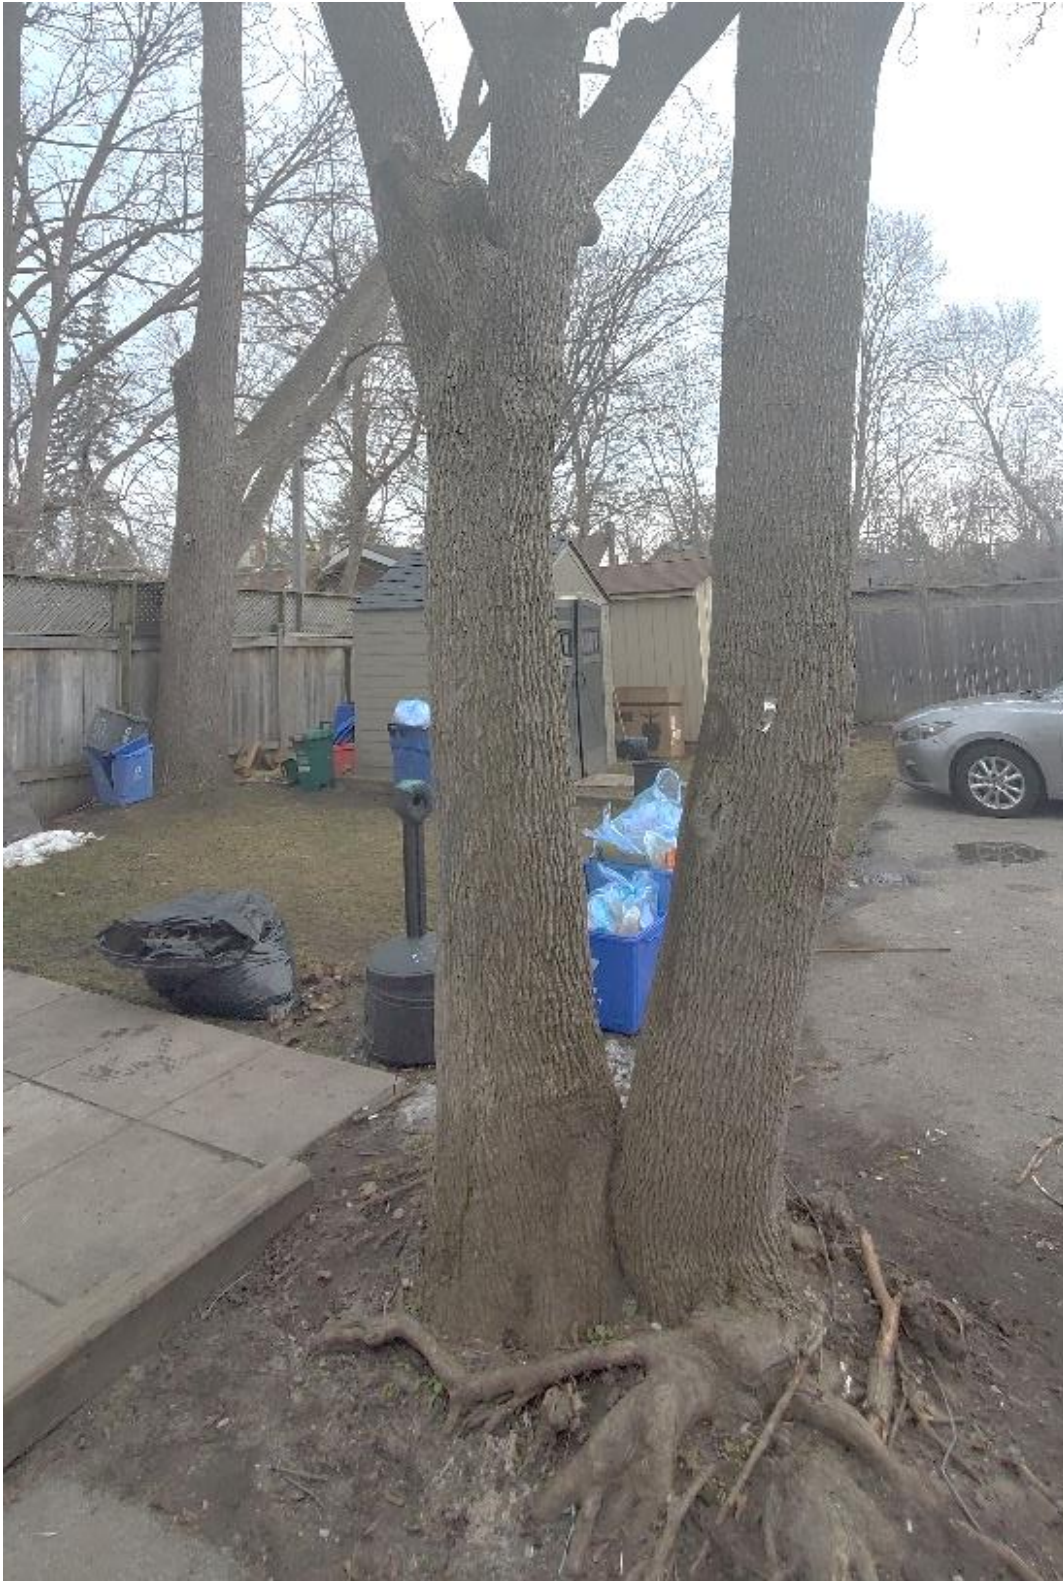
Tree No. 1 (Norway Maple) was found to be in declining health with significant girdling roots (see **Photo A, Appendix D**), Tree No.1 is canopy is found conflicting with the proposed development envelope (see **TP-1, Appendix B**).

| ONSITE TREE INVENTORY | | | | | | |
|---|---|---|---|---|---|---|
| 1 | <i>Acer platanoides</i> | Norway Maple | 34, 44 | Co-dominant stem with included bark, branch dieback, damaged roots and trunks, and significant girdling roots. | Poor | 7.4 |

**Photo A:** Facing North East, Tree No. 1 (Norway Maple) with significant girdling roots. Adjacent patio stones and parking lot is restricting tree's growth surface area and depth. Tree No. 1 is found in conflict with proposed development and is recommended for removal.

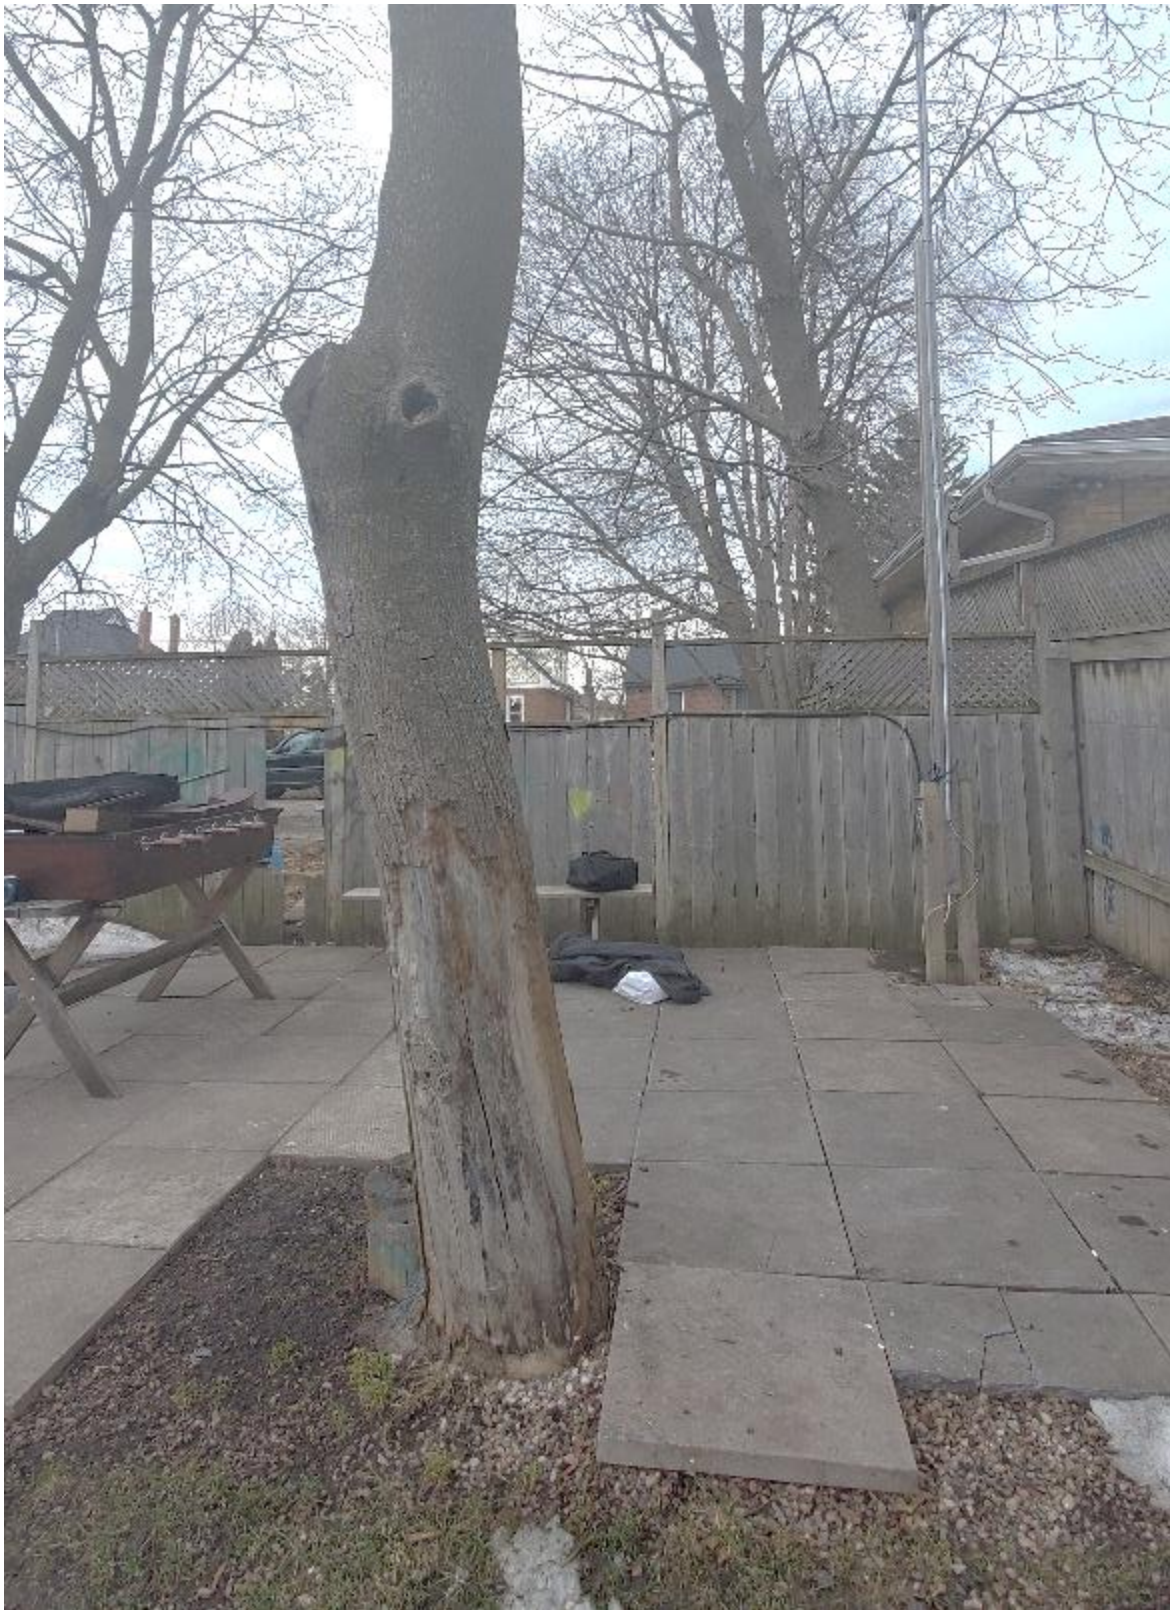
Tree Nos. 2 & 4 (Norway Maple & Sugar Maple) were also observed to be in declining health with health defects such as branch dieback, damaged bark, multiple leaders and included bark (see **Photo B, Appendix D**). Tree Nos. 2 & 4 locations and canopies were found conflicting with the proposed development's amenity area.

| ONSITE TREE INVENTORY | | | | | | |
|---|---|---|---|---|---|---|
| 2 | <i>Acer platanoides</i> | Norway Maple | 34 | Significant bark damage, branch dieback and missing bark. | Poor | 3.3 |

**Photo B:** Facing North West, Tree No. 2 (Norway Maple) with damaged bark, pruning wounds and root compaction due to adjacent patio stones. Tree No. 2 is recommended for removal as it conflicts with the proposed development's amenity area and grading.

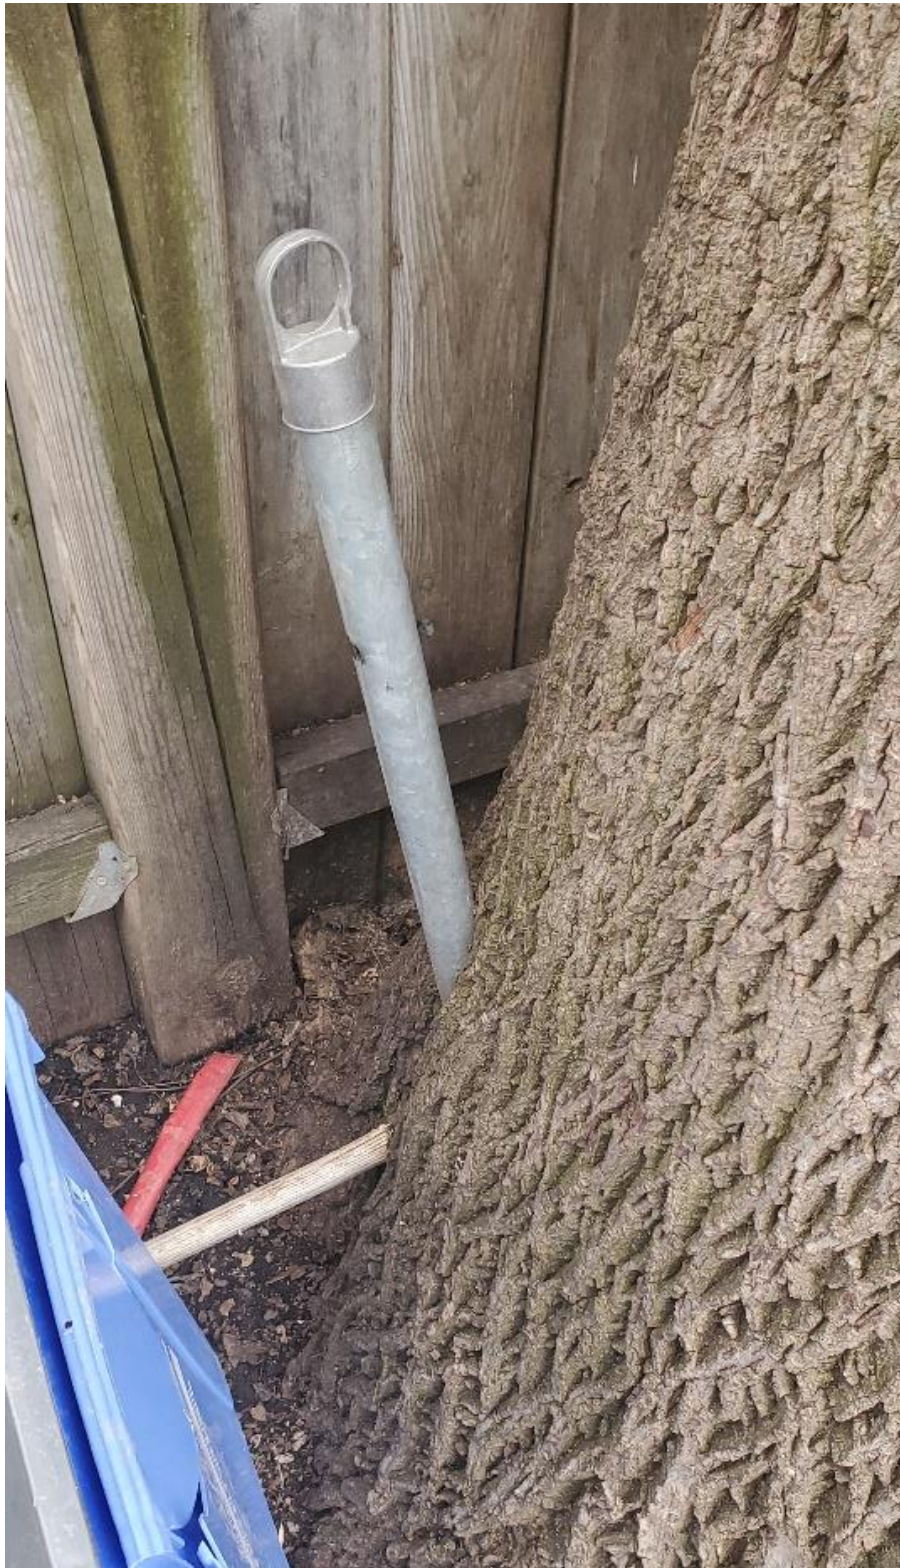
LEGroup staff observed one (1) boundary tree located along the property line in the rear yard, identified to be Tree No. 3 (Black Walnut). Tree no. 3 was assessed to be in fair condition, with defects including the trunk of the tree is growing around a metal fence pole near its base, along with minor branch dieback (see **Photo C, Appendix D**). Tree No. 3 location is found to minimally conflict with the proposed amenity area along with having an extended canopy near the proposed building envelop.

| ONSITE TREE INVENTORY | | | | | | |
|---|---|---|---|---|---|---|
| 3 | <i>Juglans nigra</i> | Black Walnut | 74 | Branch dieback, embedded metal pole, multiple leaders and included bark. | Fair | 7.3 |

**Photo C:** Facing North, Tree No. 3 (Black Walnut) with embedded metal at its basal area. Photo directed to the north

As it currently stands, LEGroup staff recommend the preservation of Tree Nos. 3 that is a boundary tree located along the shared property line along the north side of the subject site.

This tree is recommended to be retained and preserved for the development as it is a mature and suitable tree for the new development however its canopy is in minor conflict with the proposed development rear deck footprint. Deck construction in general can be conducted with minimal harm to the tree as excavation is minor in order to install the post footings. For this tree to be preserved throughout the development, it is expected that there may be some minor harm to its root zone and in which, it is recommended that the applicant receive consent from the owners of 51 Drury Lane for Tree no. 3 to be minimally harmed and preserved throughout development.
