October 11, 2023

ARBORIST REPORT  
126 Bradford Street, Barrie, Ontario

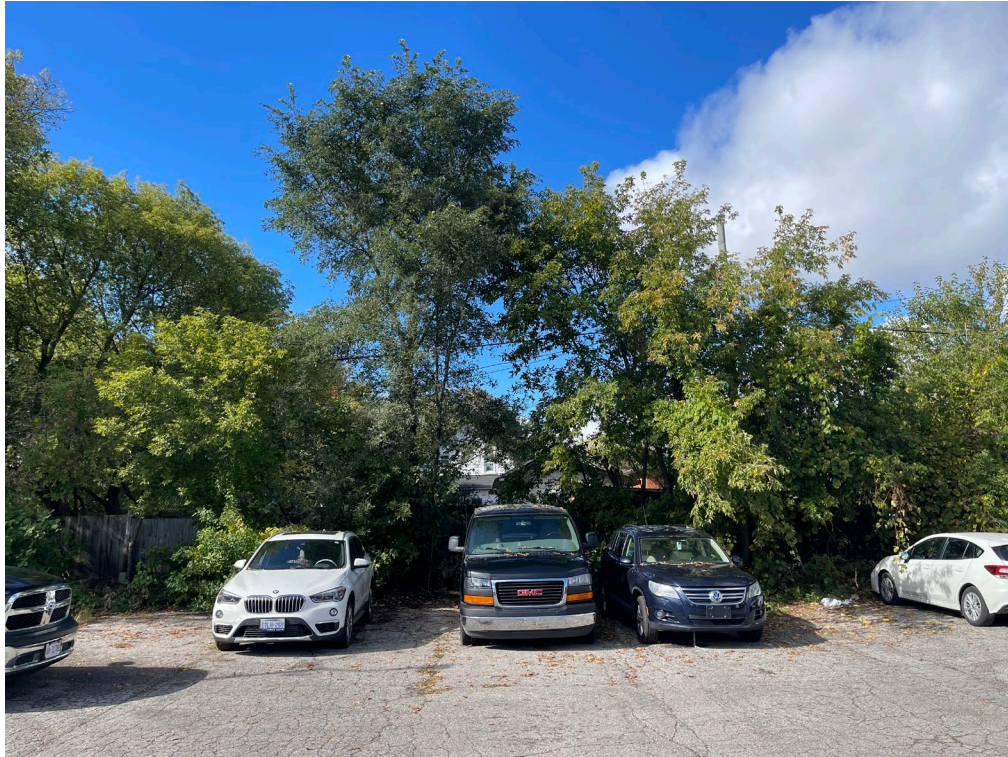
Trees 524 – 526

| Tree # | Common Name | Botanical Name | DBH (CM) | Condition | Comments | Recommendation |
|---|---|---|---|---|---|---|
| 524 | Manitoba Maple | Acer negundo | 14 | F | Multi-stem at base, multiple stems previously cut, boundary tree | Remove due to construction |
| 525 | Siberian Elm | Ulmus pumila | 23 | F | 2 stem at 0.1 metres | Remove due to construction |
| 526 | Manitoba Maple | Acer negundo | 19 | F | Multi-stem at base, multiple stems previously cut | Remove due to construction |

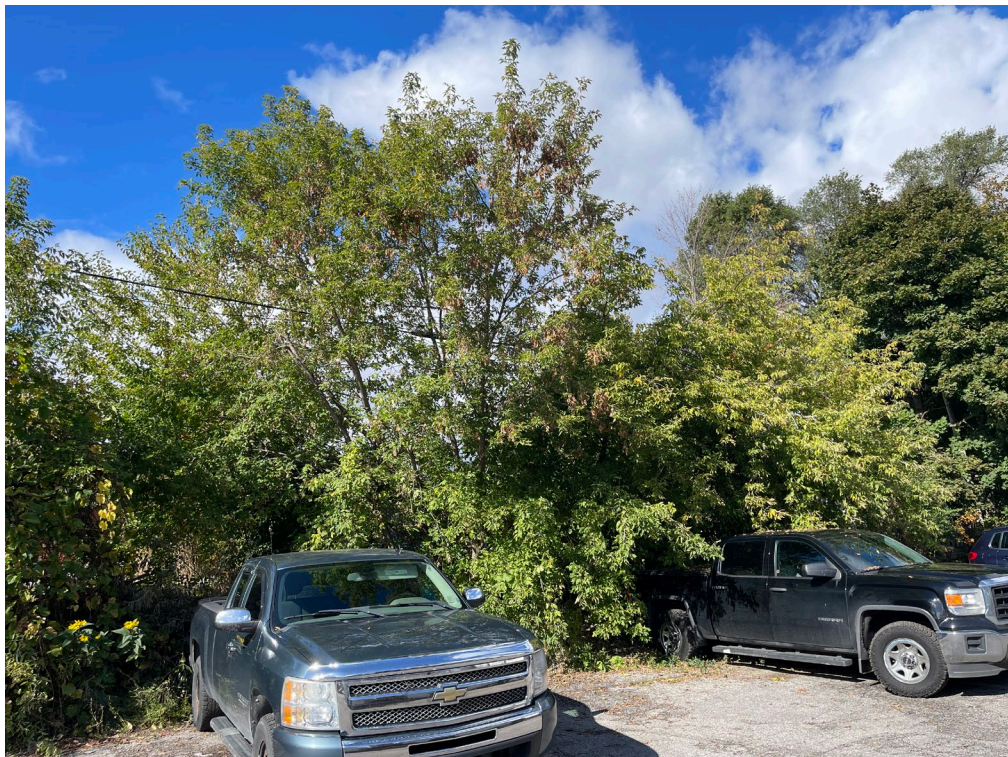
Trees 527 – 529

| Tree # | Common Name | Botanical Name | DBH (CM) | Condition | Comments | Recommendation |
|---|---|---|---|---|---|---|
| 527 | Manitoba Maple | Acer negundo | 11 | F | Mild lean, previously topped, boundary tree | Remove due to construction |
| 528 | Manitoba Maple | Acer negundo | 17 | F | 2 stem at base, boundary tree | Remove due to construction |
| 529 | Manitoba Maple | Acer negundo | 16 | F/P | Multi-stem at base, multiple stems previously cut, growing through fence half on private property half on neighbour, all stems cut on neighbour side, boundary tree | Remove due to construction |

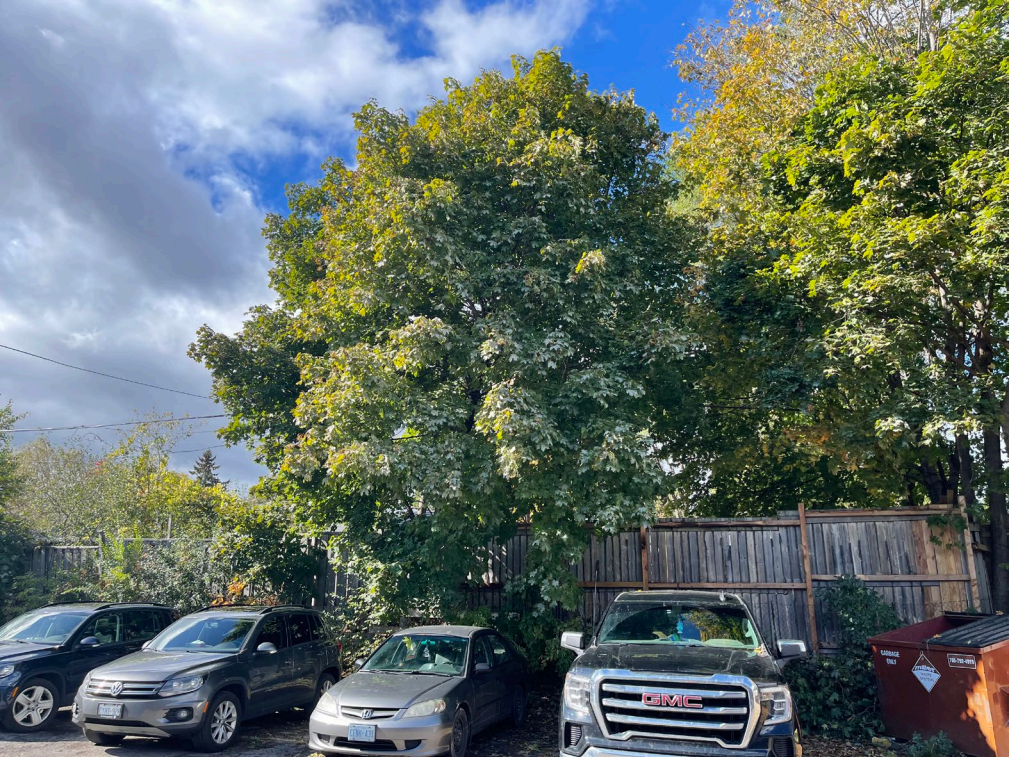
Trees 530, O2

| Tree # | Common Name | Botanical Name | DBH (CM) | Condition | Comments | Recommendation |
|---|---|---|---|---|---|---|
| 530 | Norway Maple | Acer platanoides | 19 | F | Co-dominant at 1.3 metres, one stem grown through wire fence, signs of mildew disease, boundary tree | Remove due to construction |

| O2 | Norway Maple | Acer platanoides | ~31 | F | Split in lower trunk callousing over, mild lean, growing in overhead wires | Retain |

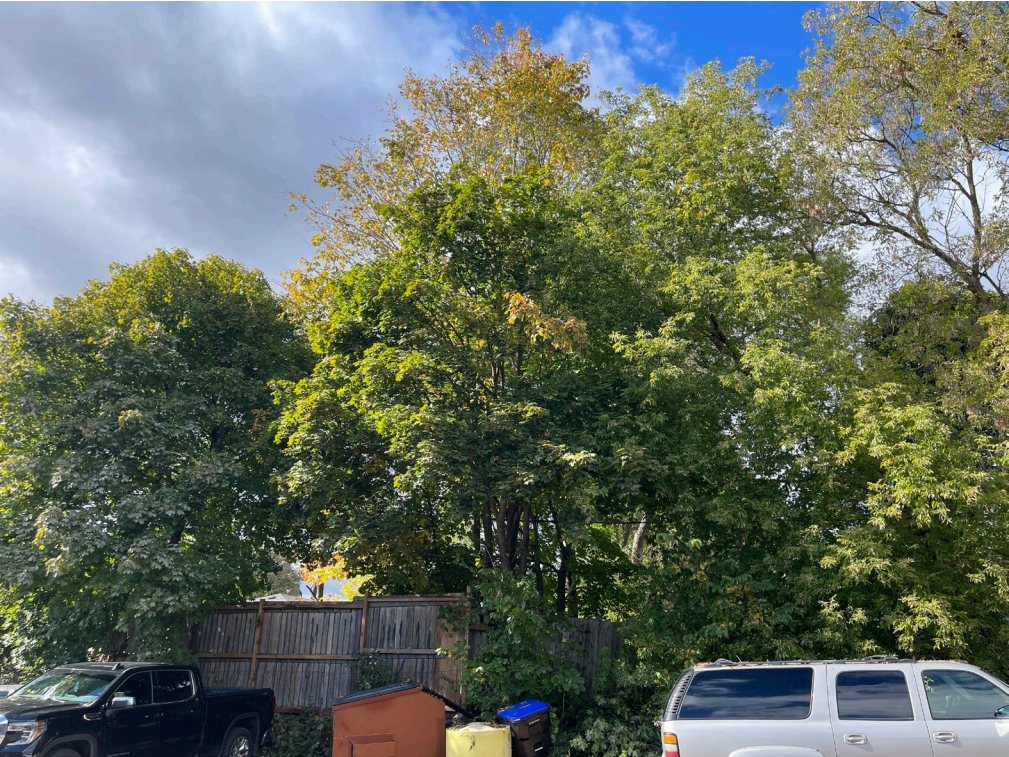
Trees 531, O3

| Tree # | Common Name | Botanical Name | DBH (CM) | Condition | Comments | Recommendation |
|---|---|---|---|---|---|---|
| 531 | Norway Maple | Acer platanoides | 28 | F | Co-dominant at base, growing in overhead wires, minor deadwood in canopy | Retain |

| O3 | Norway Maple | Acer platanoides | ~24 | F | 2 stem at 0.5 metres, minor deadwood in canopy | Retain |

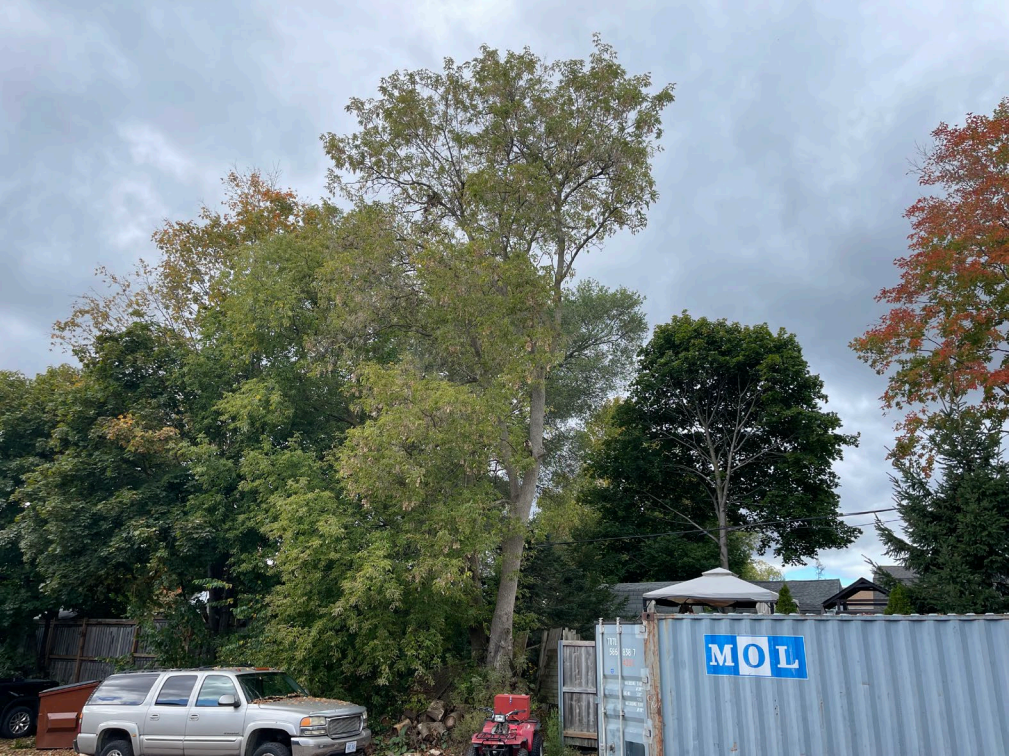
Tree 532

| Tree # | Common Name | Botanical Name | DBH (CM) | Condition | Comments | Recommendation |
|---|---|---|---|---|---|---|
| 532 | Manitoba Maple | Acer negundo | 44 | F | Minor deadwood in canopy, co-dominant at 0.2 metres, mild lean, growing in overhead wires | Retain |

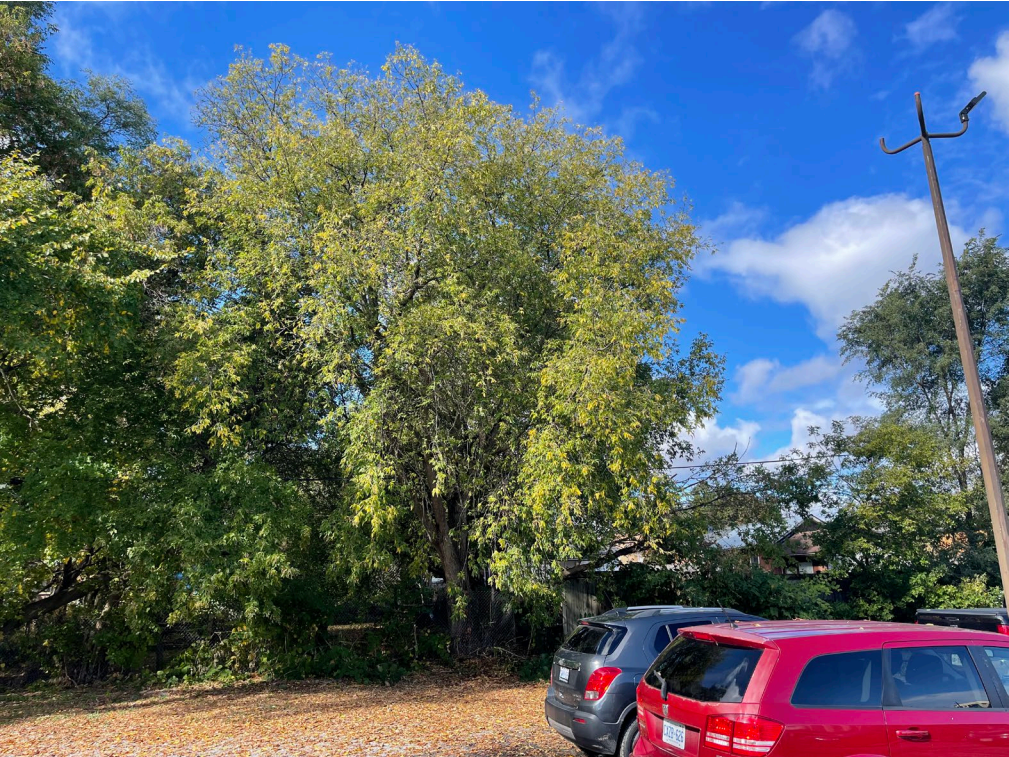
Tree O1

| O1 | Manitoba Maple | Acer negundo | ~77 | F | Minor deadwood in canopy, co-dominant at 2.5 metres, one stem at 0.2 metres with significant lean, growing in overhead wire | Retain |

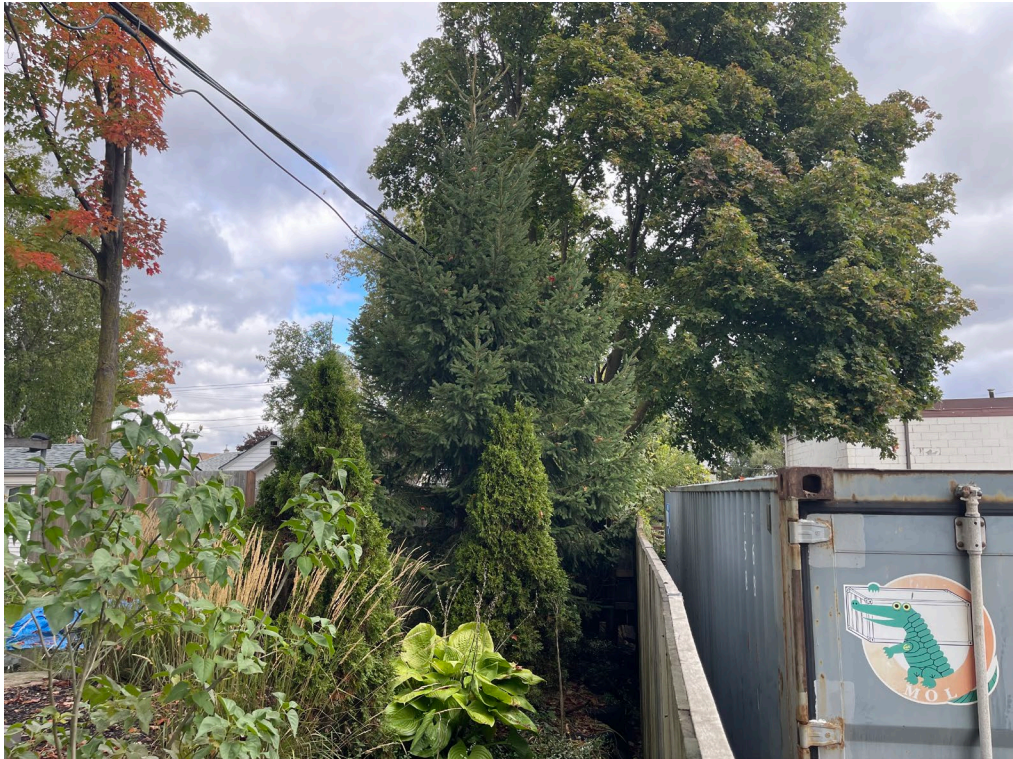
Tree O4

| O4 | Colorado Spruce | Picea pungens | ~12 | F/G | Growing in overhead wires | Retain |

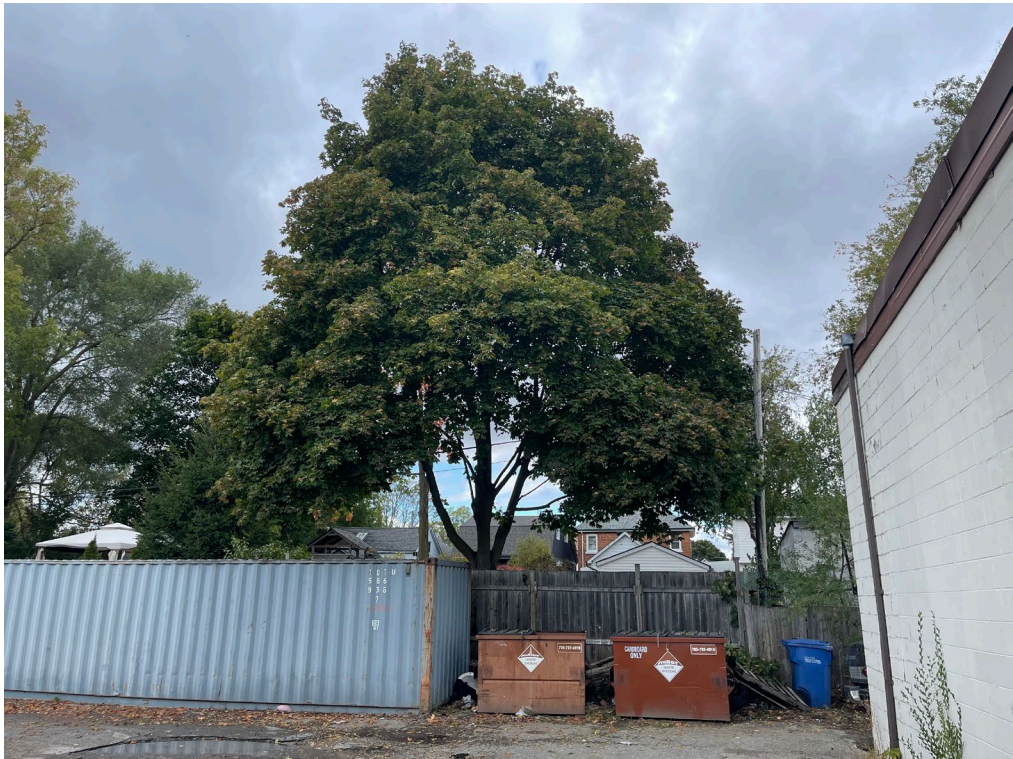
Tree O5

| O5 | Norway Maple | Acer platanoides | ~37 | F | Growing in overhead wires | Retain |
