# CYGNUS DEVELOPMENTS

## TREE INVENTORY, ANALYSIS AND PRESERVATION REPORT

189-197 DUCKWORTH ST. BARRIE ONTARIO

JUNE 2021

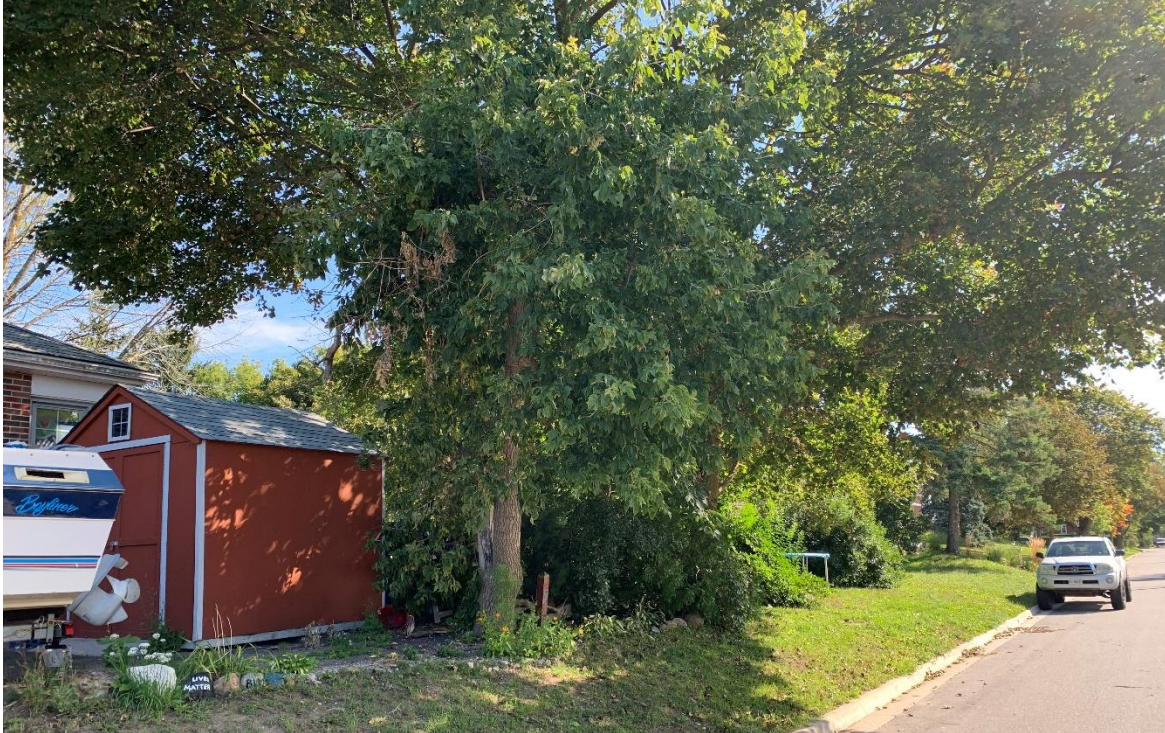
Tree Nos. 1-3 (Manitoba Maple and Norway Maples) are located along the south property limit at Mountbatten Rd. along the City of Barrie boulevard, and are generally in poor to marginal condition. With a shed and driveway nearby in this area, it is suspected that the tree base has compacted soil.

| Key | Latin Name | Common Name | Tree DIA<br>(cm dbh) | Notes | Assessment | Canopy<br>Radius (m) | Canopy<br>Radius (m <sup>2</sup> ) | Remove/<br>Preserve |
|---|---|---|---|---|---|---|---|---|
| 1 | <i>Acer negundo</i> | Manitoba Maple | 26.7 | dual leader, one dead, significant pruning, competition with tree no 2 | 1 Poor | 3.5 | 38.5 | Remove |
| 2 | <i>Acer platanoides</i> | Norway Maple | 57 | dual leaders, leaf scorch/dessication, included bark, exposed basal flare | 2 Marginal | 8.3 | 216.3 | Remove |
| 3 | <i>Acer platanoides</i> | Norway Maple | 40.8 | dual leaders, included bark, suspected interior decay, branch crossover, significant dieback | 1 Poor | 6.1 | 116.8 | Remove |

**Photo A:** View looking from west to east at trees 1-3 with compacted soil, adjacent to driveway on Mountbatten Rd.

LEGroup staff are of the opinion that 16 of the 27 (Tree Nos. 1- 3, 9-17, 22-25) trees located on site are in poor to fair condition, conflict with the proposed development, and are of limited aesthetic value to be retained for the development. The majority of these trees are not significant in size and have defects as outlined in the Tree Inventory Table (**Appendix C**). Tree Nos. 9 & 10 are White Ash and show signs of significant decline due to advanced infestation of the Emerald Ash Borer. For this reason and the reasons listed above, it is our recommendation that these trees be removed.

Tree Nos 1, 2 & 3 are located along the shared property line of the City of Barrie's boulevard. For a tree to be considered a "Public Tree", a minimum of 50% of the main stem has to be located on City of Barrie Property (*By-law 2014-116*). LEGroup found that Tree Nos. 1, 2 & 3 do not have a main stem with more than 50% located on City of Barrie property and therefore are not considered Public Trees. Tree Nos. 1-3 are recommended for removal as a significant portion of their critical root zone will be impacted by the proposed sidewalk and they are not expected to survive post-construction. They were found to be in poor to marginal condition.

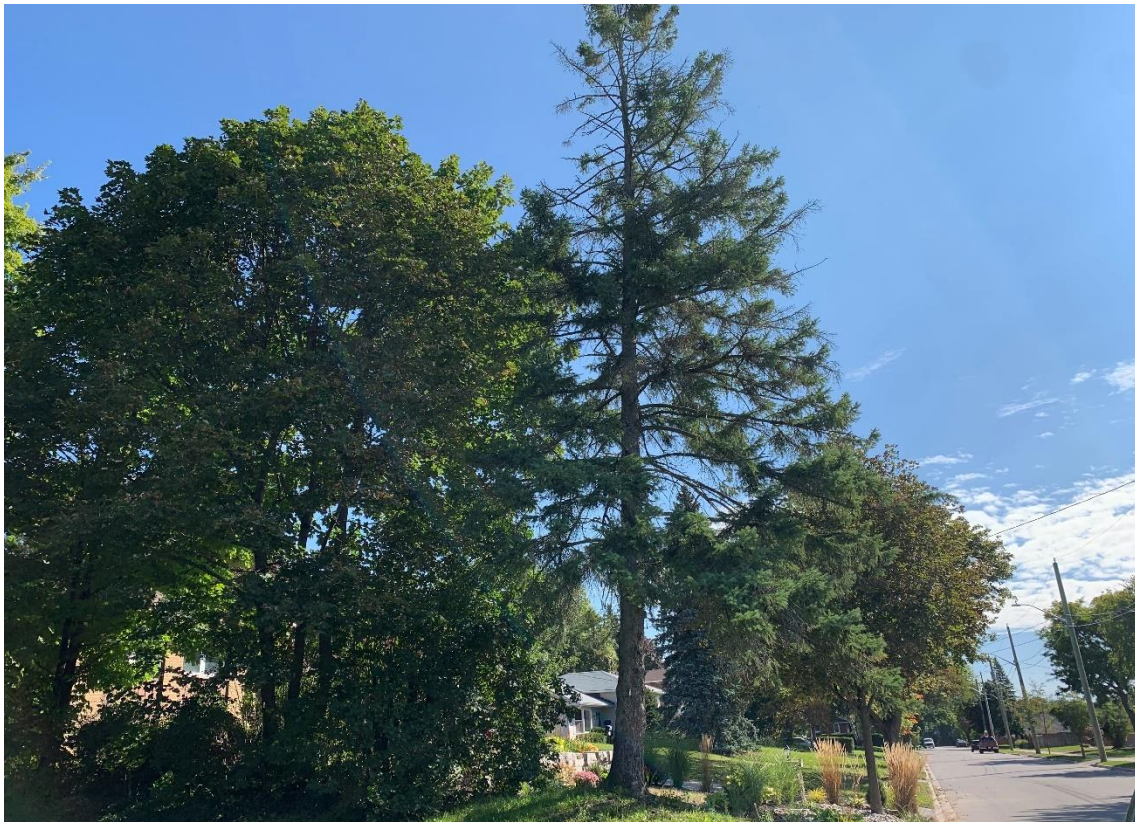
| Key | Latin Name | Common Name | Tree DIA<br>(cm dbh) | Notes | Assessment | Canopy<br>Radius (m) | Canopy<br>Radius (m <sup>2</sup> ) | Remove/<br>Preserve |
|---|---|---|---|---|---|---|---|---|
| 4 | <i>Picea glauca</i> | White Spruce | 41.4 | exposed roots, lower branch pruning, sap bleeding, dieback | 2 Marginal | 4.1 | 52.8 | Preserve |
| 5 | <i>Acer platanoides</i> | Norway Maple | 18.2, 22.5 | dual trunk, competition with tree no. 6, minor leaf dessication, one sided branching | 2 Marginal | 5.3 | 88.2 | Preserve |
| 6 | <i>Acer platanoides</i> | Norway Maple | 23.6 | winding trunk, one sided branching, minor leaf dessication | 2 Marginal | 4.6 | 66.4 | Preserve |
| 7 | <i>Acer saccharum</i> | Sugar Maple | 13.6, 20.1 | dual trunk, vines, included bark | 3 Fair | 4.4 | 60.8 | Preserve |

**Photo B:** Showing Trees 4-7 to be retained at the rear lot line.

We note that eight (8) trees recorded to be over 10cm DBH are recommended for retention (Tree Nos. 4-8, 18, 19 & 20 as set out in **Appendix C**) due to their optimum location, buffering screening potential, and their moderate tolerance of in-situ post construction grading changes. These trees are located along the east property line of the proposed site, and are to be protected with tree preservation fencing as laid out in **TP-2**. Tree Nos. 4-7 are boundary trees and Tree Nos. 18, 19 & 20 are located offsite and will require a 'consent to harm' signoff from the adjacent neighbours.

- That eight (8) existing trees (Tree Nos. 4-7, & 18-21) located offsite and along the shared property line of 6 Mountbatten are recommended to obtain 'consent to harm' agreements from the respective neighbour;

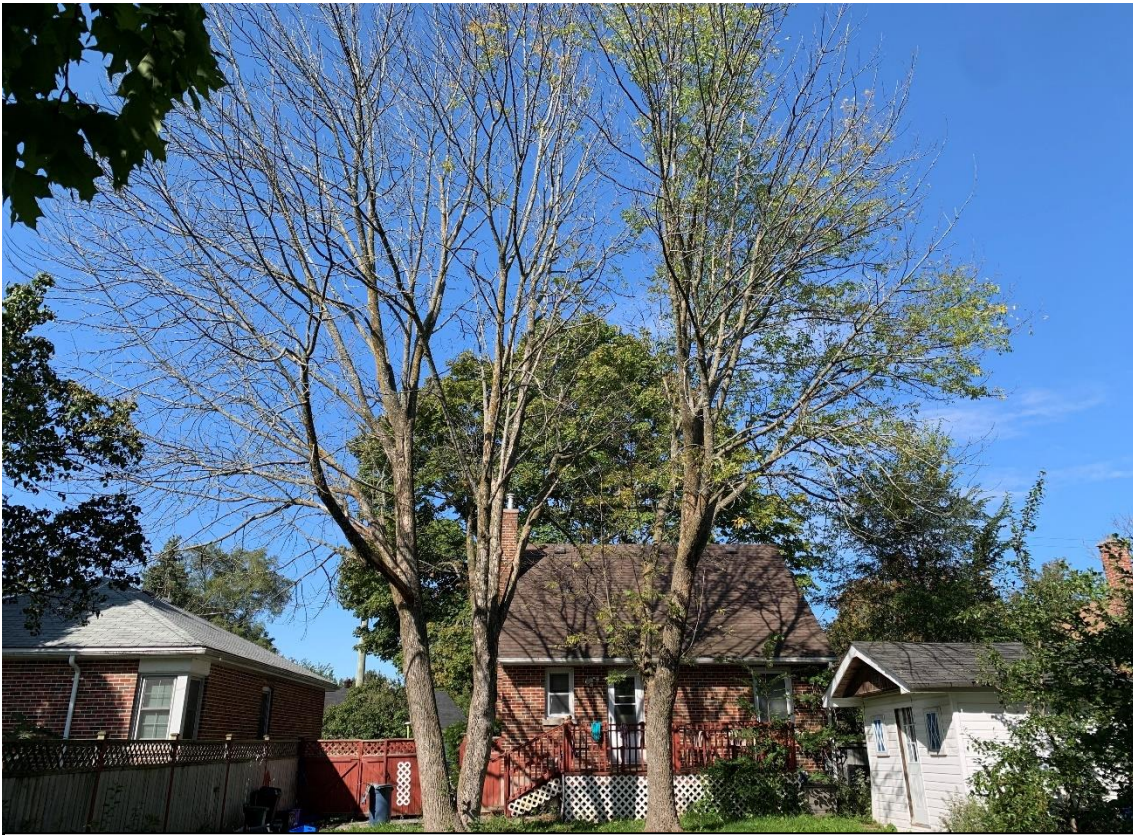
Tree Nos. 9 & 10 are White Ash located near the centre of the site and show advanced signs of Emerald Ash Borer (EAB) infestation including significant dieback, bark necrosis, and D-shaped holes created by EAB larvae. These trees are both in poor condition, and are in significant decline.

| Key | Latin Name | Common Name | Tree DIA<br>(cm dbh) | Notes | Assessment | Canopy<br>Radius (m) | Canopy<br>Radius (m <sup>2</sup> ) | Remove/<br>Preserve |
|---|---|---|---|---|---|---|---|---|
| 9 | <i>Fraxinus americana</i> | White Ash | 43.1, 42.4 | significant dieback, advanced EAB, bark necrosis | 1 Poor | 6.0 | 113.0 | Remove |
| 10 | <i>Fraxinus americana</i> | White Ash | 42.5 | dual leaders, advanced EAB, significant dieback, bark necrosis | 1 Poor | 5.5 | 95.0 | Remove |

**Photo C:** Showing Trees 9 & 10 with advanced Emerald Ash Borer infestation.

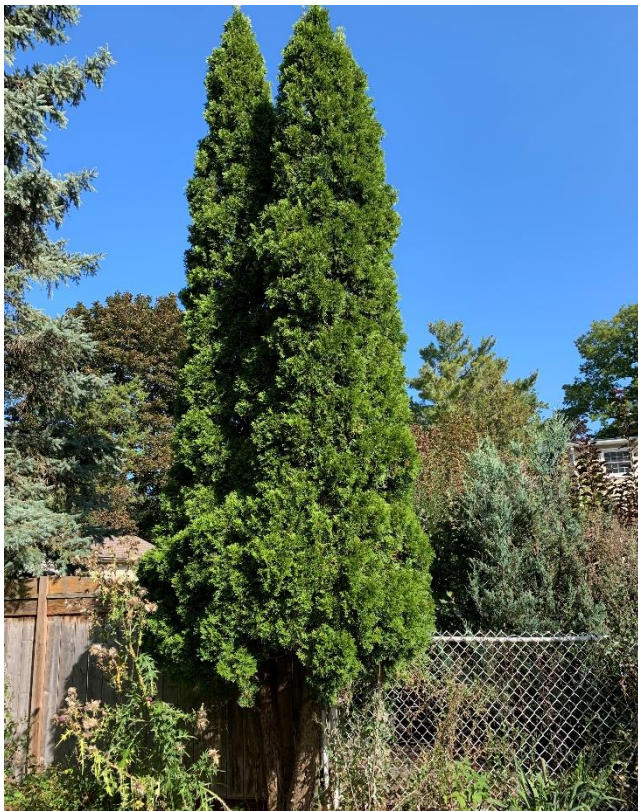
| Key | Latin Name | Common Name | Tree DIA<br>(cm dbh) | Notes | Assessment | Canopy<br>Radius (m) | Canopy<br>Radius (m <sup>2</sup> ) | Remove/<br>Preserve |
|---|---|---|---|---|---|---|---|---|
| 27 | <i>Thuja occidentalis</i> | Eastern White Cedar | 12.0, 14.0 | dual trunk | 3 Fair | 1.0 | 3.1 | Preserve |

**Photo D:** Showing Tree 27 with dual trunks to be retained.

In addition, there are two (2) trees (Tree No. 26 & 27) located onsite along the north property line, bordering 7 Napier Street (refer to **TP-1 & TP-2**). These trees are recommended for retention and are to be protected with tree preservation fencing as laid out in **TP-2**. With many of these trees proposed to have construction activities within their driplines, it is our recommendation that they be monitored during and post construction

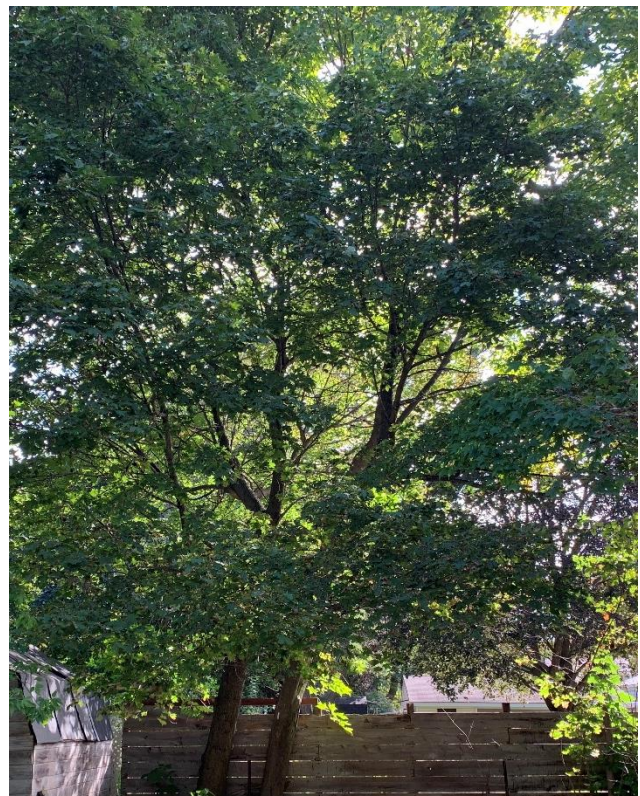
| Key | Latin Name | Common Name | Tree DIA<br>(cm dbh) | Notes | Assessment | Canopy<br>Radius (m) | Canopy<br>Radius (m <sup>2</sup> ) | Remove/<br>Preserve |
|---|---|---|---|---|---|---|---|---|
| 19 | <i>Acer saccharum</i> | Sugar Maple | 30.6 | rubbing on fence, dual leaders, large wound/cavity, included bark, suspected interior decay | 2 Marginal | 6.3 | 124.6 | Preserve |
| 20 | <i>Acer platanoides</i> | Norway Maple | 32.8 | lower branch dieback, minor lean | 3 Fair | 5.1 | 81.7 | Preserve |

**Photo E:** Showing Trees 19 & 20 to be retained.
