March 18, 2019 BEL 217408

Re: Boundary Trees and Tree Protection Measures, 105 – 111 Edgehill Drive, City of Barrie.

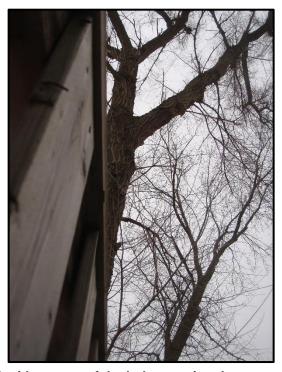
Based on additional field investigations, the base of both trees #312 and #313 are located wholly within the subject property. In addition, the bole of neither tree was found to cross or straddle the property limit (**Photograph 1** and **2**). The property survey confirmed that the wooden fence along the western boundary accurately represents the property limit. Therefore, neither of these trees should be considered a boundary tree.

Photograph 1. Tree No. 312 with no part of the bole crossing the property line/fence (Mar 13, 2019).

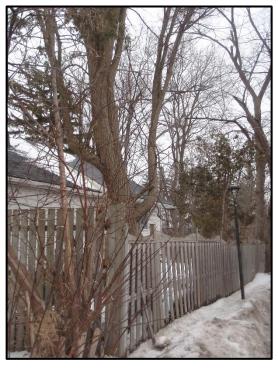
Photograph 2. Tree No. 313 with no part of the bole crossing the property line/fence (Mar 13, 2019).

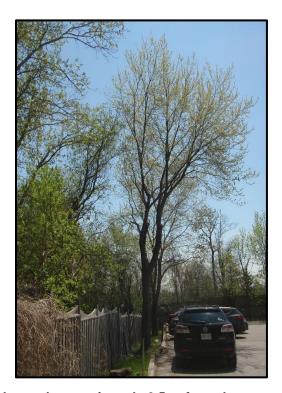
Comments were also received from City staff regarding tree protection measures for three trees recommended for preservation due to their proximity to the proposed construction. Tree #310 is located on the neighbouring property to the west, approximately 0.5 m from the property limit (**Photograph 3**). The proposed building on the subject property is to be located 2.43 m from the property limit. Based on the tree's dripline/crown radius, the recommended Tree Protection Zone (TPZ) for tree #310 is 2.5 m. The total distance from the base of tree #310 to the proposed building on the subject property is approximately 2.93 m. However, some site disturbance and excavation will be required within the tree's

Photograph 3. Tree No. 310 located approximately 0.5 m from the property line/fence (May 16, 2018).

- 1. Prior to construction, a tree protection fence consisting of 1.2 m (4 ft) high paige wire fencing and metal T-bars will be installed around the tree and located at the limit of required excavation. The fencing shall be in accordance with the City's Tree Preservation Manual and Standards (BSD-1232).

- 9. A qualified arborist should supervise excavation activities within tree TPZ's and a follow up monitoring inspection should be conducted to ensure tree protection measures are implemented and maintained.
