**219 BAYFIELD STREET, BARRIE, ONTARIO  
ADAPTATIVE RE-USE DEVELOPMENT**

**TREE INVENTORY, ANALYSIS, AND PRESERVATION PLAN**

FEBRUARY 2022

OUR FILE: LA 538-21  
CITY OF BARRIE FILE: D28-055-2020

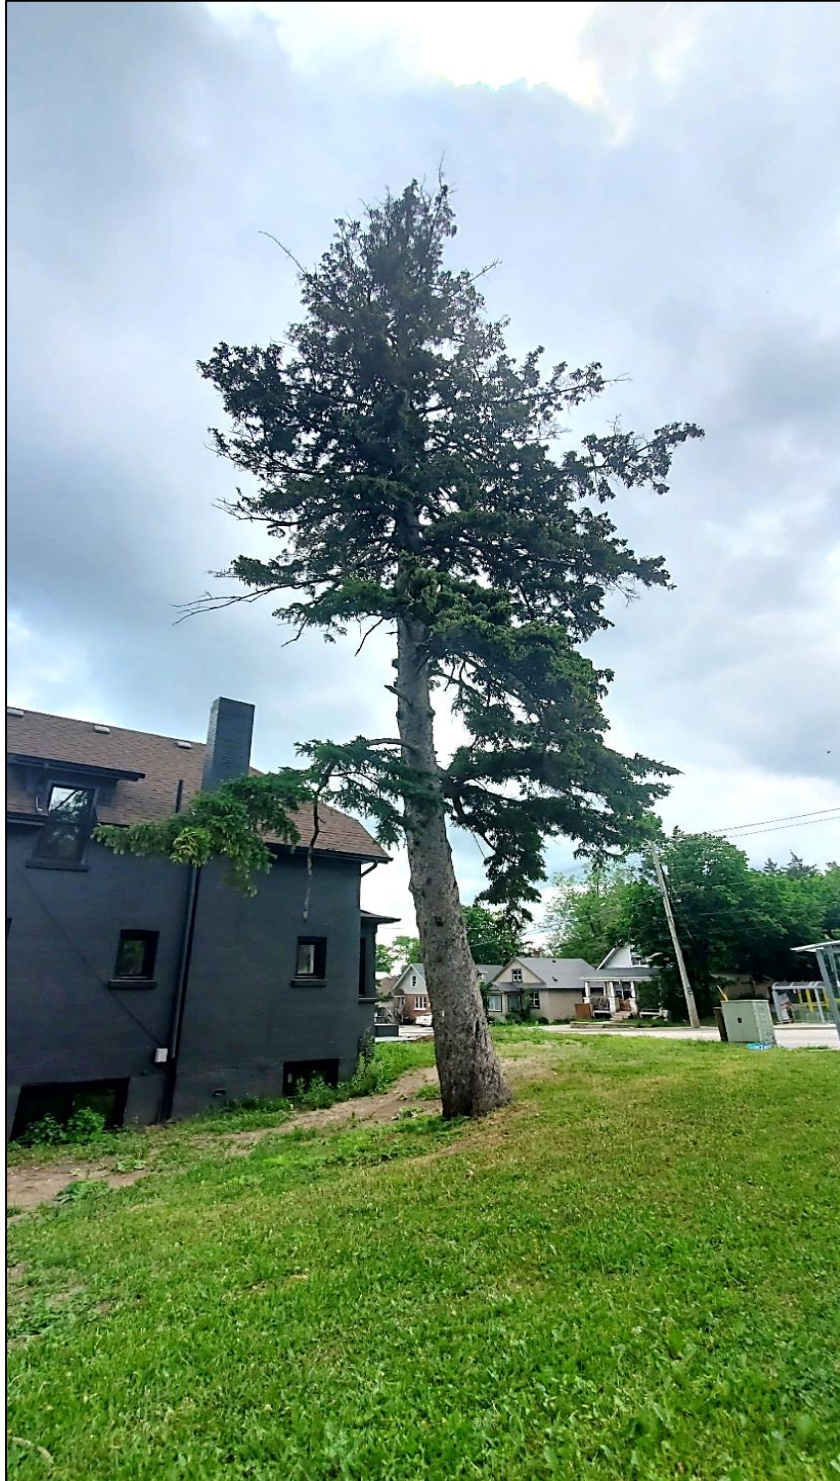
considered of low intrinsic value and in marginal health. LEGroup staff observed previous pruning wounds along the main trunk and Eastern Spruce Budworm damage. Overall Tree No.1 was observed to be in declining health (see **Photo A, Appendix D**).

**Photo A:** Tree No. 1 (White Spruce), positioned on the sloping terrain, adjacent to Bayfield Street & Grove Street East intersection. Notice deadwood, branch dieback and overall declining health. Tree is recommended for removal. Photo facing south.

LEGroup staff are of the opinion that Tree No. 1 (White Spruce) is in marginal health, provides low intrinsic value at the front of the property, is expected to conflict with the proposed development and is therefore recommended for removal.

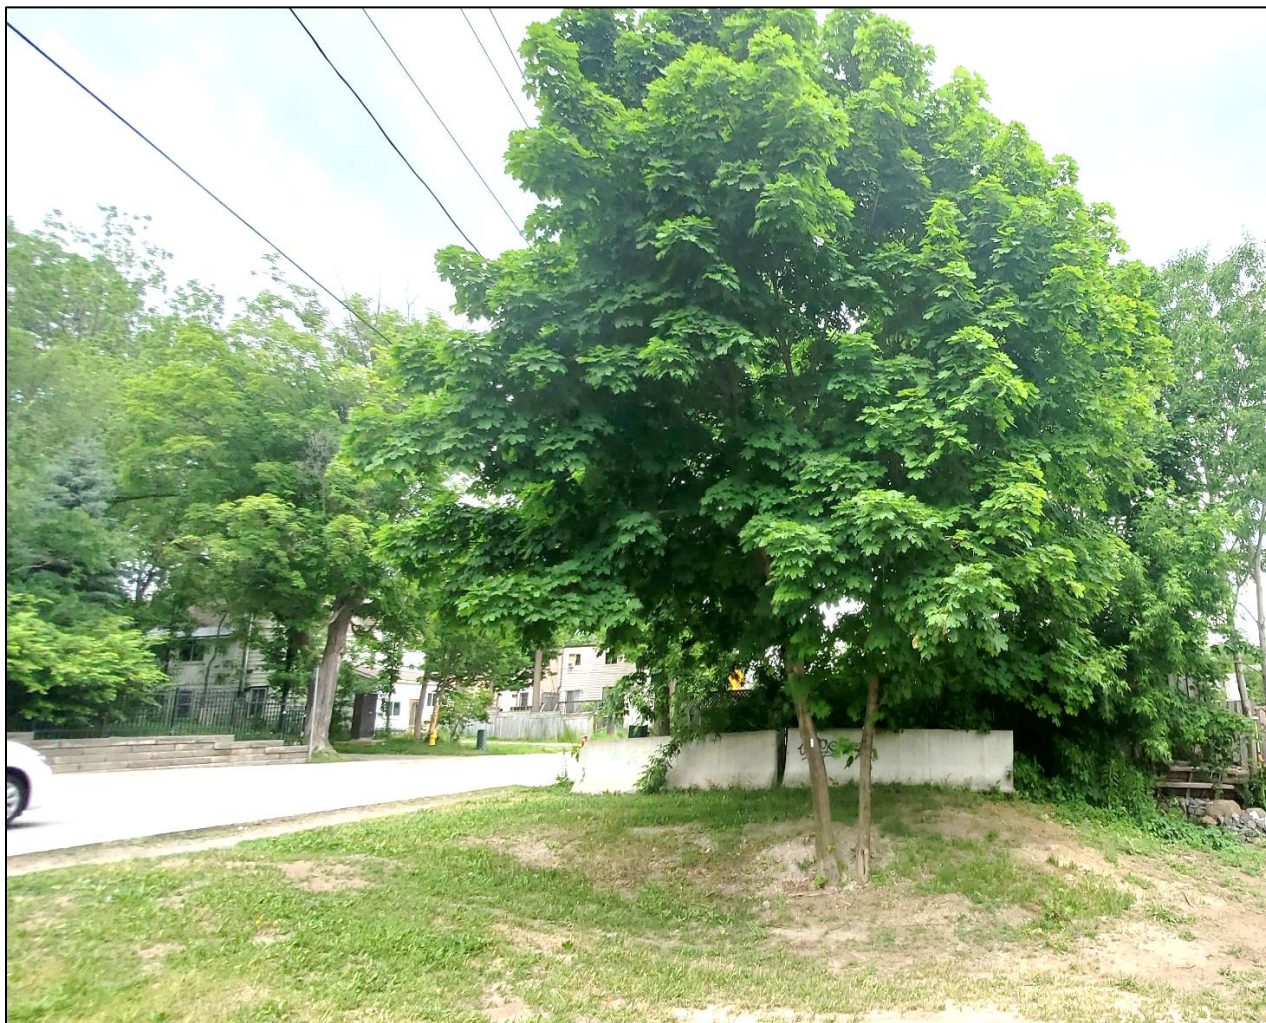
LEGroup staff observed two (2) trees located near the north-east corner of the subject site and have been identified to be Tree Nos. 2 & 3 (Norway Maples). Both trees were located slightly onto the existing slope and were exhibiting health defects such as epicormic branching, included bark and trunk damage. The ground found at the basal area of Tree Nos. 2 & 3 was observed to be very compacted and could potentially lead to further lower trunk vulnerabilities (see **Photo B, Appendix D**). Although this species of trees can be very resistant to the urban conditions and can offer positive inputs to a property frontage, the trees have been found of low intrinsic value, invasive and in declining health.

**Photo B:** Tree Nos. 2 & 3; Norway Maples (center of image), located onto the sloping terrain, heavy soil compaction observed at basal area and trunk wounds (suspected interior decay). Photo facing north.

LEGroup staff have evaluated Tree Nos. 2 & 3 (Norway Maples) to be in marginal health, are considered an invasive species, of low intrinsic value and conflict with the proposed developable site; therefore Tree Nos. 2-3 are recommended for removal.

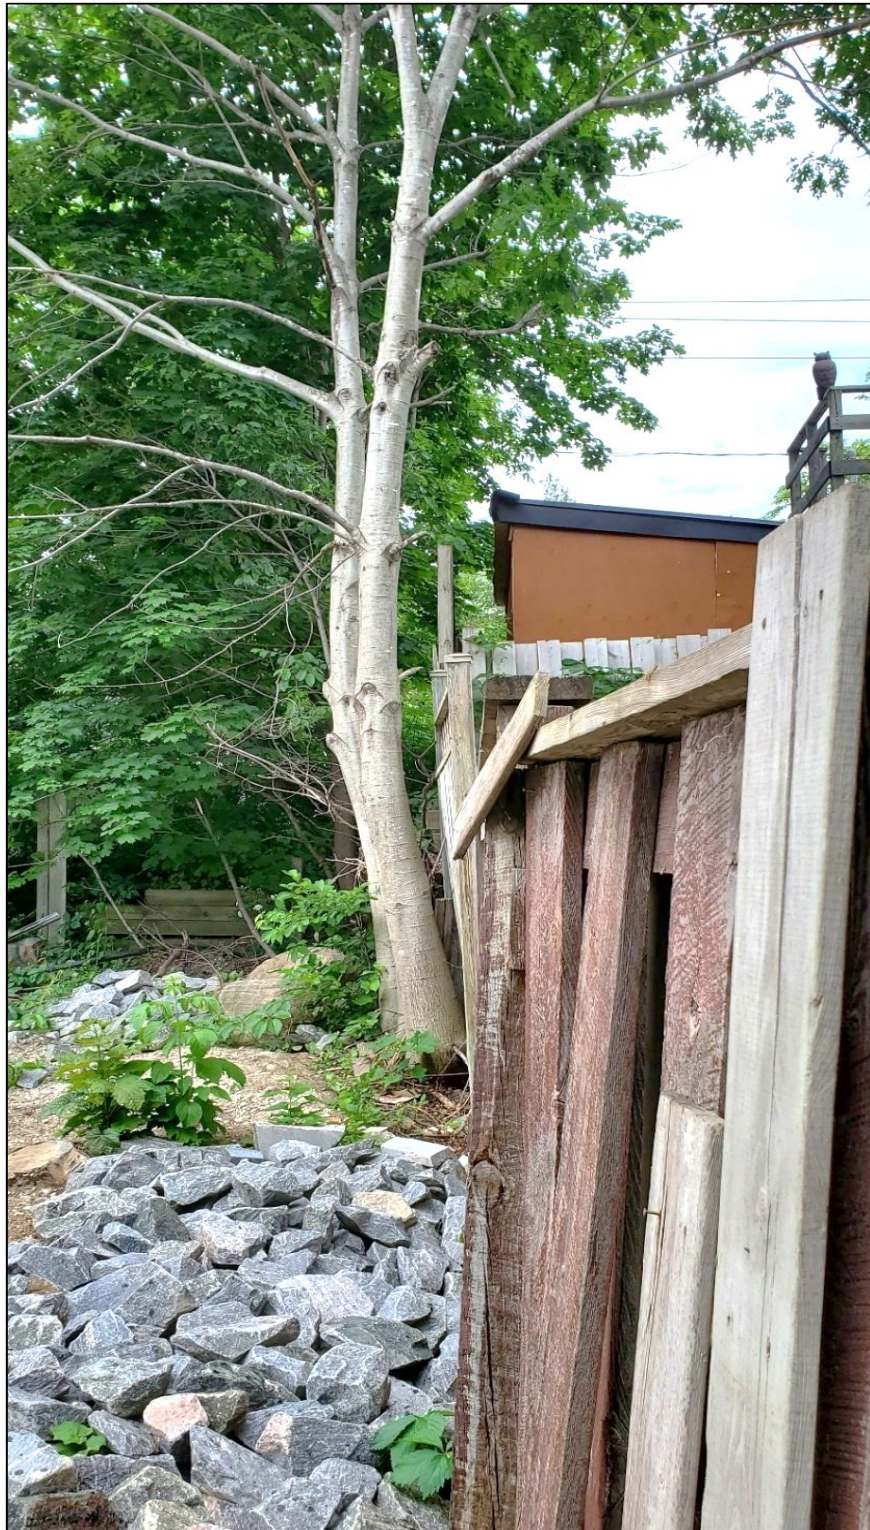
**Photo C:** Tree Nos. 7 & 8 (Red Oak), located along the northeast property line. Notice compacted root systems due to large rocks and excess fill from previous site disturbances. Photo facing north.

LEGroup staff have attributed Tree Nos. 7-9 (Norway Maple & Red Oak), located on the northeast property limit, to be providing a considerable amount of privacy by buffering between the subject site and residential property 13 Grove Street East. The trees canopy also provides good shade in the warmer months, offer streetscape aesthetic value and do not conflict with the proposed development; therefore Tree No. 7-9 are recommended for preservation.

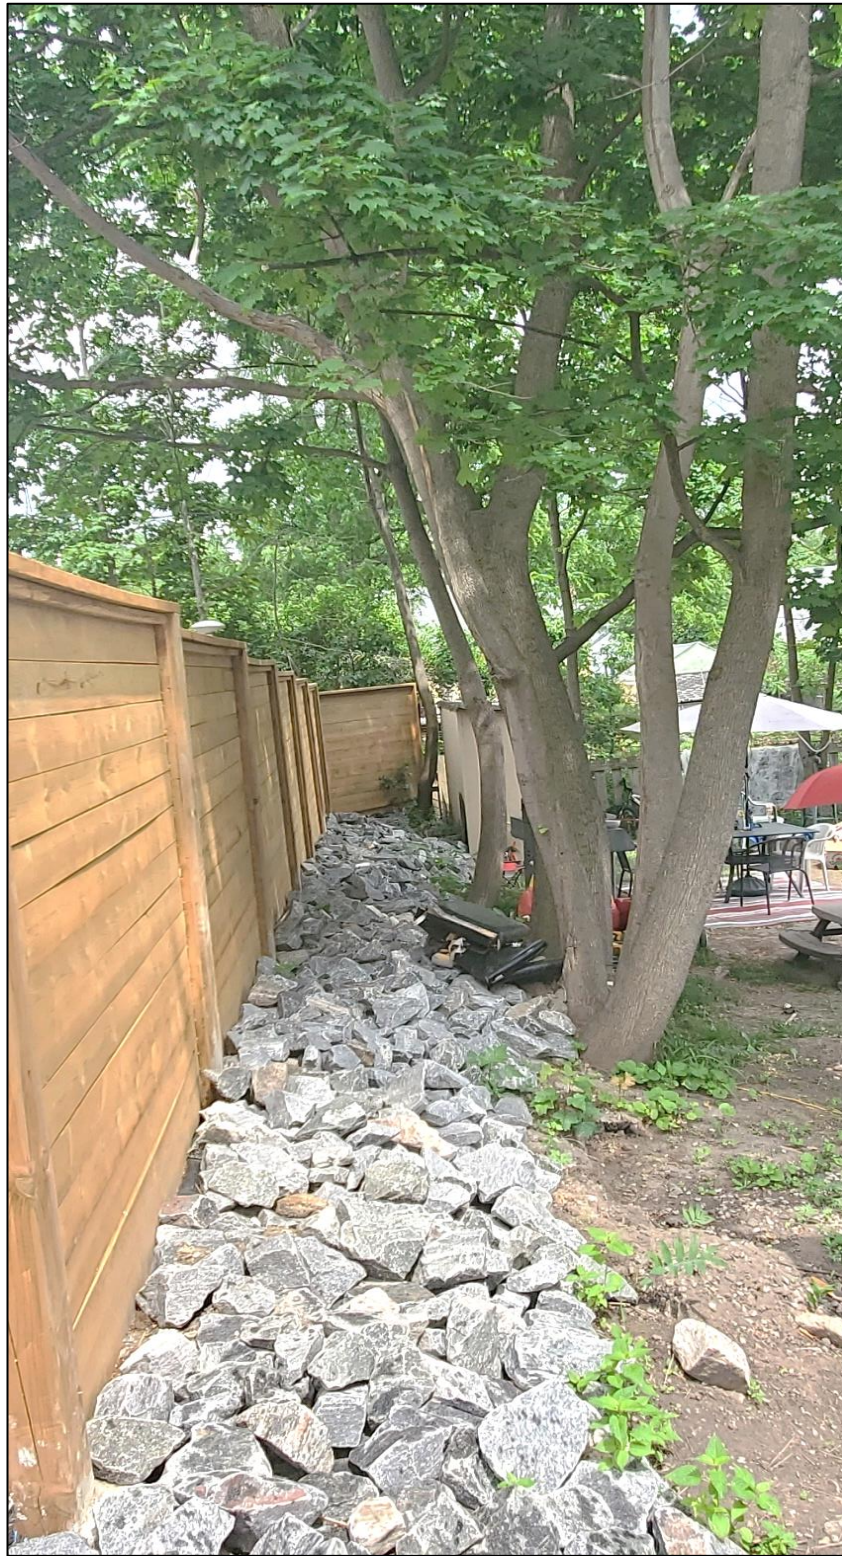
Also, LEGroup staff observed the four (4) offsite trees located along the south side of the subject site, onto residential property 215 Bayfield Street and were identified to be Tree D, E, F, G (Norway Maples). Prior to LEGroup staff field review, a board fence (mentioned in the proposed development site plan, **Appendix A**) was installed within the driplines of Tree D-F near the south property line (as seen in **Photo D, Appendix D**). These trees were observed to have slight phototropic leans over the subject site, deadwood, branch dieback and cobra canker (*Eutypella parasitica*) observed on Tree G lower branch.

**Photo D:** Tree D, E, F, G (Norway Maple), located onto residential property 215 Bayfield Street. Wooden fence and large stone (3m landscape buffer; Site Plan) constructed above the tree's root systems. Evidences of deadwood, epicormic branching and leans. Photo facing north.

- That trees located off-site (Tree A, B, & D-G) be protected to the extent possible and that tree preservation fencing be provided at the dripline of each tree which represents the tree preservation zone as shown on **TP-2** in **Appendix B**. Where tree preservation fencing cannot be established at the dripline, the tree preservation fence should be installed as far as practical from the trunk. The Arborist/Landscape Architect or qualified personnel is recommended to be on site during the erection of the tree preservation fencing for guidance;
