April 17, 2020
RS# 2019-195

SUBJECT: Tree Inventory, Assessment and Preservation Plan, 2 Arbour Trail, City of Barrie.

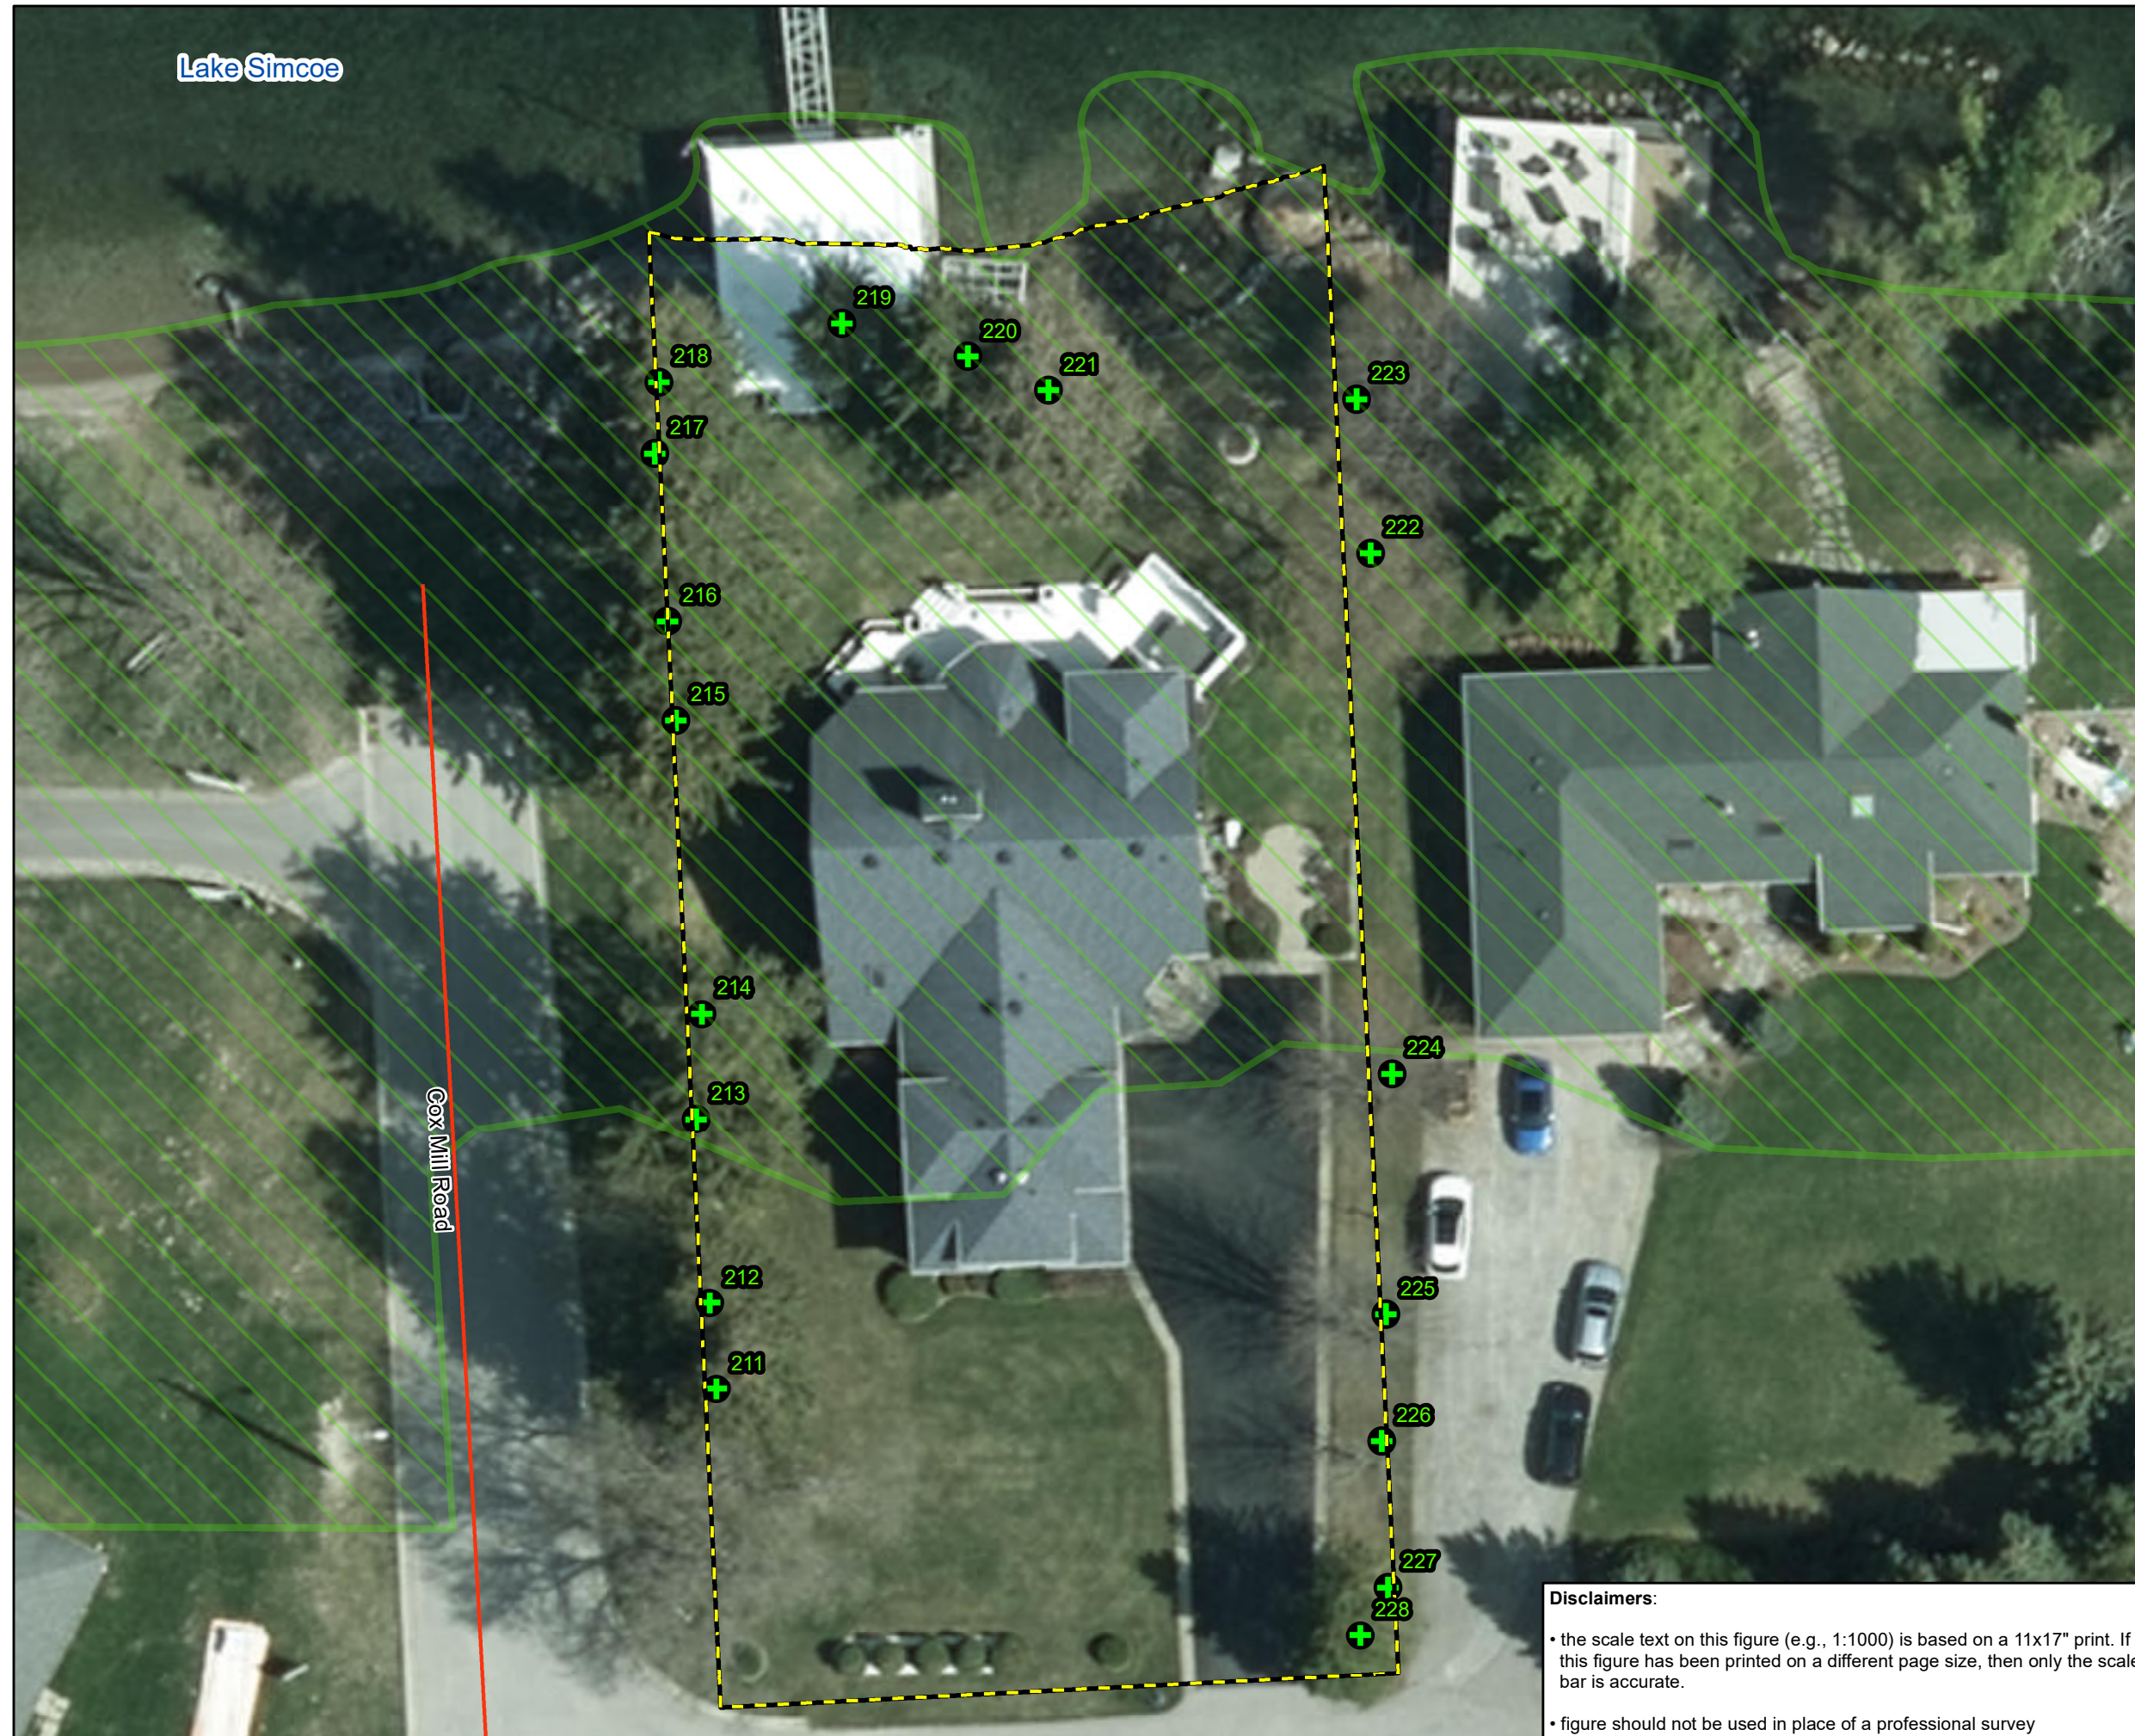
Figure 2. Tree Inventory.
2 Arbour Trail, City of Barrie.

The results of the tree inventory and health assessment are provided in **Appendix A**. The locations of all tagged and assessed trees specifying those > 10 cm DBH are shown in **Figure 2**.

Eighteen (18) trees >10cm DBH were tagged and assessed. Norway Spruce (*Picea abies*) was the most abundant tree assessed followed by Red Maple (*Acer rubrum*) and White Spruce (*Picea glauca*) all within the manicured area of the subject property. Overall, individuals are in good to fair health, with some exhibiting a range of defects. For safety reasons, the property owner should be reviewing these trees regularly to ensure the trees for

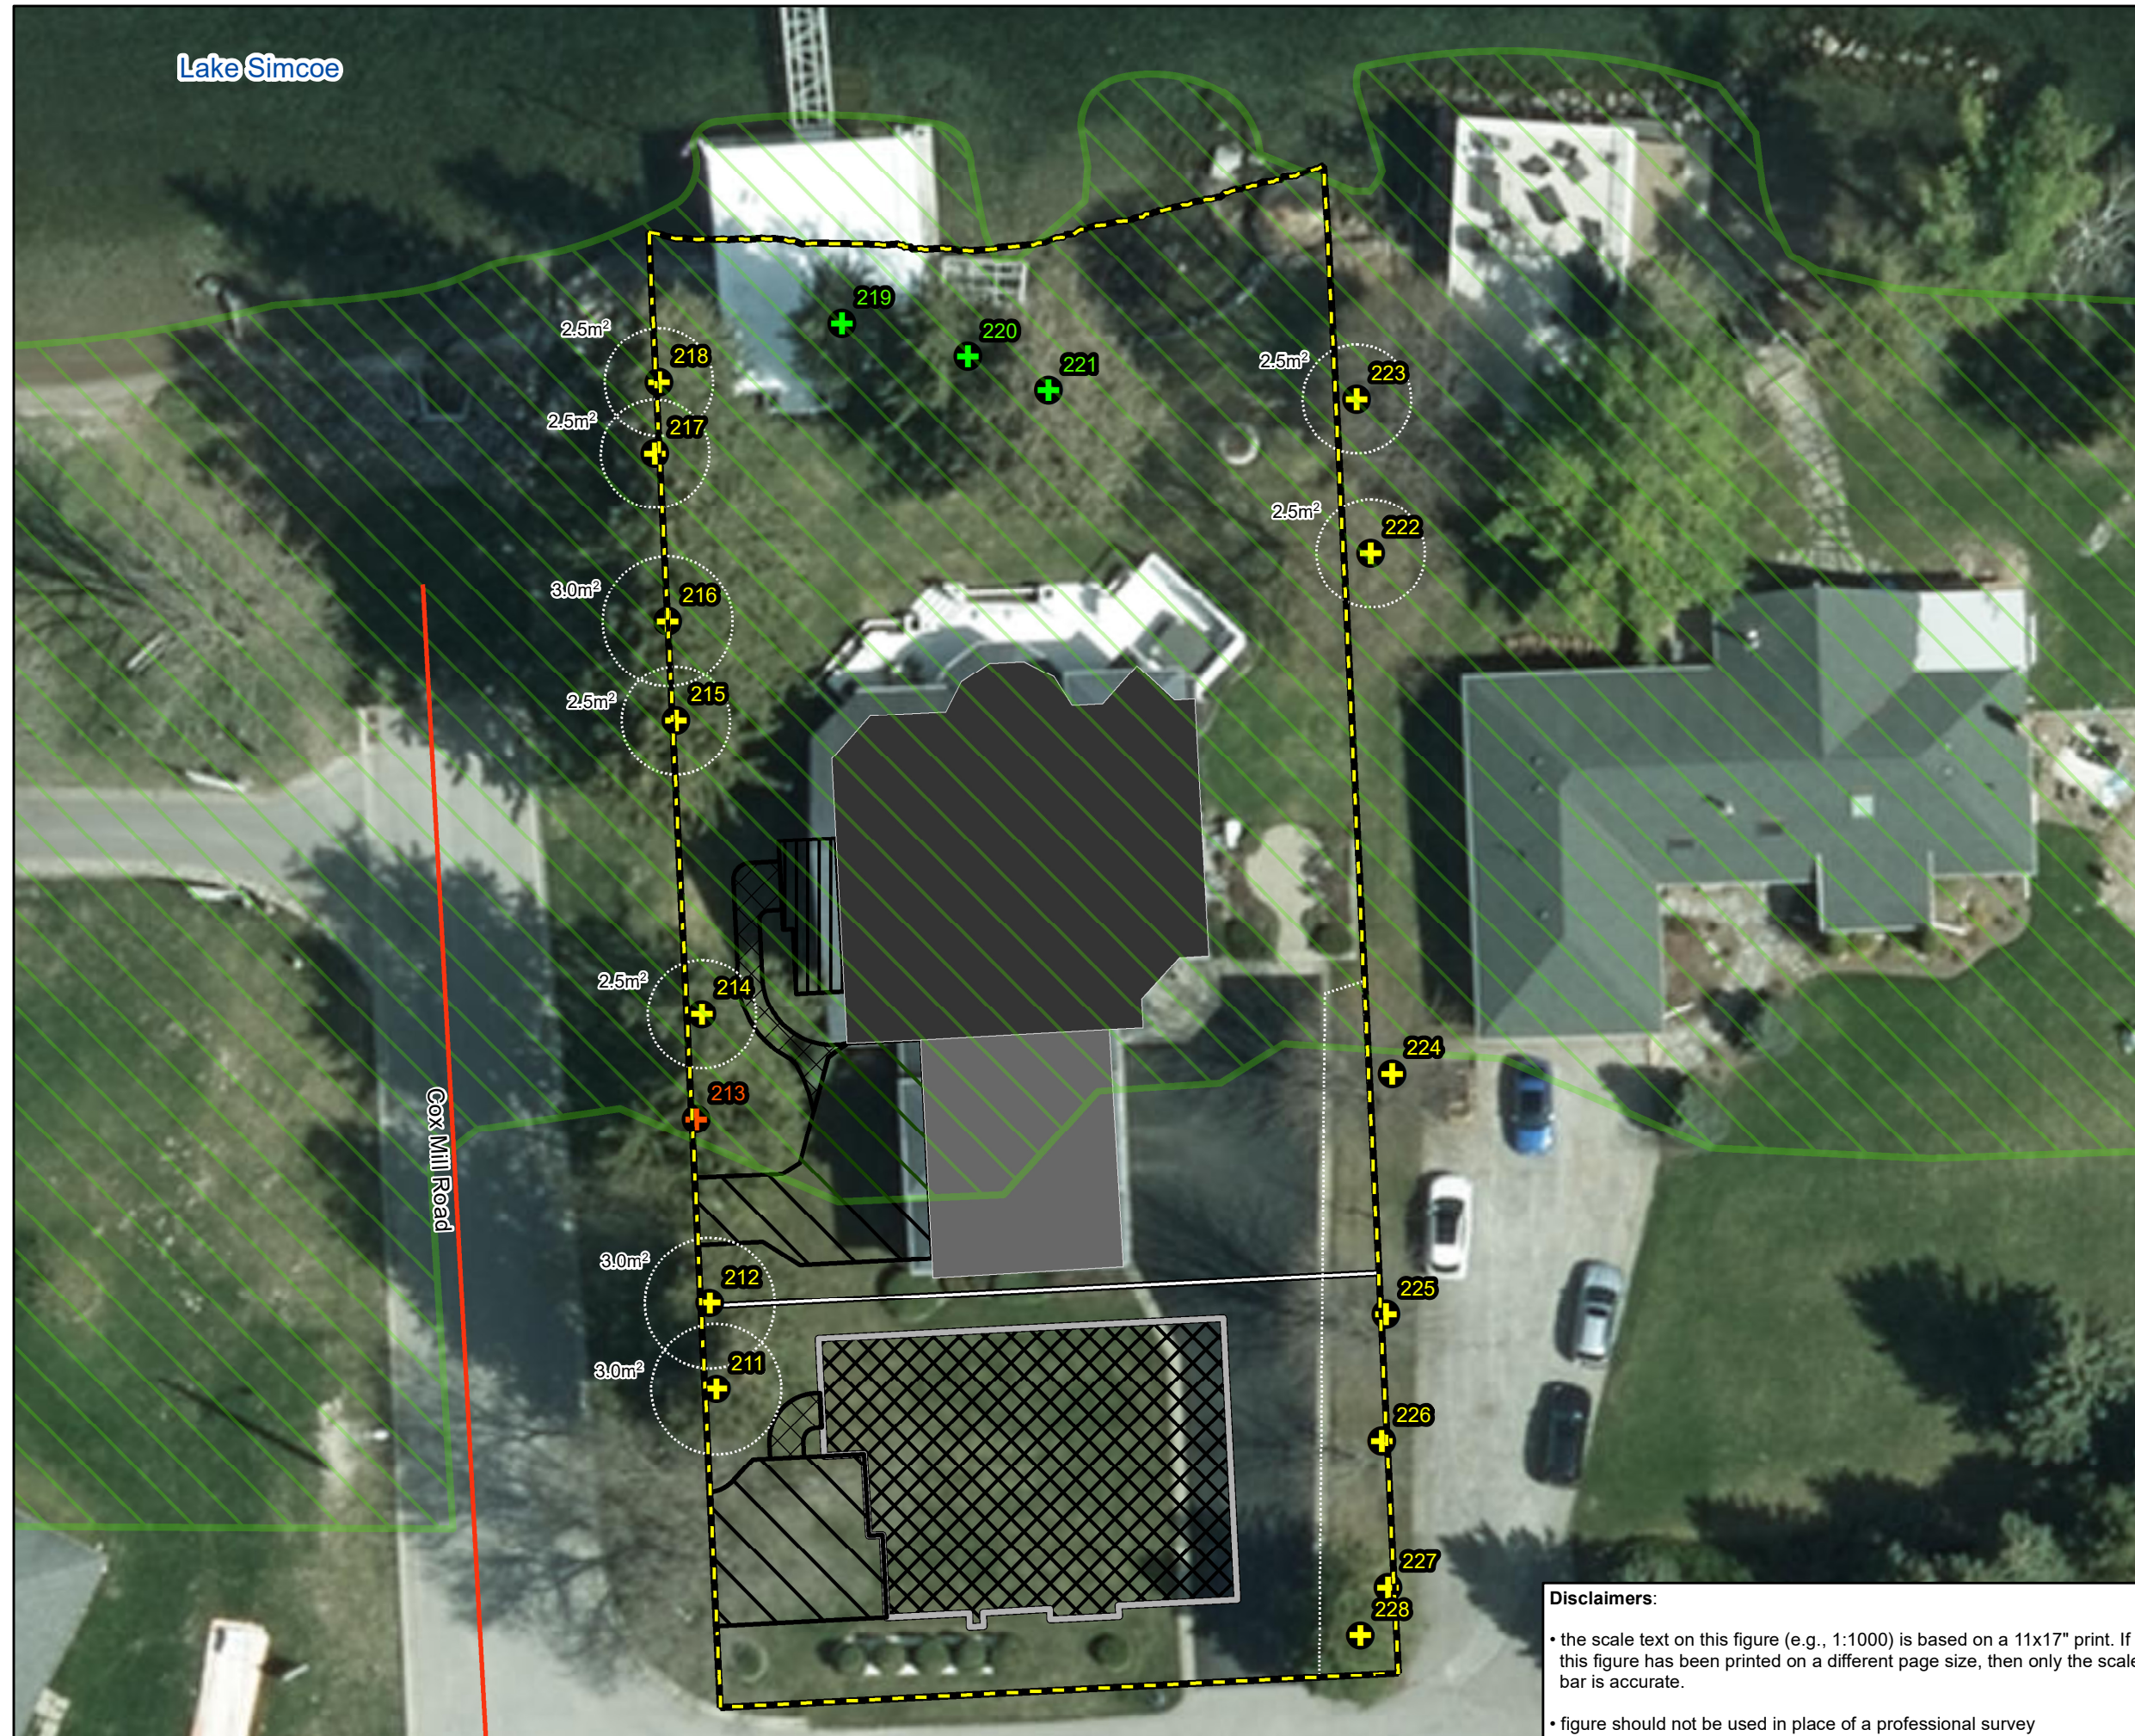
Figure 3. Tree Preservation Plan:
Site Features, Proposed Development, Constraints, Recommendations.
2 Arbour Trail, City of Barrie.

Figure 3 provides an overlay of the proposed building siting with RiverStone's tree preservation/removal direction. Based on discussions with the project team RiverStone one (1) tree may need to be removed during the project, as noted in **Appendix A**. In accordance with City of Barrie policy, consultation with neighbours would be required if work around boundary trees is to occur. As no grading limit was specifically defined, it was assumed that all trees within 3 m of the development may experience some damage to canopies and roots. These include trees 212, 212, 214, for the construction of a new driveway off Cox Mill Road into the existing garage and construction of a new dwelling and trees 224, 225, 226, 227, 228 during the removal of the existing driveway and site grading. The tree protection zone (TPZ) extends from the outside edge of the tree base. Based on the development plan provided only trees 212 and 214 have canopies that extend over walkways, driveways, and the proposed dwelling.

All trees that were inventoried were given a tree protection value as outlined in the City of Barrie Tree Protection Manual. Based on Step 9 of the manual, there are no endangered species and/or habitat or heritage trees on the subject property. Eight (8) boundary trees (211, 212, 213, 214, 215, 216, 217, 218) were located along the west property boundary and an additional seven (7) trees (223, 222, 224, 225, 226, 227, 228) along the east property boundary. These bordering trees either have canopy, or part-of or all the tree trunk growing on or overhanging the subject property. Consultation with neighbours would be required if work around boundary trees is to occur. All trees that occur along the east and west property boundaries have been given protection value of 2 until consent for removal has been secured. The City of Barrie's tree compensation plan is based on several factors including the health of the tree, species of tree, location of tree and current size of tree. For

- **Prior to removal of any trees, along the east or west property boundaries, consent from adjacent landowner will be required.**
- **Detailed redevelopment and grading plans for subject property consider all trees recommended for retention on Figure 3 as design constraints.**
