**407-419 MAPLEVIEW DRIVE INC - ENCORE GROUP**

**TREE INVENTORY, ANALYSIS AND PRESERVATION REPORT**

407 – 419 MAPLEVIEW DRIVE WEST  
CITY OF BARRIE, ON, COUNTY OF SIMCOE

JULY 2020  
REVISED OCTOBER 2021

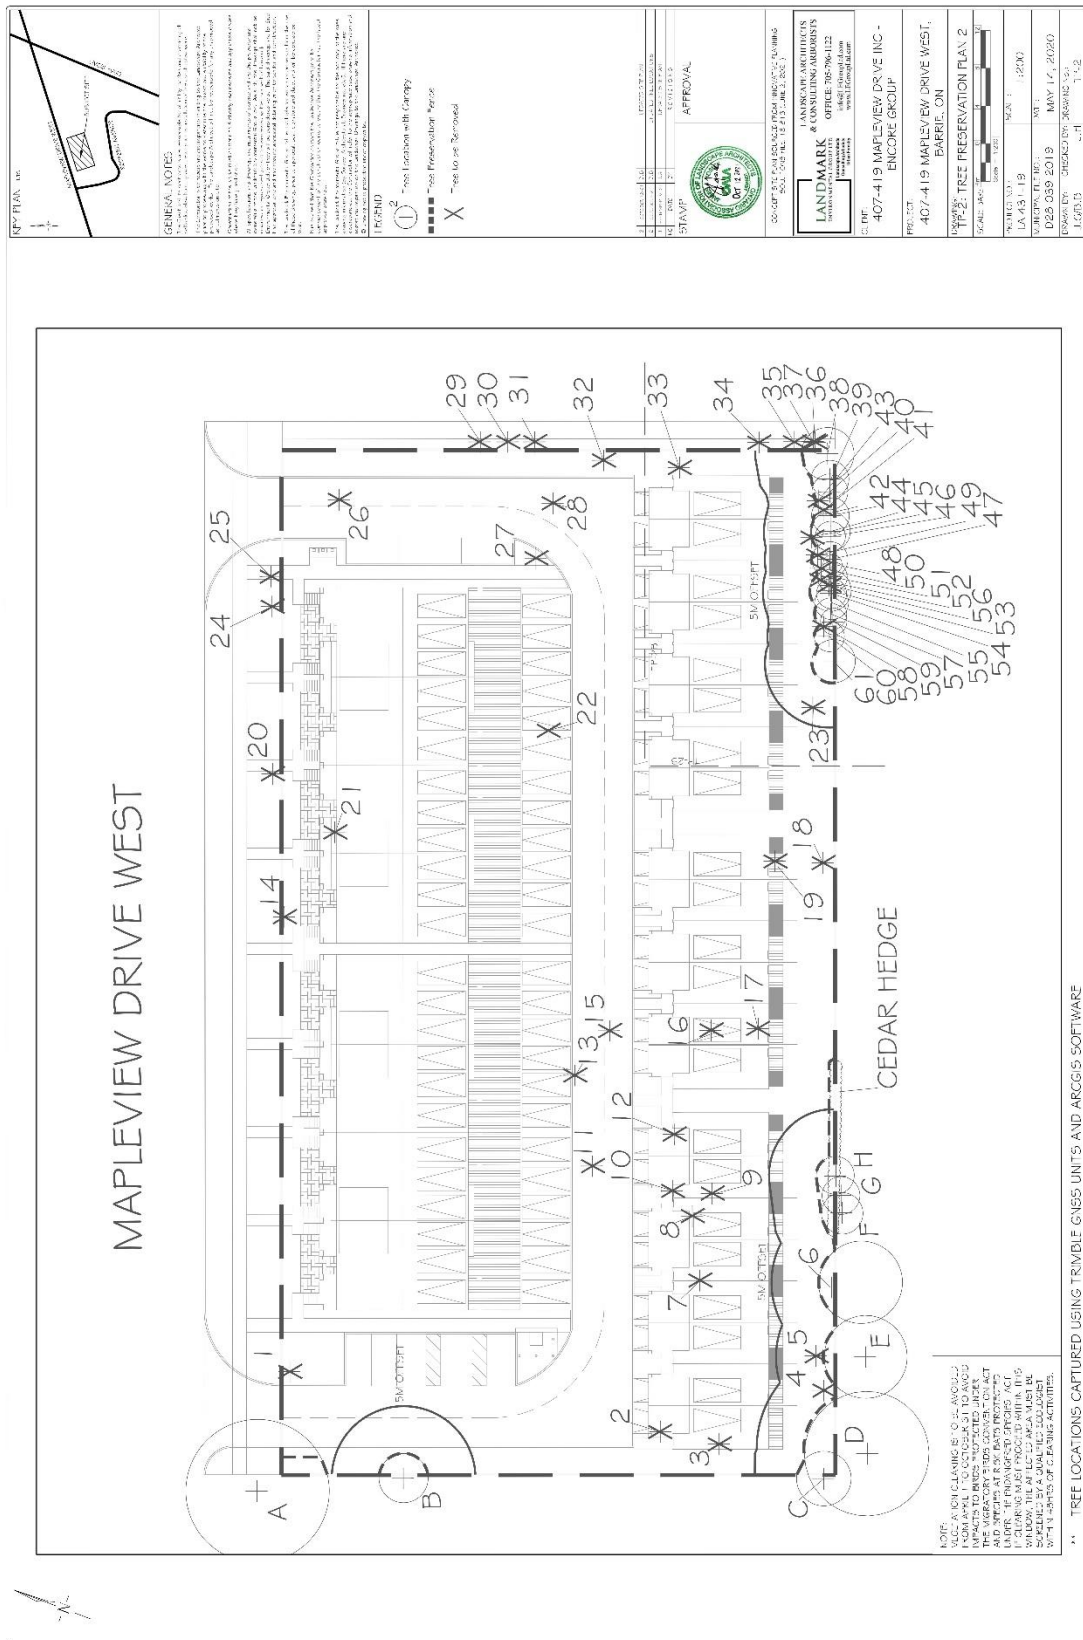
## Tree Inventory/Preservation Plan (TP-2)

LEGroup staff observed an existing cedar hedge located along the south lot line of the site, which is recommended to be retained and protected with tree protection fencing as shown on **TP-2** in **Appendix B**.

LEGroup staff note that although there is encroachment within the 5.0 m development setback (See **TP-2, Appendix B**), as outlined by the City of Barrie (*Tree Protection Manual, 2019*). LEGroup is of the opinion that the effects of encroachment will be negligible, as Tree nos. 38-40, 42, 44, 46-48, 51, 53-55, 57, 59-61 & C-H have canopies that are outside of the proposed grading zone and development works.

- Tree Nos. 20, 24 and 25 located on the City of Barrie right of way, are recommended to be removed as they cannot be adequately protected during development works as shown on **TP-2** in **Appendix B**.

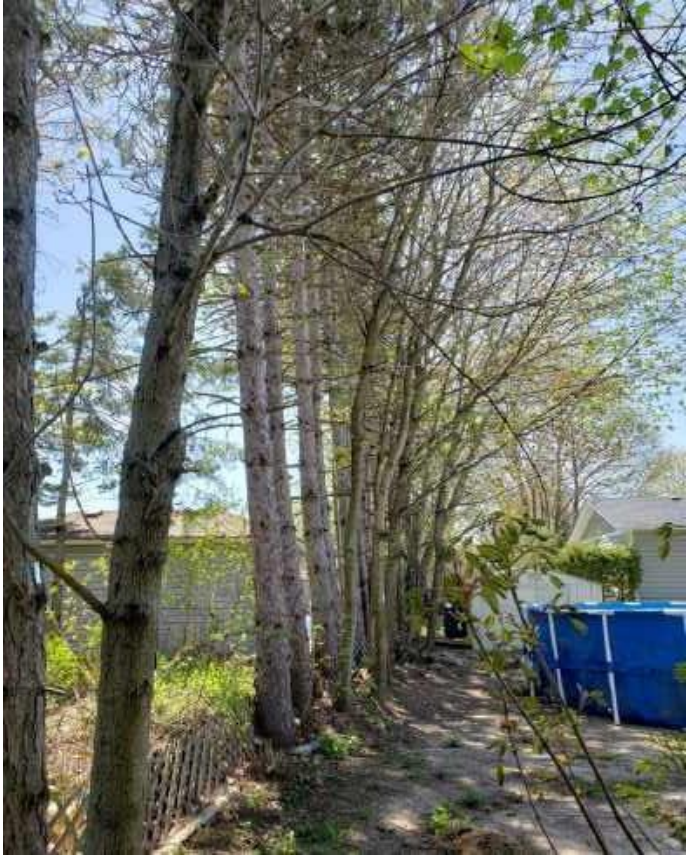
Staff note that Tree Nos. 41, 43, 45, 49, 50, 52, 56 & 58 along the south-east corner of the subject site were assessed to be in poor to marginal condition, with trunk lean, lower branch dieback, structural

deficiencies, and conflict with the proposed development. These trees are also recommended to be removed.

**Photo A:** Boundary trees to be retained along the south-east boundary (Tree Nos. 35, 37-40, 42, 44, 46-48, 51, 53-55, 57, 59-61) On site trees (Tree Nos. 36, 41, 43, 45, 49, 50, 52, 56, & 58) to be removed.

- Boundary Tree Nos. 6, 38-40, 42, 44, 46-48, 51, 53-55, 57, 59-61 are to be retained and protected with tree preservation fencing as outlined in **TP-1** and **TP-2, Appendix B**, and monitored during and post-construction;

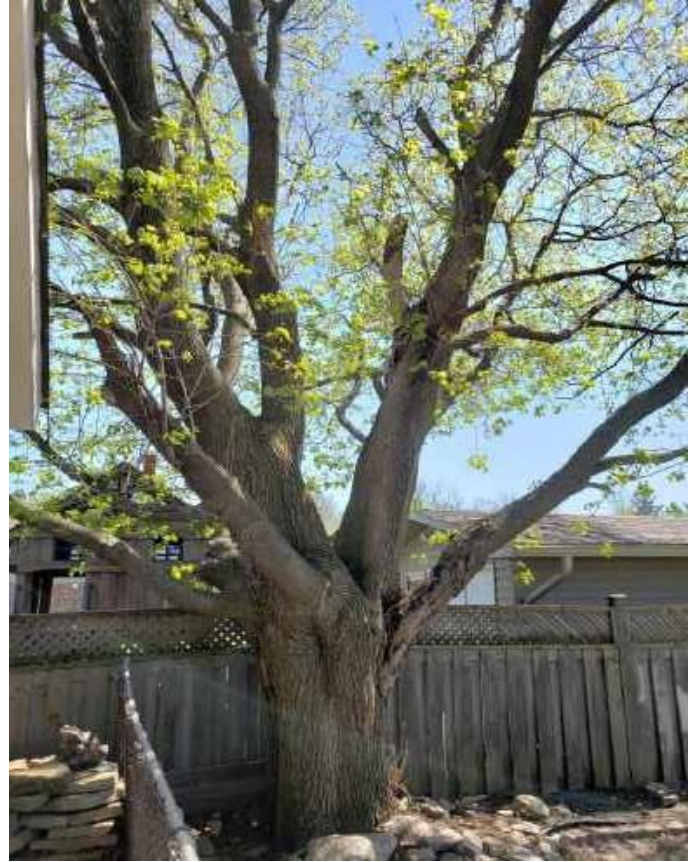
LEGroup staff note that Tree Nos. 18, 19, 21-23, 26-37 are growing on the east side of the site and many of their canopies to varying degrees, conflict with the proposed building footprint. These trees are recommended to be removed. These trees contain many defects such as bark necrosis, included bark, basal cracks, exposed roots, and root damage.

| ONSITE TREE INVENTORY | | | | | | |
|---|---|---|---|---|---|---|
| 18 | Acer platanoides | Norway Maple | 94 | cavities in trunk, suspected interior decay, dieback, branch crossover, included bark | 2 Marginal | 7.7 |

**Photo B:** Showing a tree (Tree No. 18) near the south-west fence to be removed.

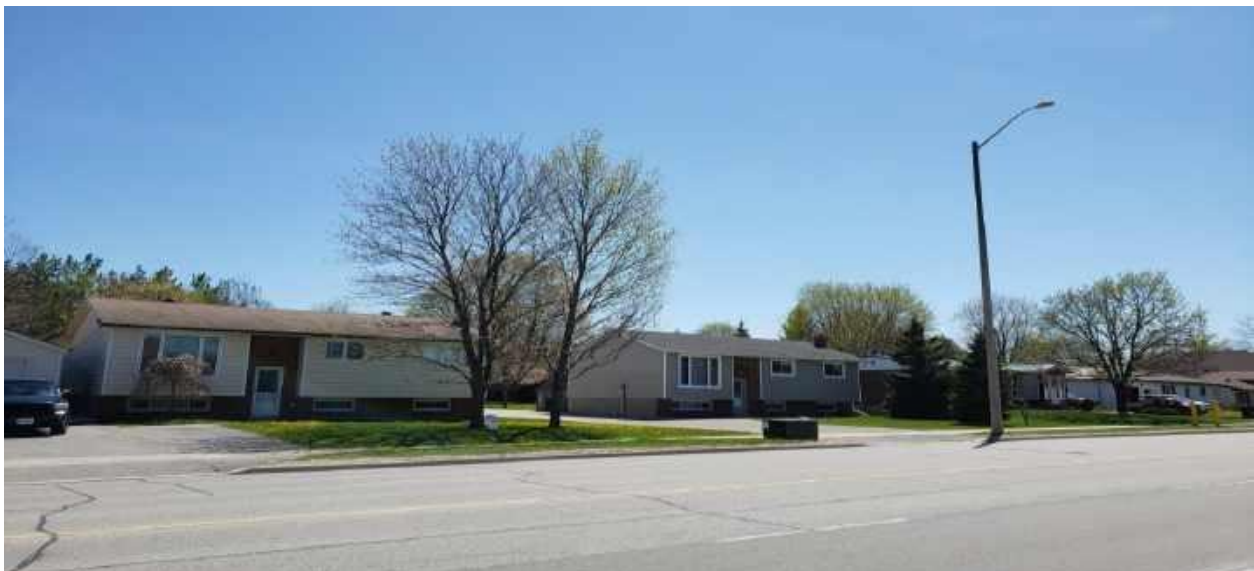
LEGroup note Tree Nos. 20, 24 and 25 located on the City of Barrie Maplevue Drive West Right of Way, are recommended to be removed as they cannot be adequately protected during development works (**TP-1 and TP-2** in **Appendix B**).

| ONSITE TREE INVENTORY | | | | | | |
|---|---|---|---|---|---|---|
| 24 | Acer platanoides | Norway Maple | 27.8 | epicormic branching, branch crossover, multiple leaders | 2 Marginal | 4.6 |
| 25 | Acer platanoides | Norway Maple | 39 | multiple leaders, included bark, dieback, branch crossover | 2 Marginal | 5.7 |

**Photo C:** Showing trees (Tree Nos. 24 & 25) which are boulevard trees on municipal property recommended for removal

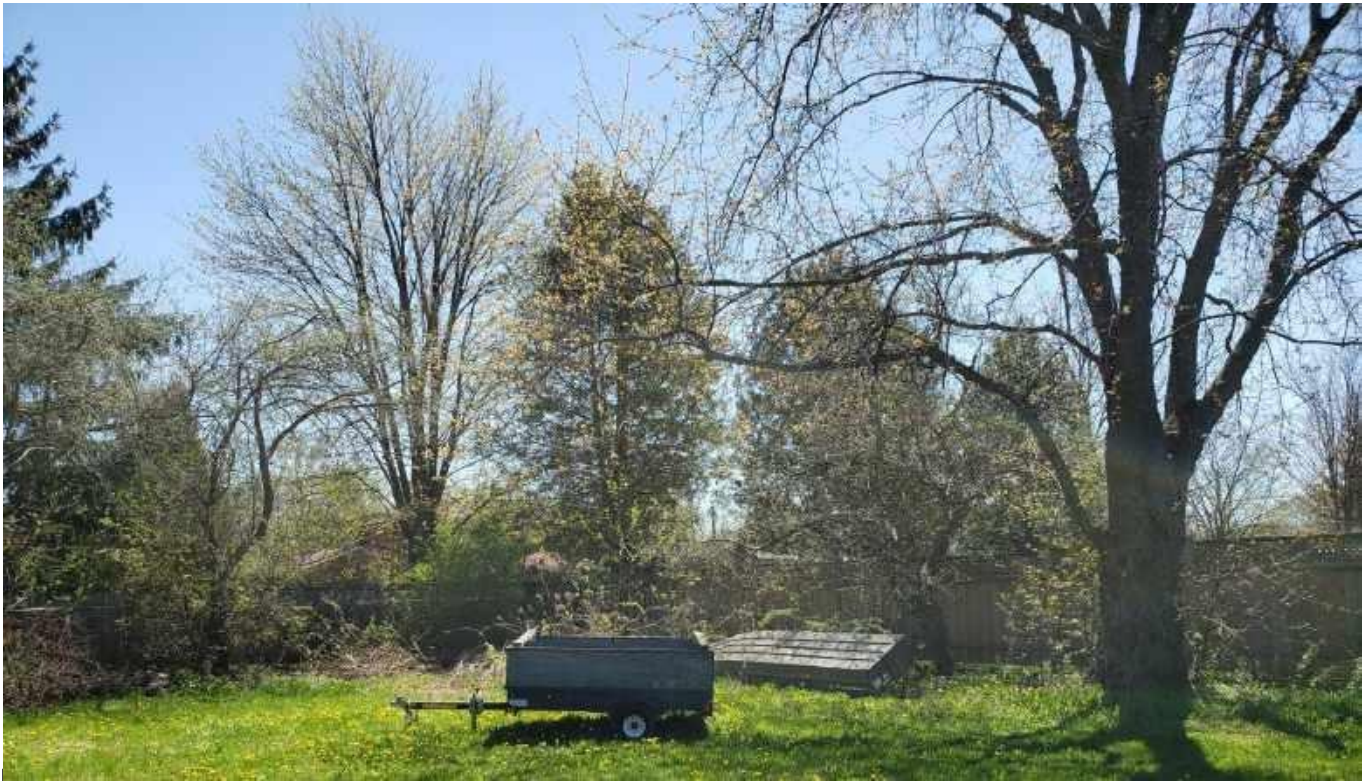
LEGroup staff are of the opinion that 16 (Tree Nos. 1-5, and 7-17) of the 17 existing trees located toward the west side of the site are in poor to marginal condition (with one exception being in fair condition), conflict with the proposed development, and are of limited aesthetic value to be retained. The majority of these trees have several defects as outlined in the Tree Inventory table (**Appendix C**). Additionally, many have signs of girdling roots, significant dieback, embedded fences, and basal trunk cracks that create concerns over their structural soundness. We therefore recommend that these trees be removed.

| ONSITE TREE INVENTORY | | | | | | |
|---|---|---|---|---|---|---|
| 4 | Malus ssp | Common Apple | 27.2 | dual leader, dieback, suspected interior decay, branch crossover | 2 Marginal | 2.2 |
| 5 | Malus ssp | Common Apple | 27.2, 32.2 | included bark, dieback, large trunk wounds basal crack, included bark | 1 Poor | 5 |

**Photo D:** Showing tree (Tree Nos. 4-5) to be removed in the southwest corner of the site.

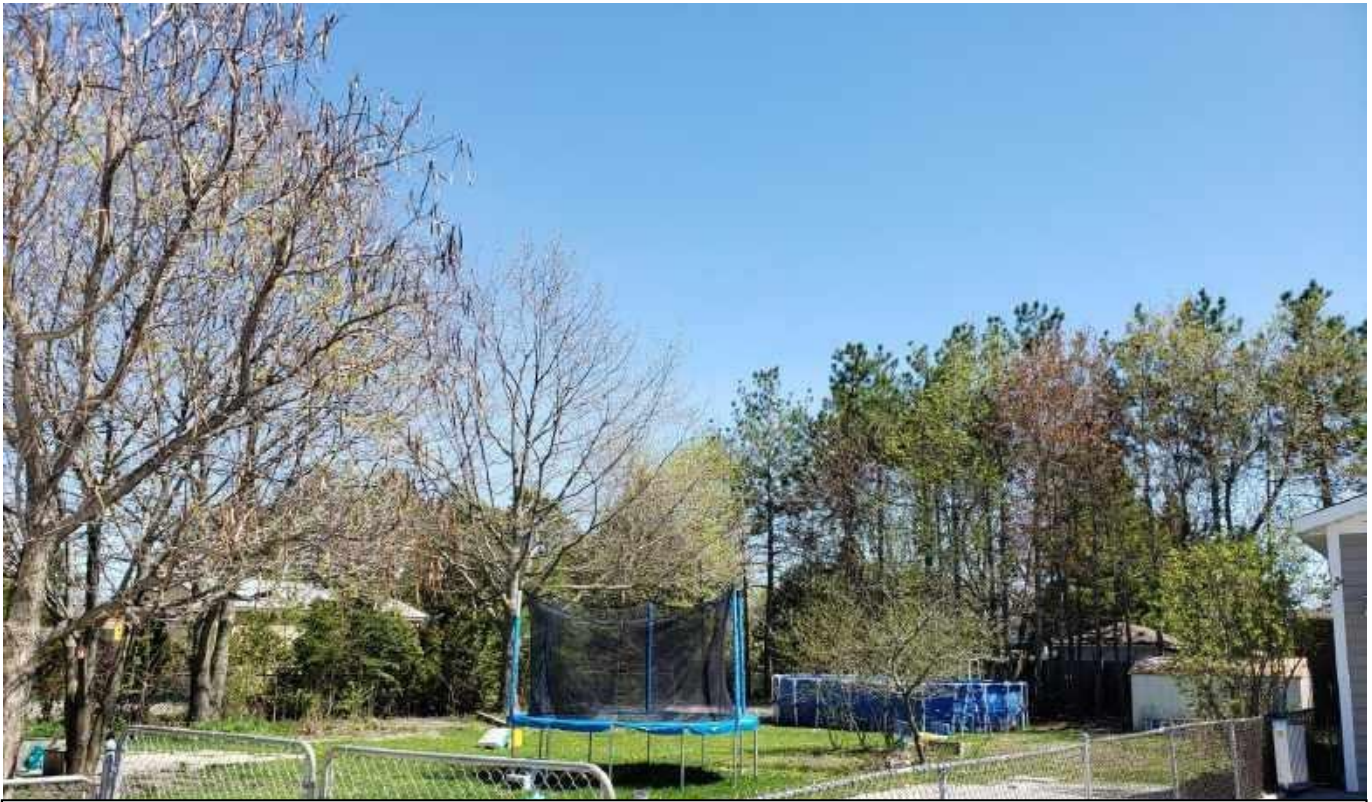
**Photo E:** Showing trees along the south and east boundaries with defects and compacted soil beside the park path on the east side, in the backyard of what is currently 407 Maplevue Drive.
