**428 Little Avenue  
Barrie, Ontario**

**Arborist Report  
428 Little Inc.**

**November 2019  
SLR Project No.: 209.40465.00000**

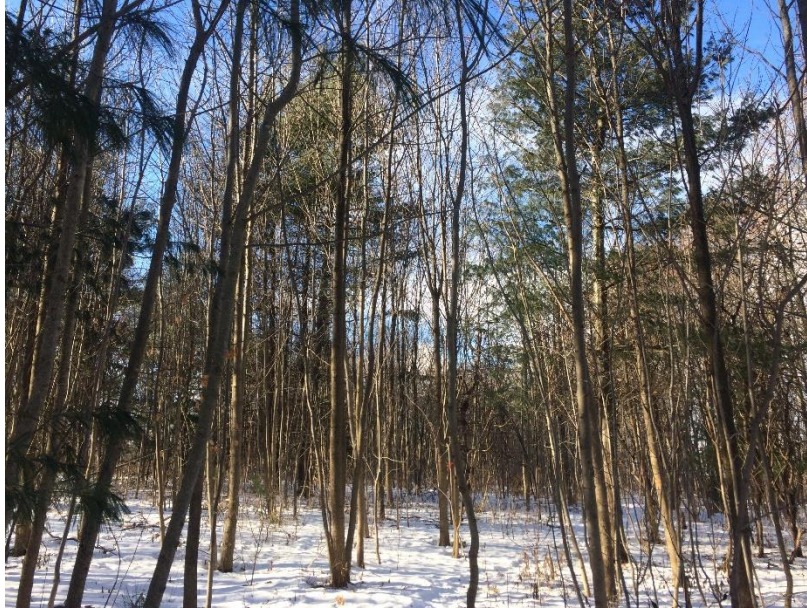
All the trees within the central portion of the property require removals to accommodate the grading and servicing necessary for the proposed development. Ash trees are the dominate species within this area, average 10 cm DBH with Emerald Ash Borer evidence prevalent. A few mature Pine trees will need to be removed to accommodate the house foot prints, grading and servicing (water and sewer).

Photograph 1. Representative photo of trees within the Central Property Area.

**Preservation Value – Low.** Removals are outlined on the accompanying TPP, Tree Inventory Table and summarised in Table 1 below.

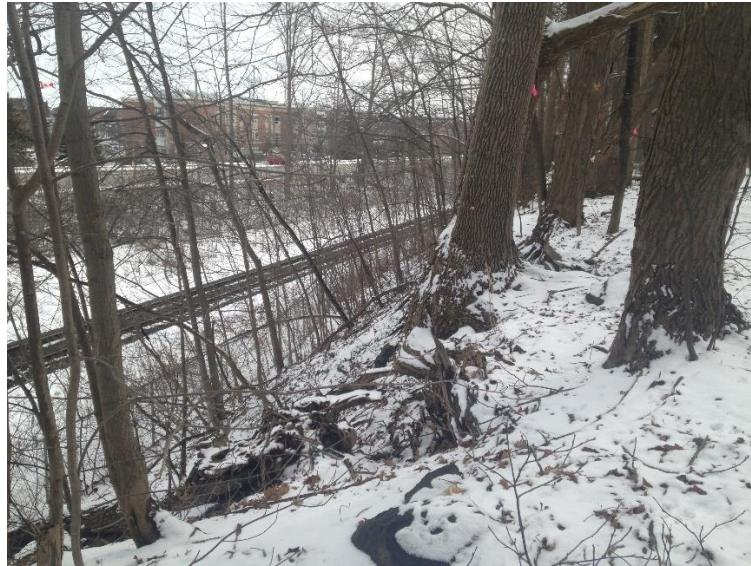
Several mature Oak's (40cm, 60cm, and a few over 100 cm DBH) occur within this area and will be preserved as part of the proposed plan. These trees also represent suitable roost habitat for bats and should be protected. The sidewalks, parking areas, garbage receptacles and bioretention cells have been adjusted as much as possible to maintain an approximate tree preservation zone of a minimum of 8 - 10 m for the large trees (measure from the outermost edge of the trunk). This captures the majority of the tree's driplines and root zones. Landscaping is also limited within this area and no amenity areas (e.g. trails, parks) are proposed to protect trees from root compaction. Working with Crozier & Associates a limit of grading and disturbance was established to assist in evaluating feasibility for protection. The grading plan dated September 4, 2019, and the TPP reflects this limit where no grading or earth works will occur. This limit will also serve as an interim Tree Preservation Fence (TPF) limit (hoarding) until after construction. A permanent chain-link fence (requested by Metrolinx) is to be installed along the Top of Slope. This fence will require field fitting on site to ensure no tree roots are impacted by the installation of posts. The permanent fence will generally follow an existing compacted informal trail which traverses the edge limits of the property.

Photograph 2. Representative view of mature trees at top of slope.

It will be important to consider alternative means for managing hazard risks (such as cabling or bracing limbs) and by implementing preventative measures to reduce hazard potential other than full tree removal (unless absolutely necessary). Mature trees are important to protect and may also provide roost habitat for SAR Bats. A management plan prepared in consultation with Metrolink, City of Barrie and the owner of the Condo Corporation should be developed for the Mature Oaks and Maple to be preserved along the Top of Slope.
