**505, 511, 515 & 533 YONGE ST, BARRIE DEVELOPMENT  
TREE INVENTORY, ANALYSIS, AND PRESERVATION REPORT**

505, 511, 515 & 533 YONGE ST., BARRIE

DECMEBER 2021

MUNICIPAL FILE: D28-008-2021

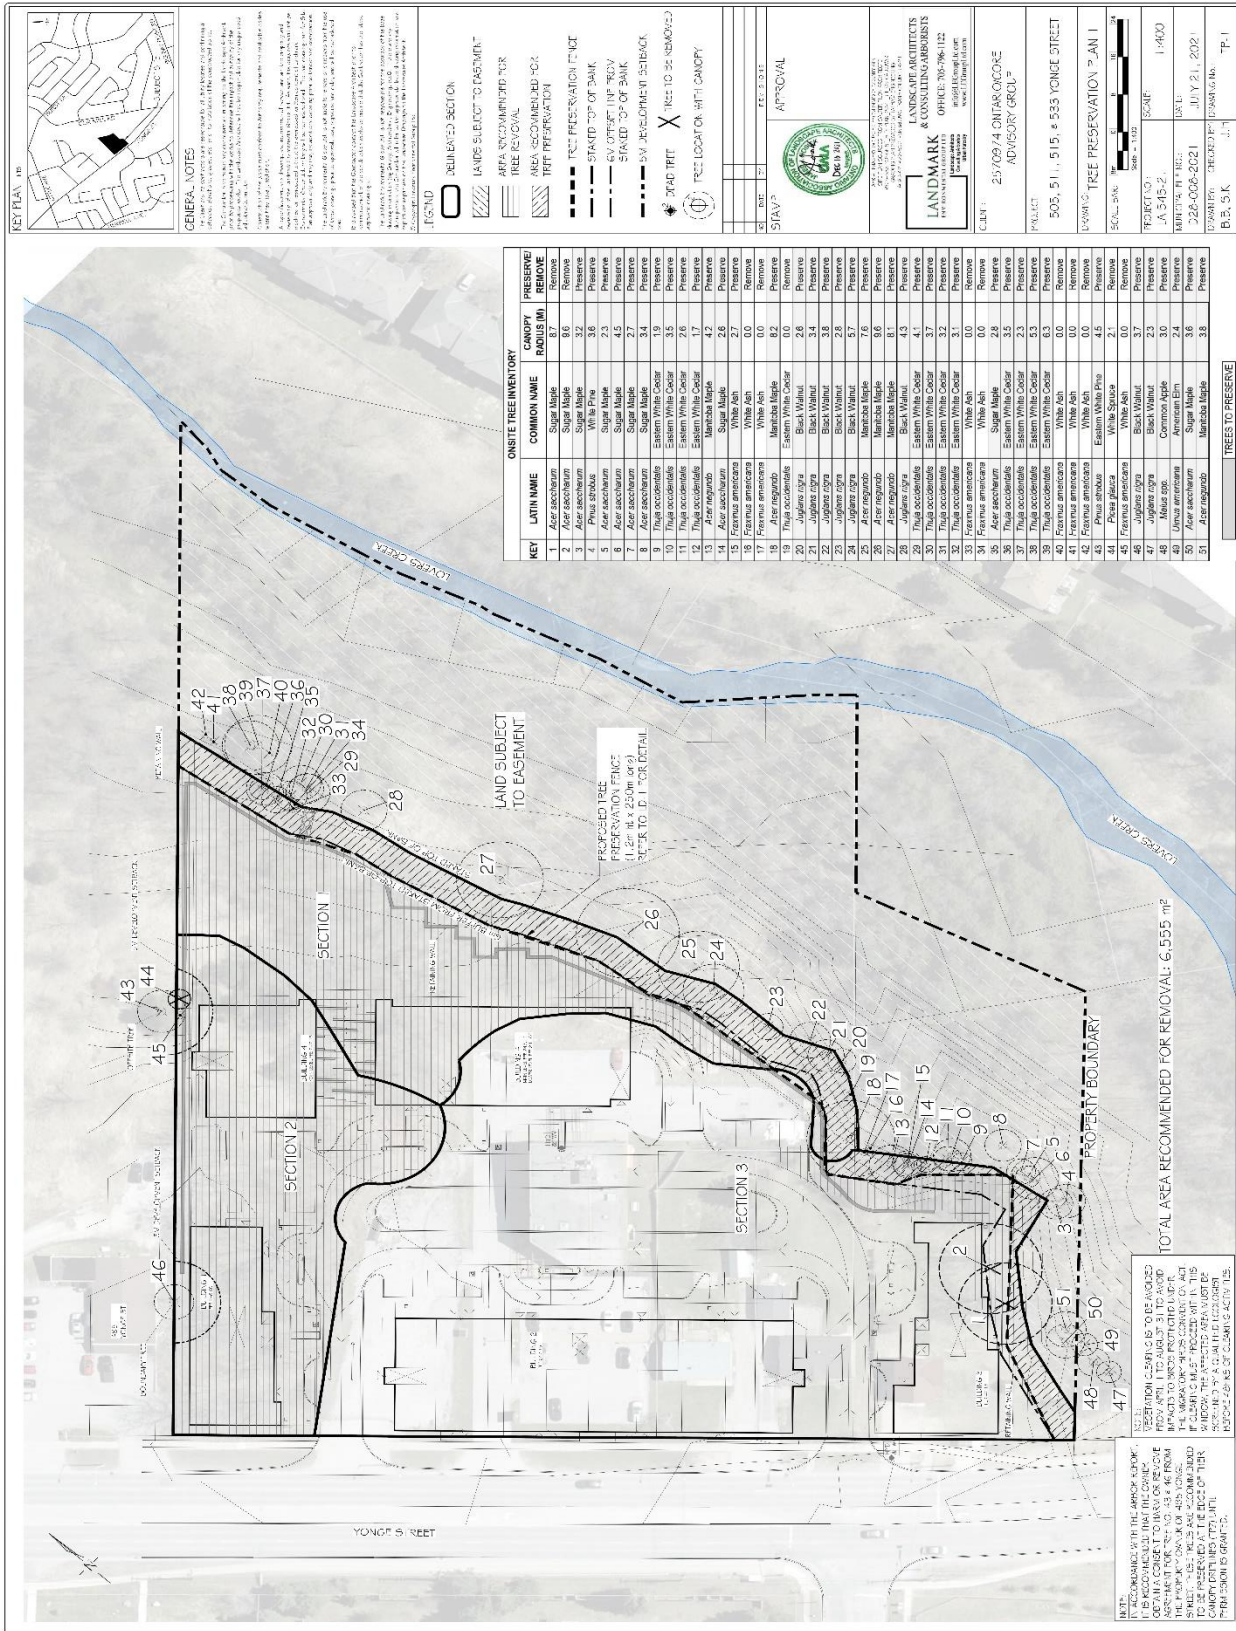
## Tree Preservation Plan 1 (TP-1)

LEGroup staff observed fifty-one (51) trees during the canopy survey and are recommending the preservation of thirty-nine (39) live trees (Tree nos. 3-15, 18, 20-32, 35-39, 43 & 46-51) along the LSRCA Top of Bank line and along the north property line delineated in **TP-1 and TP-2**.

LEGroup observed nine (9) dead trees (Tree nos. 16, 17, 19, 33, 34, 40, 41, 42, & 45) along the LSRCA top of bank that are recommended for removal to increase the aesthetics in the area and to reduce potential tree failures in the future.

After review of the subject site grading plan, LEGroup notes that there are grading activities proposed to encroach the canopies of Tree No. 43, 44, 45 & 46 (see **TP-1 & TP-2, Appendix B**). Tree No. 44 & 45 are located onsite along the north property and are recommended for removal as there is a proposed retaining wall located inside the canopy of Tree No. 44 and Tree No. 45 is dead. Tree No. 43 is located offsite on 495 Yonge Street and Tree No. 46 is located on the shared property line. LEGroup recommends the applicant to obtain signatures from the owners of 495 Yonge Street for their consent to harm or remove Tree No. 43 & 46 and to encroach the 5m Development Setback line as set out on **TP-1 & TP-2** (as per City of Barrie detail *BSD-1235*). Tree No. 43 & 46 are to be preserved with tree preservation fencing at the edge of their dripline. The recommendations for preservation/removal noted above can be reviewed in **TP-1 and TP-2, Appendix B**.

- That Tree nos. 3-15, 18, 20-32, 35-39, 43 & 46-51 in the north east portion of the site within the LSRCA setback and along the north properties line are to be protected with tree preservation fencing at the edge of the trees dripline as shown on **TP-1 & TP-2 in Appendix B**;
- That Tree nos. 1, 2, 16, 17, 19, 33, 34, 40, 41, 42, 44 & 45 Trees captured in the canopy survey conflict with the proposed development, or are dead, are recommended for removal as delineated in **TP-2 & TP-2 in Appendix B**;
- That trees in Sections One to Three conflict with the proposed development envelopes and possess low intrinsic value, are recommended for removal as delineated in **TP-1 & TP-2**. The detail for tree

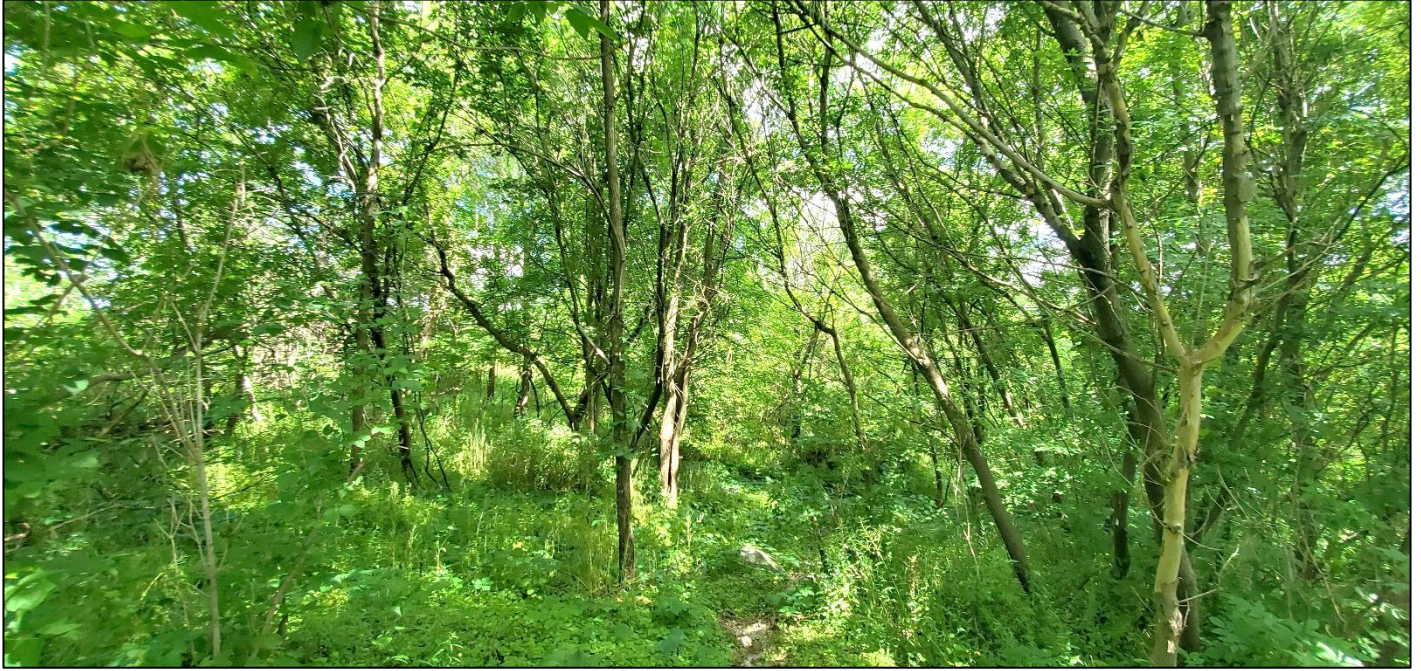
Willow, Birch, Red Cedar and White Spruce. LEGroup staff observed two (2) separate cohorts type comprised of a mature canopy, and intermediate canopy trees. The mature canopy trees consisted of White Spruce and a few Black Willows with an average DBH of 30-40cm. The intermediate canopy trees consisted of Manitoba Maple and Black Walnut with an average dbh of 15-25cm. Advanced and small regenerative trees were commonly observed to thrive in area of canopy gaps and primarily consists of White Ash, Manitoba Maple, Black Cherry, Black Walnut and Norway Maple. A typical view of Section One can be seen in **Photo A, Appendix D**.

**Photo A:** Section One (1), photo taken looking east towards Lovers Creek Channel. A typical view of the Section's woody plant materials.

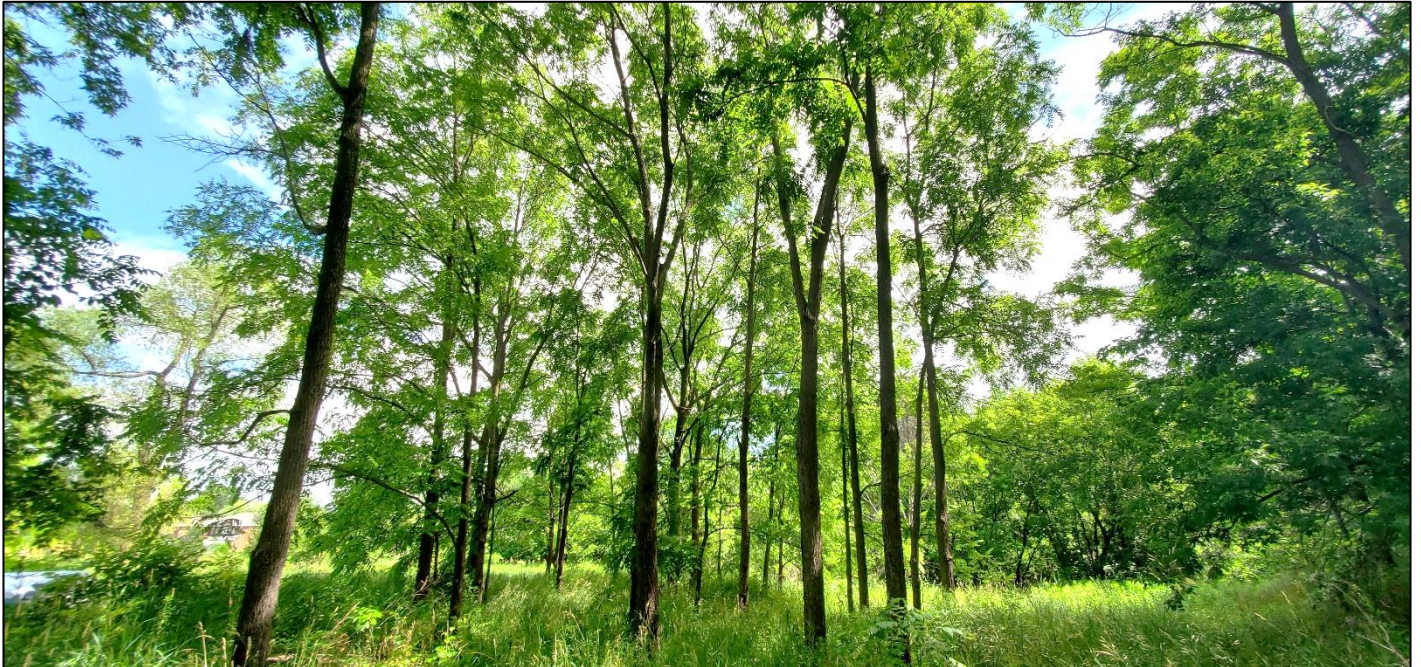
LEGroup staff observed Section Two to be located in the north west corner of the subject site. This Section is dominantly comprised of Black Walnut and to a lesser extent, Manitoba Maple and Black Locust. Sugar Maple and American Elm were observed to be randomly present in Section Two. LEGroup staff observed two cohort types in Section Two which is comprised mainly of intermediate canopy trees and one (1) mature Black Walnut. The intermediate canopy trees consisted of Black Walnut, Manitoba Maple and Black Locust with an average DBH of 15-25cm. Advanced and small regenerative trees were commonly observed to thrive in area of canopy gaps which primarily consisted of Manitoba Maple, Black Cherry, American Elm, and Black Locust. A typical view of this Section can be seen in **Photo B, Appendix D**.

**Photo B:** Section Two (2), photo taking looking north west toward adjacent commercial property (495 Yonge Street). A typical view of the Section's woody plant material.

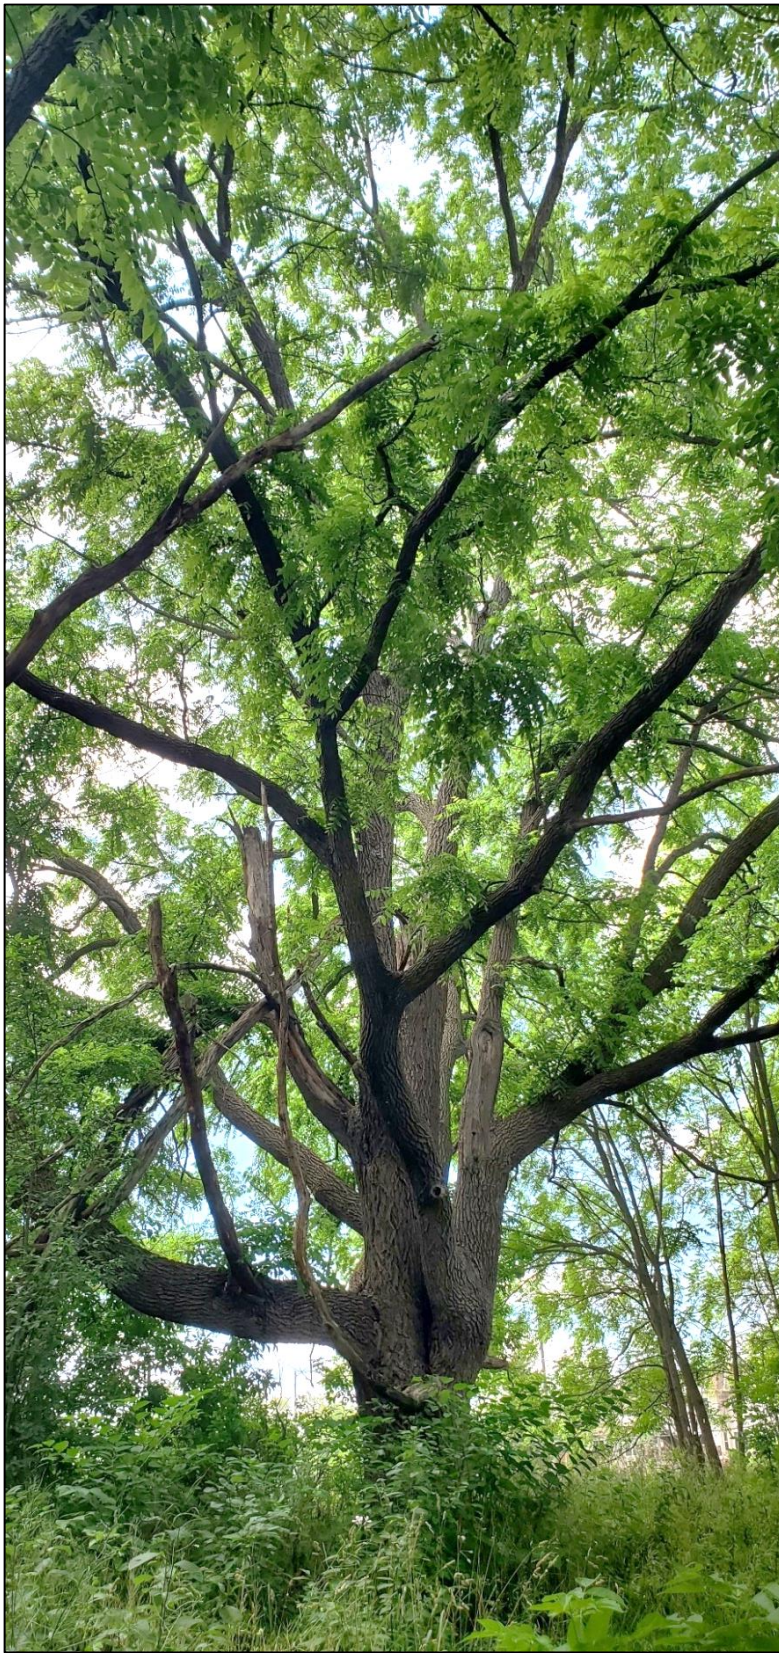
LEGroup staff observed one (1) mature Black Walnut with signs of interior decay due to the accumulation of water within the tree's main union, causing the tree to have a weaker structure and can be prone to failure during severe weather. The Black Walnut is located approximately in the center of Section Two, close to the adjacent parking lot. The damage observed by LEGroup staff indicates a compromised in the tree's structural integrity and vigor (branch die-back, large dead limbs and defoliation) (see **Photo C, Appendix D**).

**Photo C:** Section Two (2), Black Walnut potential interior decay at leader's union. Photo taking looking south towards Yonge Street.

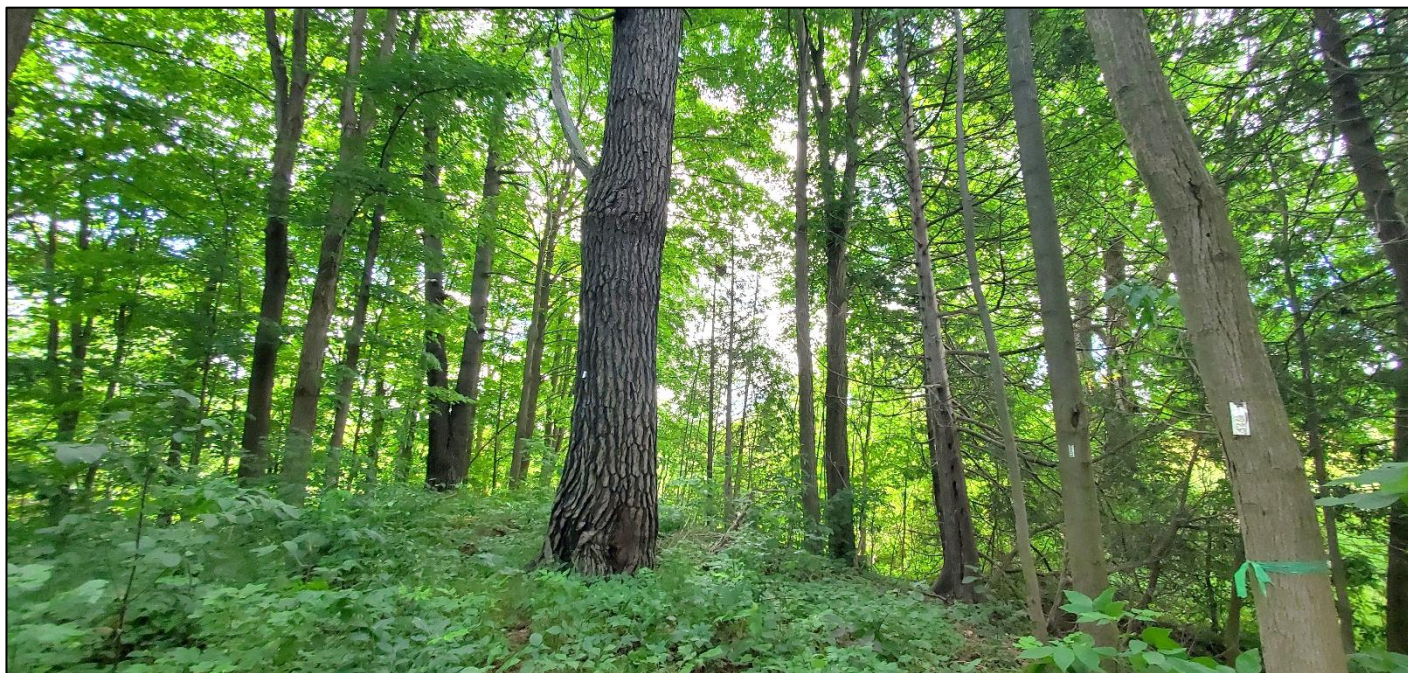
Section Three is located near the south east corner of the subject site. This Section is mainly comprised of Eastern White Cedar, Eastern White Pine, Sugar Maple and to a lesser extent, White Ash and American Elm. In this Section, LEGroup staff observed three (3) separate cohorts type comprised of mature canopy trees, and intermediate canopy trees. These trees consisted of large Eastern White Pines with a DBH of 75-85 cm. The mature canopy trees consisted of Sugar Maples with an average DBH of 35-45 cm. The intermediate canopy trees consisted of Eastern White Cedar, American Elm and White Ash with an average a DBH of 15-25 cm. Small regenerative trees and shrubs were commonly observed to thrive in area of canopy gaps and primarily consisted of White Ash and Black Cherry. A typical view of this Section can be seen in **Photo D, Appendix D**.

**Photo D:** Section Three (3), photo taking looking east. A typical view of the Sections woody plant material.

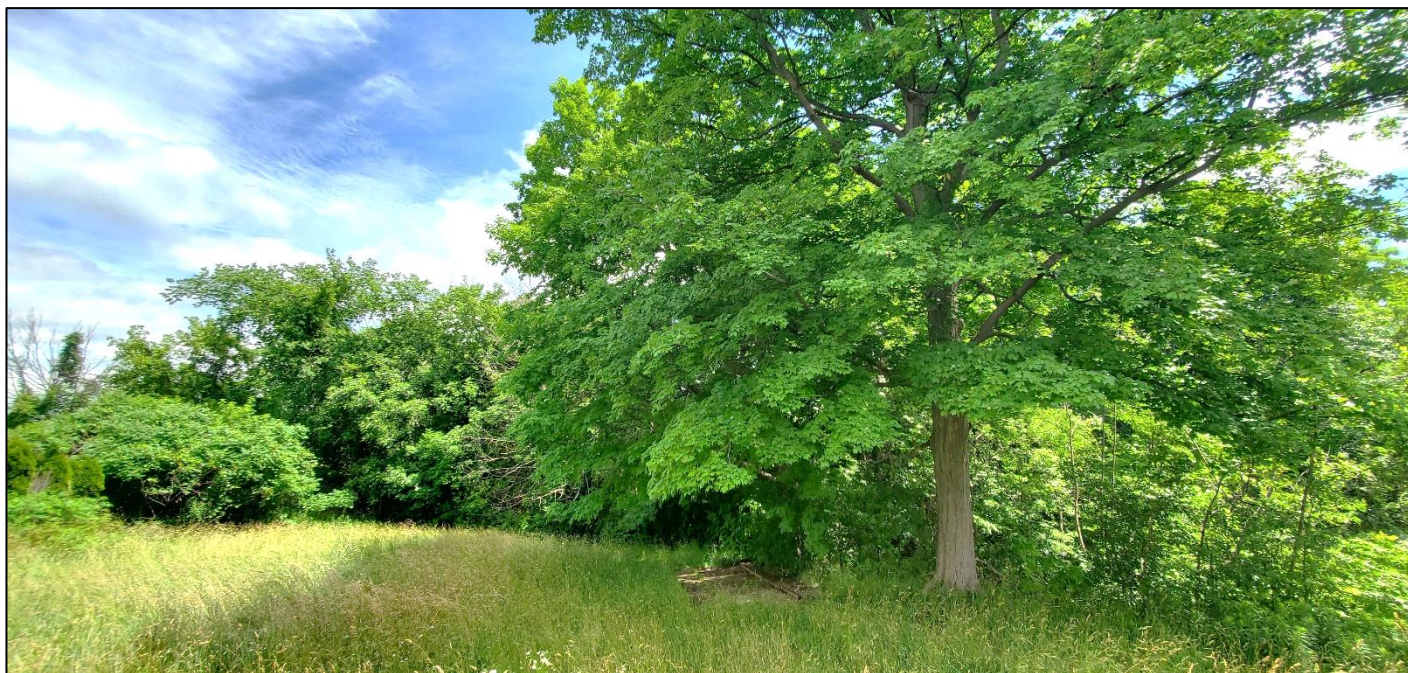
LEGroup observed two (2) onsite trees (Tree nos. 1, & 2) along the south LSRCA Top of Bank line that conflict with the proposed development and have an existing concrete septic tank located underneath their canopies (see **Photo E, Appendix D**). With development works proposed to occur in Tree No. 1 & 2 driplines and the decommissioning works of the existing concrete septic, LEGroup recommends these trees be removed.

**Photo E:** Section Three (3), Sugar Maples (Tree No. 1 & 2) recommended for removal in close proximity of existing concrete septic. Photo taken looking east.

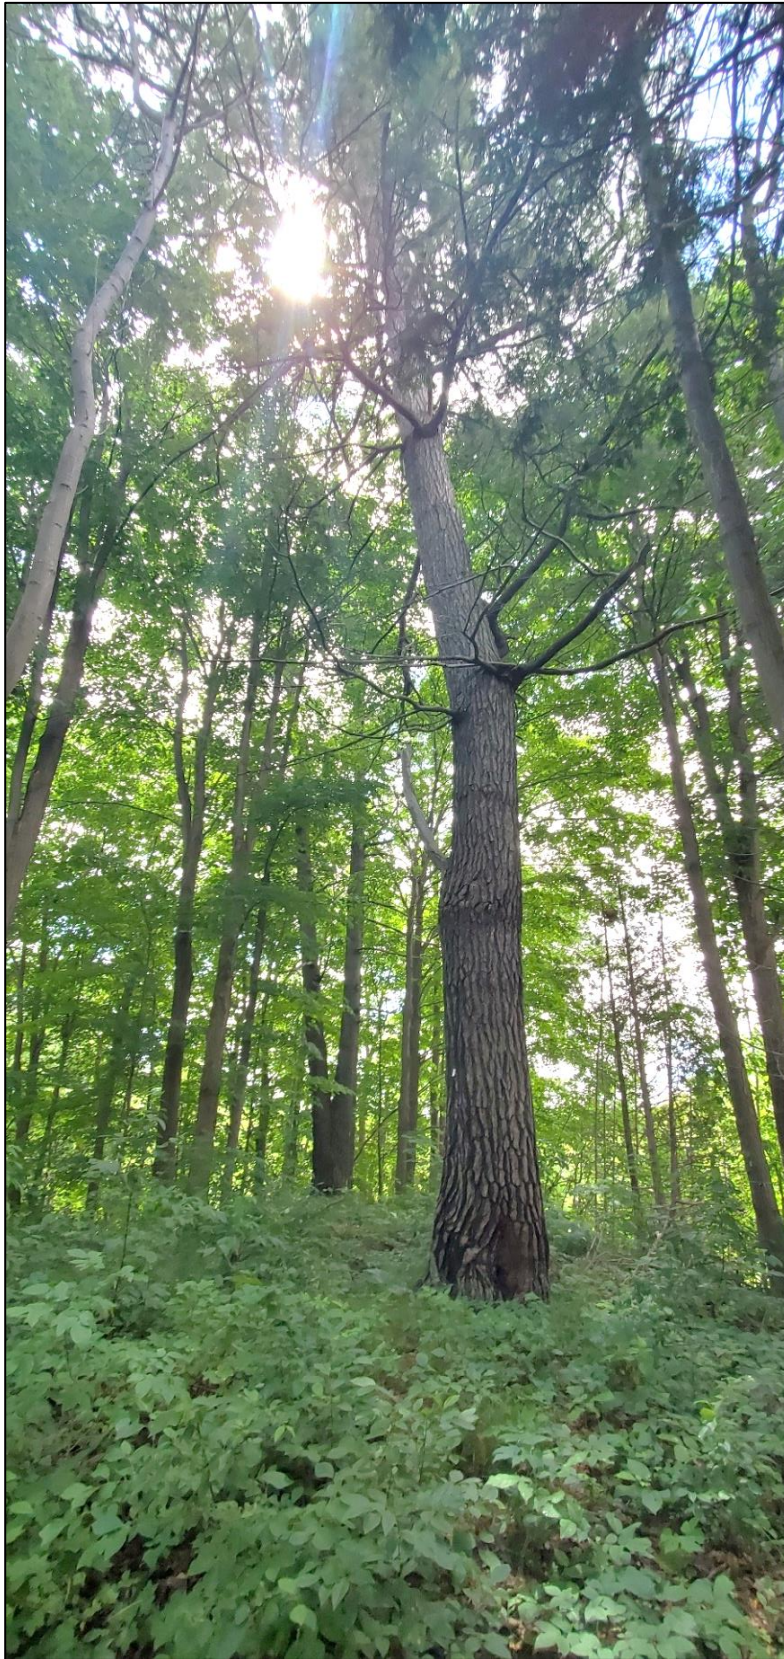
**Photo F:** Photo of Eastern White Pines recommended for preservation near the LSRCA Setback. Photo taken looking east.
