# **Di Poce (Innisfil) Inc.**

## **Geomorphic Assessment**

### **Salem Secondary Plan Area**

### **Bear Creek Watershed**

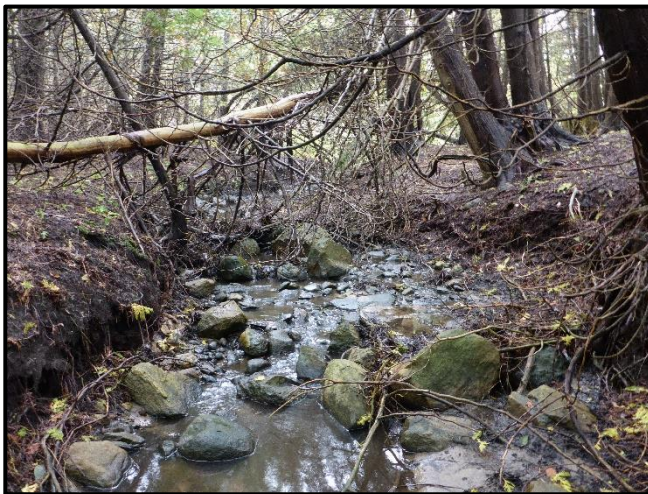
**Photo 3 (Photo Location 3)**  
**Reach BEA1-3A**  
**Upstream view of channel with large cobble and boulder substrate.**

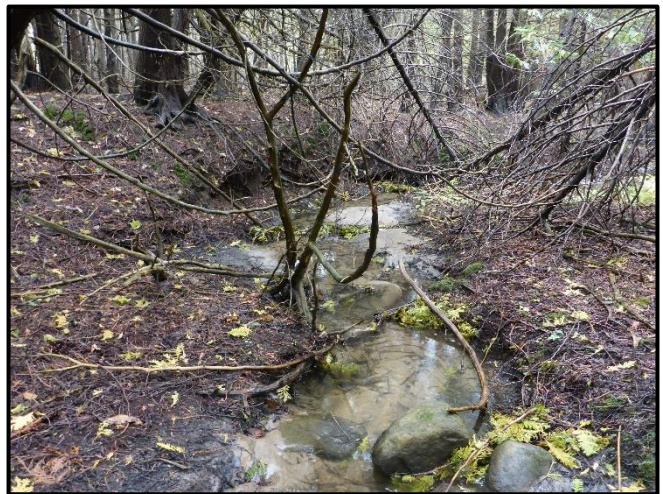
**Photo 4 (Photo Location 4)**  
**Reach BEA1-3A**  
**Downstream view of active bank erosion.**

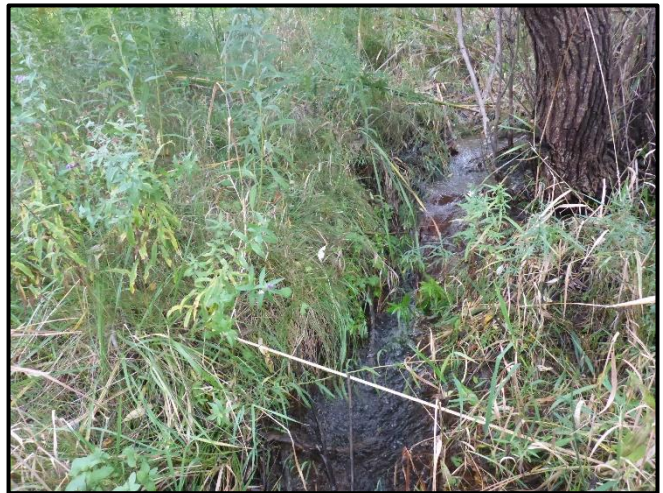
**Photo 8 (Photo Location 6)**  
**Reach BEA1-3B**  
**Upstream view of channel with a tree root forming  
a knickpoint.**

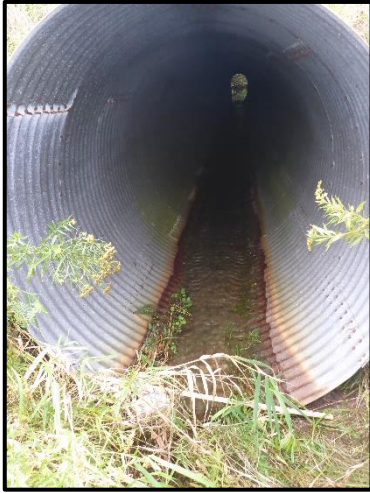
**Photo 9 (Photo Location 14)**  
**Reach BEA1-4**  
**Downstream view of CSP (1250 mm) under County Road 27.**

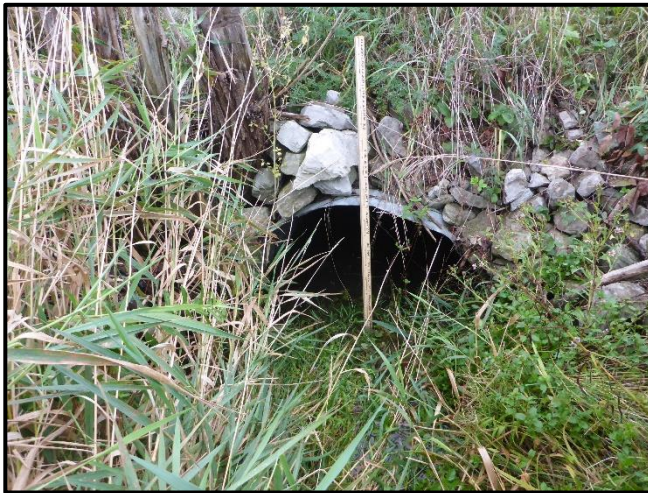
**Photo 11 (Photo Location 10)**  
**Reach BEA1-4**  
**CSP (750 mm) under informal crossing.**

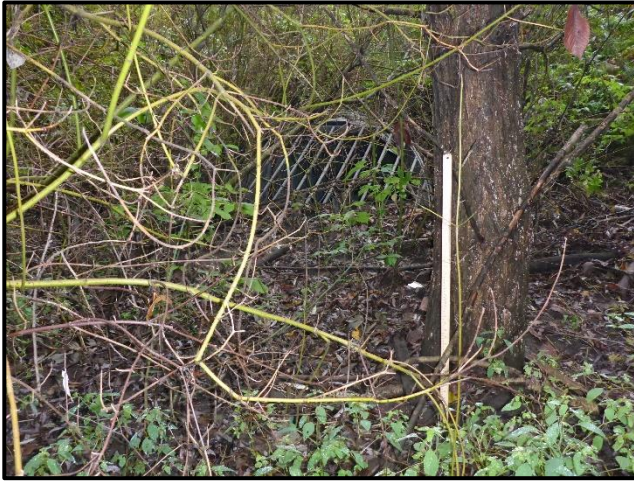
**Photo 13 (Photo Location 20)**

**Reach BEA2-6  
Lougheed Road culvert with debris accumulation.**

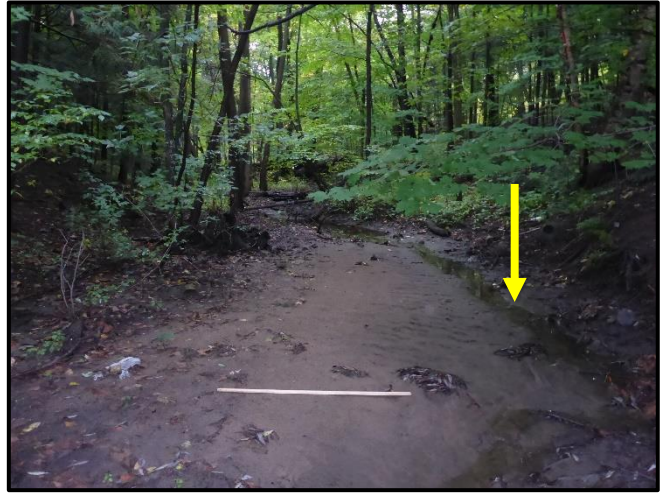
**Photo 14 (Photo Location 19)**

**Reach BEA2-6  
Upstream view of large lateral bar deposit with  
thalweg along photo right.**

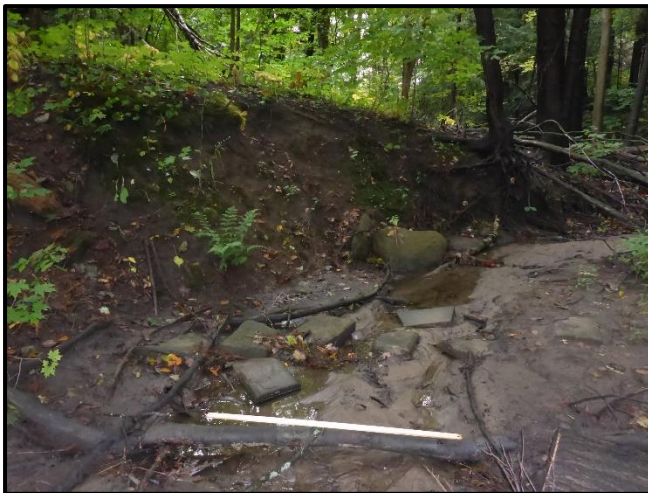
**Photo 15 (Photo Location 18)**

RGA results indicated that Reach BEA2-6 was stable, or 'in regime', with a score of 0.18 with minor evidence of widening, planimetric form adjustment, and aggradation. Evidence of widening consisted of fallen and leaning trees, large organic debris within the channel, and exposed tree roots. Evidence of planimetric form adjustment consisted of the presence of valley wall contact points, chute formation and thalweg misalignment. Aggradation was observed in the form of pool siltation. An RSAT score of 25.5 indicated a 'good' degree of overall ecological health with physical instream habitat identified as the primary limiting factor. The Downs model indicated a combined evaluation of S – 'stable' and m – 'lateral migration', which reflects the RGA evaluation and the minor modes of adjustment that were observed.

**Reach BEA2-6  
Downstream view of bank erosion and large  
boulders in the channel.**

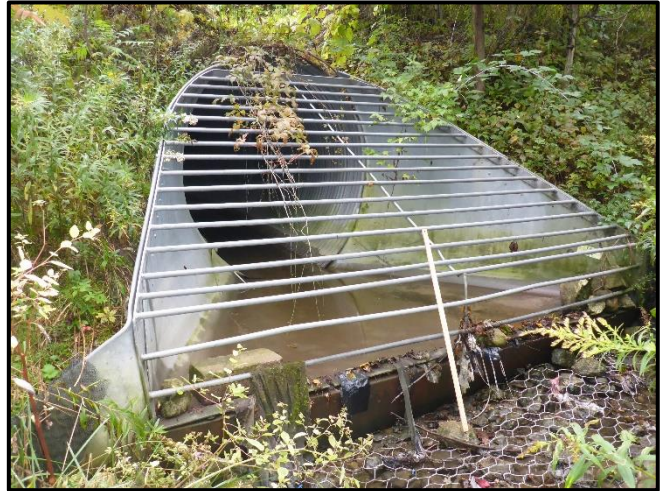
**Photo 18 (Photo Location 21)**  
**Reach BEA2-7**  
**Upstream view of Loughheed Road culvert and gabion drop structure.**

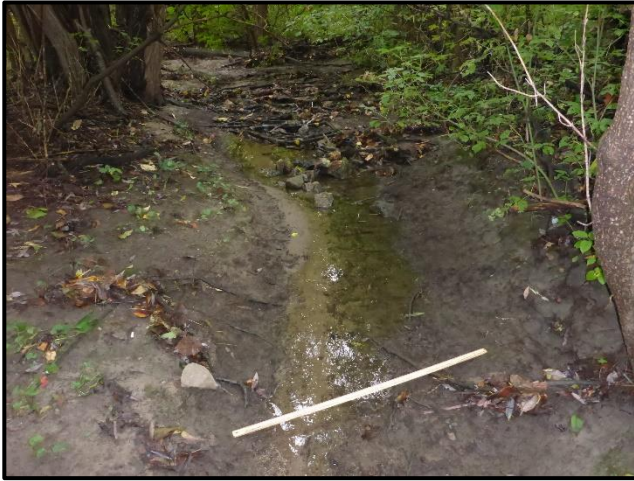
**Photo 21 (Photo Location 23)**  
**Reach BEA2-7**  
**Downstream view of pool and tree root cascade.**

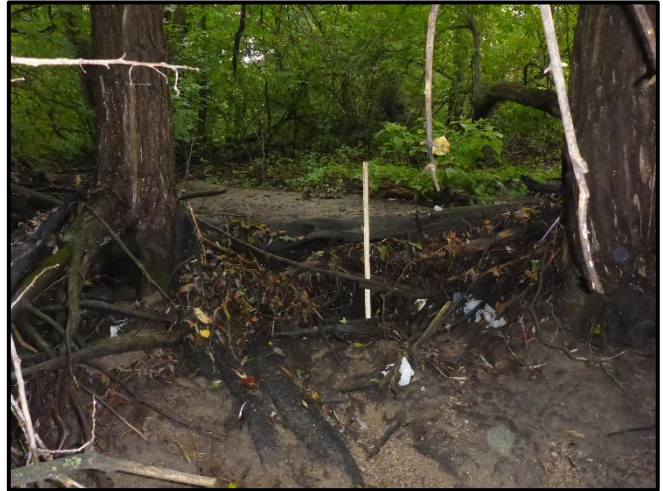
**Photo 22 (Photo Location 24)**  
**Reach BEA2-7**  
**Upstream view of log debris jam. Pool located downstream.**

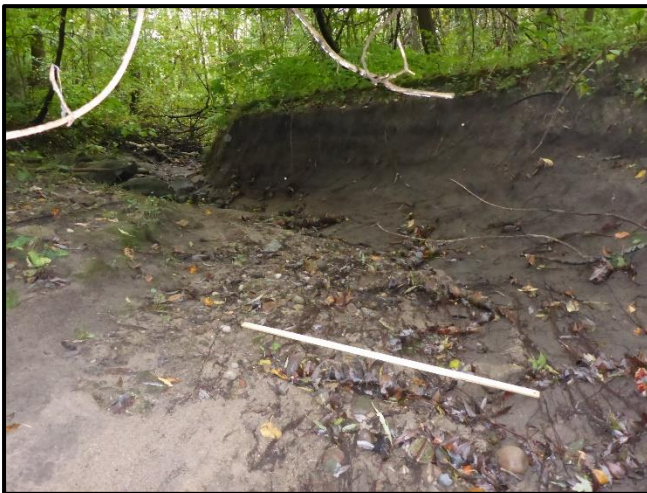
RGA results indicated that Reach BEA2-7 was 'in transition' with a score of 0.25. The channel displayed evidence of widening in the form of fallen trees, the occurrence of large organic debris, exposed tree roots, and basal scour on both sides of the channel through the riffle. Evidence of degradation was observed through undermined gabion baskets, knickpoint migration, and terracing through older bar material. Evidence of aggradation was observed in the form of medial/lateral bar formation. Evidence of planimetric form adjustment was observed in the channel evolution from a single thread to multiple. An RSAT evaluation of 19.5 indicated a 'fair' degree of overall ecological health with physical instream habitat and water quality identified as the primary limiting factors. The Downs model reflected the RGA evaluation through a classification of U – 'undercutting' based on observation of erosion along the outer bank and deposition along the inner.

**Photo 23 (Photo Location 25)**  
**Reach BEA2-7**  
**Downstream view of bank erosion. Note: minimal flow present within channel.**
