# **Di Poce (Innisfil) Inc. Properties**

## **Geomorphic Assessment**

### **Salem Secondary Plan Area**

### **Bear Creek Watershed**

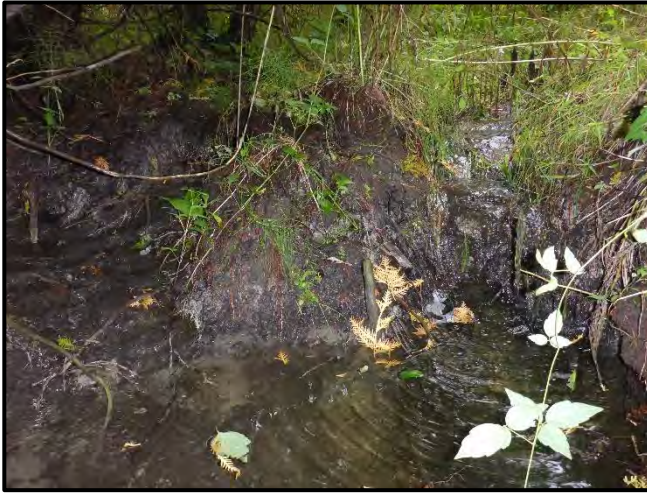
**Photo 1 (Photo Location 1)**  
**Reach BEA1-3A**  
**Upstream view of general conditions.**

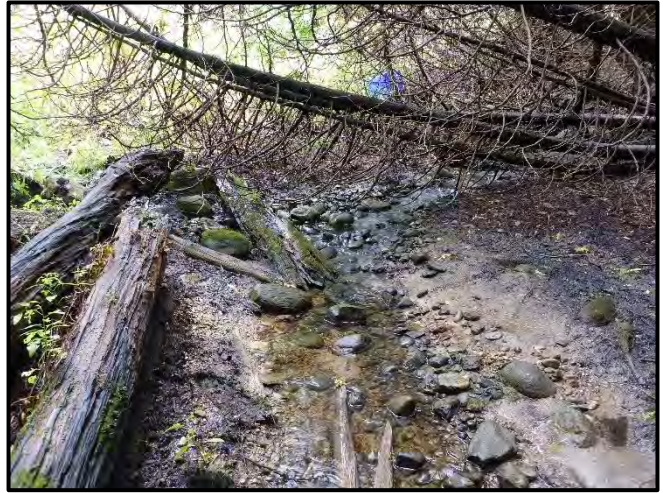
**Photo 2 (Photo Location 2)**  
**Reach BEA1-3A**  
**Upstream view of general conditions.**

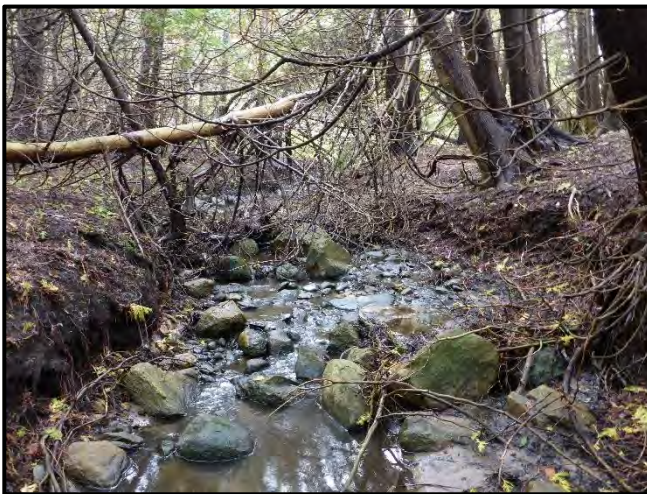
**Photo 3 (Photo Location 3)**  
**Reach BEA1-3A**  
**Upstream view of channel with large cobble and boulder substrate.**

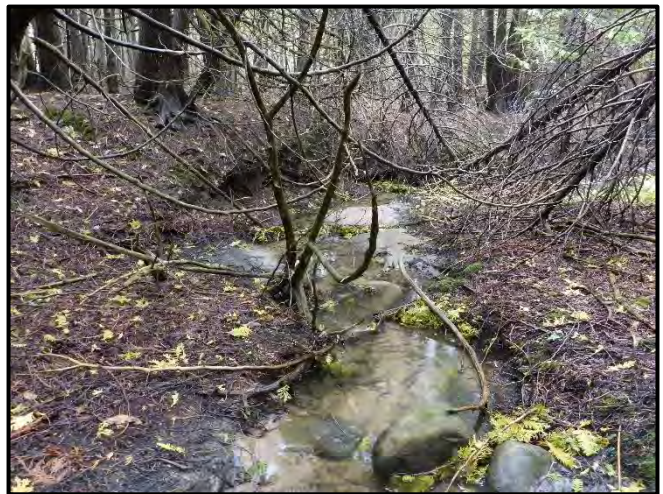
**Photo 4 (Photo Location 4)**  
**Reach BEA1-3A**  
**Downstream view of active bank erosion.**

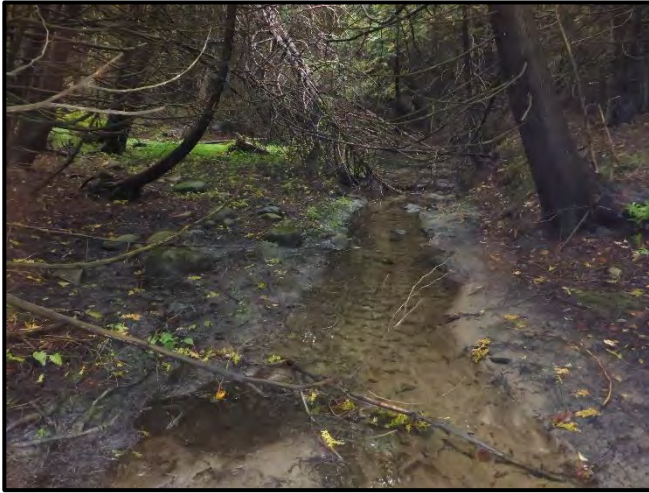
**Photo 5 (Photo Location 5)**  
**Reach BEA1-3A**  
**Upstream view of general conditions.**

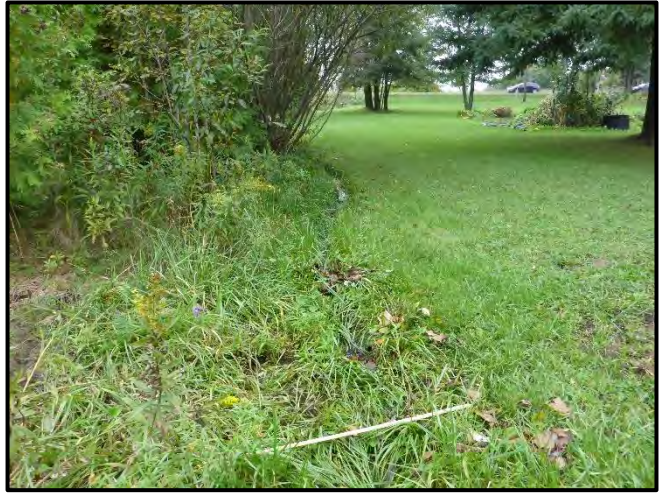
**Photo 6 (Photo Location 6)**  
**Reach BEA1-3B**  
**Upstream view of drainage feature that was  
observed adjacent to the existing residential  
dwelling.**

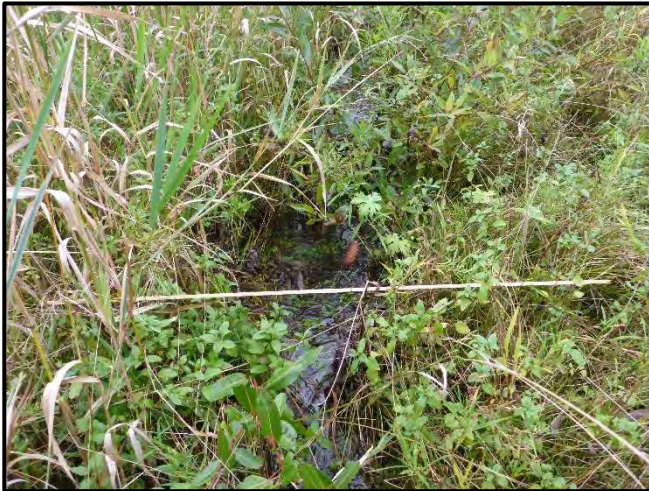
**Photo 7 (Photo Location 6)**  
**Reach BEA1-3B**  
**Upstream view of general conditions.**

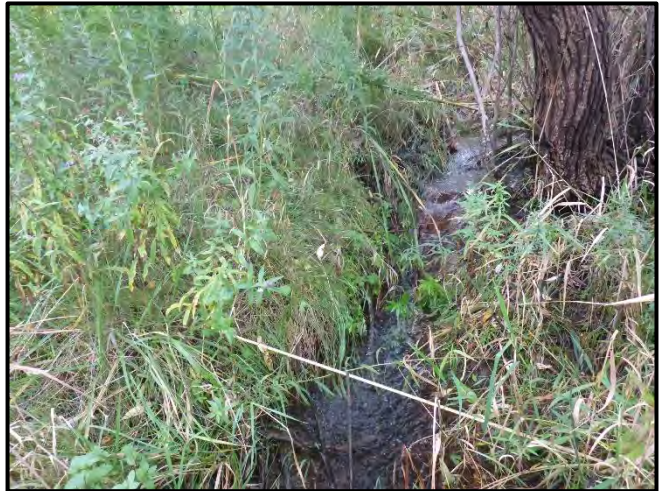
**Photo 8 (Photo Location 6)**  
**Reach BEA1-3B**  
**Upstream view of channel with a tree root forming  
a knickpoint.**

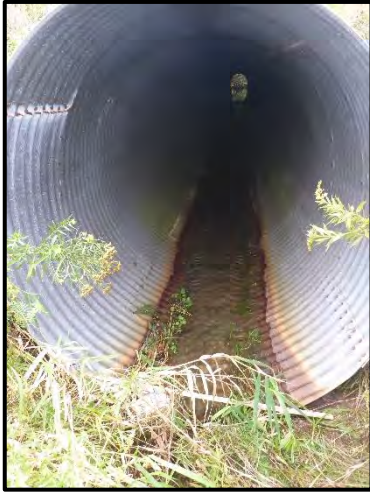
**Photo 9 (Photo Location 14)**  
**Reach BEA1-4**  
**Downstream view of CSP (1250 mm) under County Road 27.**

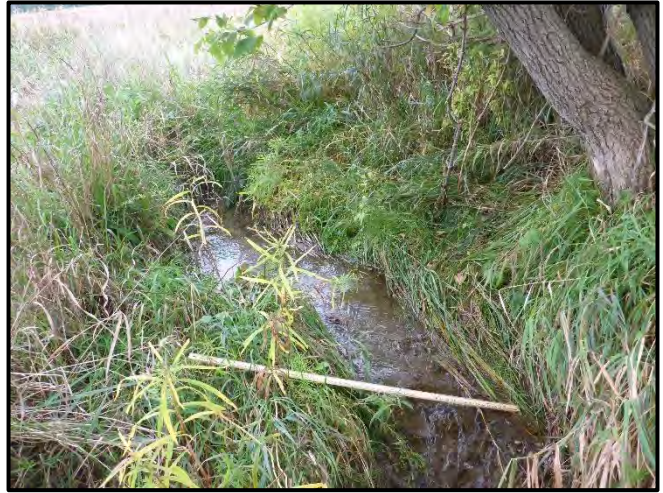
**Photo 10 (Photo Location 11)**  
**Reach BEA1-4**  
**Upstream view of general conditions.**

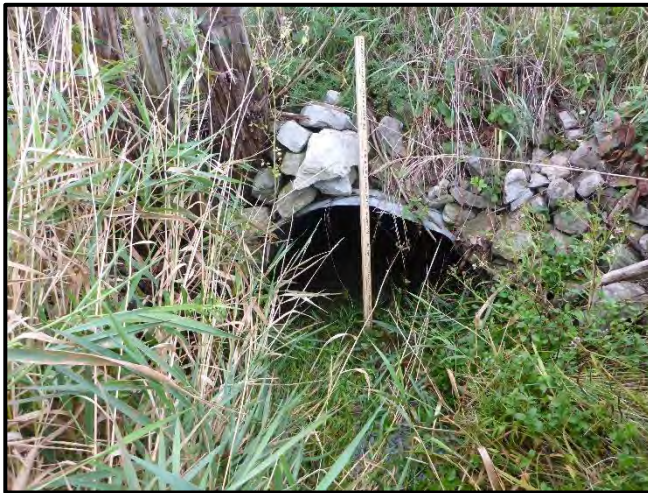
**Photo 11 (Photo Location 10)**  
**Reach BEA1-4**  
**CSP (750 mm) under informal crossing.**

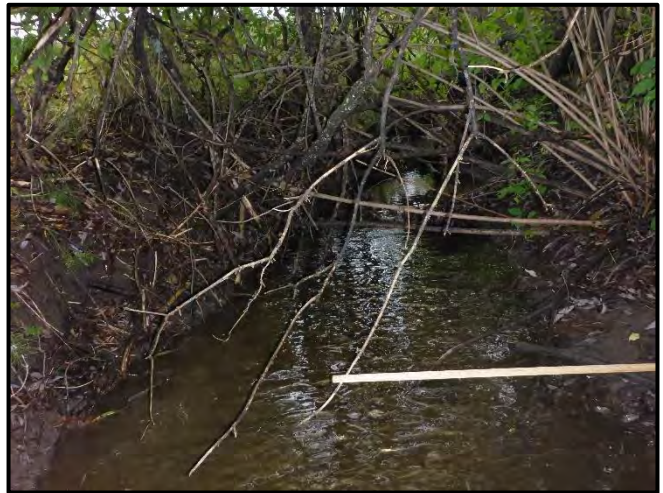
**Photo 12 (Photo Location 9)**  
**Reach BEA1-4**  
**Upstream view of channel.**

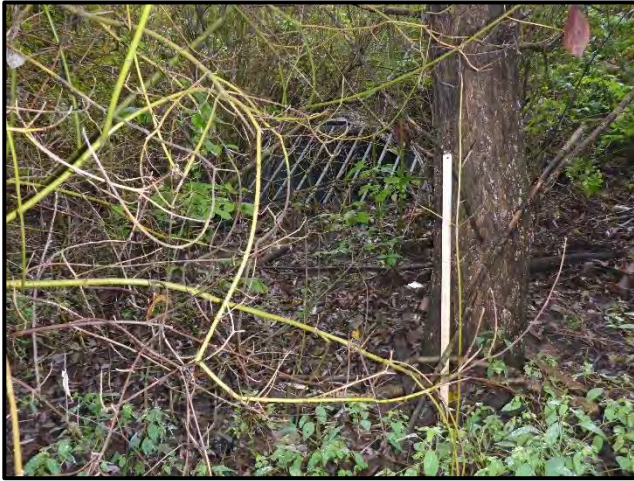
**Photo 13 (Photo Location 20)**

**Reach BEA2-6**  
**Lougheed Road culvert with debris accumulation.**

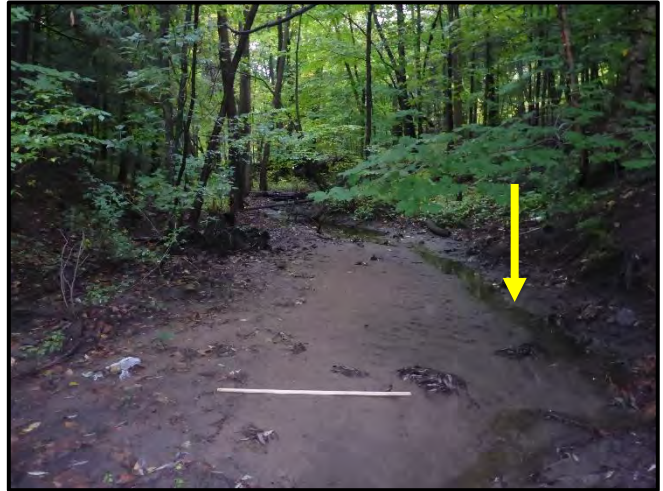
**Photo 14 (Photo Location 19)**

**Reach BEA2-6**  
**Upstream view of large lateral bar deposit with  
thalweg along photo right.**

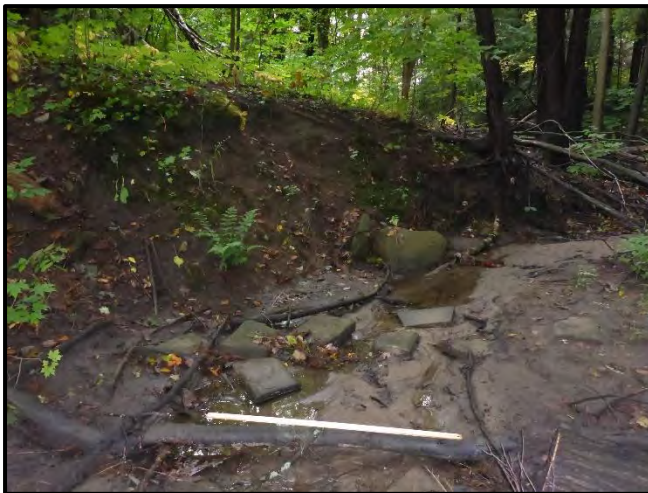
**Photo 15 (Photo Location 18)**

**Reach BEA2-6**  
**Downstream view of bank erosion and large  
boulders in the channel.**

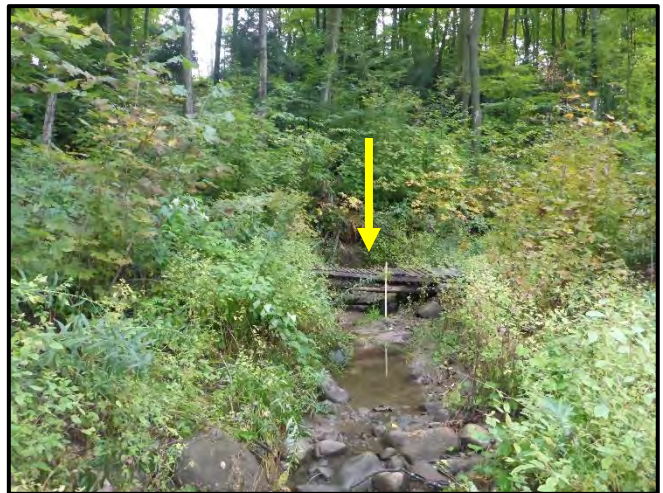
**Photo 16 (Photo Location 17)**

**Reach BEA2-6**  
**Upstream view of channel with informal  
pedestrian boardwalk crossing.**

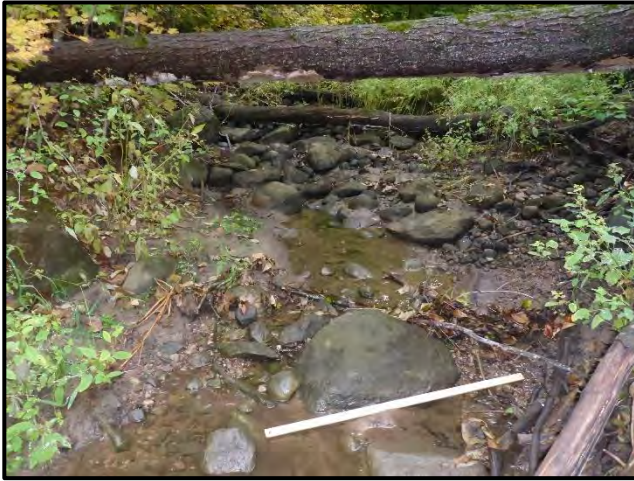
**Photo 17 (Photo Location 16)**  
**Reach BEA2-6**  
**Upstream view of valley wall contact and large boulder substrate.**

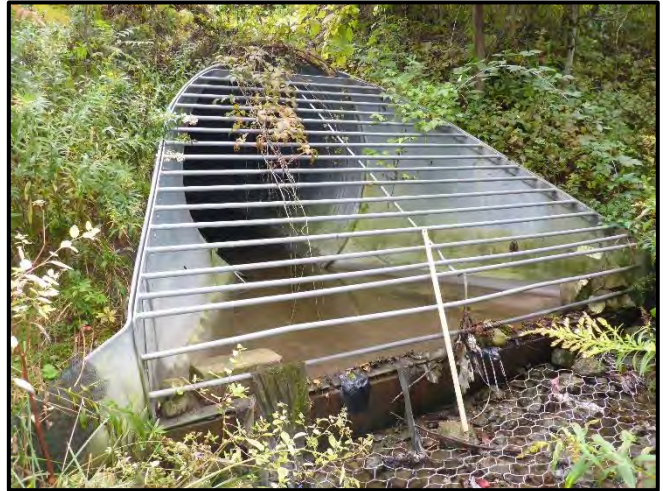
**Photo 18 (Photo Location 21)**  
**Reach BEA2-7**  
**Upstream view of Loughheed Road culvert and gabion drop structure.**

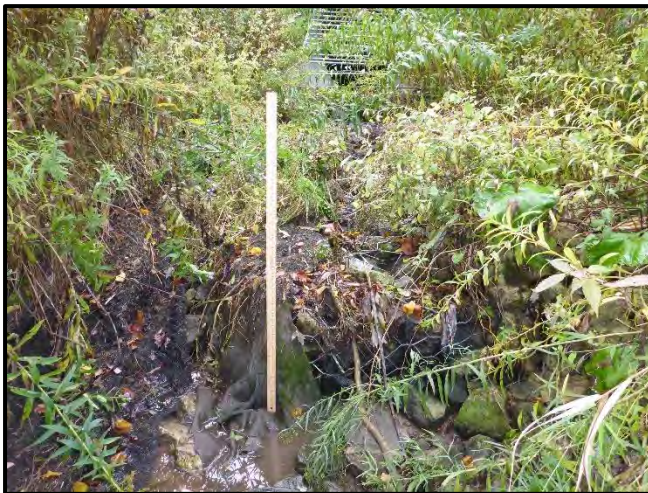
**Photo 19 (Photo Location 22)**  
**Reach BEA2-7**  
**Upstream view at downstream transition of gabion gabion drop structure.**

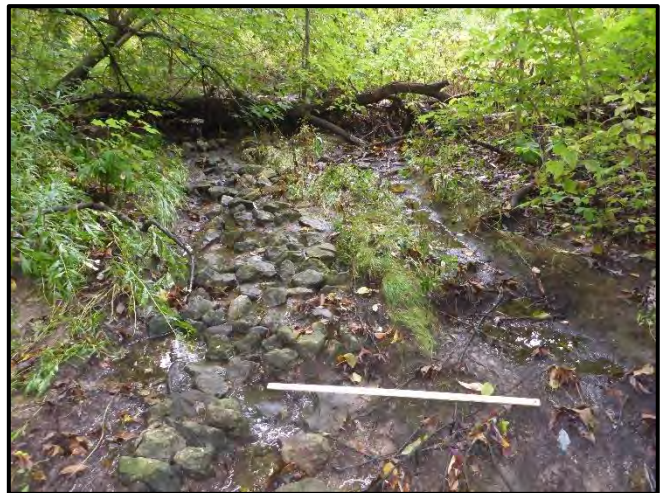
**Photo 20 (Photo Location 22)**  
**Reach BEA2-7**  
**Upstream view of general conditions.**

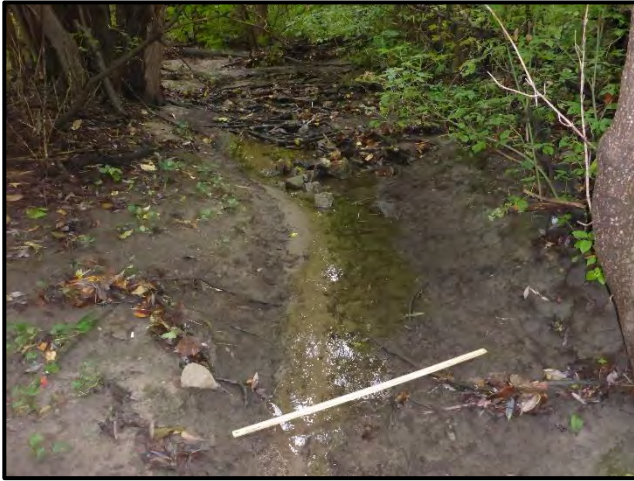
**Photo 21 (Photo Location 23)**  
**Reach BEA2-7**  
**Downstream view of pool and tree root cascade.**

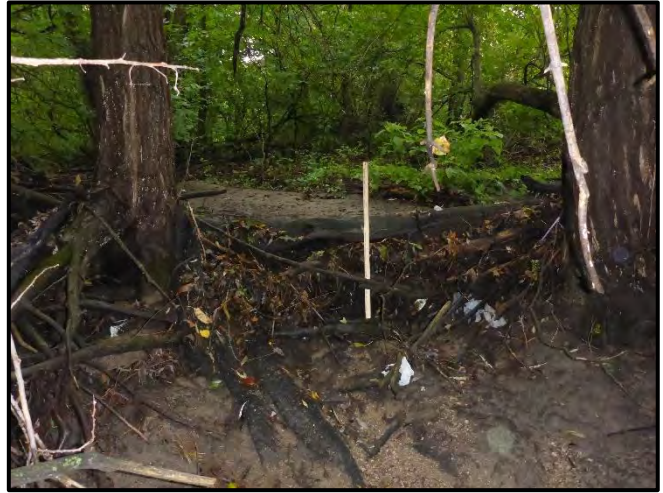
**Photo 22 (Photo Location 24)**  
**Reach BEA2-7**  
**Upstream view of log debris jam. Pool located downstream.**

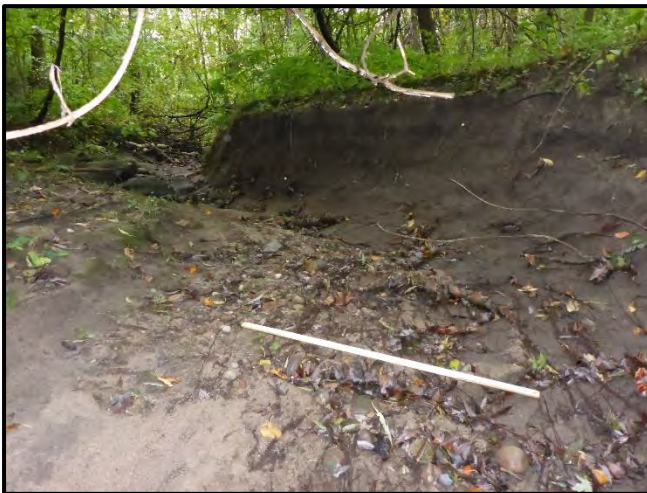
RGA results indicated that Reach BEA2-7 was 'in transition' with a score of 0.25. The channel displayed evidence of widening in the form of fallen trees, the occurrence of large organic debris, exposed tree roots, and basal scour on both sides of the channel through the riffle. Evidence of degradation was observed through undermined gabion baskets, knickpoint migration, and terracing through older bar material. Evidence of aggradation was observed in the form of medial/lateral bar formation. Evidence of planimetric form adjustment was observed in the channel evolution from a single thread to multiple. An RSAT evaluation of 19.5 indicated a 'fair' degree of overall ecological health with physical instream habitat and water quality identified as the primary limiting factors. The Downs model reflected the RGA evaluation through a classification of U – 'undercutting' based on observation of erosion along the outer bank and deposition along the inner.

**Photo 23 (Photo Location 25)**  
**Reach BEA2-7**  
**Downstream view of bank erosion. Note: minimal flow present within channel.**

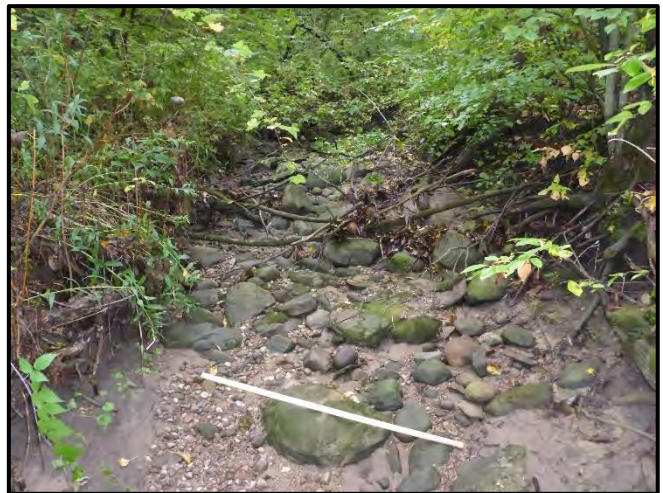
**Photo 24 (Photo Location 26)**  
**Reach BEA2-7**  
**Upstream view of general conditions.**
