Project Memo

H353437

## City of Barrie, MTO Harvie Essa Bryne

### Drainage Design - Field Inspection Memo

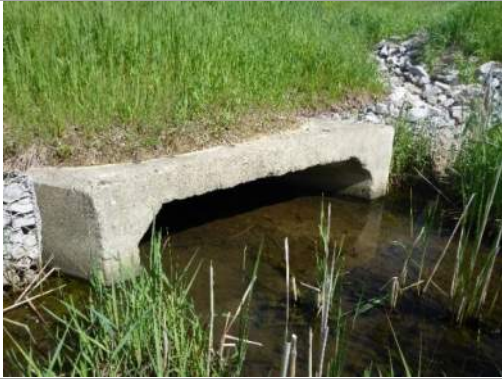
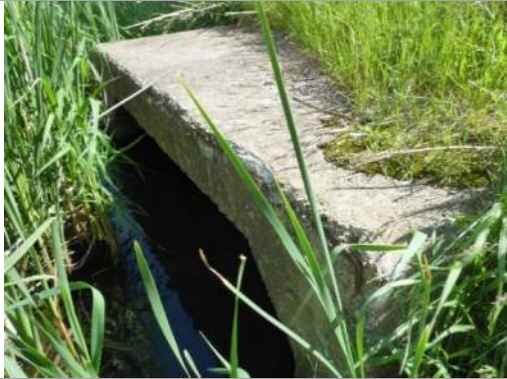
Box Concrete Culvert @ Essa Road – Bear Creek (CV #1)	
#1 – Downstream Face of the Culvert, observed water standing at the inlet	#2 – Downstream Face of Culvert, observed damage/spalling in the face

<p><b>Comments:</b>                      Unclear if the culvert is open bottom culvert. Heavy vegetation observed at inlet and outlet. Stable condition. No erosion observed. Water level at 0.13m D/S face. Total Bank width at 3.5-4.2m, with total depth of fill approx. 3m. Culvert structure appears to be hydraulically deficient given the inlet/outlet channel size. Standing water at the inlet and gabion erosion protection demonstrates the required size for replacement. Damage and Spalling are observed on the downstream face.</p> <p><b>Recommendations:</b></p> <ul style="list-style-type: none"> <li>- Redesign or upsize due to hydraulic concerns.</li> <li>- Recommendations to be confirmed through hydraulic evaluation.</li> </ul>

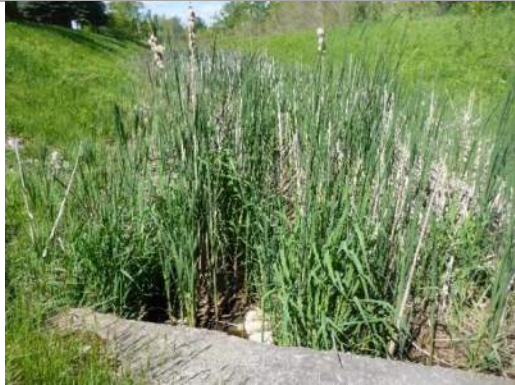
#3 – Heavy Vegetation at Upstream End	#4 – Heavy Vegetation at Downstream End

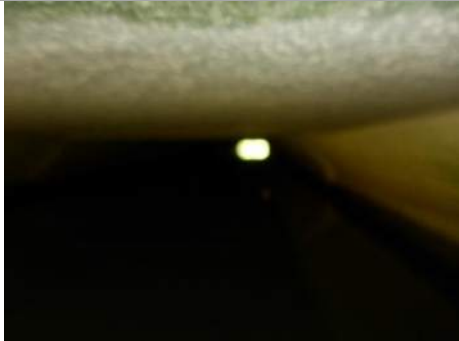
#4 – Inside the Culvert, no cracks observed within the barrel

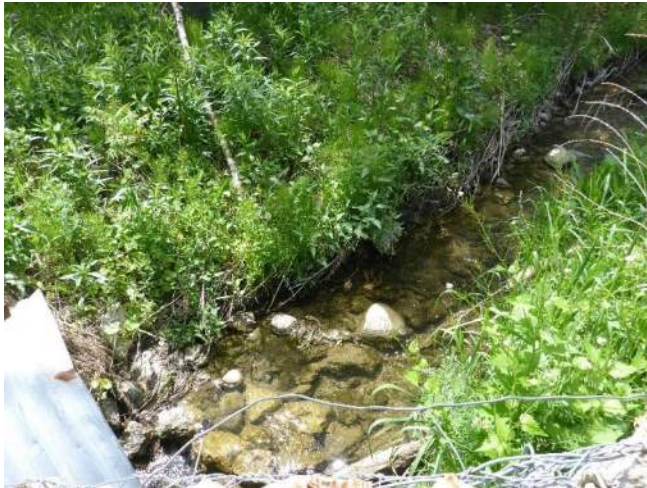
**#1 – Upstream Face of the Culvert**

The plates are slightly caved in at the outlet of the structure. Cobbles as well as debris are observed at the inlet of the culvert. DS channel observed to be approx. 3-4 m wide, with a approx. side slope of 3:1.

- To remain and replace when the future Harvie Road ultimate design is completed.
- Currently this culvert is out of the limit of the Harvie Essa Bryne Project, and was documented for completeness.

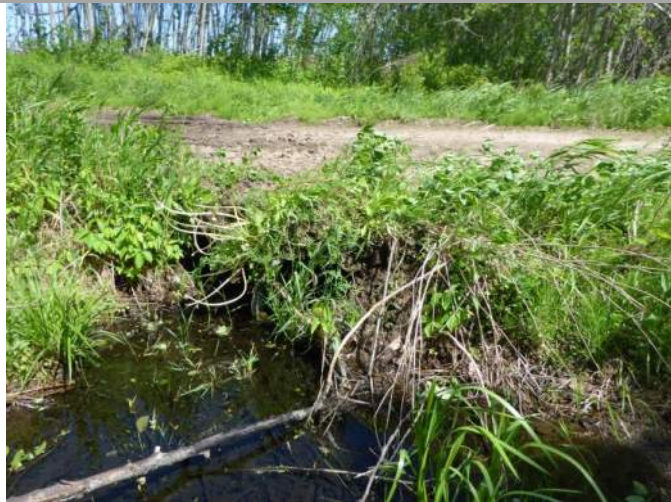
**#1 – Upstream Face of the Culvert**

The existing culvert located at on an existing rural roadway north of the existing south section of Bryne Drive, downstream of the existing SWM pond LV14. The existing structure is in poor condition. Debris are found at the inlet and outlet of the structure. No erosion is observed onsite. Given the ponded water on top of the roadway surface, the existing culvert is undersized. The D/S channel bottom width is observed to be approx. 3m, with a side slope of 5:1 on right and left side bank.

- Redesign and replace the existing structure given hydraulic deficiency.
- The future size of the culvert to be confirmed through the hydraulic evaluation based on proposed design condition.

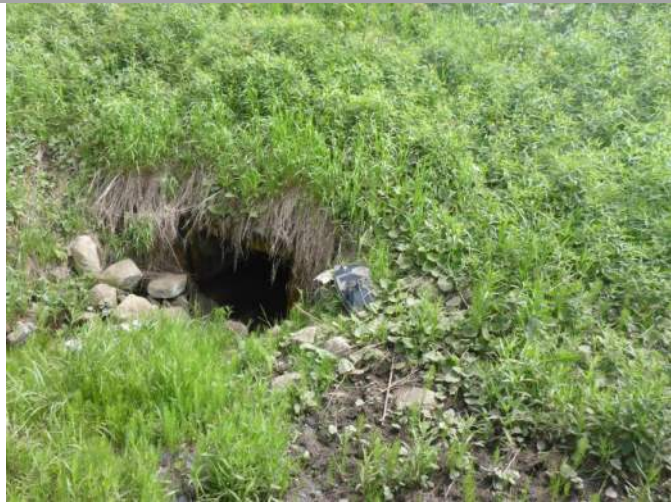
**#1 – Upstream Face of the Culvert**

The culvert at Highway 400 are observed to be in good condition. The upstream channel is measured to be 1-2 m wide. Heavy vegetation is observed in the upstream channel. Debris observed at the inlet. No dimension of the culvert is measured on site due to the inaccessibility of the culvert on site.

- Maintain the structure at this location.
- Adjustments for future ultimate condition will be required.

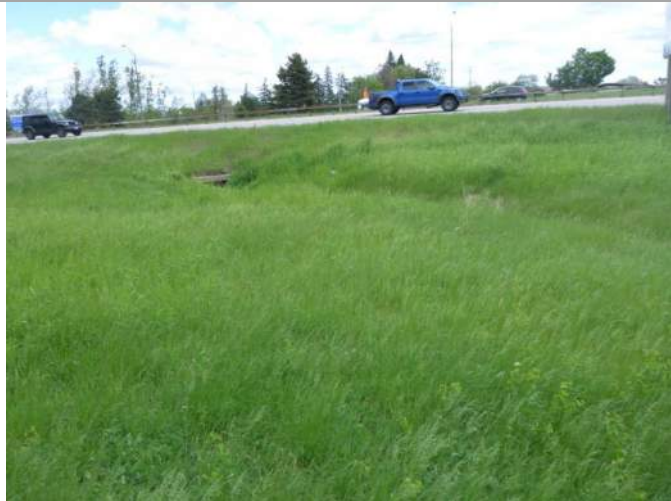
**#1 – Upstream Face of the Culvert**

The culvert size is determined to be a 1.8 x 1.2m conc. box, based on visual observation from a distance of 40-50 meters. Ditch is found immediately upstream of the culvert, however, no creek is observed beyond the fence. No dimension is measured due to the inaccessibility of the culvert on site.

- Maintain the structure at this location.
- Adjustments for future ultimate condition will be required.

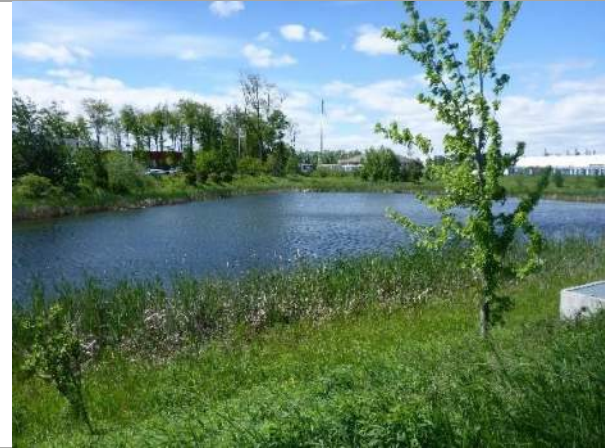
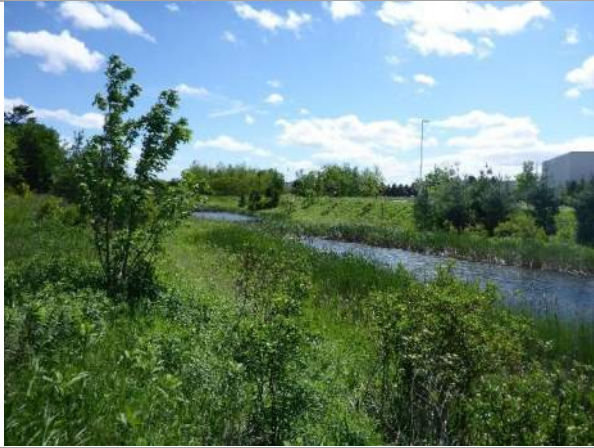
SWM Pond LV14	
#1 – SWM Wet Pond LV14	#2 – Forebay of Pond LV14

<p><b>Comments:</b>                      The SWM facility is in good condition. Diameter of the outlet pipe from the pond is approximately 800 mm. The width of the downstream channel of the outlet structure is approximately 3-3.5m wide, and a 3:1 side slope. Rip rap is placed at the bottom of the channel. Heavy vegetation is observed within the channel.</p> <p><b>Recommendations:</b></p> <ul style="list-style-type: none"> <li>- Maintain the Pond LV14, the existing structures are in good condition.</li> <li>- Extension of existing pond may be required due to the increase of surface flow from future Bryne Drive.</li> </ul>

SWM Pond ID	Location Description	Recommendation
SWM Pond LV14	Lovers Creek Subwatershed west of Highway 400	Maintain current SWM facility, extension of existing pond may be required based on future ultimate design.
