City of Barrie

Culvert Inspection Memo

Hewitts Secondary Plan Area (SPA)

H353997
Rev. A
November 21, 2016

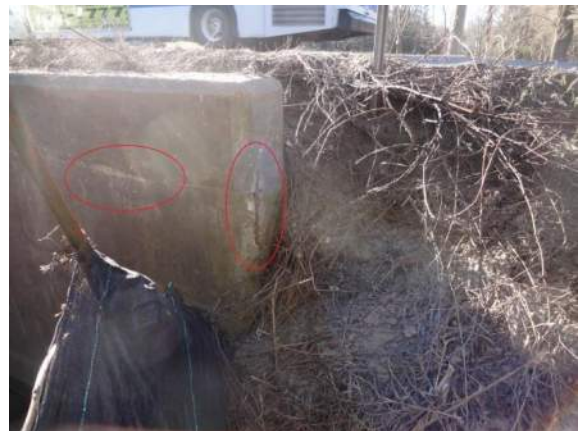
#4 – Exposed Rebars and Horizontal Cracks at Top Slab

Open bottom concrete box culvert. Side wall thickness is around 2.5m. Top slab thickness is 0.3m. Insufficient depth of cover. Observed cracks, buckling and spalling. Minor debris accumulation at stream bed. Noted bank erosion and flow scour.

Recommend to repair erosion/scour.

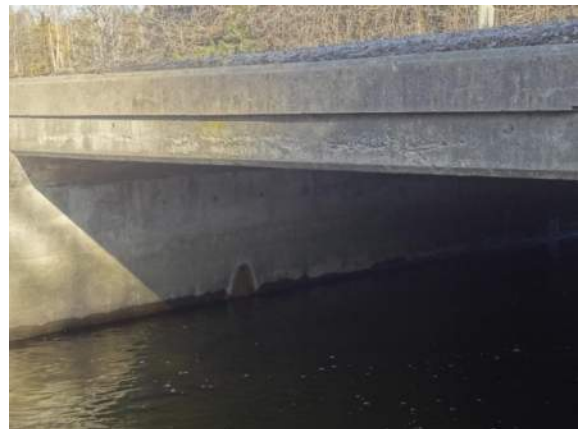
#6 – Observed Spalling at Top Slab

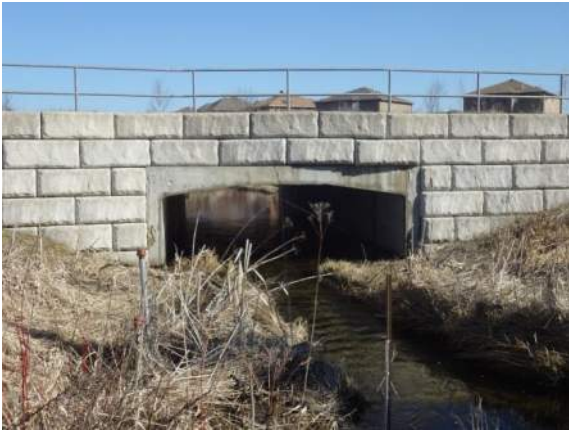
#3 – Inlet End

Observed bank erosion and flow line scour at inlet end.

Recommend to repair and extend.

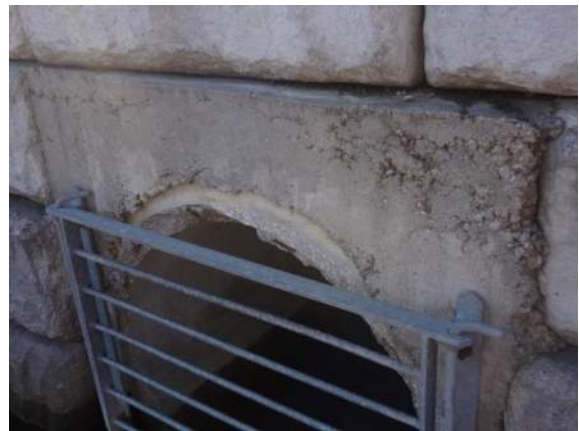
#6 – Buckling and Spalling at Storm Sewer Outlets

Open bottom concrete box culvert has a dimension of 4267 mm W x 1630 mm H. Structure in good condition with minor sign of corrosion and concrete deterioration, especially at the storm outlet.

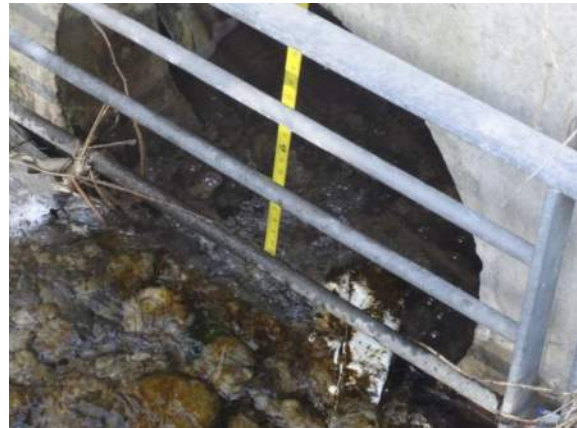
#4 – Heavy Debris Accumulation at Inlet

External drainage ditch flow from super-critical to sub-critical condition. CSP extension at outlet are near fully submerged. Observed bank erosion and debris accumulation at inlet end.

Recommend to be upsized.

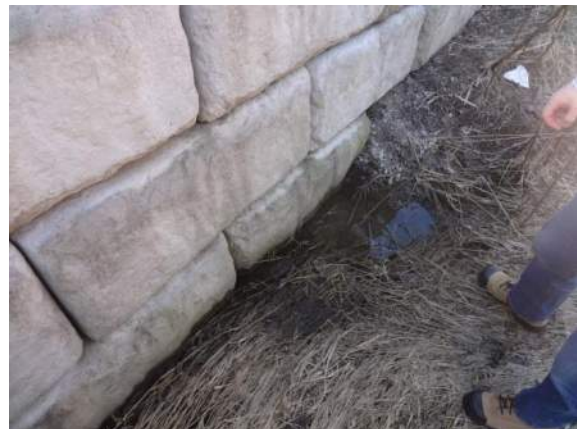
#6 – Excessive Water Seeping through the Retaining Wall

Outlet are placed under a 1 meter height retaining wall. Downstream bankfull width of 1.2 m with measured water elevation around 0.3 m.

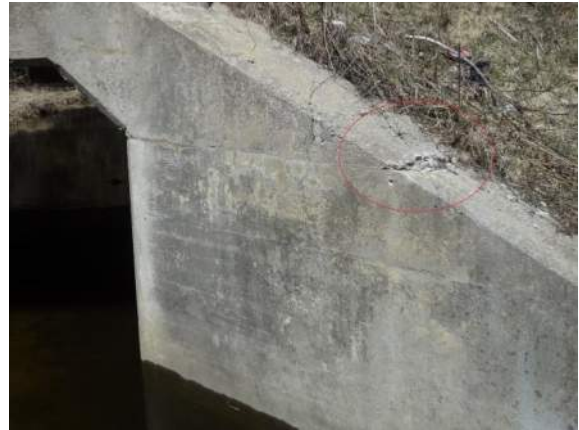
#4 – Concrete Spalling at Inlet WingWall

Open bottom concrete box culvert with head wall and wing walls. Structure in good condition with minor sign of rust or corrosion.

Recommend to repair and extend.

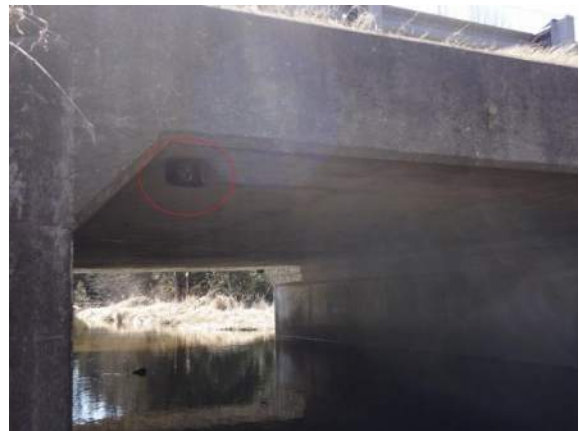
#6 – Potential Storm Sewer Outfall

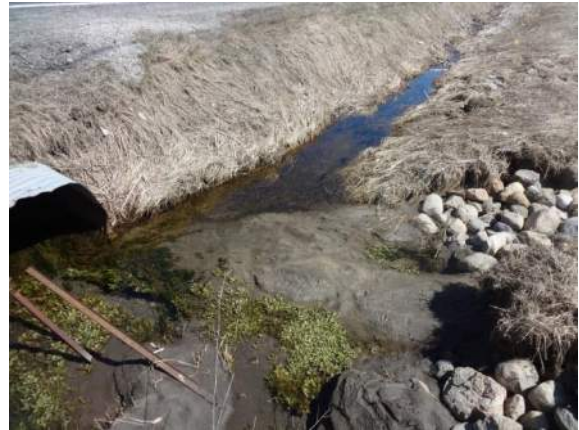
#4 – Erosion at Inlet End

900 mm diameter CSP culvert. Observed sever bank erosion. Evidence of over topping.

Recommend to replace.

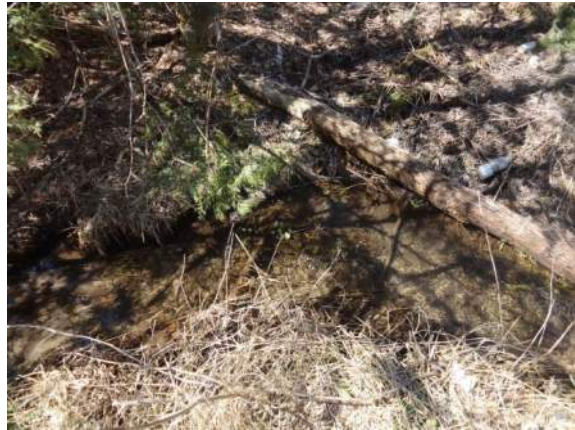
#4 – Heavy Vegetation Growth Near Inlet

900 mm diameter HDPE pipe. Heavy vegetation growth noted near inlet. Observed bank erosions and flow line scour.

Recommend to retain and extend.

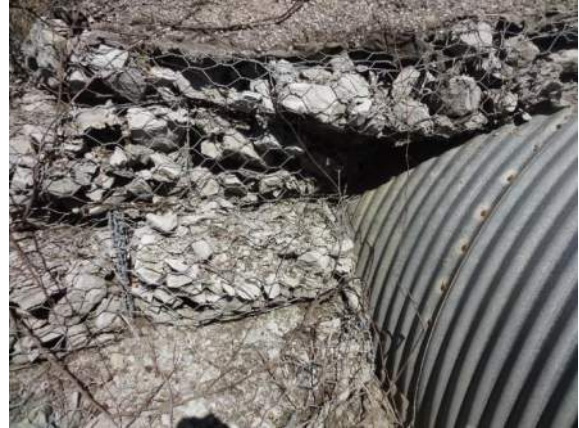
#4 – Deformation on Gabion Basket at Inlet End

2440 mm diameter CSP culvert. Observed deformation at gabrion.

Recommend to repair/replace and Extend.

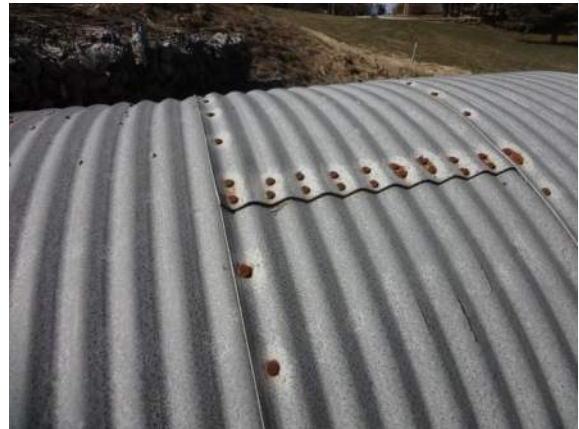
#6 – Rusted Bolts Appears to be non-galvanized

Minor sign of corrosion, bolts appear to be non-galvanized and has potential to accelerating corrosion of the plates.
