**159 HURONIA ROAD, BARRIE, ONTARIO**

**RESIDENTIAL DEVELOPMENT**

**TREE INVENTORY, ANALYSIS, PRESERVATION PLAN & CANOPY SURVEY**

MARCH 2023

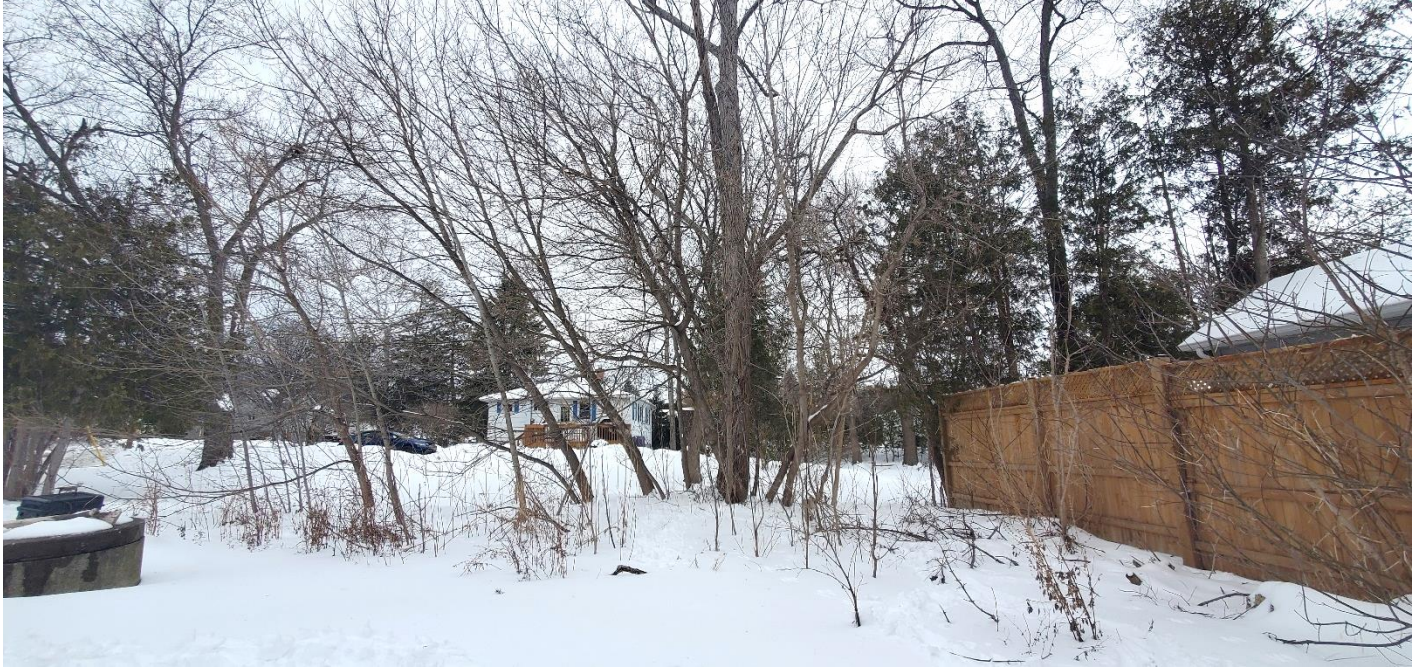
LEGroup staff observed Tree Nos. 1-8 to be located along the north property line (see **Photo A, Appendix D**). Tree Nos. 1-8 (Manitoba Maple & Balsam Poplar) are assessed to be in poor condition due to epicormic branching, branch dieback, multi-leaders causing poor form and included bark. Tree no. 5 (Balsam Poplar) was found to have had a leader that failed and is now caught into the canopy of Tree no. 4 causing concern for branches failure.

**Photo A:** Typical view of the area along the north east side of property where Tree 1-9 are located featuring a Balsam Poplar in the center of the photo. Photo taken looking north.

LEGroup staff recommend trees that are in poor to fair health and conflict with the proposed development, be removed. Therefore, LEGroup staff recommends the removal of Tree Nos. 1, 2, 5, 6, 7, & 8 that are in poor to fair condition with branch dieback, epicormic branching, and signs of decline associated with suppressed canopy conditions.

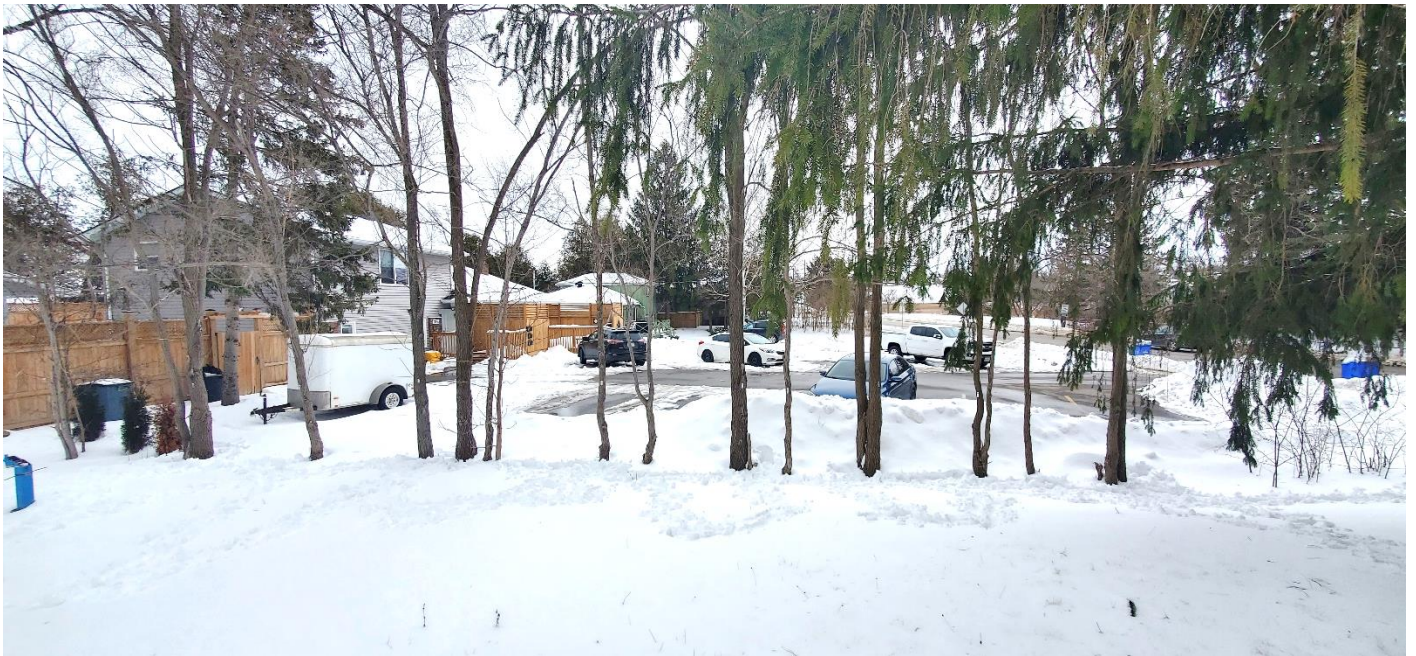
Tree Nos. 9-23 are located along the east property line (Siberian Elms) are assessed to be in poor condition with epicormic branching, one sided branching, bark damages, poor form and branch dieback. Siberian Elm trees tend to grow rapidly causing them to possess poor form characteristics and grow inadequately for long term health.

Generally, trees along the east side of the site were observed to be in poor condition which is caused from their inherent tree characteristics of having a high growth rate and poor form. This in turn is commonly observed in trees by their stress response of epicormic branching (branch suckering) and branch dieback and applicable in this scenario.

**Photo B:** Typical view of the east side of the subject site featuring poor Siberian Elm trees located along the shared property lines. Photo is facing east.

As it currently stands, LEGroup staff recommend the preservation of Tree Nos. 3-4, & 9-23 that are boundary trees located along the shared property line until such time permission is granted by the adjacent neighbors. These trees are in poor declining condition and are ultimately not suitable candidates for retention but they will require permission for their removal.
