# Tree Inventory, Assessment, and Preservation Plan

750 Lockhart Road  
City of Barrie, Ontario

**FEBRUARY 2022**

**GEI FILE: 1901398**

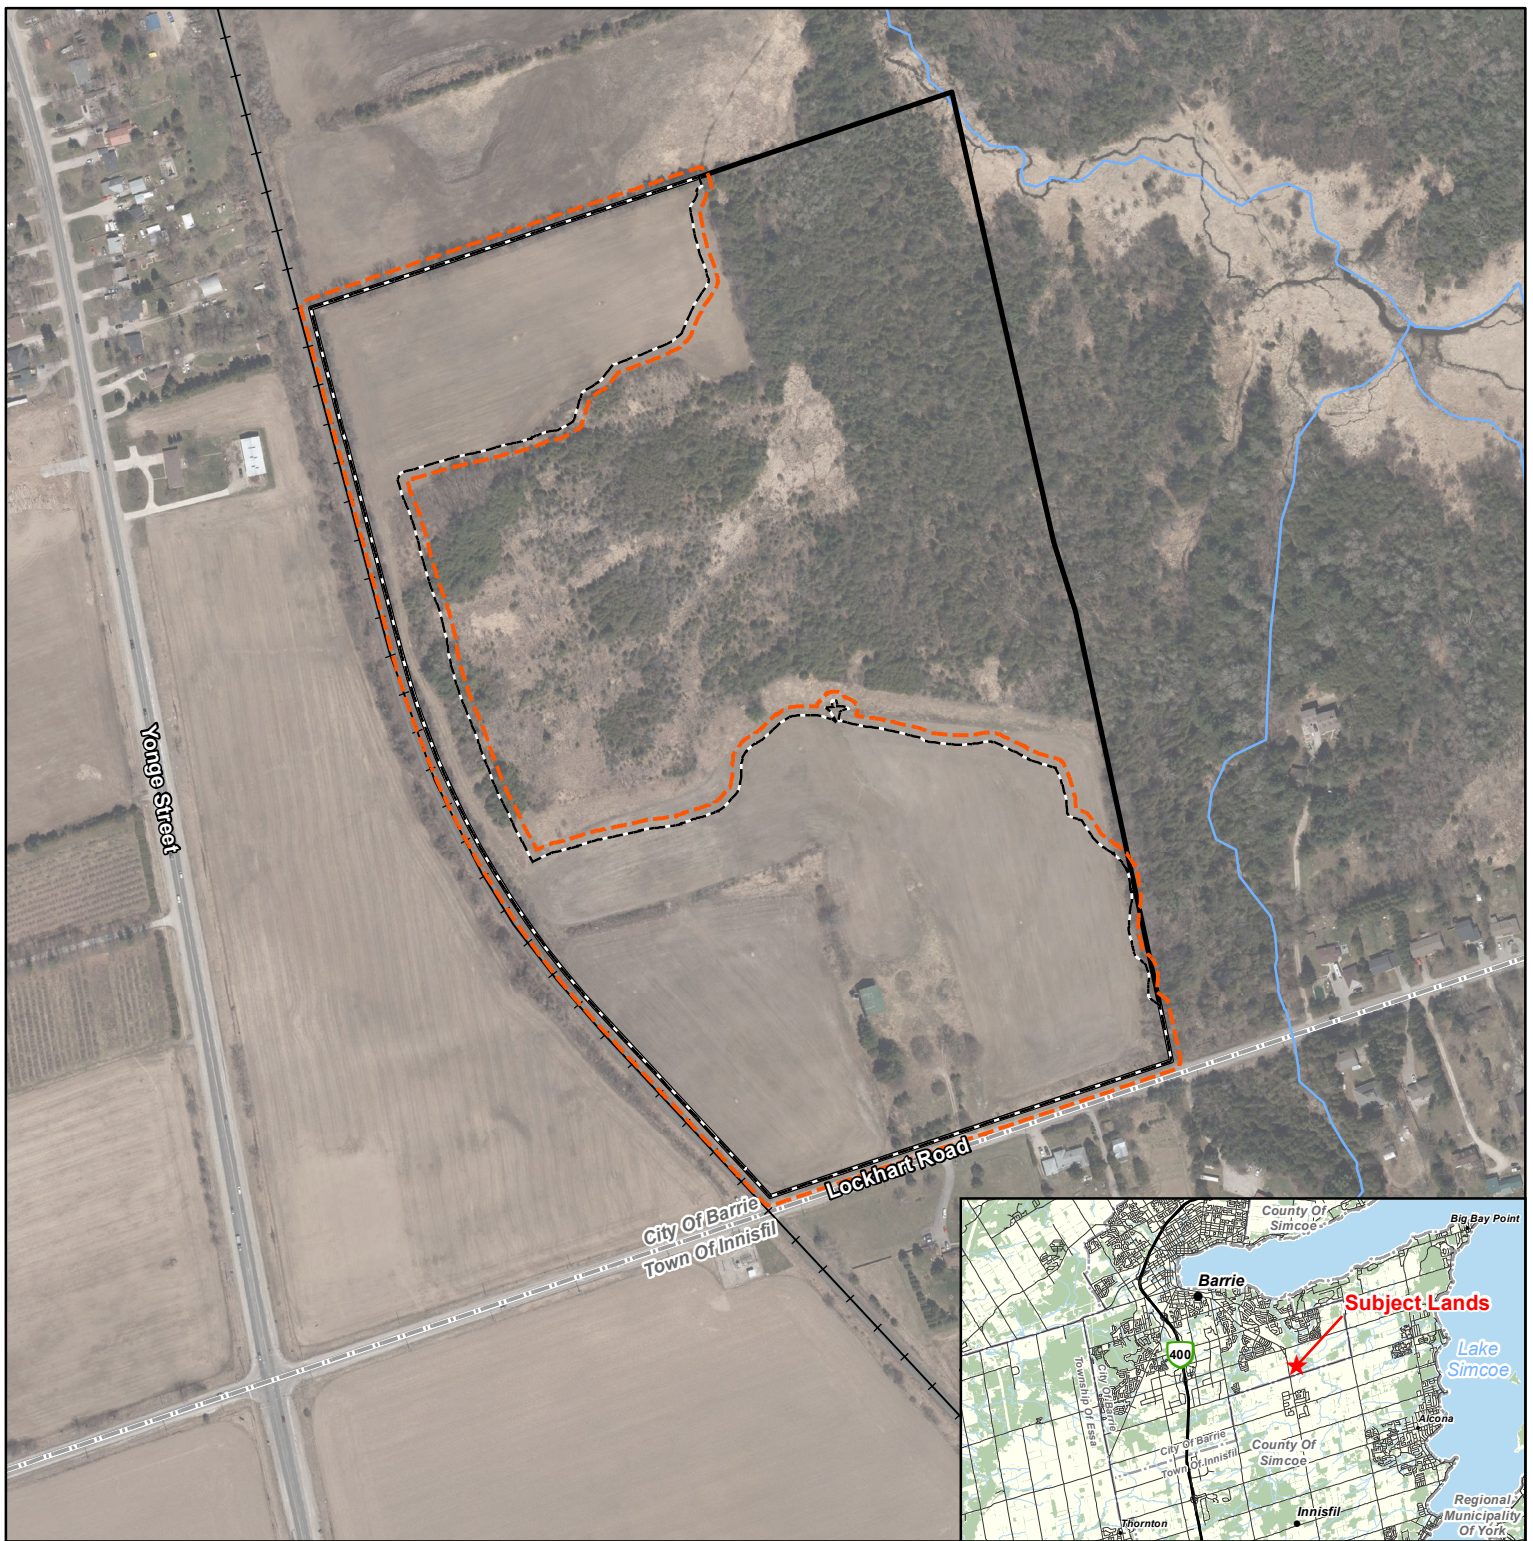
Figure 1  
 Subject Lands

GEI defined the Study Area for the tree inventory as the proposed development limit (including the limit of grading) and the immediately adjacent 6 m (**Figure 1, Appendix A**). GEI completed the tree inventory on December 3, 2020, in accordance with preliminary discussions held with the City of Barrie on November 6, 2020 (pers. comm. William McGregor).

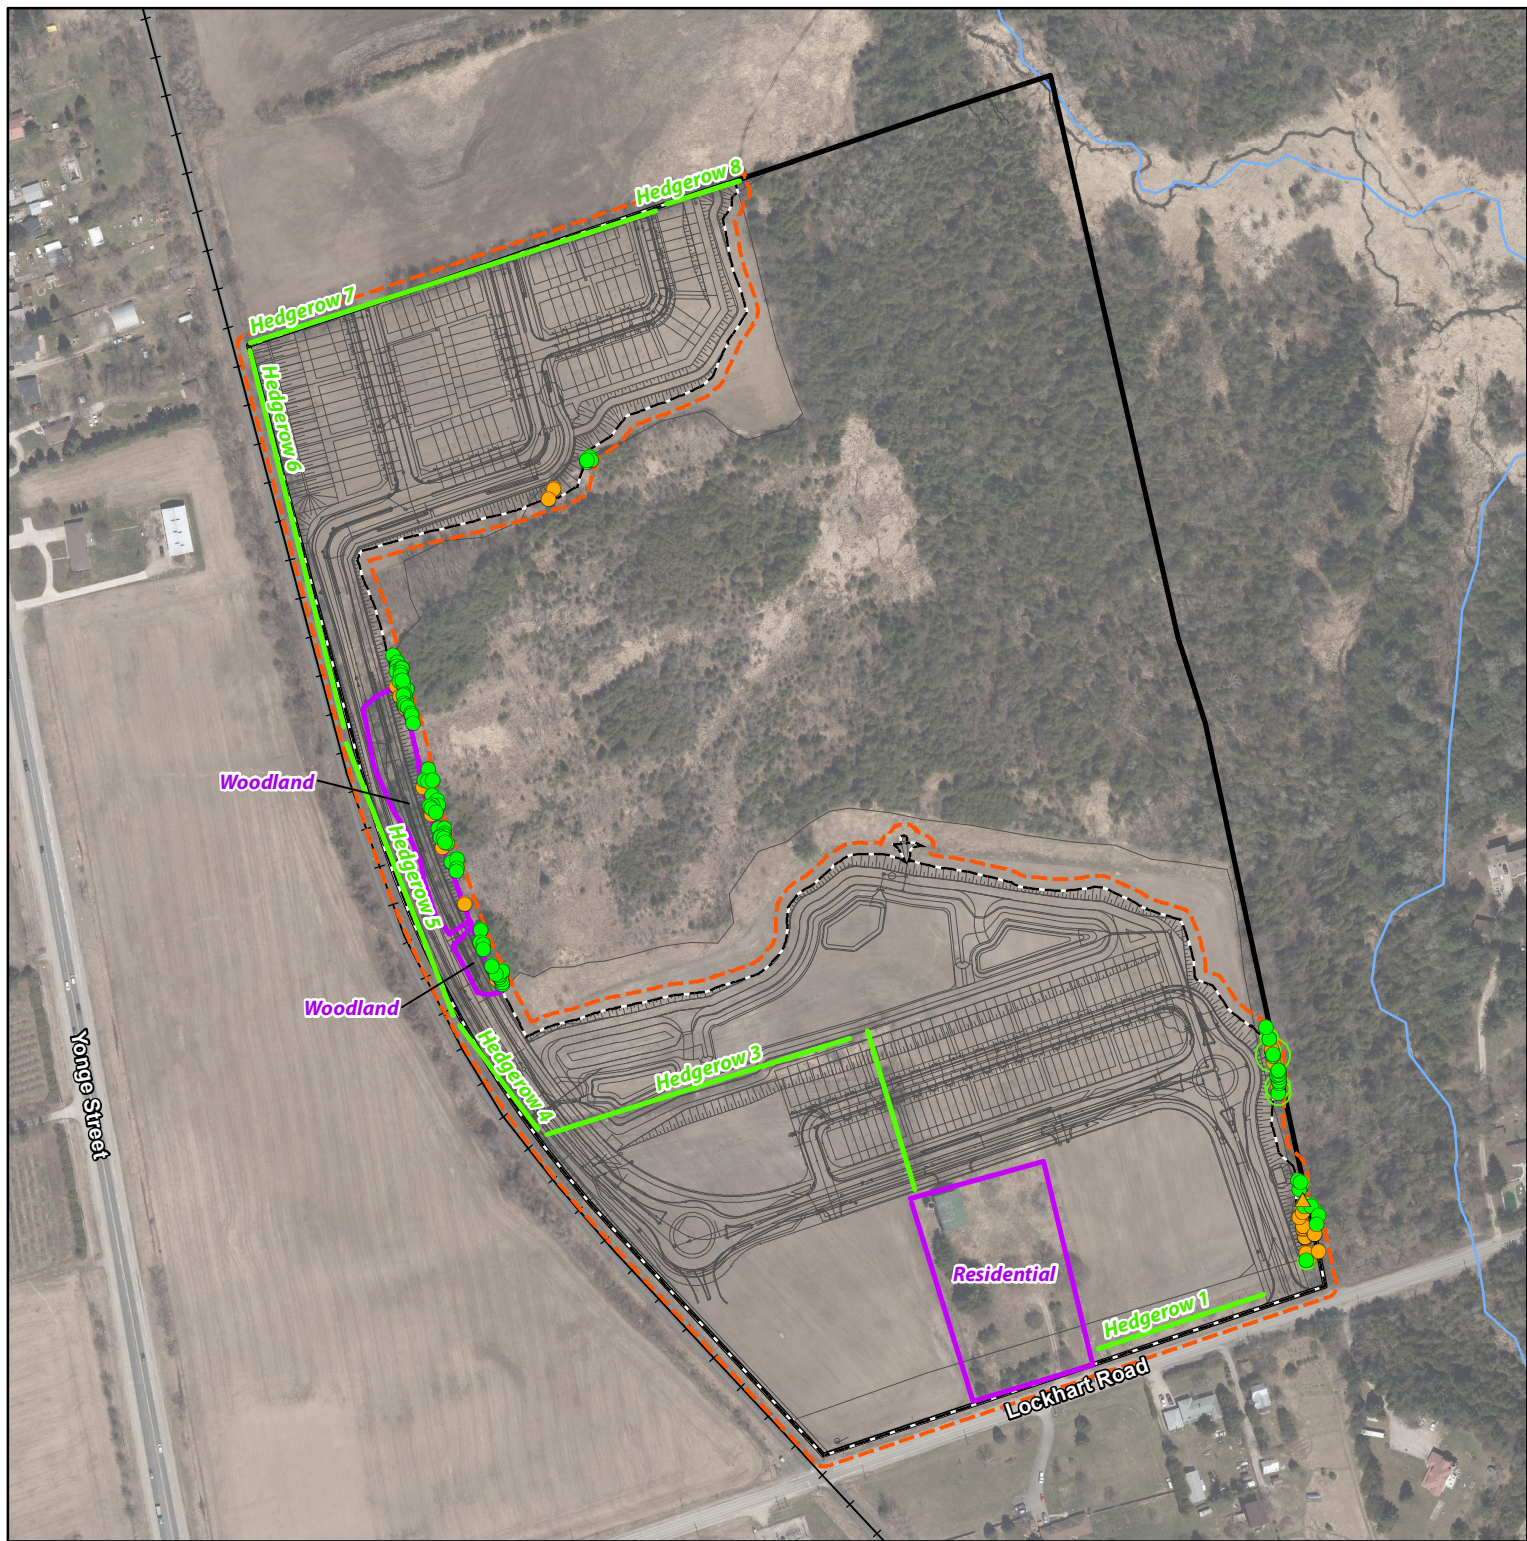
## Figure 3.1 Tree Inventory

A total of 124 live trees and one dead tree were individually assessed and another 650 trees were tallied during this tree inventory, for a total of 775 inventoried trees (**Figure 2, Appendix A**).
