**Tree Inventory and Preservation Plan Report
340 and 334 Ardagh Road
City of Barrie, Ontario**

5 December 2022, revised 14 July 2023

KUNTZ FORESTRY CONSULTING Inc. Project P3539

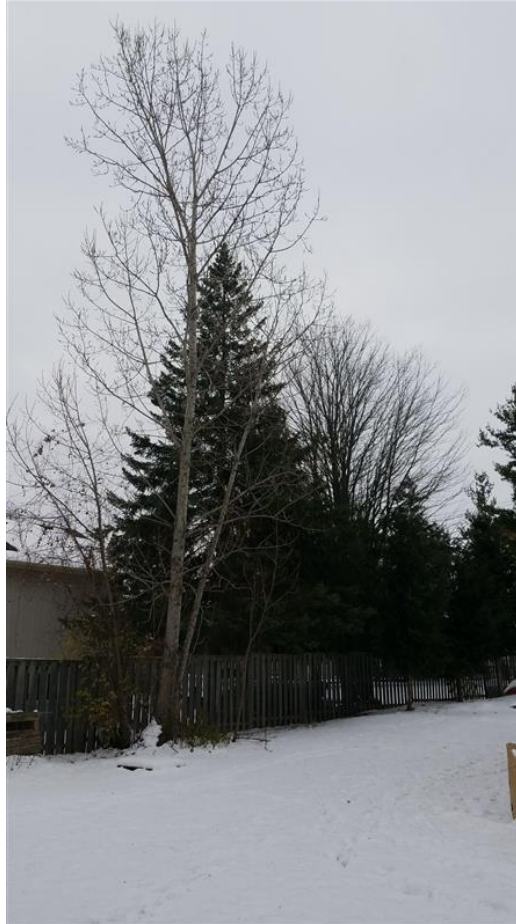
Tree 850 and A-C

Encroachment into the driplines of Trees A-C will be required to accommodate a proposed swale. The following mitigation measures must be implemented prior to construction to ensure the trees respond well to construction.

1. Under the supervision of a Certified Arborist, air-spading technology shall be utilized to excavate a trench at the proposed excavation limits within the driplines of trees A-C as shown in TP-1.
2. Exposed roots are to be pruned within the trench in accordance with Good Arboricultural Standards.
3. The trench is to be back filled with loam soil.
4. Vertical tree protection fencing is to be installed directly east of the excavation limits as shown in TP-1.

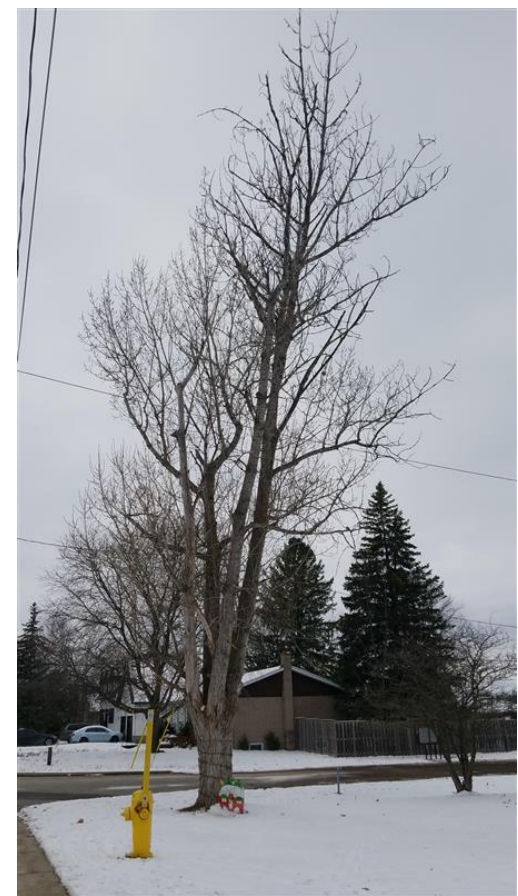
The removal of Tree 856 is recommended regardless of the site plan due to it's condition. A large, dead, overextended branch is leaning towards the existing building.
