# 211 DOCK ROAD TREE PRESERVATION PLAN BARRIE, ON

MUNICIPAL FILE: D30-036-2023

LANDMARK ENVIRONMENTAL GROUP LTD.

PROJECT NO. LA 832-23

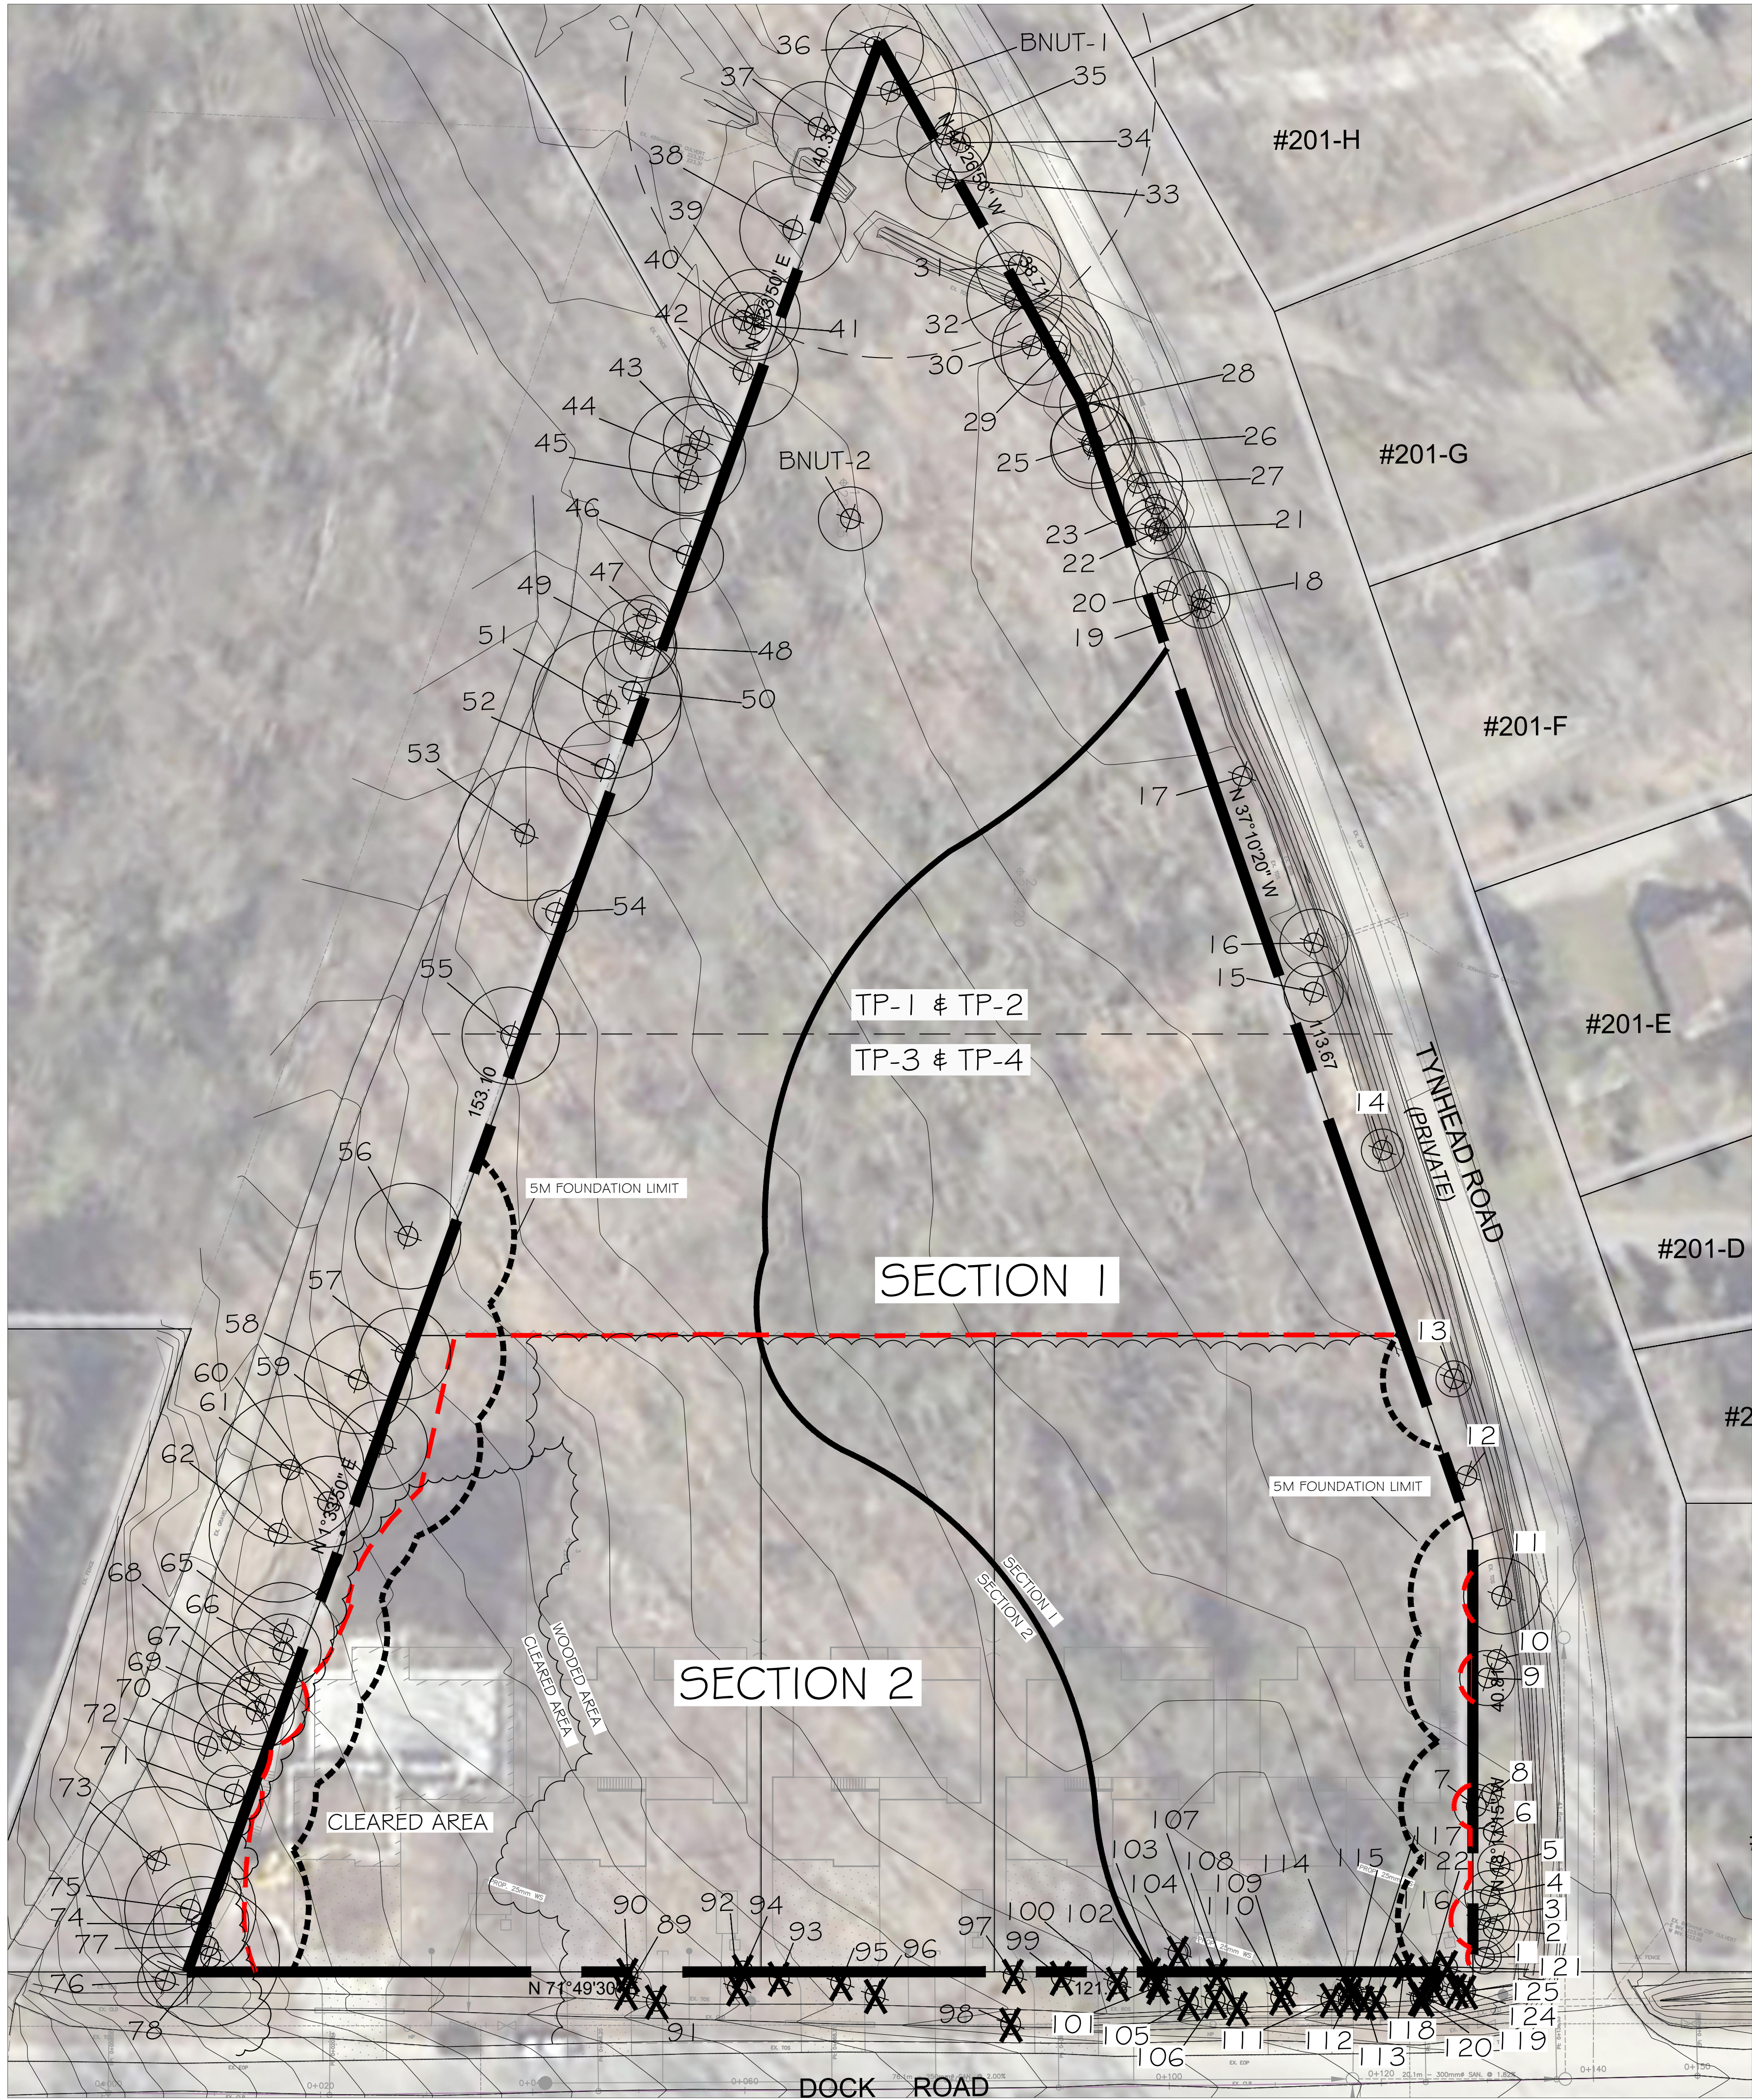
| DRAWING No.:<br>TP-1 | |

\*TWO BUTTERNUT TREES WERE LOCATED AND ARE LABELLED AS BNUUT-1 & BNUUT 2. BNUUT-2 WAS FOUND TO BE NON-RETAINABLE. (SOURCED FROM JOHN D.BELL ASSOCIATES LTD. FILE 1134A-17. DWG TP-1)
