# RIVERSTONE

July 29, 2021  
RS# 2020-004

**SUBJECT: Tree Inventory/Assessment and Preservation Plan/Removal Plan, Dundonald Street, City of Barrie.**

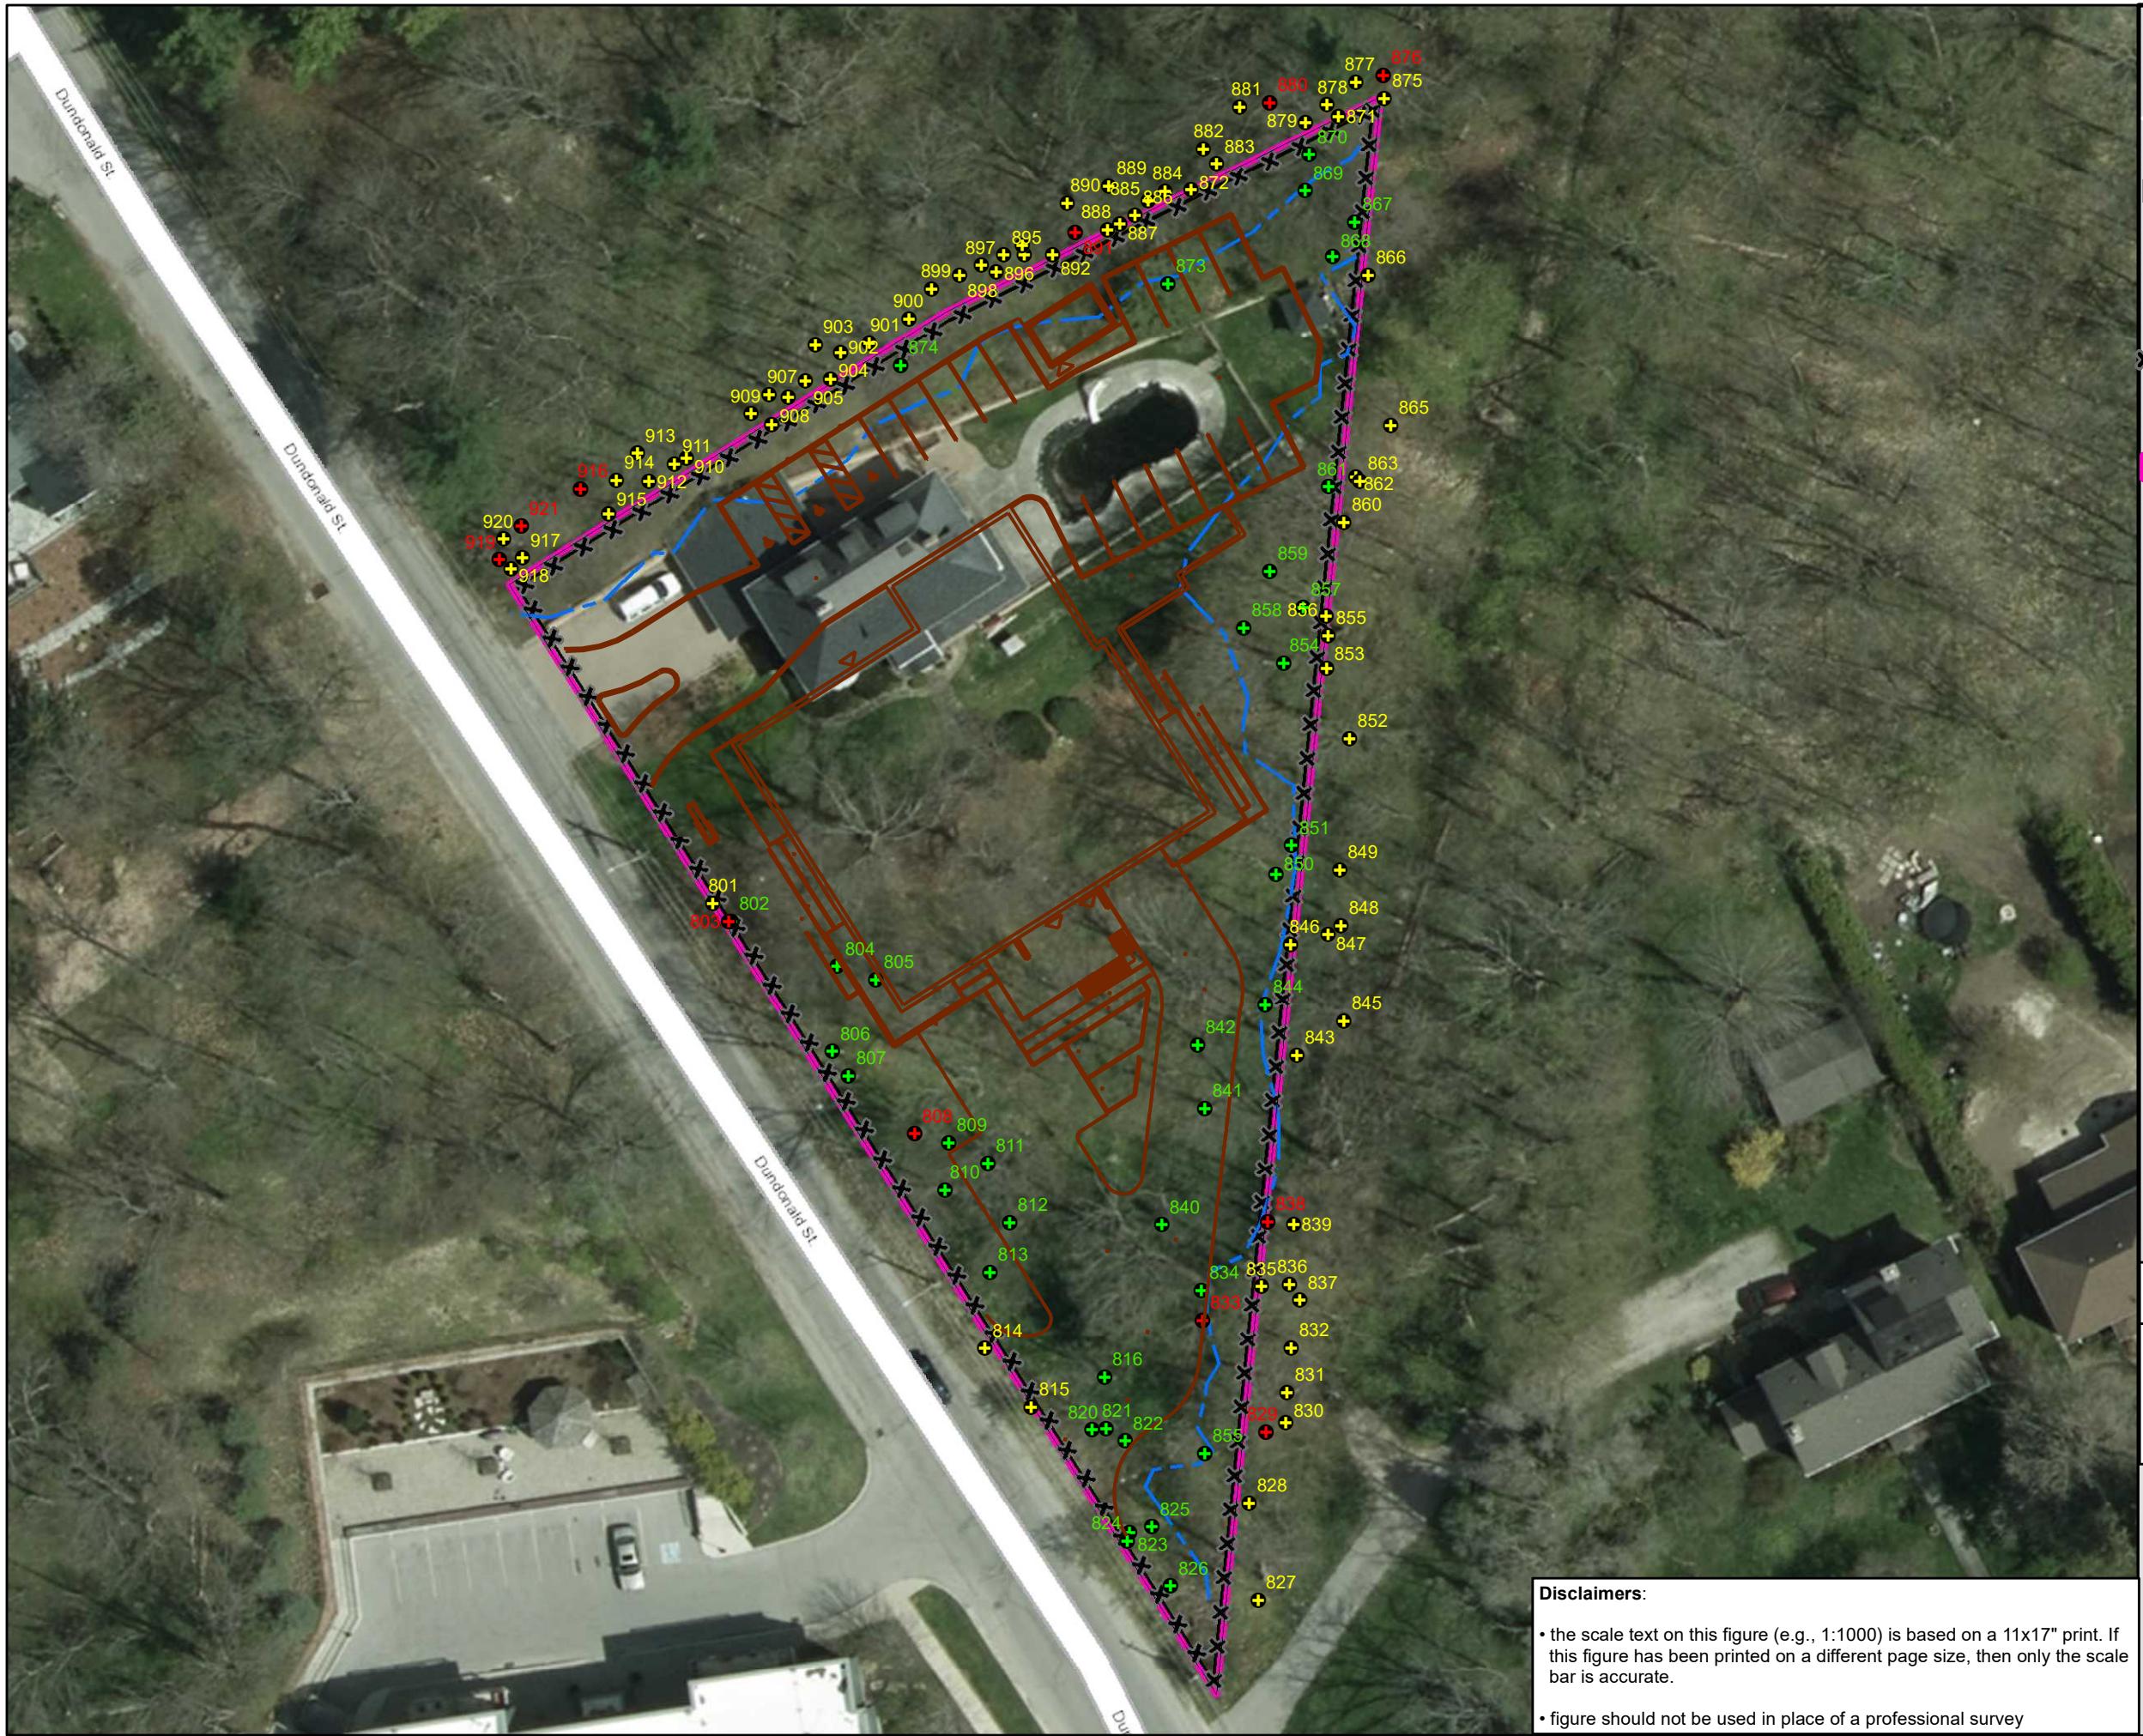
**Figure 3** provides an overlay of the proposed building siting with RiverStone's tree preservation/removal direction. Based on discussions with the project team, it is assumed that the grading limits of the development will extend to the property boundary to facilitate construction of retaining walls. RiverStone anticipates that thirty-five (35) trees within the subject property, in addition to the three (3) right-of-way trees, will need to be removed (**Appendix A**). In accordance with City of Barrie policy, trees occurring along property edges will require adjacent landowner permission for removal. Trees to be removed and boundary trees are shown on **Figure 3**.

In addition to the three (3) trees planned for removal within the Dundonald right-of-way, construction will be grading up to the property boundary adjacent to boundary trees located on private lands to the north and City of Barrie lands to the east. Currently there is no requirement for any of these trees to be removed however it is important to note that construction activities are anticipated to be within the dripline of adjacent trees and construction is likely to cause indirect disturbance such as compaction of soils within the root zone and damage to roots. A retaining wall is currently along the north portion of the property and the location of the new retaining wall will be along the existing walls path. It is assumed that trees along the north property boundary have grown with the retaining wall as a restriction to growth and development impact is anticipated to potentially cause impacts to root. There will also be a requirement for the removal of overhanging branches of boundary trees that have grown into the subject property and currently form a portion of the dripline. A number of trees on adjacent lands to the north have grown over the property boundary and large portions on the trees canopy are solely overhanging the subject property. Due to the proximity of the proposed development within the driplines of boundary trees to be retained and the requirement for pruning of branches overhanging the subject property, these specimens require protection measures to be implemented. To guide the preparation of final site plans for the subject property, RiverStone recommends the following measures:

- All trees identified as boundary trees (except for the three (3) to be removed) are to be treated as conditional maintenance trees. These trees are to be monitored during and post construction, with trees being monitored and maintained by a certified arborist related to any decline. If trees are damaged (root system, trunk or canopy) and decline to a point of requiring removal, trees will be compensated based on values determined in appendix A for trees located on City land and any agreement with associated neighbouring landowners.

- Construction within the dripline of boundary trees (Figure 3) is to be limited as much as possible. Protection mitigation for root systems, such as mulch layers or protection pads, are to be established prior to construction in consultation with an arborist.

- At a minimum, tree protection fencing should be installed for all trees along the boundary of the property and maintained for the duration of the proposed development. Where possible and where grading permits, tree protection zones shall be established for boundary trees on adjacent lands. Tree protection zones are to be calculated as the crown radius around the stem of tagged trees shown in Appendix A with tree protection zones placed at a minimum distance from tagged trees according to individual minimum tree protection zones shown in Appendix A. No site alteration activities (e.g., grading, etc.), machinery movement, or storage of any equipment or materials should occur within the tree protection fencing.
