220 BRADFORD STREET RESIDENTIAL DEVELOPMENT

TREE INVENTORY, ANALYSIS AND PRESERVATION REPORT

FEBRUARY 2020

OUR FILE: LA 439-19

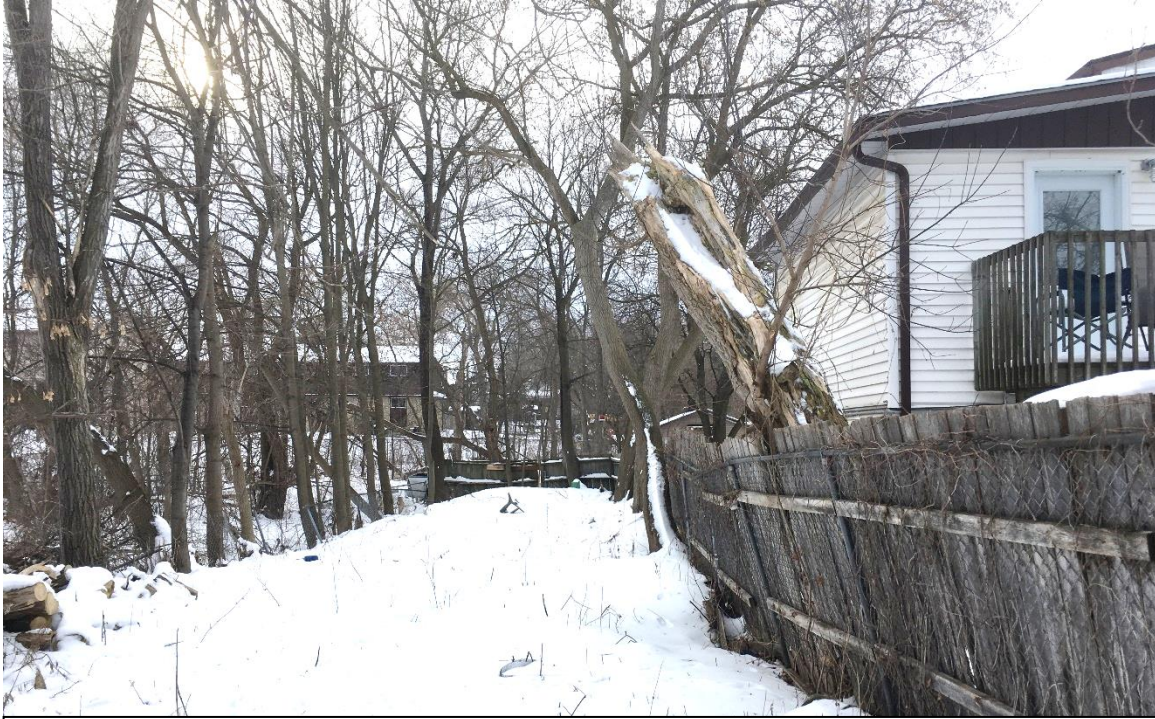
Photo 1: Looking south-west showing proposed location of the 'soft landscape' area. Showing Trees 1-9 on the left (south) fence-line.

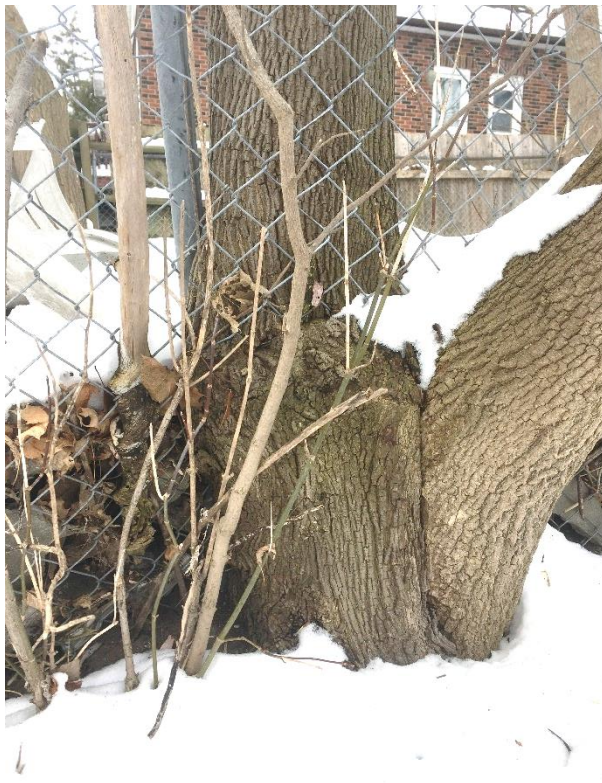
The interior/frontage of the site is relatively bare, with very little vegetation (see **Photo, front cover page**). The existing trees are shown to be mostly distributed around the perimeter of the site with no trees captured at the interior towards the centre. The trees on the site have not been subject to pruning or other maintenance practices. There are both wood and non-wood privacy and chain link fences of varying heights/materials observed along the north and western boundary adjacent to existing residences (see **Photos 1-5, 6-10 in Appendix D**) and many of these fences are observed to be affecting the health of perimeter trees (see **Photos 2, 9, 10 & 11 in Appendix D**).

Photo 2: Showing typical growth of trees on southern fence-line; grown through fence.

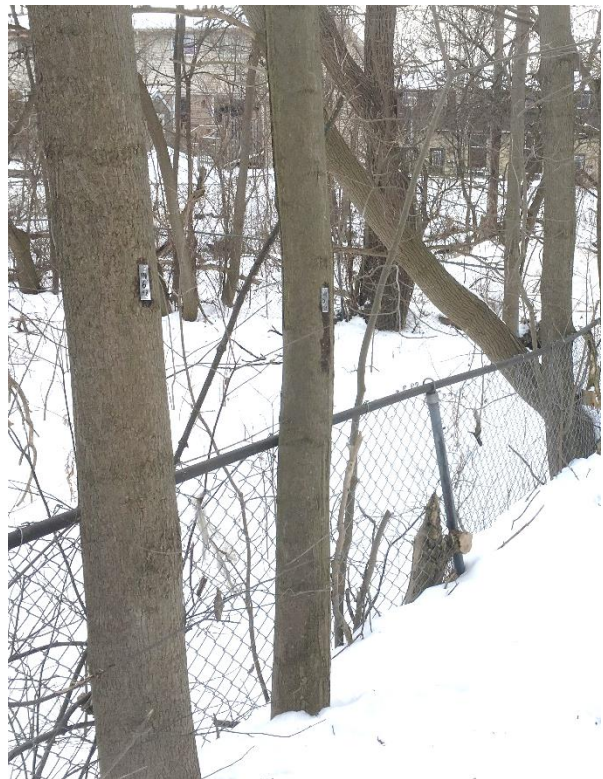
Photo 3: Showing southern fence-line.

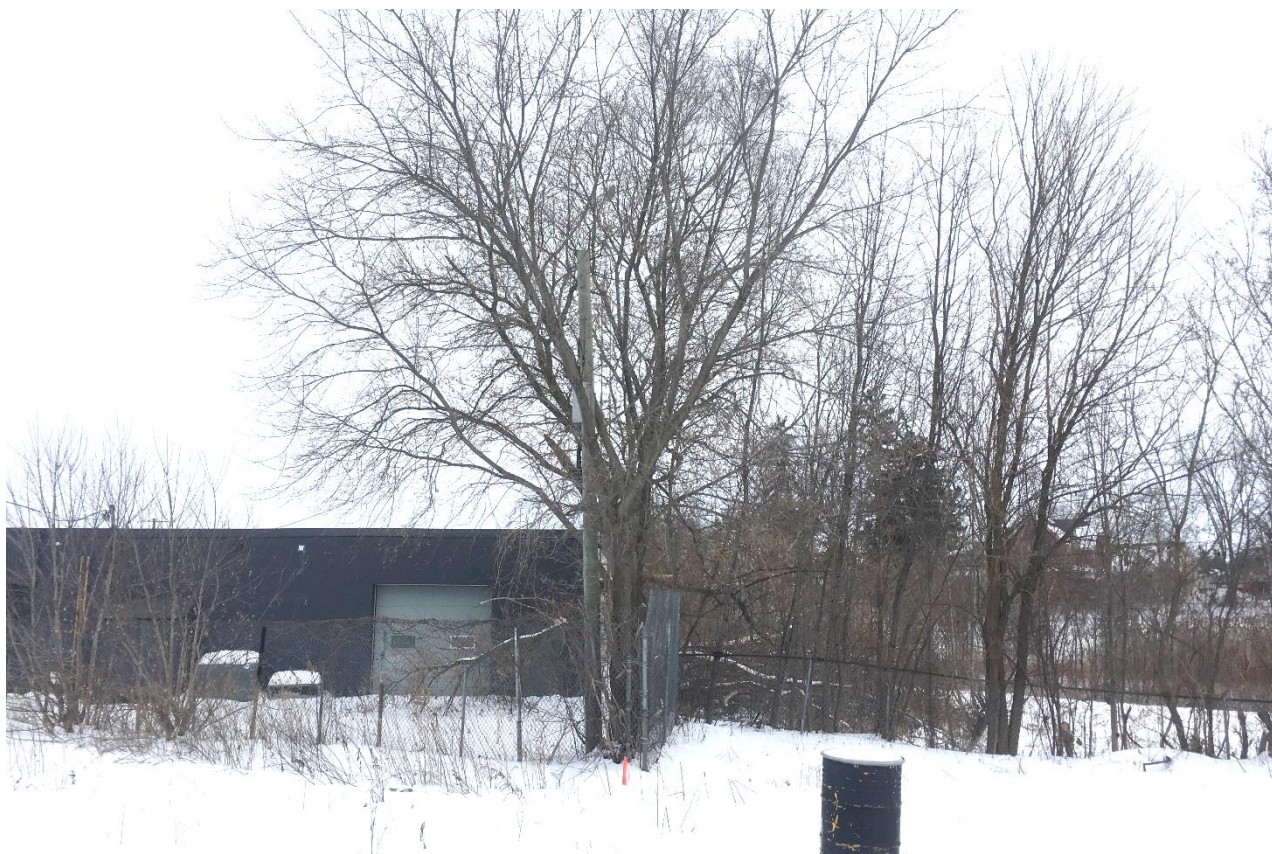
Photo 4: Showing offsite trees with canopies that encroach into the site in the jutting portion of the property line on the south-east fence-line, including Tree nos. 16, 17.

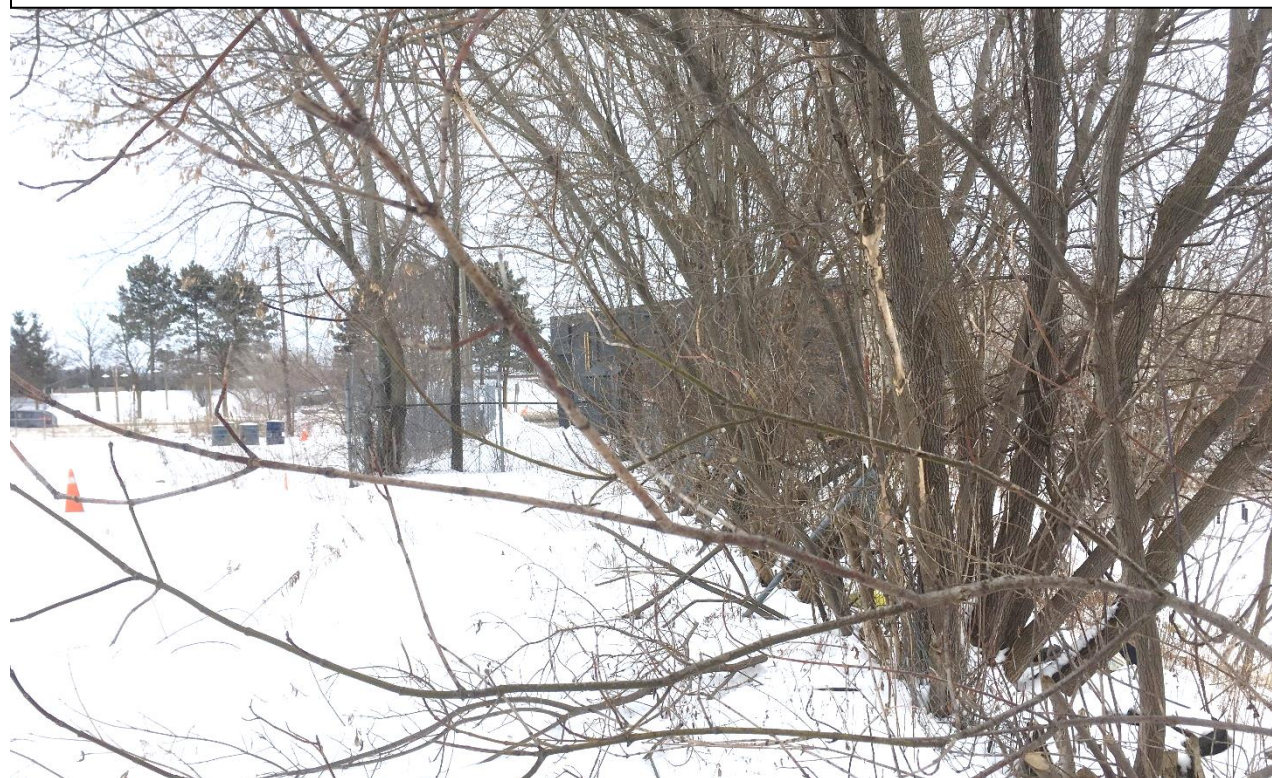
Photo 5: Showing the extent of the overhanging canopies of offsite trees near Tree nos. 16, 17

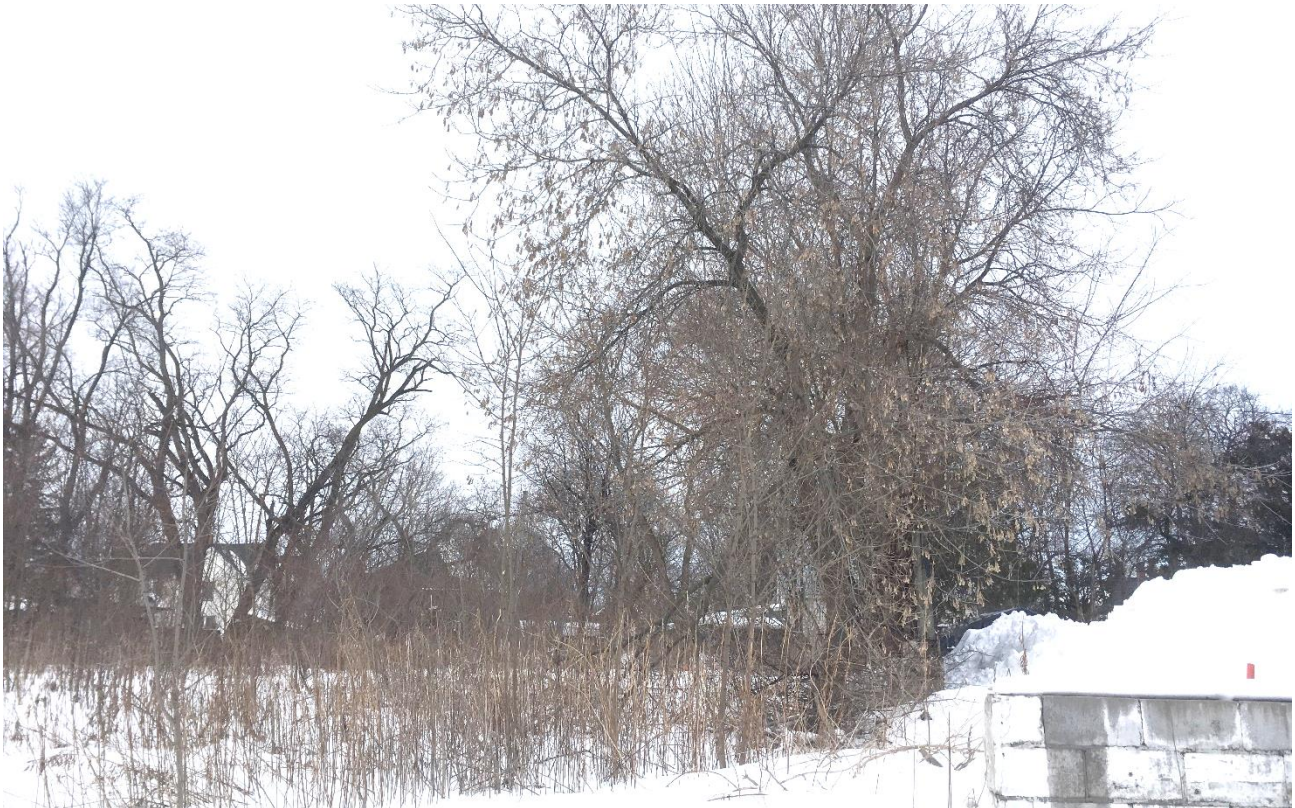
LEGroup staff observed that the trees appear to be mature, in varying states of decline/poor condition with generally poor form (Tree Nos. 3,4, 7-11, 13-20, 23-43, 48, 49) **Photos 6-11, Appendix D**. Many of these trees had grown through the chain-link and paige wire fencing in various locations on the site, girdling the trunks of the trees from an early age which has contributed to their decline and poor condition. The trees that had grown through this chain-link fence and featured significant portions of the fence embedded deeply within their trunks (Tree Nos. 3, 4, 7, 11, 15, 17, 25-36, 40, 41, 43, 48-51) also showed a number of characteristics

Photo 6: Photo looking north-east into the northern arm of the site.

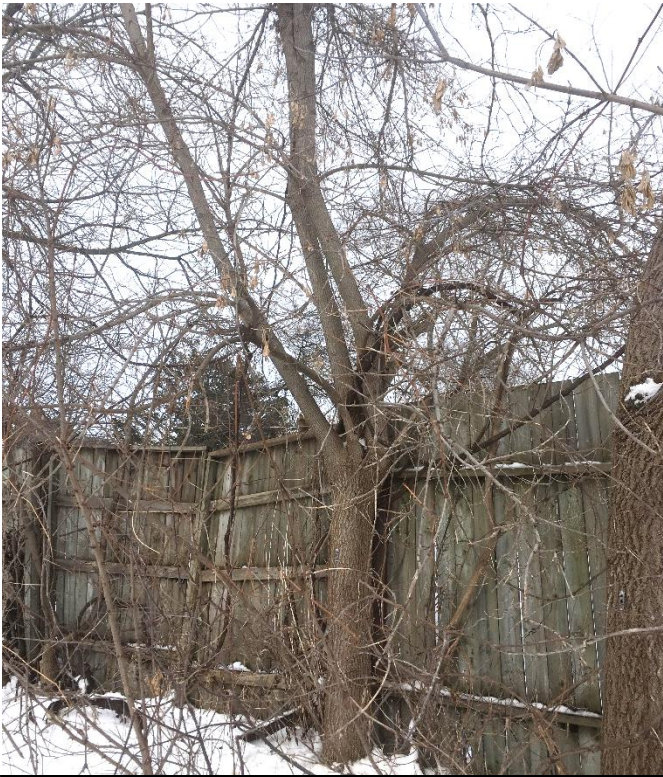
Further it was noted that Riverbank Grape (*Vitus riparia*), an aggressive high-climbing woody parasitic vine that competes for light with the host tree, is found on nearly all of the trees on the site and negatively affects the health of the host tree.

Photo 7: Showing Tree no. 19 and presence of Riverbank Grape, typical to this section of the site.

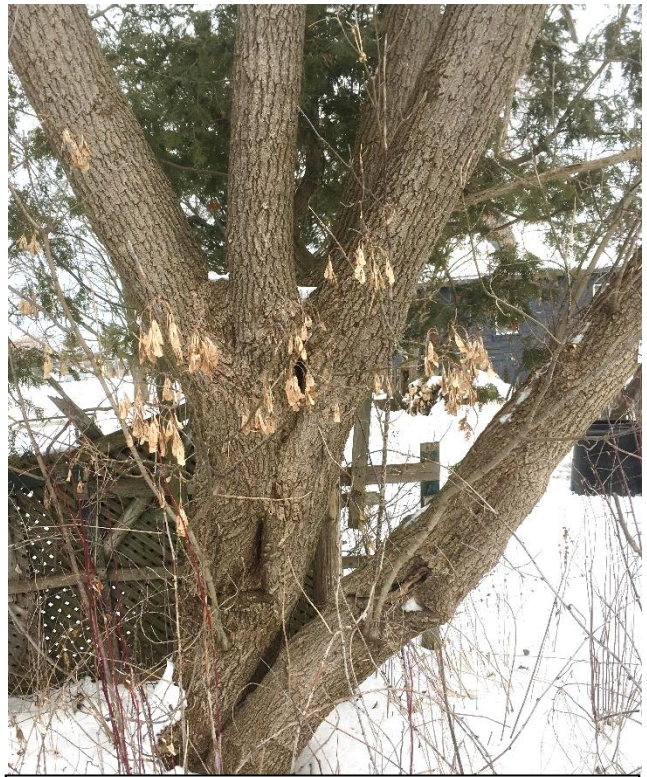
Photo 8: Showing Tree no. 23, a large Manitoba Maple in poor condition along the north-east fence-line.

The remaining trees that are recommended to be removed include Tree Nos. 3, 9-10, 13-14, 16-17, 23, 25, 29-36, 40-43 & 49-51 (see **Tree Inventory Table in Appendix C**). It is expected that the origin of these trees are 'fly-ins' and considered to be a weak-wooded species of less intrinsic value. These trees are assessed to be in poor health due to their significant leans, branch dieback, trunk wounds, embedded fence fabric/posts and infestation with Riverbank Grape. Often these defects along with their offset tree canopies, contribute to the compromise of their structural integrity. Many are observed to have deformations in the trunk suggesting internal decay is present. Lower branch dieback also means less buffering capacity between existing residences and new adjacent uses. It is therefore anticipated that these trees noted above are not suitable for retention.

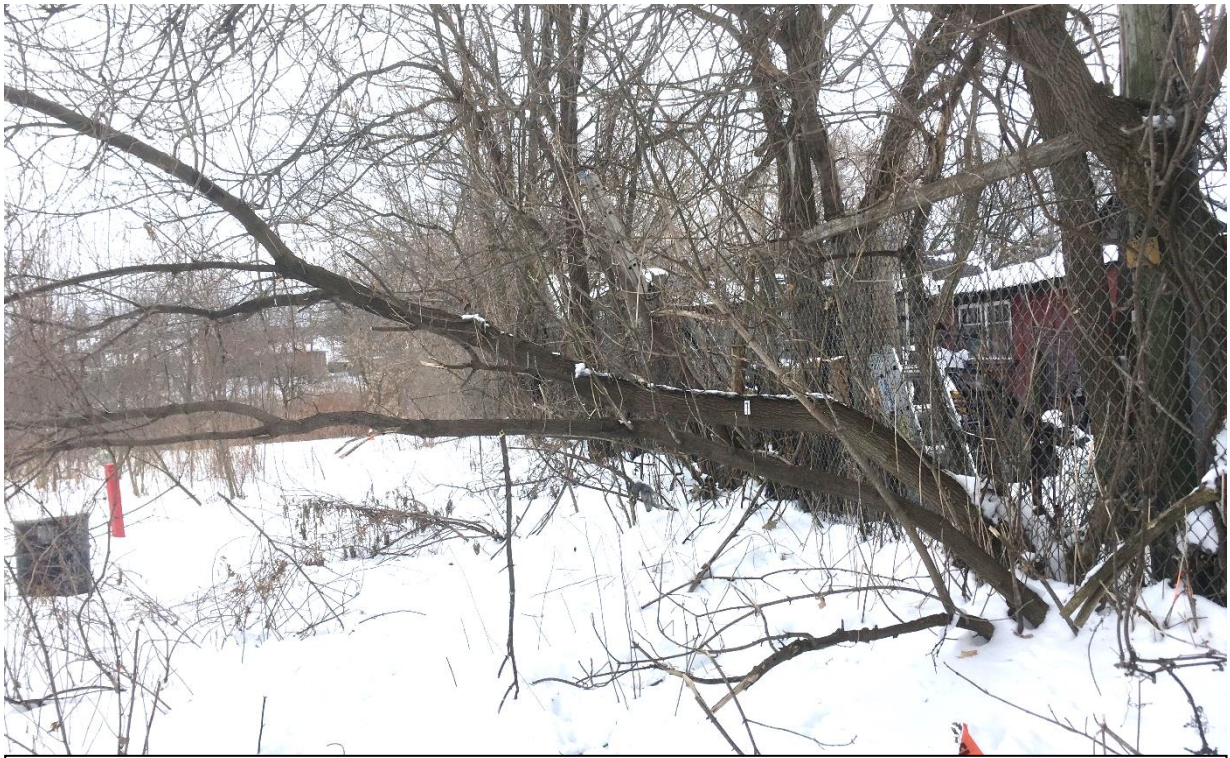
Photo 9: Showing trees along north-western fence-line, typically in poor condition, growing through chain-link fence with significant girdling.

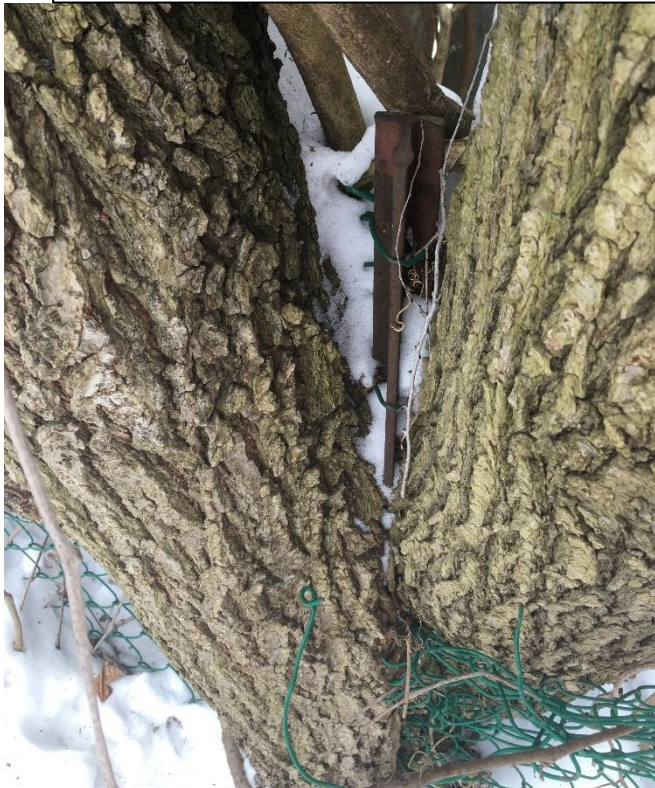
Photo 10: Showing significant girdling as Tree Nos. 33 & 34 has grown through chain-link fence, embedding the fence & T-bar within the trunk.

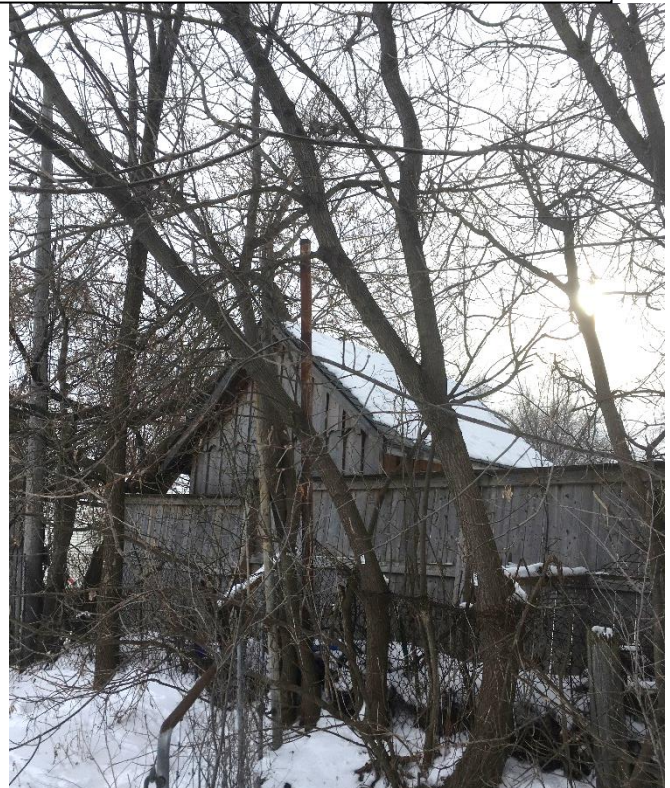
Photo 11: Showing Tree nos. 40-44, mostly girdled by chain link fence with corrected leans to encroach further into site.

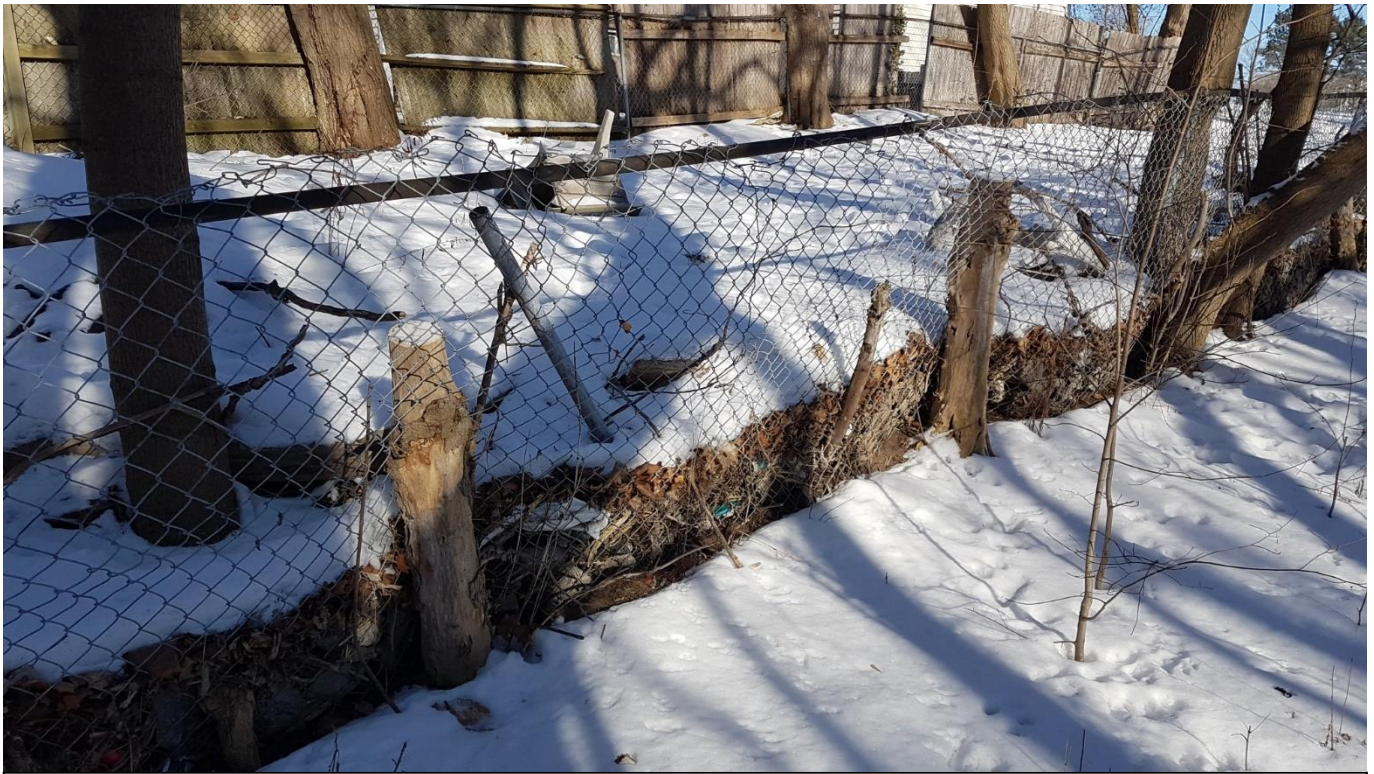
LEGroup staff observed that the site ground was relatively flat with a slight incline towards the northern arm of the property. In addition, there appeared to be minor soil filling along the south fenceline close to Sanford Street (see **Photo 10, Appendix D**). A small tributary identified as Hotchkiss Creek is located on the lands immediately south of the subject site, flowing toward Lake Simcoe.

Photo 12: Showing minor fill along south fence-line at close to Sanford Street.

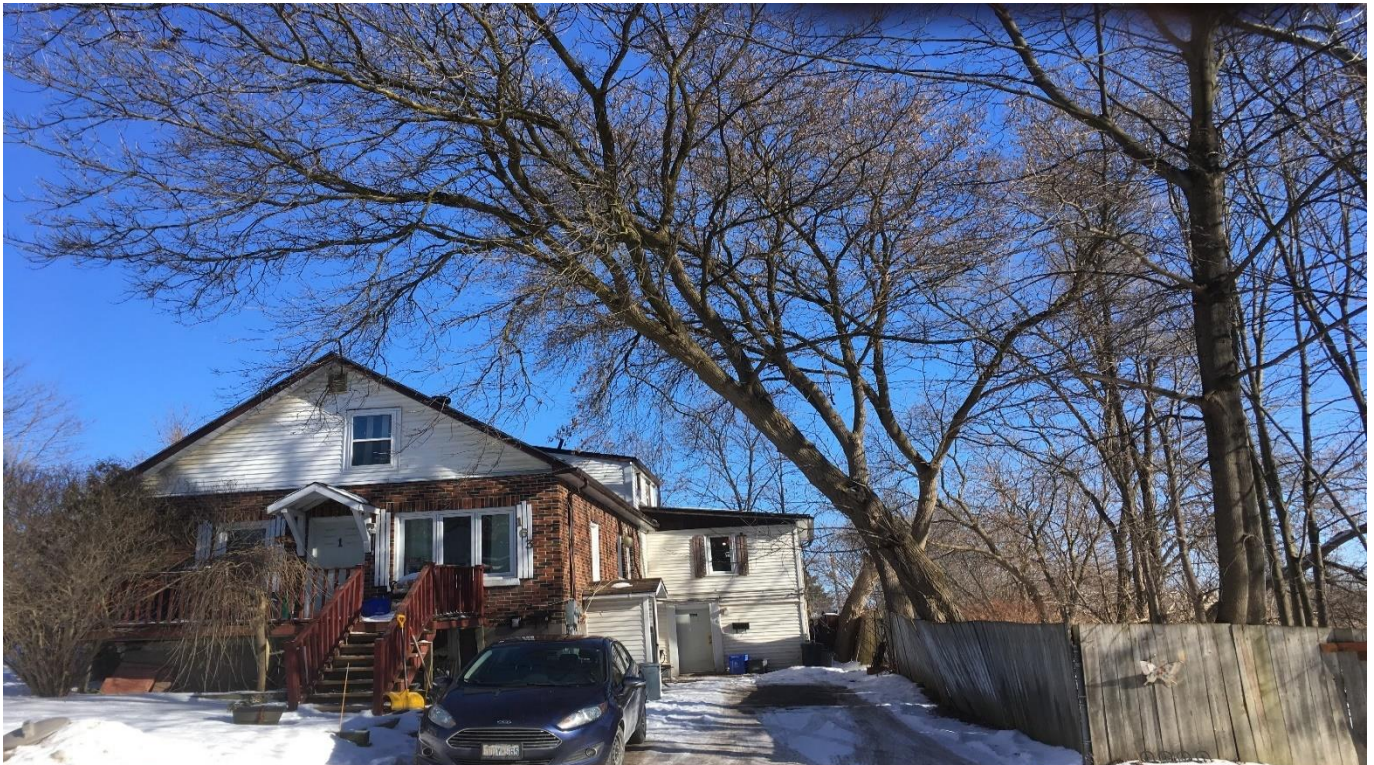
A number of the trees observed appear to be structurally uncertain with suspected interior basal decay, overreaching offset canopies and included bark. Trees Nos. 48-51 are assessed to be in poor condition and are located within target zone of static (homes) and moveable (autos) targets (see **Photo 10, Appendix D**). With the assessed poor health, these trees appear to be of a greater likelihood of failure as a result of a storm event.

Photo 13: Showing excessive lean of Tree Nos. 49, 50 & 51 adjacent to 163 Sanford Street.

3. Tree Nos. 48, 49, 50 & 51 be removed to eliminate the risk of failure of these next to home/auto within the target zone. As a minimum, we would recommend that a Level 2 or Level 3 TRAQ assessment be completed on these trees as soon as possible;
