Technical Design Brief: Realignment of Unnamed Tributary of Bunkers Creek

105 - 111 Edgehill Drive, City of Barrie

March 12, 2022
PN21075

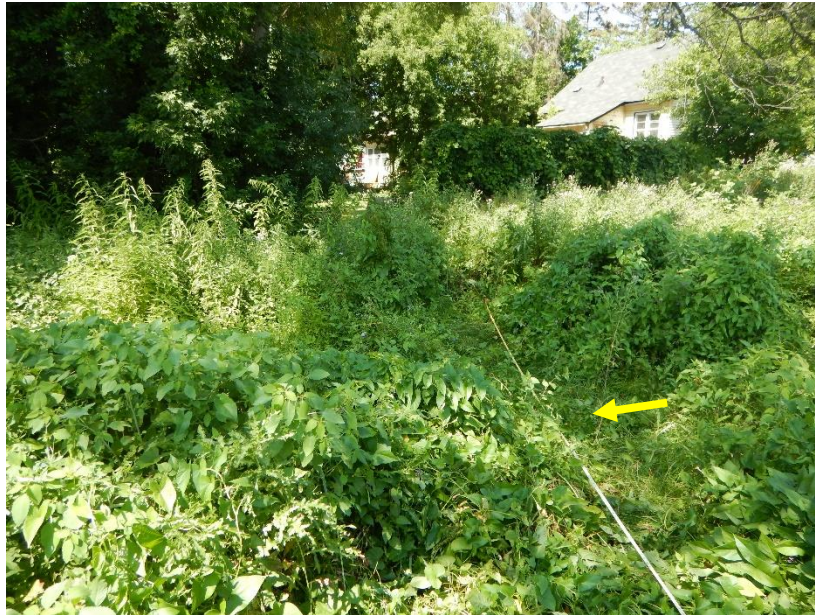
Photo 1

Reach M1: Drainage feature running from North-East to South-West within the property of 111 Edgehill Drive

Drainage feature begins at the North-Eastern quadrant of the property and runs toward the South-West direction. Yellow arrow indicates flow direction.

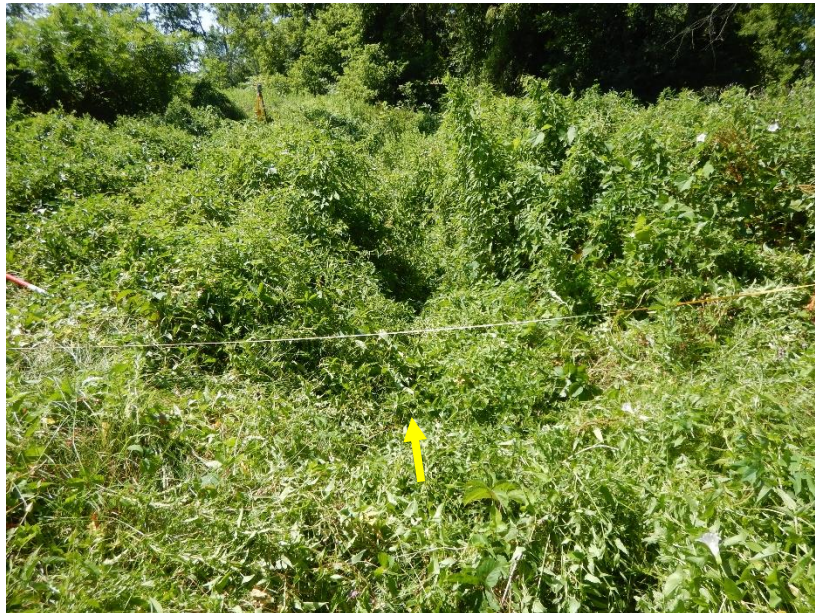
Photo 2

The drainage feature is dry, the channel bed and banks are covered by grasses and herbaceous vegetations, and are composed of a mixture of organic material, silt, and sand.

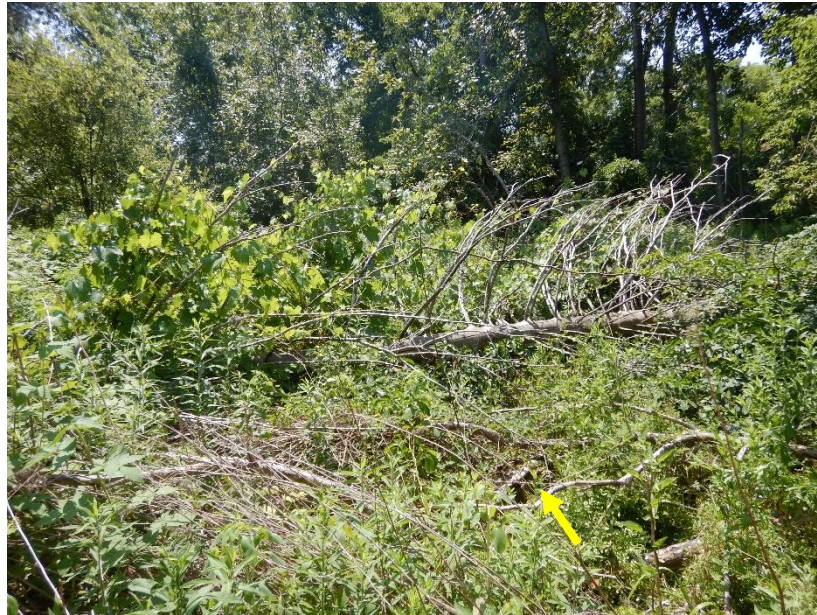
Photo 3

Large woody debris fallen across the channel. Riparian zone transitions from herbaceous dominated to forest dominated.

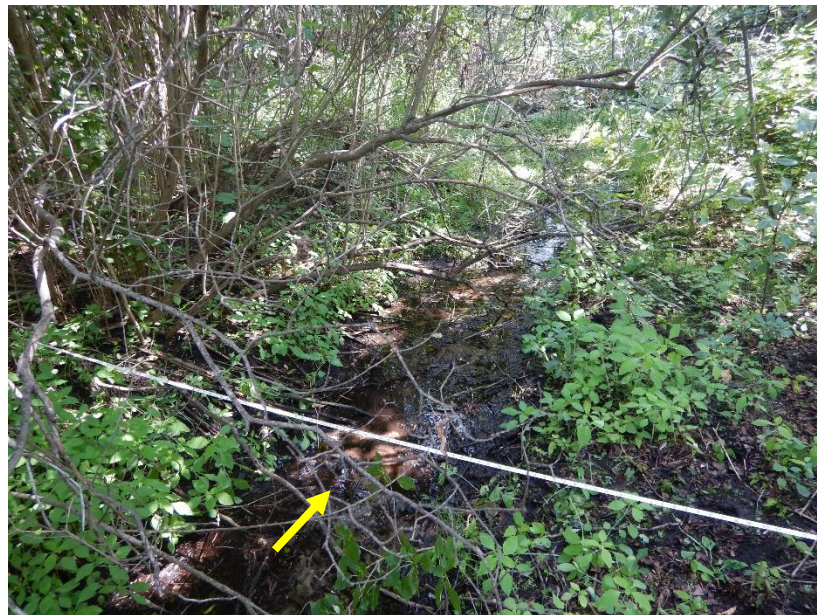
Photo 4

Shallow standing water was observed at the lower portion of the drainage feature, near the South-Western corner of the property, possibly groundwater seepage.

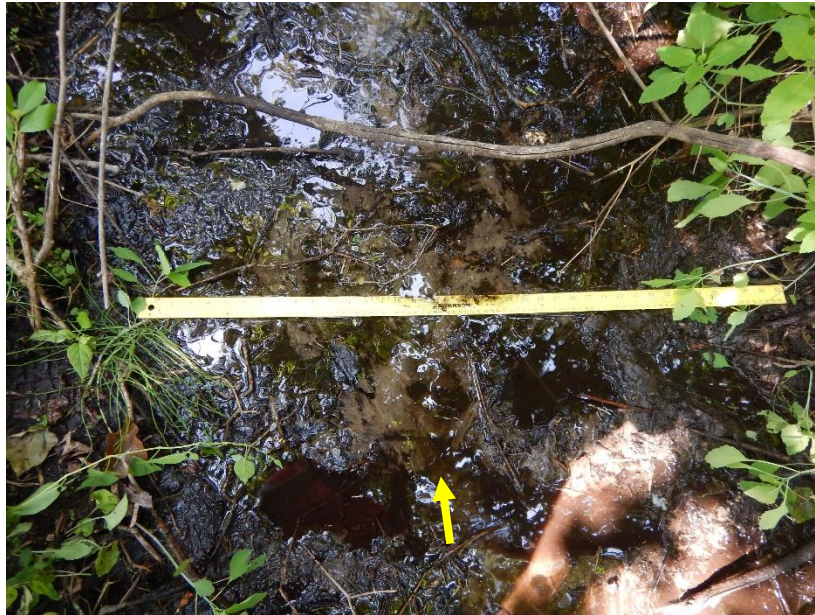
Photo 5

The channel bed is composed of organic materials (leaves, branches), silt, and sand, which is similar to bank material.

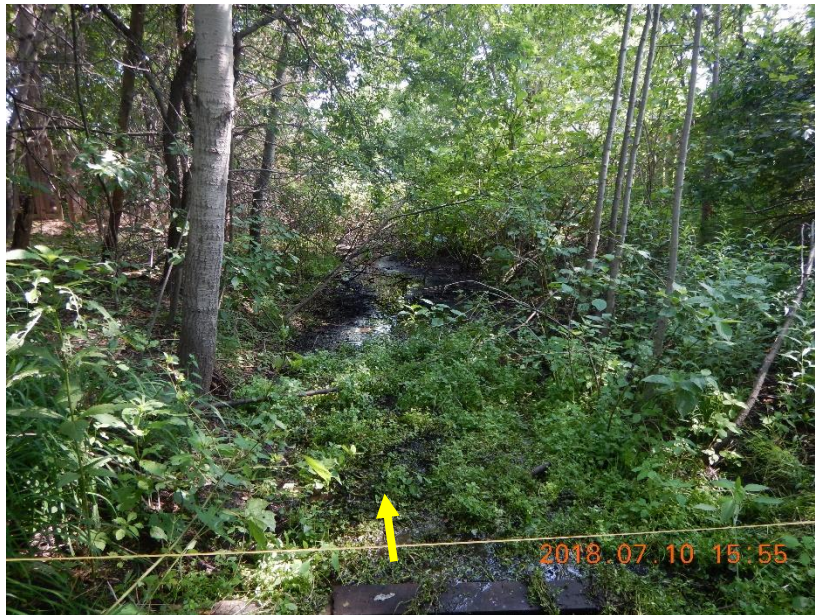
Photo 6

Lower portion of the drainage feature is a straight suspended load channel with an established forested riparian buffer. Non-vascular plant grows across shallow regions of the channel.

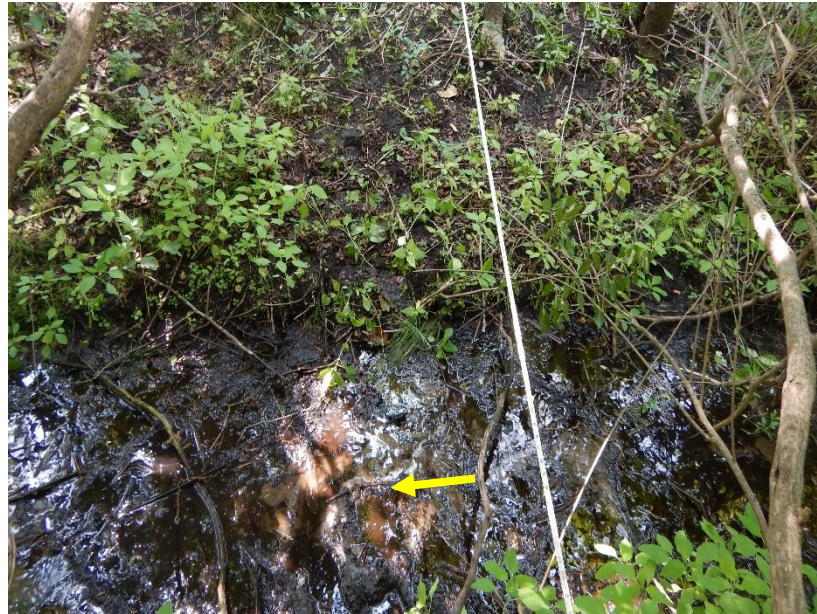
Photo 7

The unnamed Tributary had an RGA score of 0.22, indicating that the channel is *in transition or stressed*. The dominant mode of adjustment was aggradation, evident from siltation in pools, poor longitudinal sorting of bed materials and deposition in the overbank zone. The RSAT score of 27 indicated that the Reach was in *good* ecological health, with physical instream habitat being the limiting factor for this Reach. The Down's model classified this channel as 'S' – *stable*, indicating no observable morphological change.

No signs of bank erosion or channel degradation was observed. The channel gradient is consistent and no apparent pools or riffles. Some siltation and overbank deposition suggest channel aggradation.

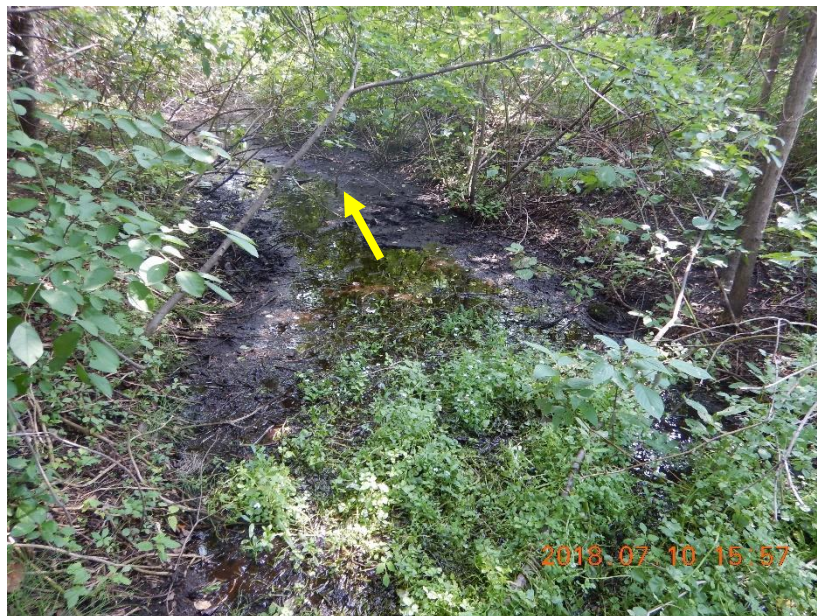
Photo 8

Reach 1 ends at the South-Western corner the property boundary, but the drainage feature continues and enters Bunkers Creek at Highway 400.

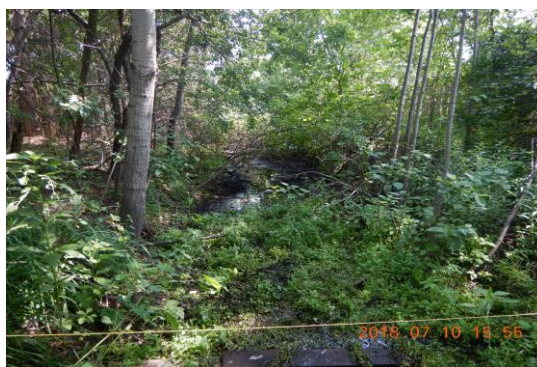
Photograph at cross section 9 (looking downstream)

Reach M1 is a drainage feature located within the property of 111 Edgehill Drive. The reach has no upstream connection and drains into Bunkers Creek at the downstream end after leaving the property boundary. Reach M1 flows through a residential area with moderate gradient and low sinuosity. Riparian vegetation is comprised of grasses, herbaceous plants, and trees, which provides a continuous buffer that is 1-4 channel widths wide. The channel was mostly dry with small pools of standing water at the time of assessment. There was no riffle-pool development. Bed and bank material was composed of mainly sand and silt. Average bankfull width and depth were 1.60 m and 0.08 m respectively. Woody debris was present in the channel but not due to channel widening. Little to no bank erosion was apparent.
