BEAR CREEK VILLAGE - PHASE 2B -SUMMERSET DRIVE DEVELOPMENT

TREE INVENTORY, ANALYSIS, PRESERVATION REPORT

BEAR CREEK SUBDIVISION, SUMMERSET DRIVE BARRIE, ONTARIO, COUNTY OF SIMCOE

OCTOBER 2020 updated to JANUARY 2021

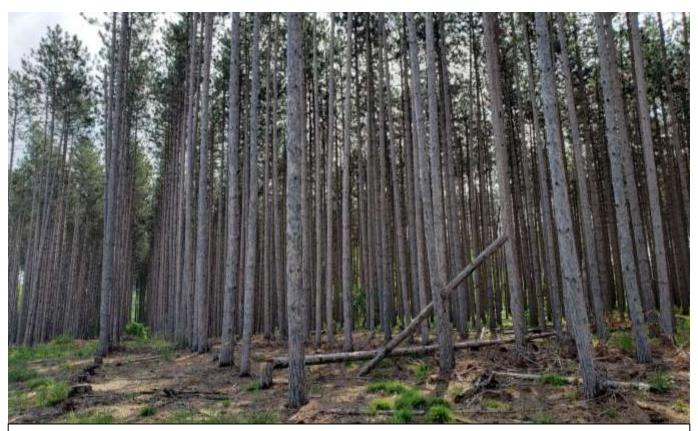
LEGroup Staff observed that most of the site was comprised of a Red Pine plantation with mixed (coniferous and deciduous) natural woodland toward the east property line. The Red Pine trees are observed to be approximately 18 metres (60') tall, make up the majority of trees on site and were observed to be in marginal to poor condition. LEGroup staff noticed that the plantation trees had small canopies due to their high density plant spacing producing lower branch dieback (see **Photo A, Appendix B)**. The plantation trees were not captured in the inventory since they were all of the identical species, comparable heights, health and structural soundness and relative lack of diversification.

As noted above, the Red Pine plantation area has been densely planted and in our opinion, this is partially responsible for the declining health of the stand which have been assessed to be in marginal to poor health. In addition, **ARB-2** and **ARB-3** show the stand will be in conflict with the proposed development. It is the opinion of LEGroup staff that when removing a portion but not all of a plantation, the remaining trees that

are preserved are subject to weather forces (eg windthrow, desiccation, storm events) which can cause health decline and potentially hazardous when their environment is drastically changed. There is already evidence of tree falls within the plantation areas. For these reasons, all the Red Pine plantation trees on site are recommended for removal as soon as possible.

Photo A: Showing the Red Pine that make up most of the proposed site with very small canopies and lower branch dieback. Note the recently fallen trees at photo centre.

In addition to the aforementioned potential hazards, since an area on the east side of the plantation has already commenced harvesting, we would recommend that the remainder of the plantation be promptly harvested.

- That the remaining Red Pine trees within the plantation be harvested, similar to the harvest that appears to have already commenced on the east side of the site;

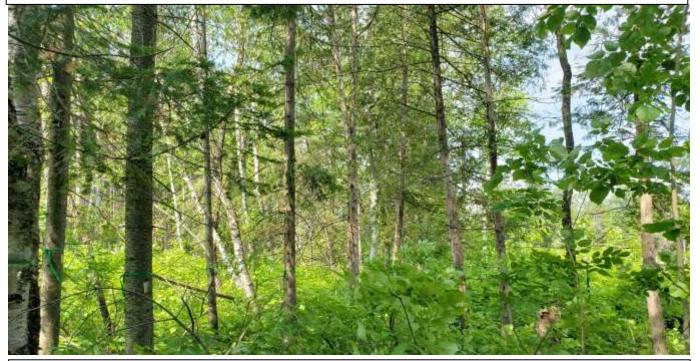
LEGroup staff observed the trees adjacent to Bear Creek is observed to be a dense mix of coniferous and deciduous trees (see **Photo B**, **Appendix B**) with a walking trail through the wooded area. These trees Bear Creek Village, Barrie, ON

were generally observed to have lower branch dieback, offset and thin canopies, multiple leaders, twisted trunks, sap bleeding, minor leans and minor trunk wounds. Additionally, there is a large area of the Red Pine plantation that has been harvested and cleared at the east side of the plantation. (see **Photo C**, **Appendix B**).

Photo B: Showing trees on the east side of the proposed development which are recommended to be retained due to their location.

The remaining 155 trees that are inventoried and assessed in the Report are recommended to be retained and preserved with tree preservation fencing. It is also recommended any existing branches of those trees to remain that interferes with the construction works be lightly pruned by qualified personnel.

- That155 trees on the east side of the site are recommended to be retained and protected using tree preservation fencing as set out in **Drawing D-1 in Appendix B**.

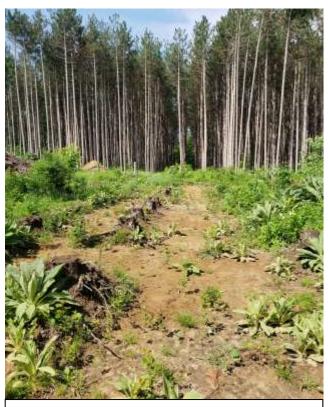
Photo C: Showing a portion of the plantation that appears to have been previously harvested on the east side of the site.

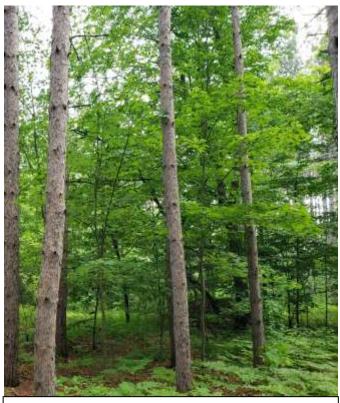
On the north-east corner of the site, trees from the wooded portion adjacent to Bear Creek have spread into the plantation growing up under the Red Pine canopies creating a mixed stand where there are several Black Cherry, Balsam Fir and Paper Birch. Many of these trees are in marginal to poor condition and display defects and health concerns including but not limited to wounded and twisted trunks, leans, dieback, one sided branching, dual leaders, included bark and epicormic branching (see **Photo D**, **Appendix B**).

Photo D: Showing mixed trees on the northeast side of the proposed site that are recommended for removal.

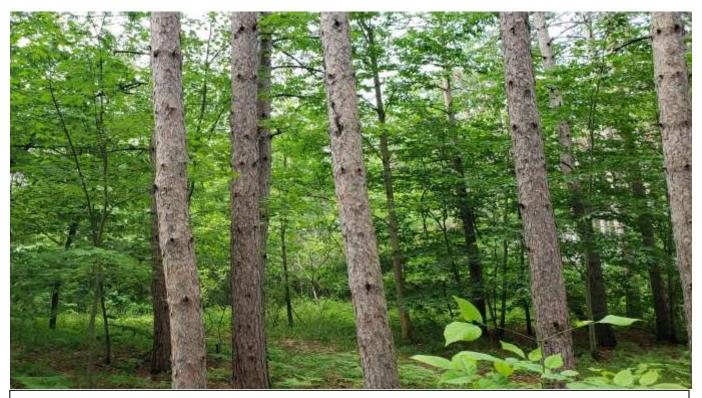
LEGroup staff also observed several deciduous trees growing up in and isolated area in the middle of the plantation (Tree Nos. 222 – 240). This stand was comprised of Black Cherry, Red Maple, Red Oak and White Ash (see **Photo E, Appendix B).** The trees in this area are rated as fair – marginal and display dual trunks, twisted trunks, dieback, minor leans and included bark. Furthermore, some of the Ash are affected by the Emerald Ash Borer.

Additionally, Tree Nos. 155-158 & 164-240 are recommended for removal. These trees conflict with the proposed development, and are in fair – poor health due to sap bleeding, twisted trunks, leans, dieback and Emerald Ash Borer damage on the Ash trees (Tree Nos. 225, 228, 229 & 237).

Photo E: Showing Tree Nos. 222 – 240 in the center of the proposed site which are recommended for removal.
