157 ARDAGH ROAD RESIDENTIAL DEVELOPMENT

TREE INVENTORY, ANALYSIS, AND PRESERVATION PLAN

157 ARDAGH ROAD

OUR FILE: LA 590-21

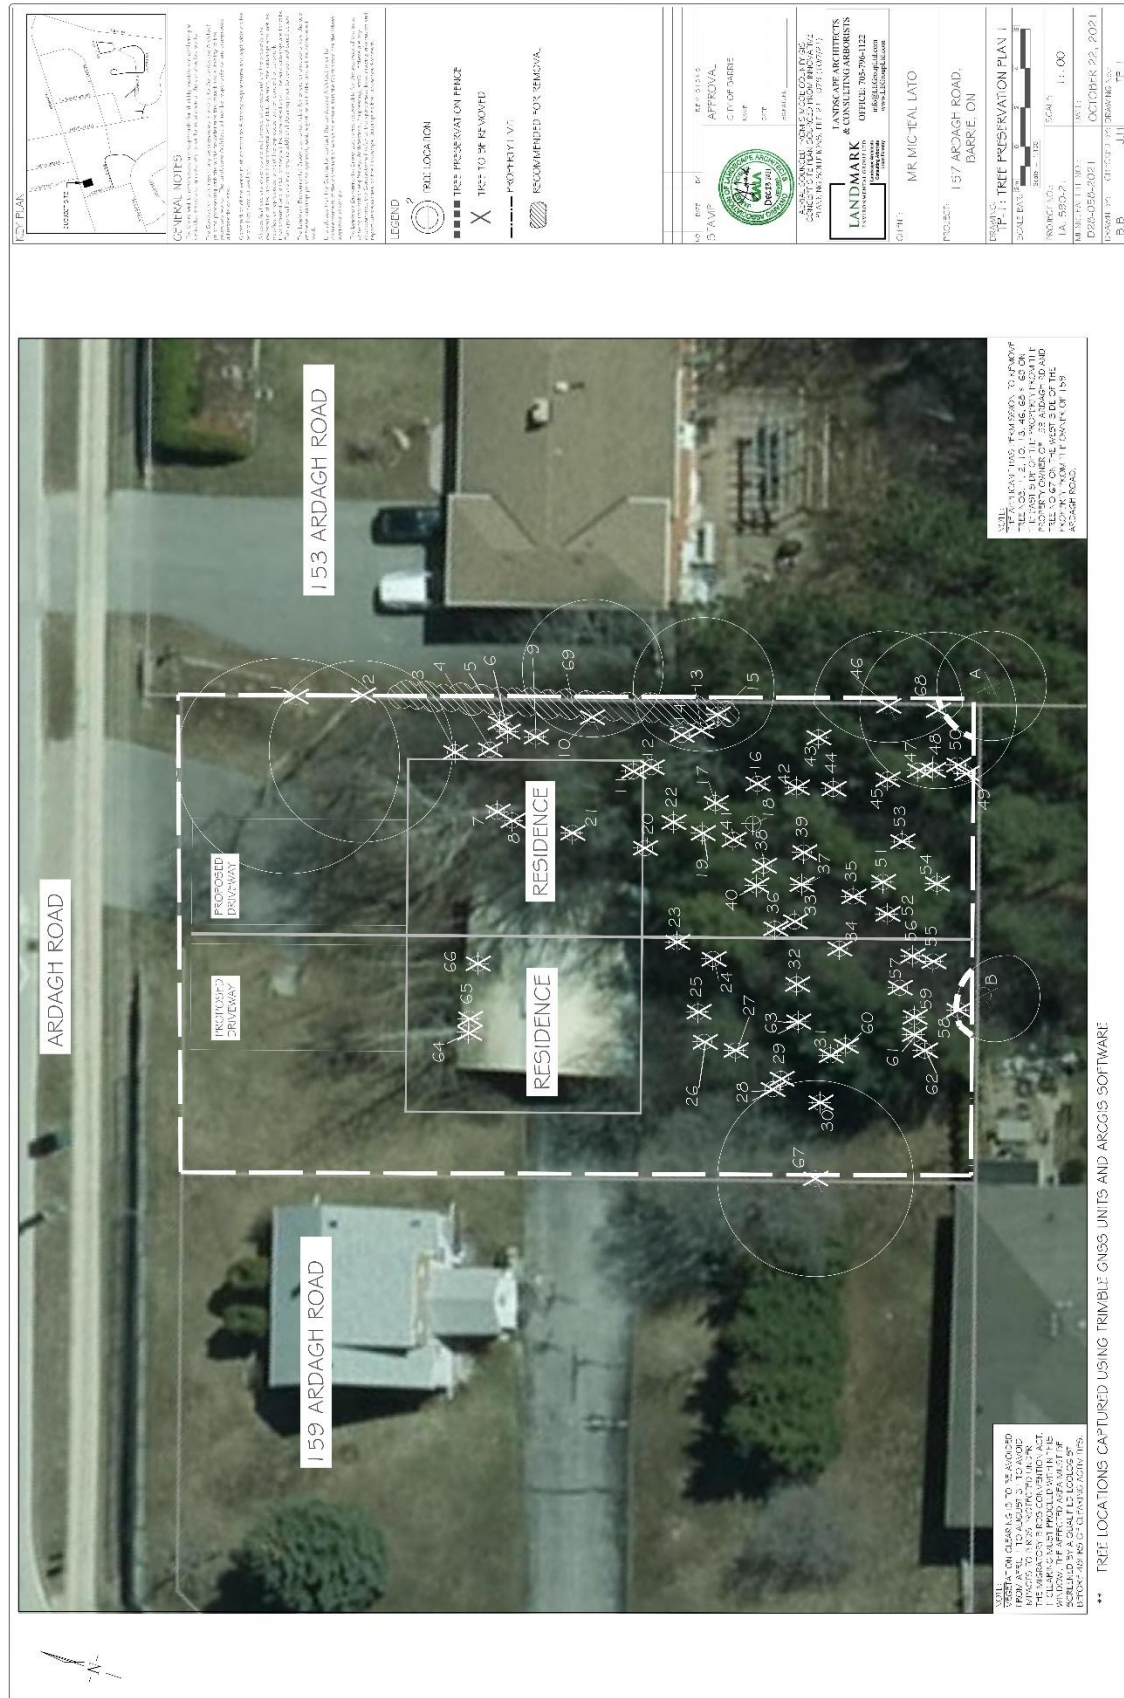
Tree Preservation Plan 1 (TP-1)

LEGroup recommends the removal of Tree No. 1, 2, 10, 13, (boundary trees) that are in poor condition, possess the potential to fail due to their leans (can be seen by their offset canopy on **TP-1**), and are of limited aesthetic/intrinsic value. Tree No. 46, 68 & 69 (boundary trees) that are in poor to marginal condition are also recommended to be removed due their decline in health from bark beetles, and low intrinsic value.

- Provide tree preservation fencing at the dripline of offsite trees (Tree A & B) which represents the tree preservation zone (refer to **TP-1 & TP-2, Appendix B**).

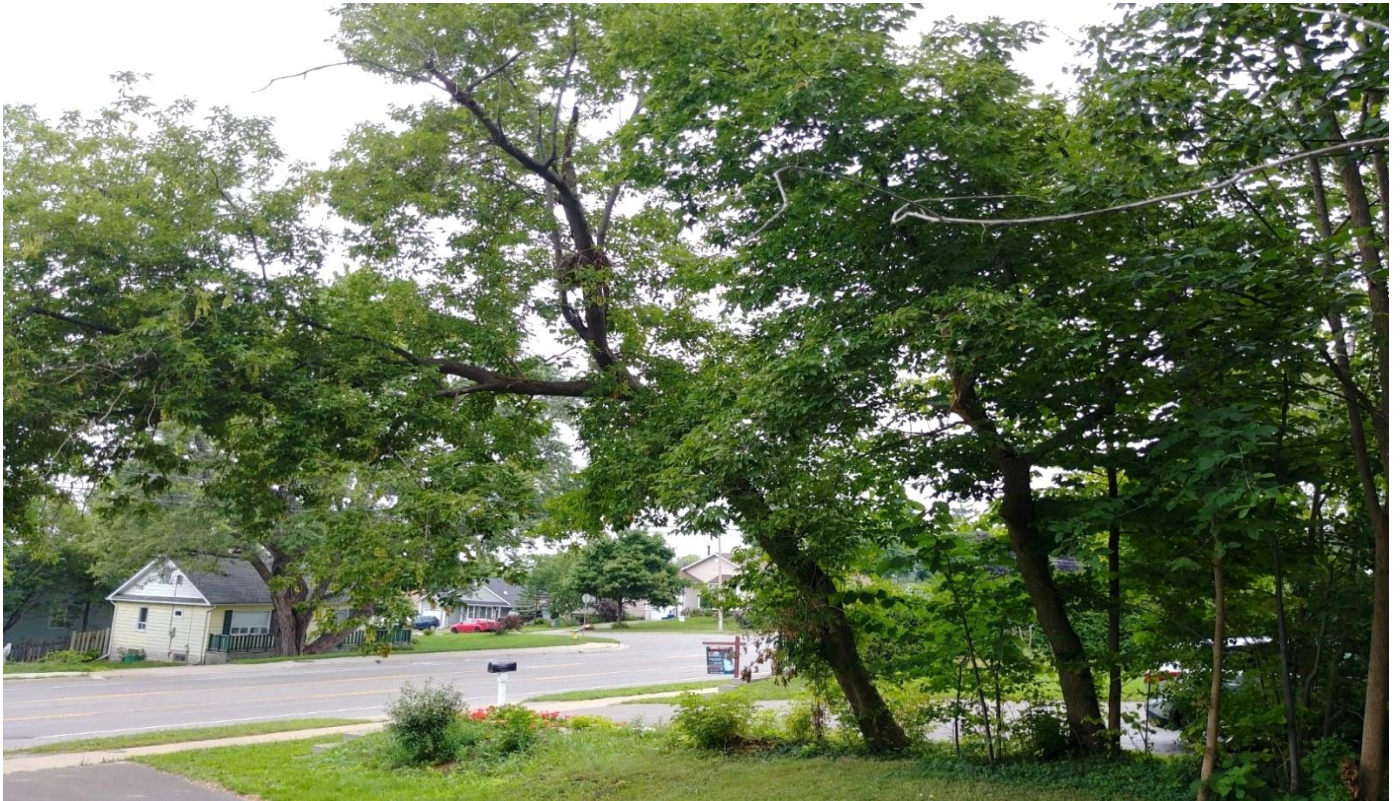
LEGroup staff observed Manitoba Maples (Tree Nos. 1, 2, 10, 15) and Black Cherry (12, 43, 50 & 59) in marginal condition and showing characteristics commonly found in wooded areas such as corrected leans, one sided canopies, trunk wounds, offset canopies and dieback (**Photo A, Appendix D**).

Photo A: Photo of Manitoba Maple (Tree Nos. 1 & 2) showing significant western lean and unstable end weight.

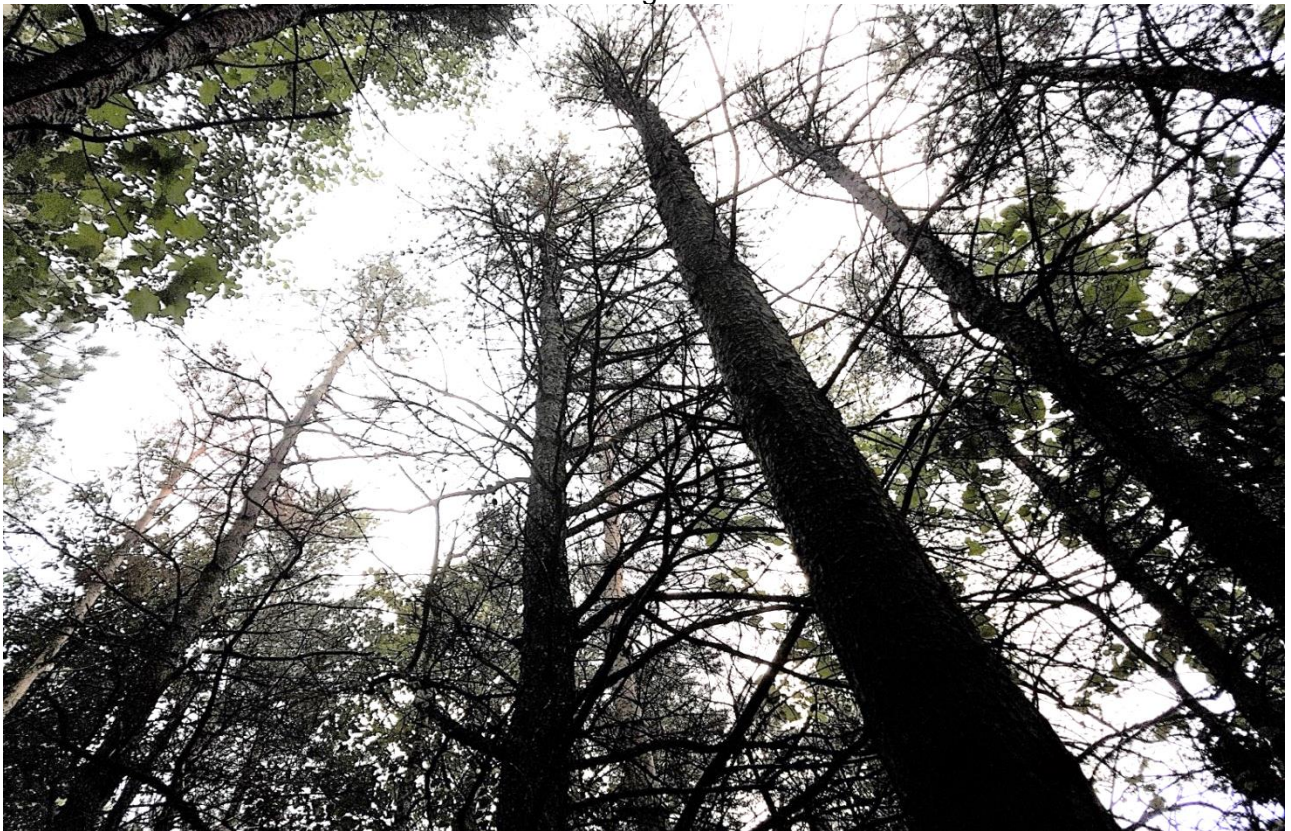
Staff observed that the Scots Pine on the site (Trees Nos. 18, 20, 31, 33-41, 51-54, 56-58, 60-63) have lower branch dieback, one-sided branching, twisted trunks and small live crowns typical of trees in forested conditions (**see Photo B, Appendix D**). Staff also noted significant needle drop and bark beetles (suspected to be Pine Engraver) causing decline in the Scots and Red Pine on site.

Photo B: Photo of typical canopy of Scots Pine at the site.
