# **TREE INVENTORY REPORT - Hedbern Homes**

158, 162, 166, and 170 Ardagh Road

Prepared for: Bernie Still - Hedbern Homes

August 28, 2019

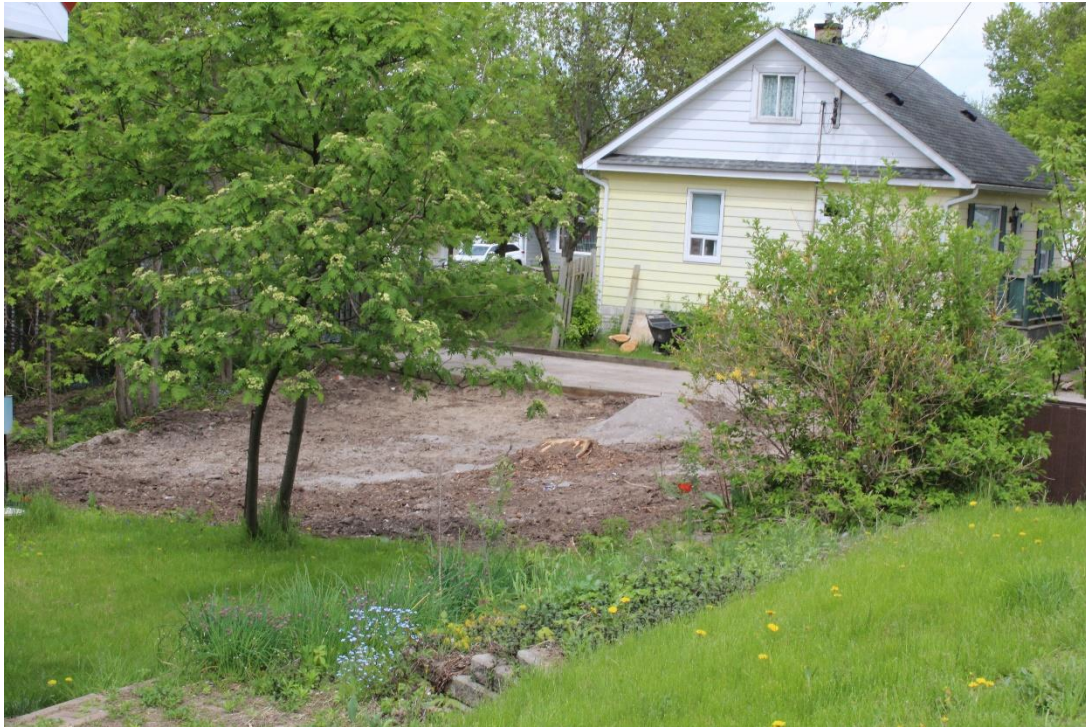
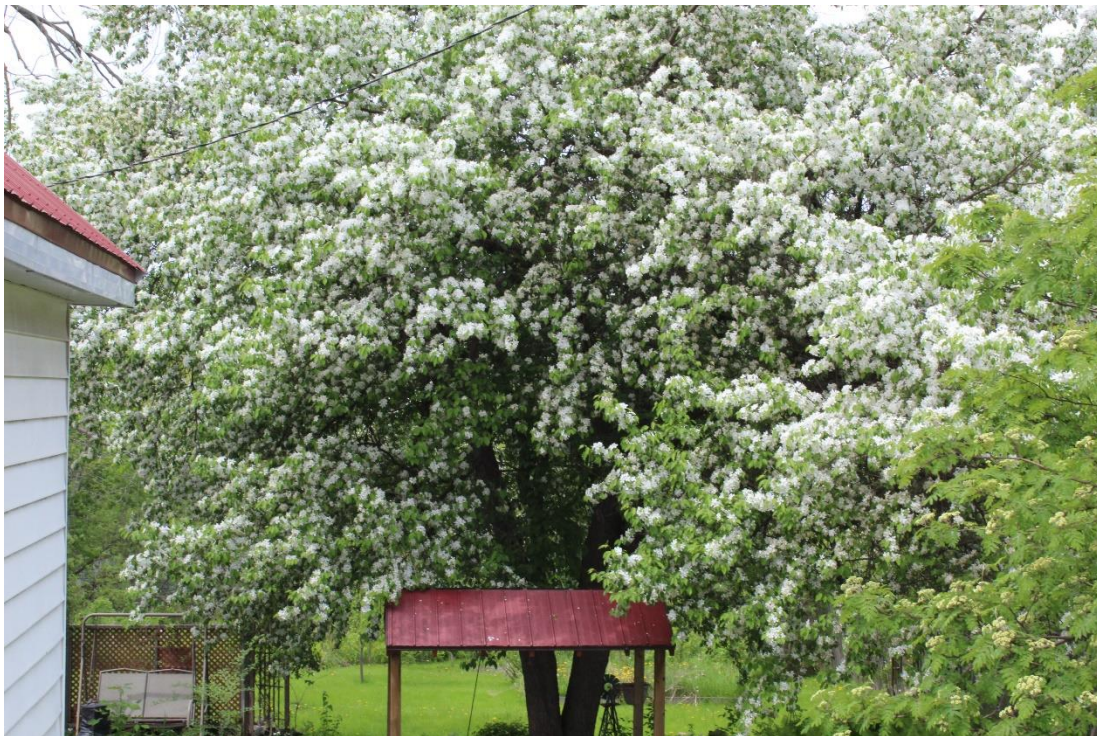
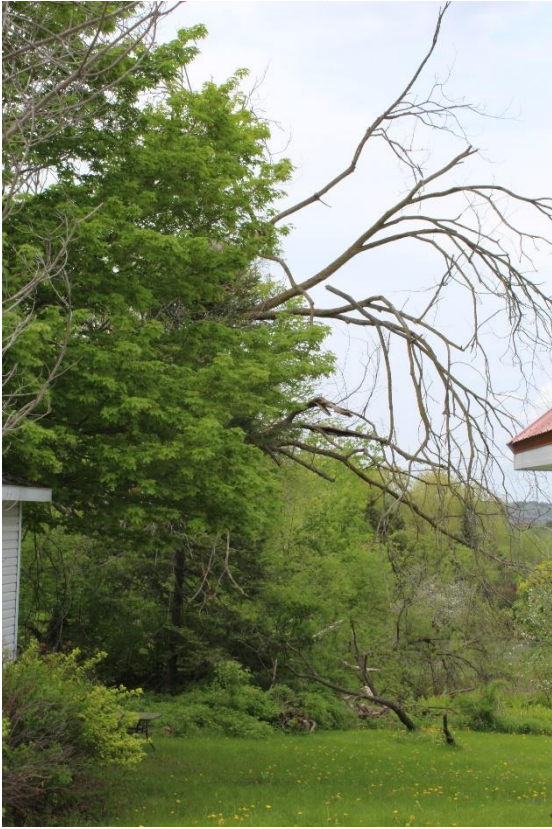
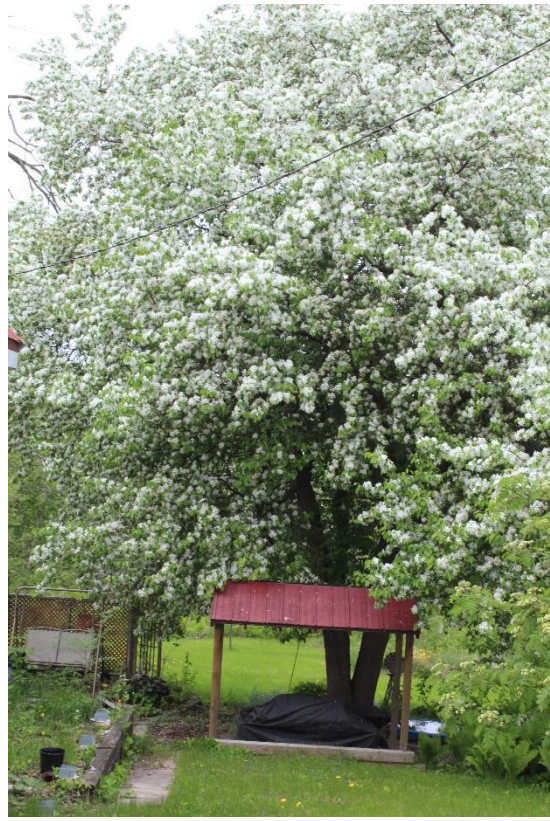
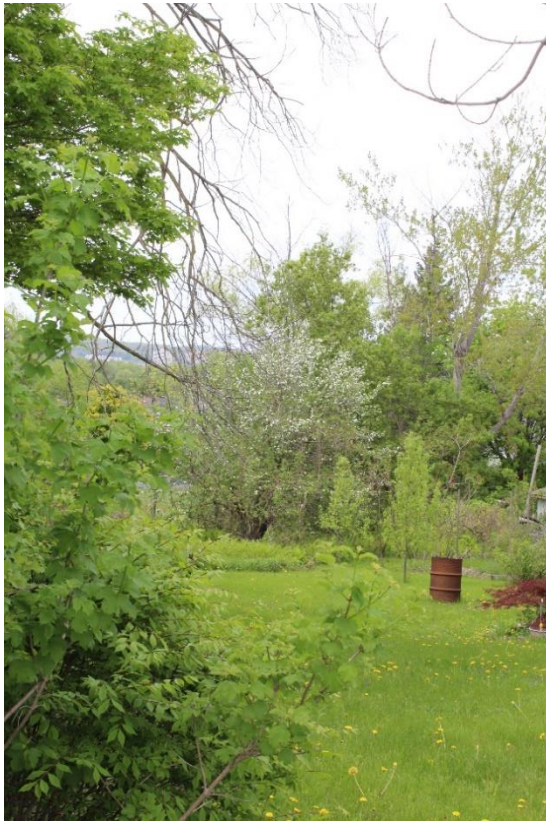
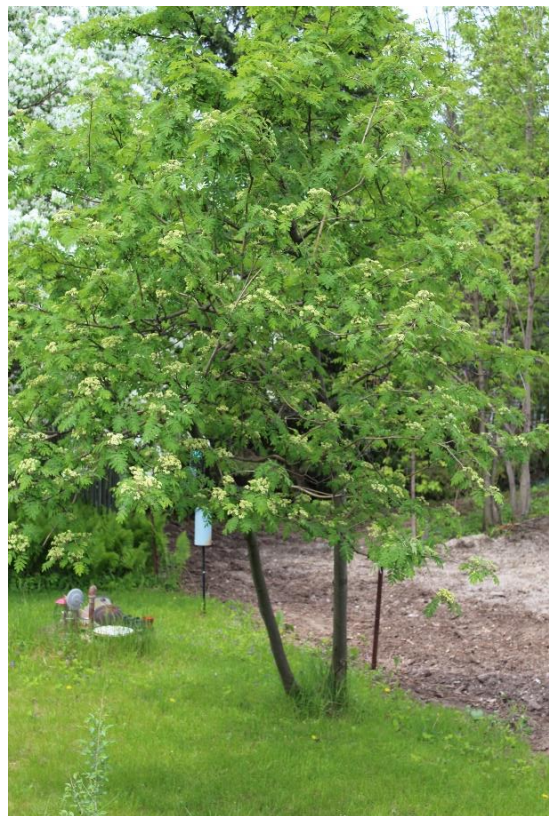
## LOT 158

This lot is located on the north side of Ardagh Road and is currently a residential property with a single-family home and garage located on the south portion of the property. Approximately 50% of this property has been cleared of vegetation in the past, likely in order to erect the home. Half

The northern portion of the property, which is used by the homeowner, has been well-maintained overall, with few trees including one (1) mature Apple (*Malus sp.*) tree (30 DBH), and one young Mountain Ash (*Sorbus americana*), less than 10 cm DBH. These trees will also require removal due to conflict with the site plan.

There are two (2) trees located on the used portion of the property including one (1) mature Apple (*Malus sp.*) tree in good health and form, and one (1) young Mountain Ash (*Sorbus americana*) in good health and form. These trees will require removal due to conflict with the site plan and are Level 0 trees that can be removed as required.

Located on the north eastern portion of the property are two (2) boundary trees that will require written permission from adjacent property owners prior to removal. This includes one Manitoba Maple (*Acer negundo*), and one Sugar Maple (*Acer saccharum*) both in fair health and form. If permission is not granted by adjacent property owners, tree preservation fencing will be required as well as monitoring of trees during and post construction. These trees are Level 1 Protection trees until permission is granted for removal.

Lot 158 is a residential lot with no trees of exceptional quality or health and therefore the trees may be removed. Boundary trees along the eastern, and north western edges of this property will require written permission from the adjacent property owner for removal or injury of the trees. If permission is not granted, preservation fencing will be required during construction, and monitoring will take place during and post construction.

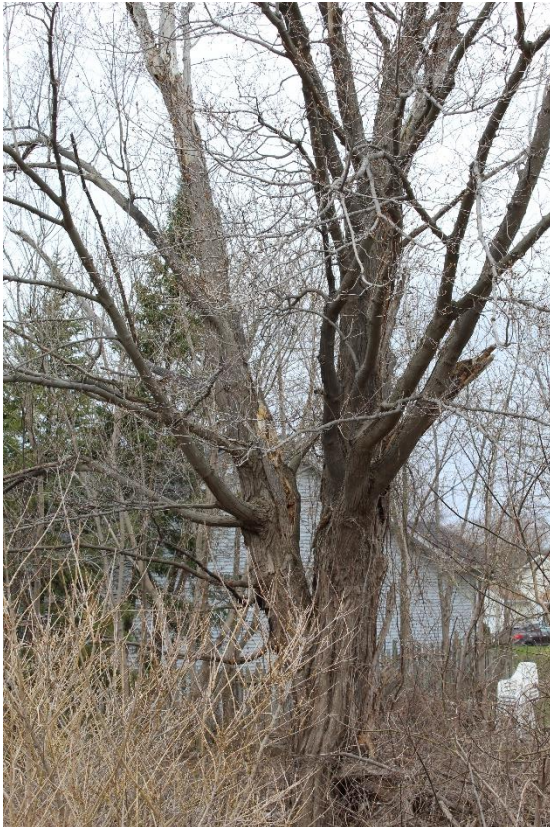
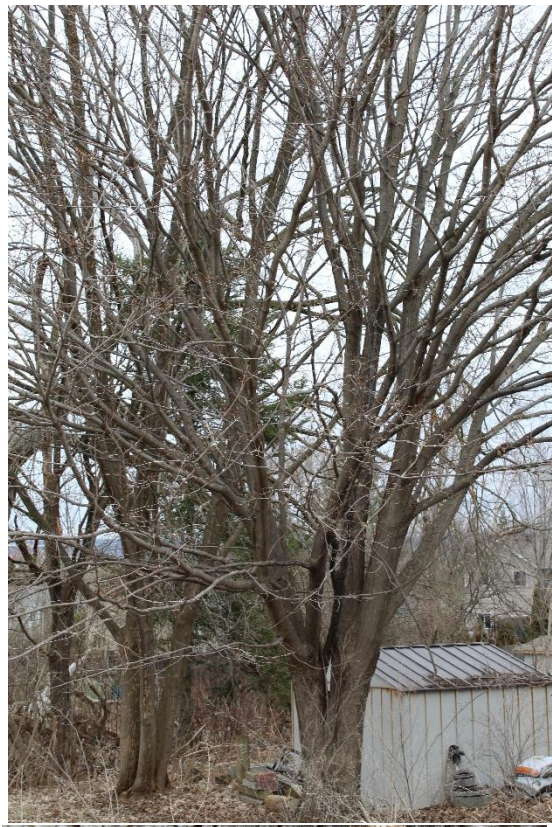
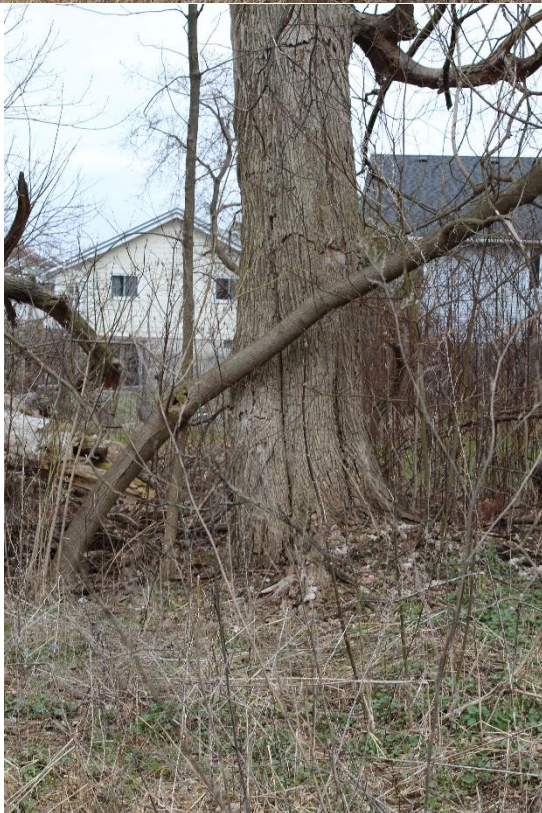
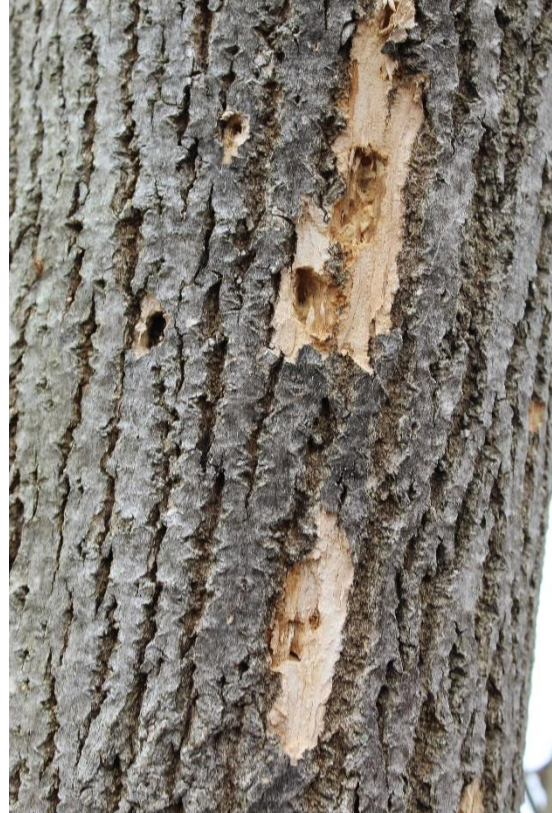
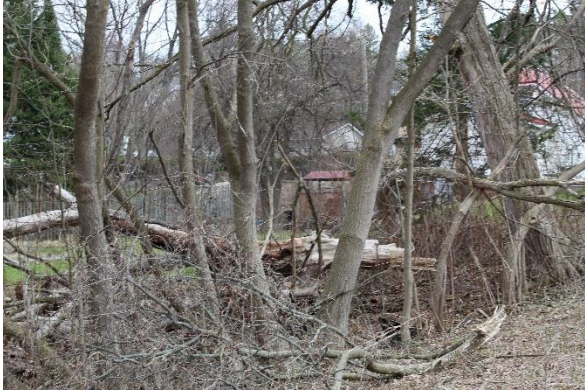
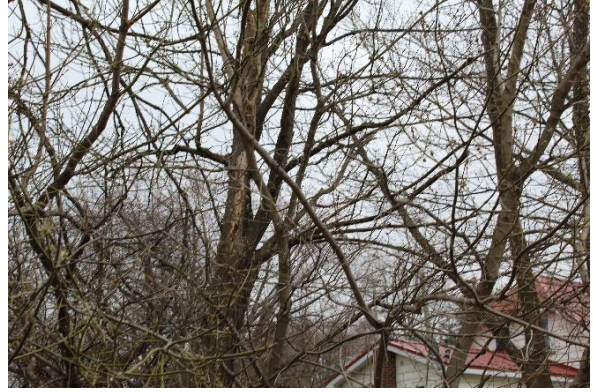
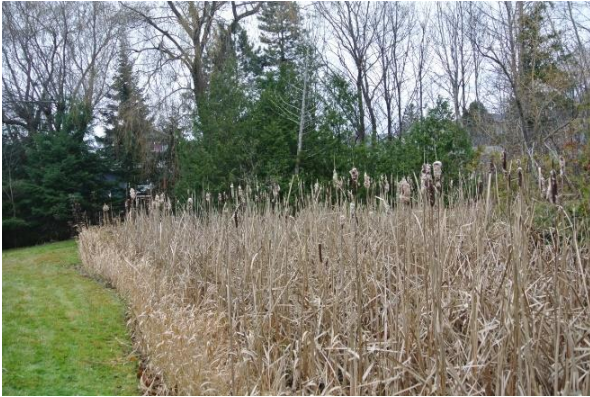
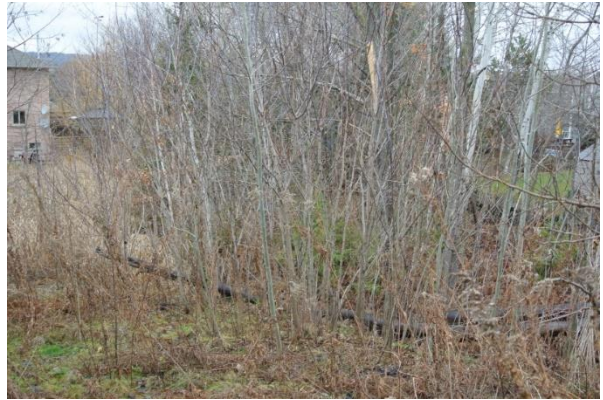
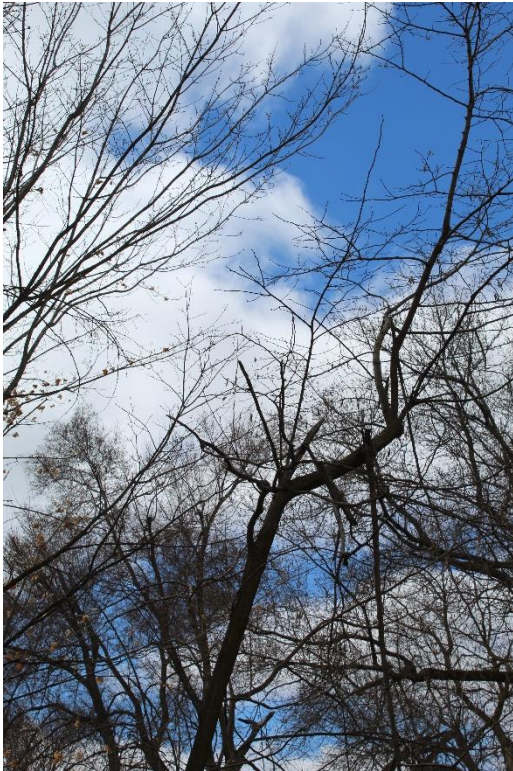
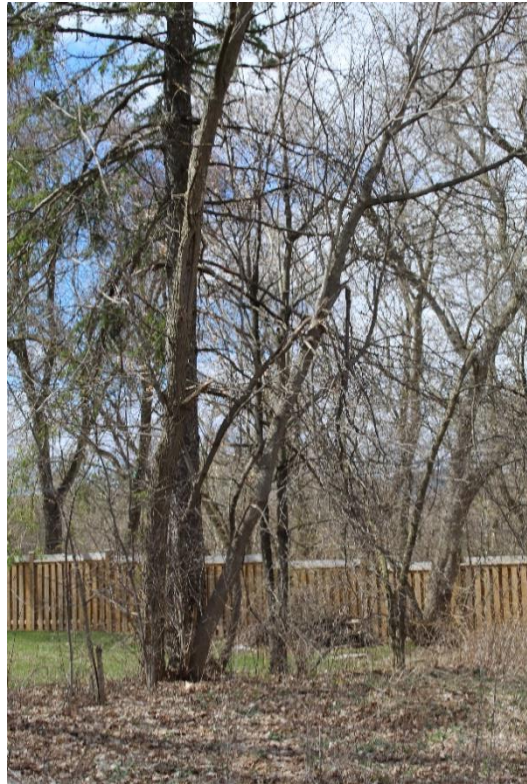
## LOT 162

The majority of this lot has been substantially cleared, and 75% of the property has been filled. On the east side, species of the original forest cover of the Ardagh Bluff can be recognized. They include Sugar Maple (*Acer saccharum*), White Ash (*Fraxinus americana*), Black Cherry (*Prunus serotina*) and Basswood (*Tilia americana*). Due to the very close filling operation along the east property line, the trees are under stress. The bottoms of the trunks have been filled up to 30 to 60 cm from the base of the roots by previous owners of the property. The western site boundary is bordered by shrub vegetation, consisting mainly of unruly Manitoba Maple (*Acer negundo*) growth.

The upper part of the filled area is grassed and currently unmaintained. The sloped part of the filled site is covered with wild grasses and native sedges. Due to present conditions, water is accumulating to the back of the lot creating a substantial wet area. Since the slope leading to the wet area has been disturbed, a grove of Cottonwood saplings, 3 to 10 cm in trunk diameter, has established itself. They are seedlings of a mature Cottonwood (*Populus deltoides*) located further north on the property, along the north eastern property line. A clump of cedars (*Thuja occidentalis*) is also located at the north-east side of the property. It is under stress, due to the very wet conditions. Much of the northern section of the site is very swampy and wet, providing a very good environment for undesirable invasive reed grasses which are growing in abundance. (*Phragmites var.*)

The trees on this property are of generally poor condition and quality. Trees of higher quality species include Sugar Maple (*Acer saccharum*) and Black Cherry (*Prunus serotina*). They are located along the easterly section of the property boundary and are not of sufficient health to be preserved as they have been compromised by current site conditions. The trees to the back of the lot are generally small Eastern Cottonwood (*Populus deltoides*), with a short life span and

generally fair quality. They are not to be considered for preservation. All trees not considered boundary trees are Level 0 Protection and will require removal due to conflict with the site plan.

There are eight (8) trees along the property boundary of 162 and 166 that have been generally well maintained by the property owner of 166. Although some are of good quality, they are Level 0 protection and will require removal due to conflict with the site plan. On the east property line, there are four (4) boundary trees in fair to poor health and form that will require written permission from the adjacent property owners prior to removal. These include tree 12, 13, 16 and 51. Tree 12 will require consent from the owner of 10 Elizabeth Street; tree 13 will require consent from owner of 12 Elizabeth Street; tree 16 will require consent from owner of 8 Elizabeth Street; and tree 51 will require consent from the owner of 15 Elizabeth Street. These trees include one (1) Eastern Cottonwood (*Populus deltoides*) in fair condition, two (2) Manitoba Maple (*Acer negundo*) trees, and one (1) Black Willow (*Salix nigra*) in good condition. If permission is not granted by adjacent property owners, tree preservation fencing will be required during construction, and monitoring shall occur during and post-construction.

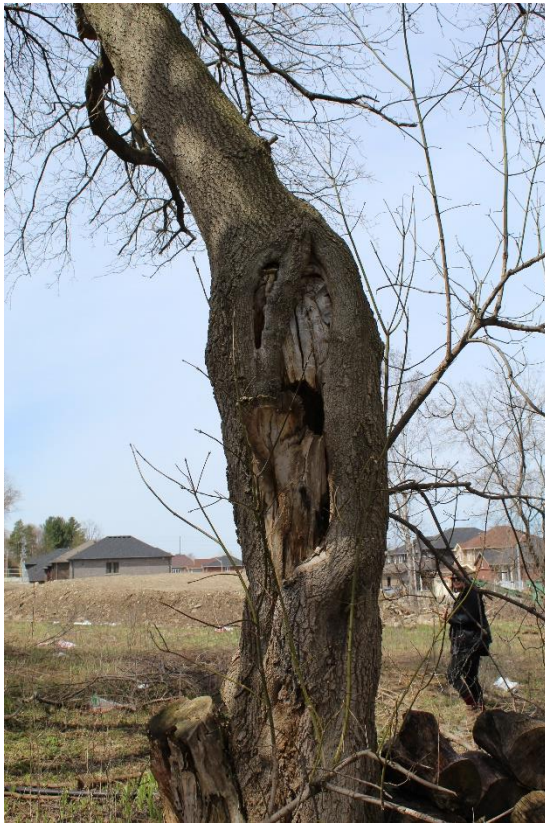
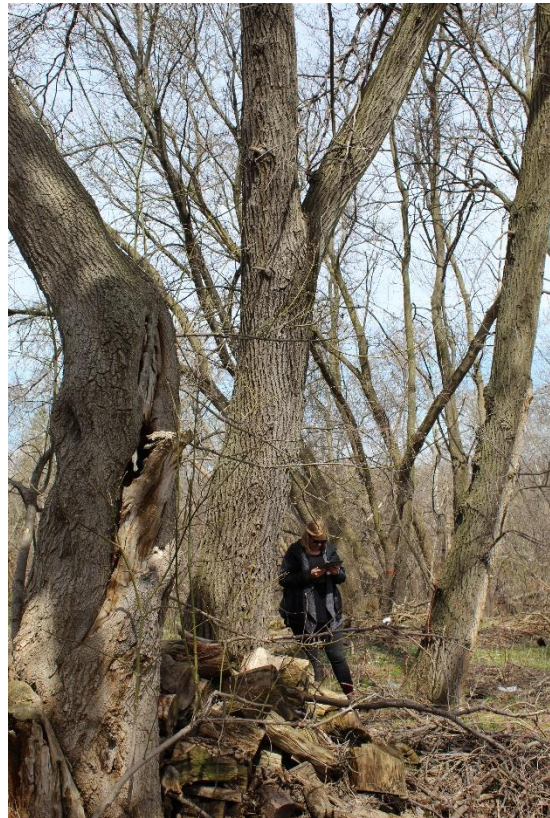
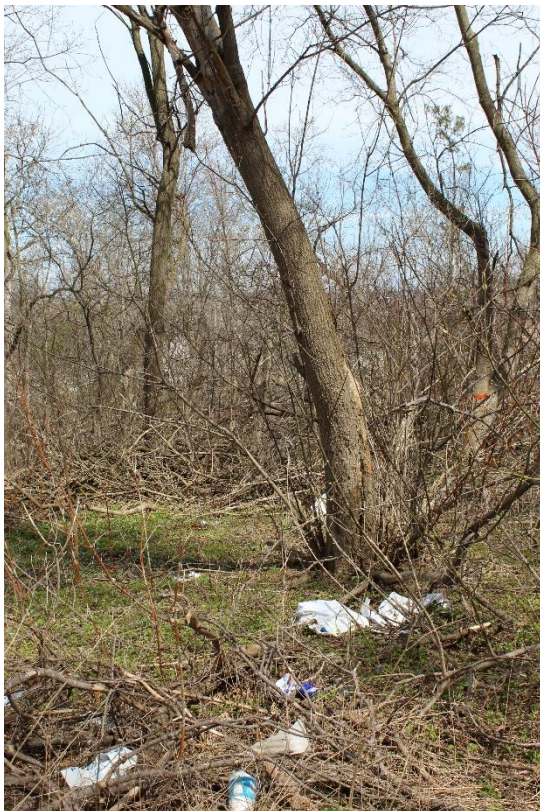
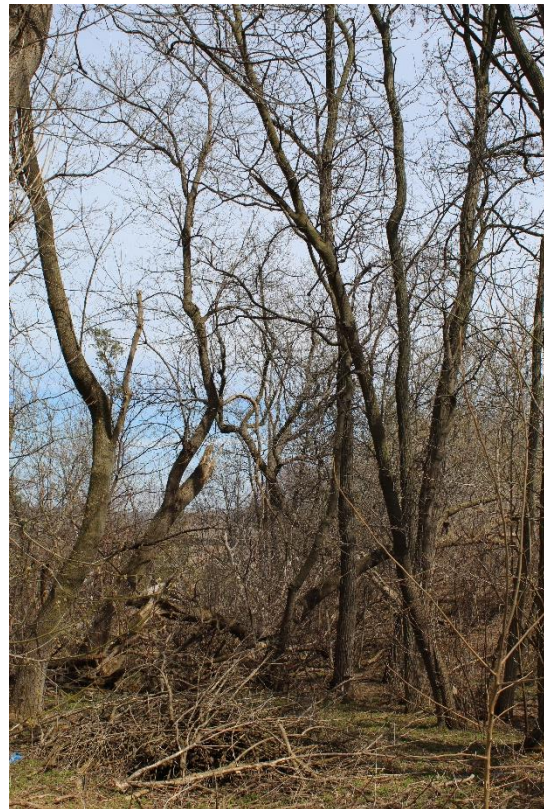
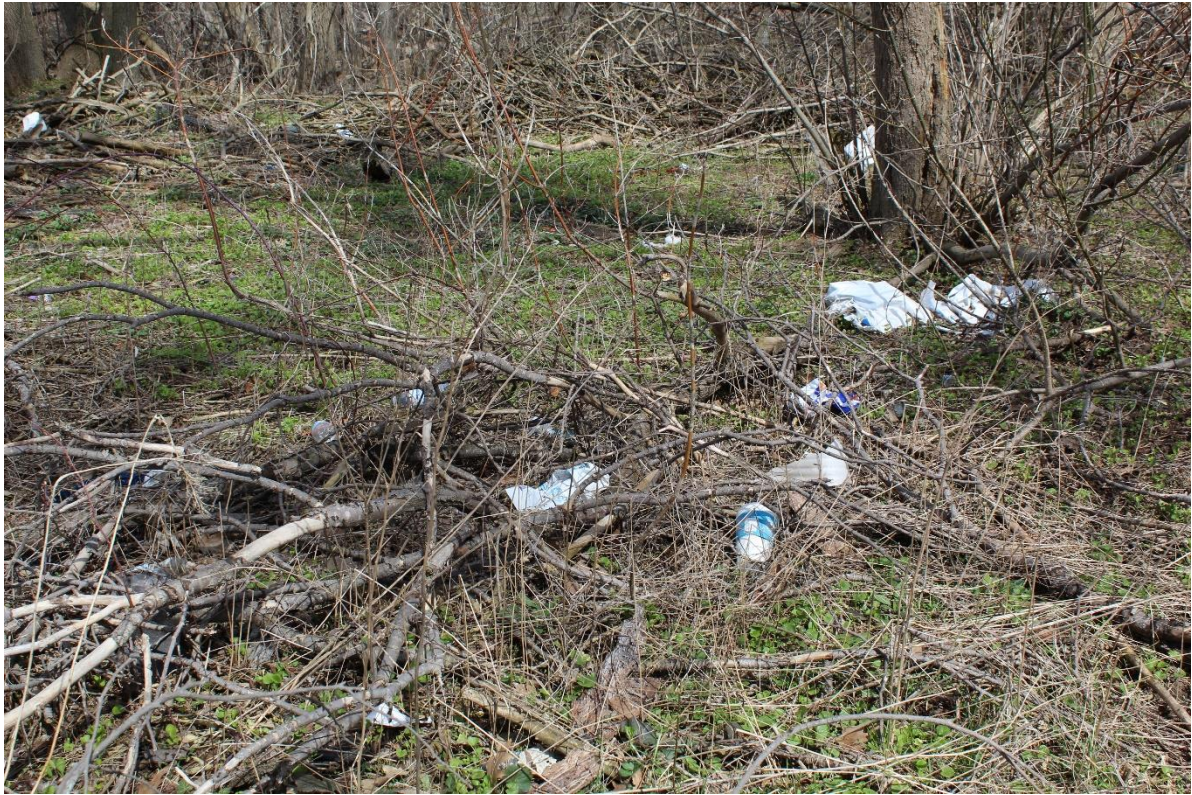
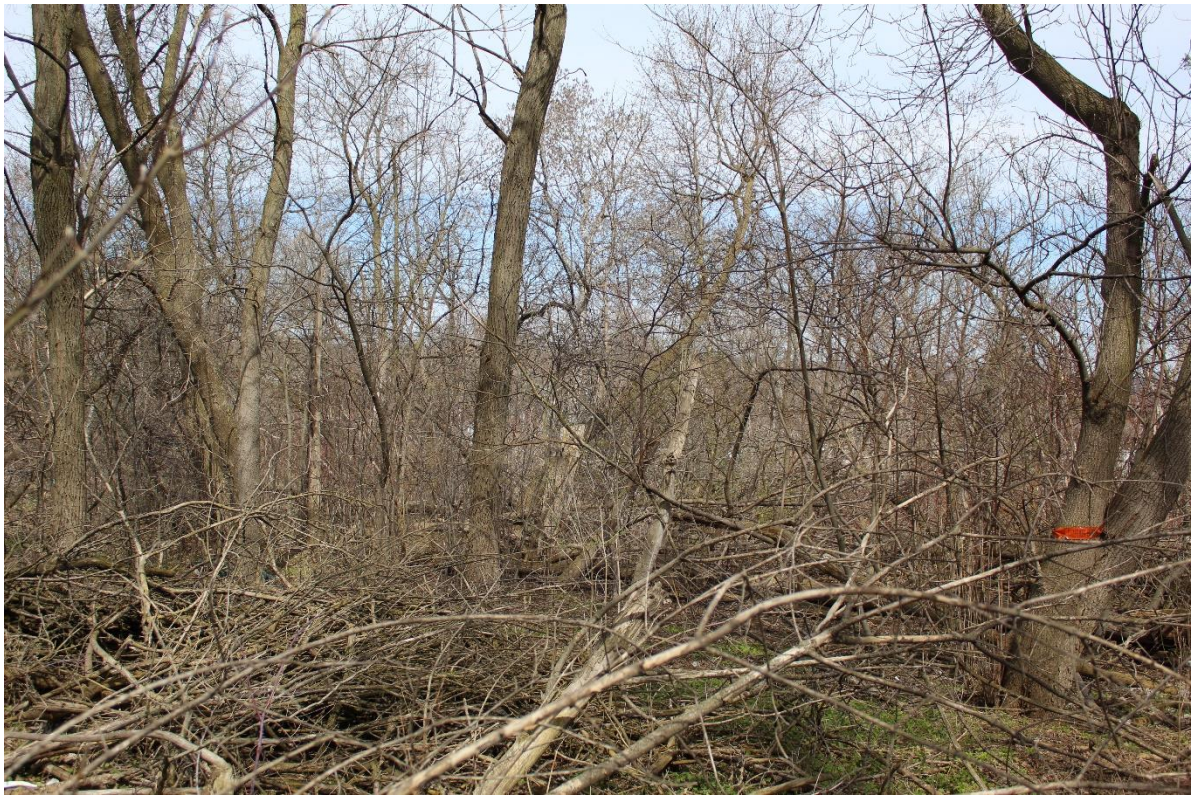
## LOT 166

A residence is currently located on the southern portion of this property containing a fenced and maintained yard with a shed in the north west corner of the fenced in area. Some grading and clearing has taken place on the back of the lot where evidence of Manitoba Maple (*Acer negundo*) removal can be seen. The back of the usable portion of the lot is divided by a dense pile of shrub branches. Behind this pile the site drops slightly and is vegetated by Manitoba Maples (*Acer negundo*) and Dogwoods (*Cornus sp.*) as well as sedges and native low grasses as underbrush. The Manitoba Maples (*Acer negundo*) create a maze of fallen stems and newly sprouting small branches and trees. Many of the trees are clumps split and halved forming an almost impossible thicket. The soil is very wet and the northern portion of the lot shows exposed surface water covered with reed grasses (*Phragmites var.*). A grove of Cottonwoods (*Populus deltoides*) and Manitoba Maples (*Acer negundo*) cover a slightly higher portion adjacent to a more manicured lower area adjacent to the Bishop cul-de-sac. A few of these trees are 45 to 75 cm in diameter, but seem to perish and topple as soon as they reach 15 to 18 m in height. Majority of the new growth on site are trees approximately 10 to 15 cm in diameter.

This lot is dominated by Manitoba Maple (*Acer negundo*) growth of considerably poor quality. The trees appear to reach an age of approximately 25-30 years when they topple over due to top weights of the branching structure that cannot be supported by the shallow root system. Some Black Locust (*Robinia pseudoacacia*) trees have been able to establish themselves on a higher node within the wet lands.

The northern portion of the lot is traversed by a low wet area. A grove of Aspen (*Populus tremuloides*) and Manitoba Maple (*Acer negundo*) have been able to establish themselves on the north-eastern section of the lot. Due to the wet site conditions, these trees are not able to mature properly. Many topple over or perish within these wet site conditions. The ground level is generally vegetated with sedges, native grasses, raspberries (*Rubus var.*) and blackberries (*Rubus var.*) and some dogwoods (*Cornus var.*) Although the site is covered by woody vegetation, no trees are worthy within the property boundaries to be preserved.

One (1) Blue Spruce (*Picea pungens*) and one (1) Norway Maple (*Acer platanoides*) can be found on the north side of the property and are boundary trees bordering the City R.O.W. These trees will require preservation fencing and monitoring during and post construction or permission from the City of Barrie for removal.

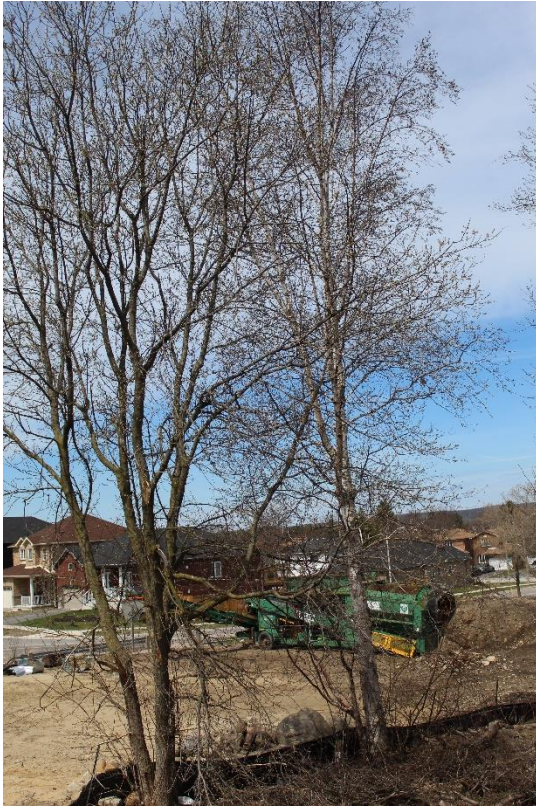
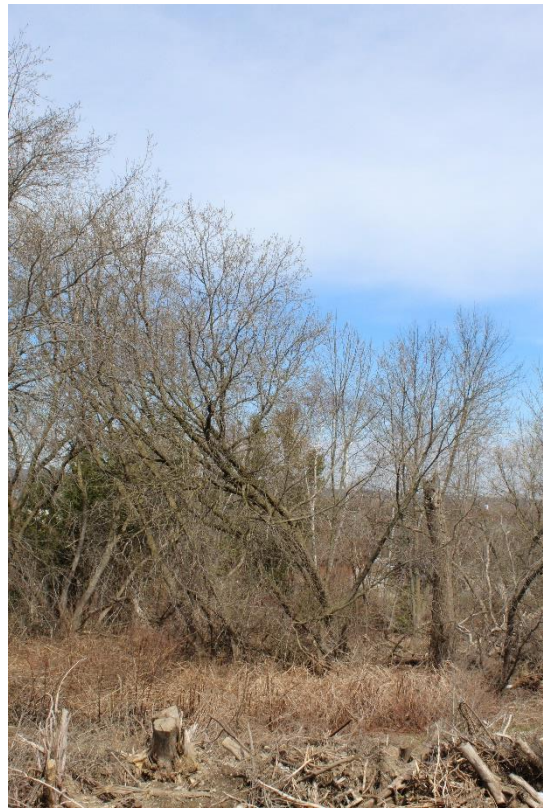
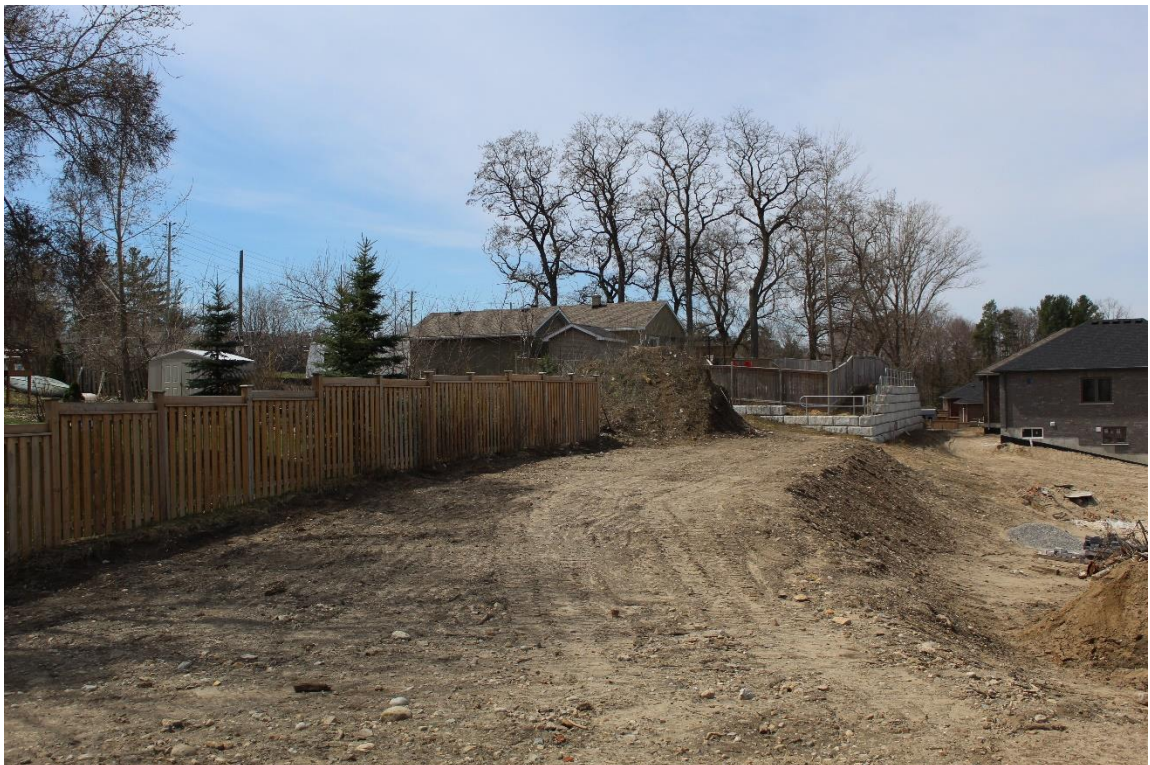
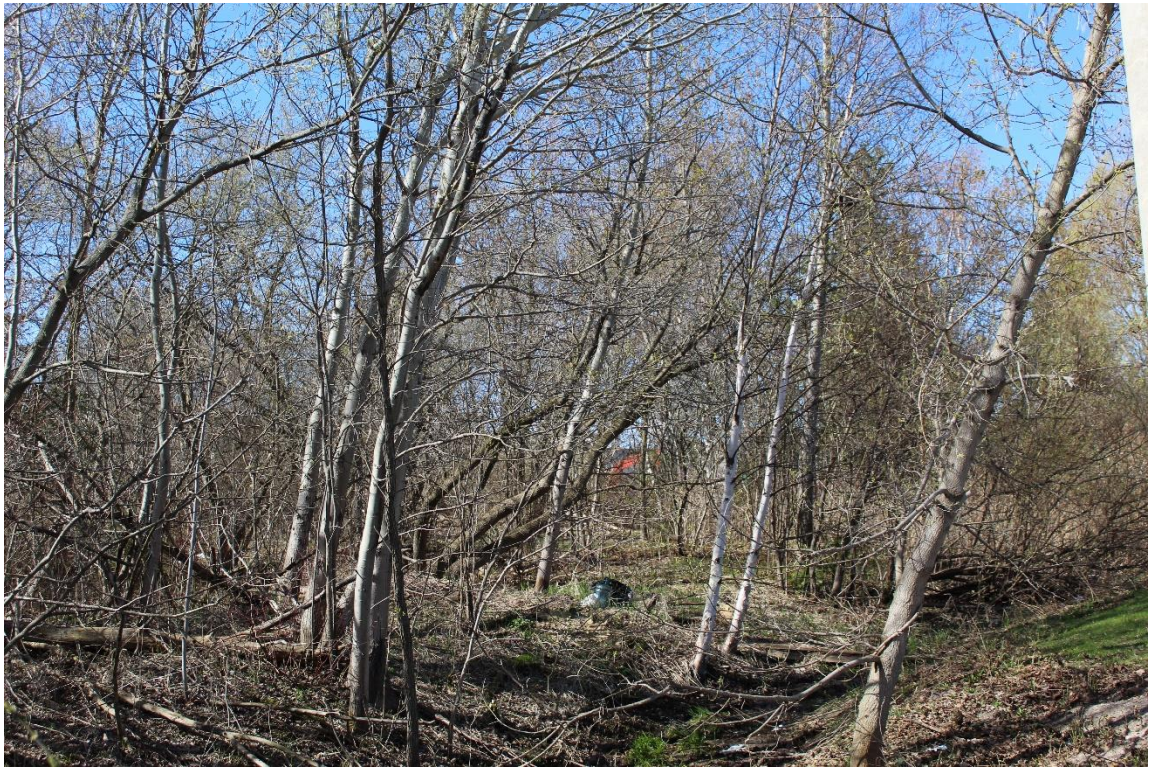
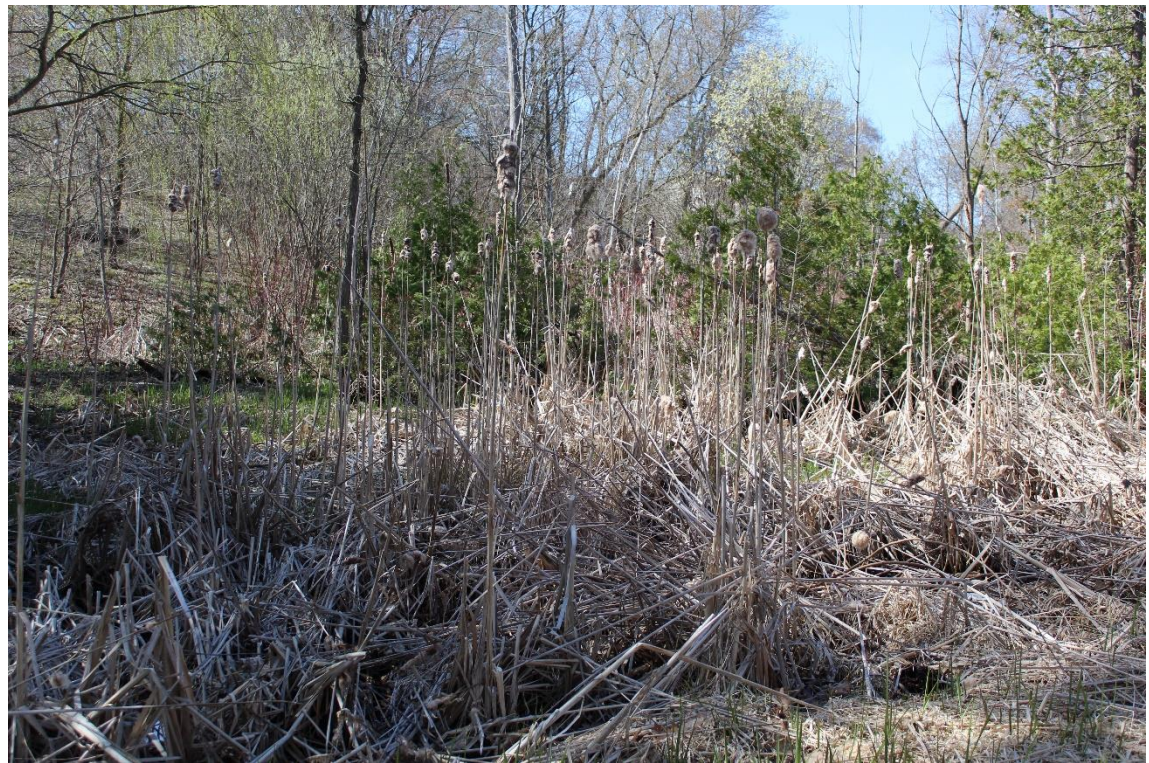
## LOT 170/Lands north of 172

This lot has been modified by filling to an extensive degree by the previous owner. Both sides (east and west boundary) have been impacted by the abrupt grade changes, from the filled area (about 2m from original ground has been added) to the elevations on the adjacent lots. The west side is dominated by compromised Manitoba Maple (*Acer negundo*). The east side shows remnants of the original forest cover of the area, whose root zones and stems have been compromised by additional fill material by previous land owners.

The northern section of the lot has been affected by filling. The lot descends in a more gradual manner in a northerly direction. The process of re-naturalization and re-vegetation has recently begun. Thus, the predominance of Aspen seedlings (*Populus tremuloides*) originating from more mature specimens on or adjacent to the site can be observed. The northern portion of the site is dominated by open wet conditions that have attracted invasive reed grasses (*Phragmites* var.), and cattails (*Typha latifolia*). On the Western knoll, a Yellow Birch (*Betula lutea*) clump has been able to establish itself successfully. A cedar clump (*Thuja occidentalis*), a Sugar Maple (*Acer saccharum*) and Cottonwood (*Populus deltoides*) are of good size (75 to 100cm) and are located close to the north-eastern corner of the site. The vegetation on this site is of very disturbed and random nature. These trees are Level 0 Protection trees and will require removal due to conflict with the site plan.

There is one boundary Manitoba Maple (*Acer negundo*) tree in poor health on the north portion of this property, bordering on the Bishop Drive cul-de-sac. This tree is a Level 1 Protection tree until permission for removal is granted, and will require written permission from the adjacent property owner prior to removal, or preservation fencing if permission is not granted.

The majority of trees on this lot are of poor condition, health and quality. Trees along the western border include Manitoba Maple (*Acer negundo*), White Ash (*Fraxinus americana*), and White Birch (*Betula papyrifera*) as well as a large area containing invasive Japanese Knotweed (*Fallopia japonica*). The northern portion contains saplings of species from the original forest as well as reed grasses (*Phragmites sp.*) and cattails (*Typha latifolia*).

The majority of the trees on this property are inferior species and in poor health and condition with some having been affected by previous construction within their root zones. All trees on the property will require removal due to conflict with the site plan and will not require preservation fencing. One (1) boundary tree located on the northern property line will require written consent from the property owner of 117 Bishop Drive prior to removal. It is recommended that an eradication plan be put in place for the removal/control of the invasive Japanese Knotweed (*Fallopia japonica*) on site to reduce the spread to other properties. This may include Best Management Practices for Controlling Invasive Knotweed as set out by the Ontario Invasive Plant Council's.
