October 16, 2019  
RS# 2017-014

Muskoka D & M Corp.

**SUBJECT: Tree Inventory and Preservation Plan, 233 and 246 Dunlop St. West,  
City of Barrie**

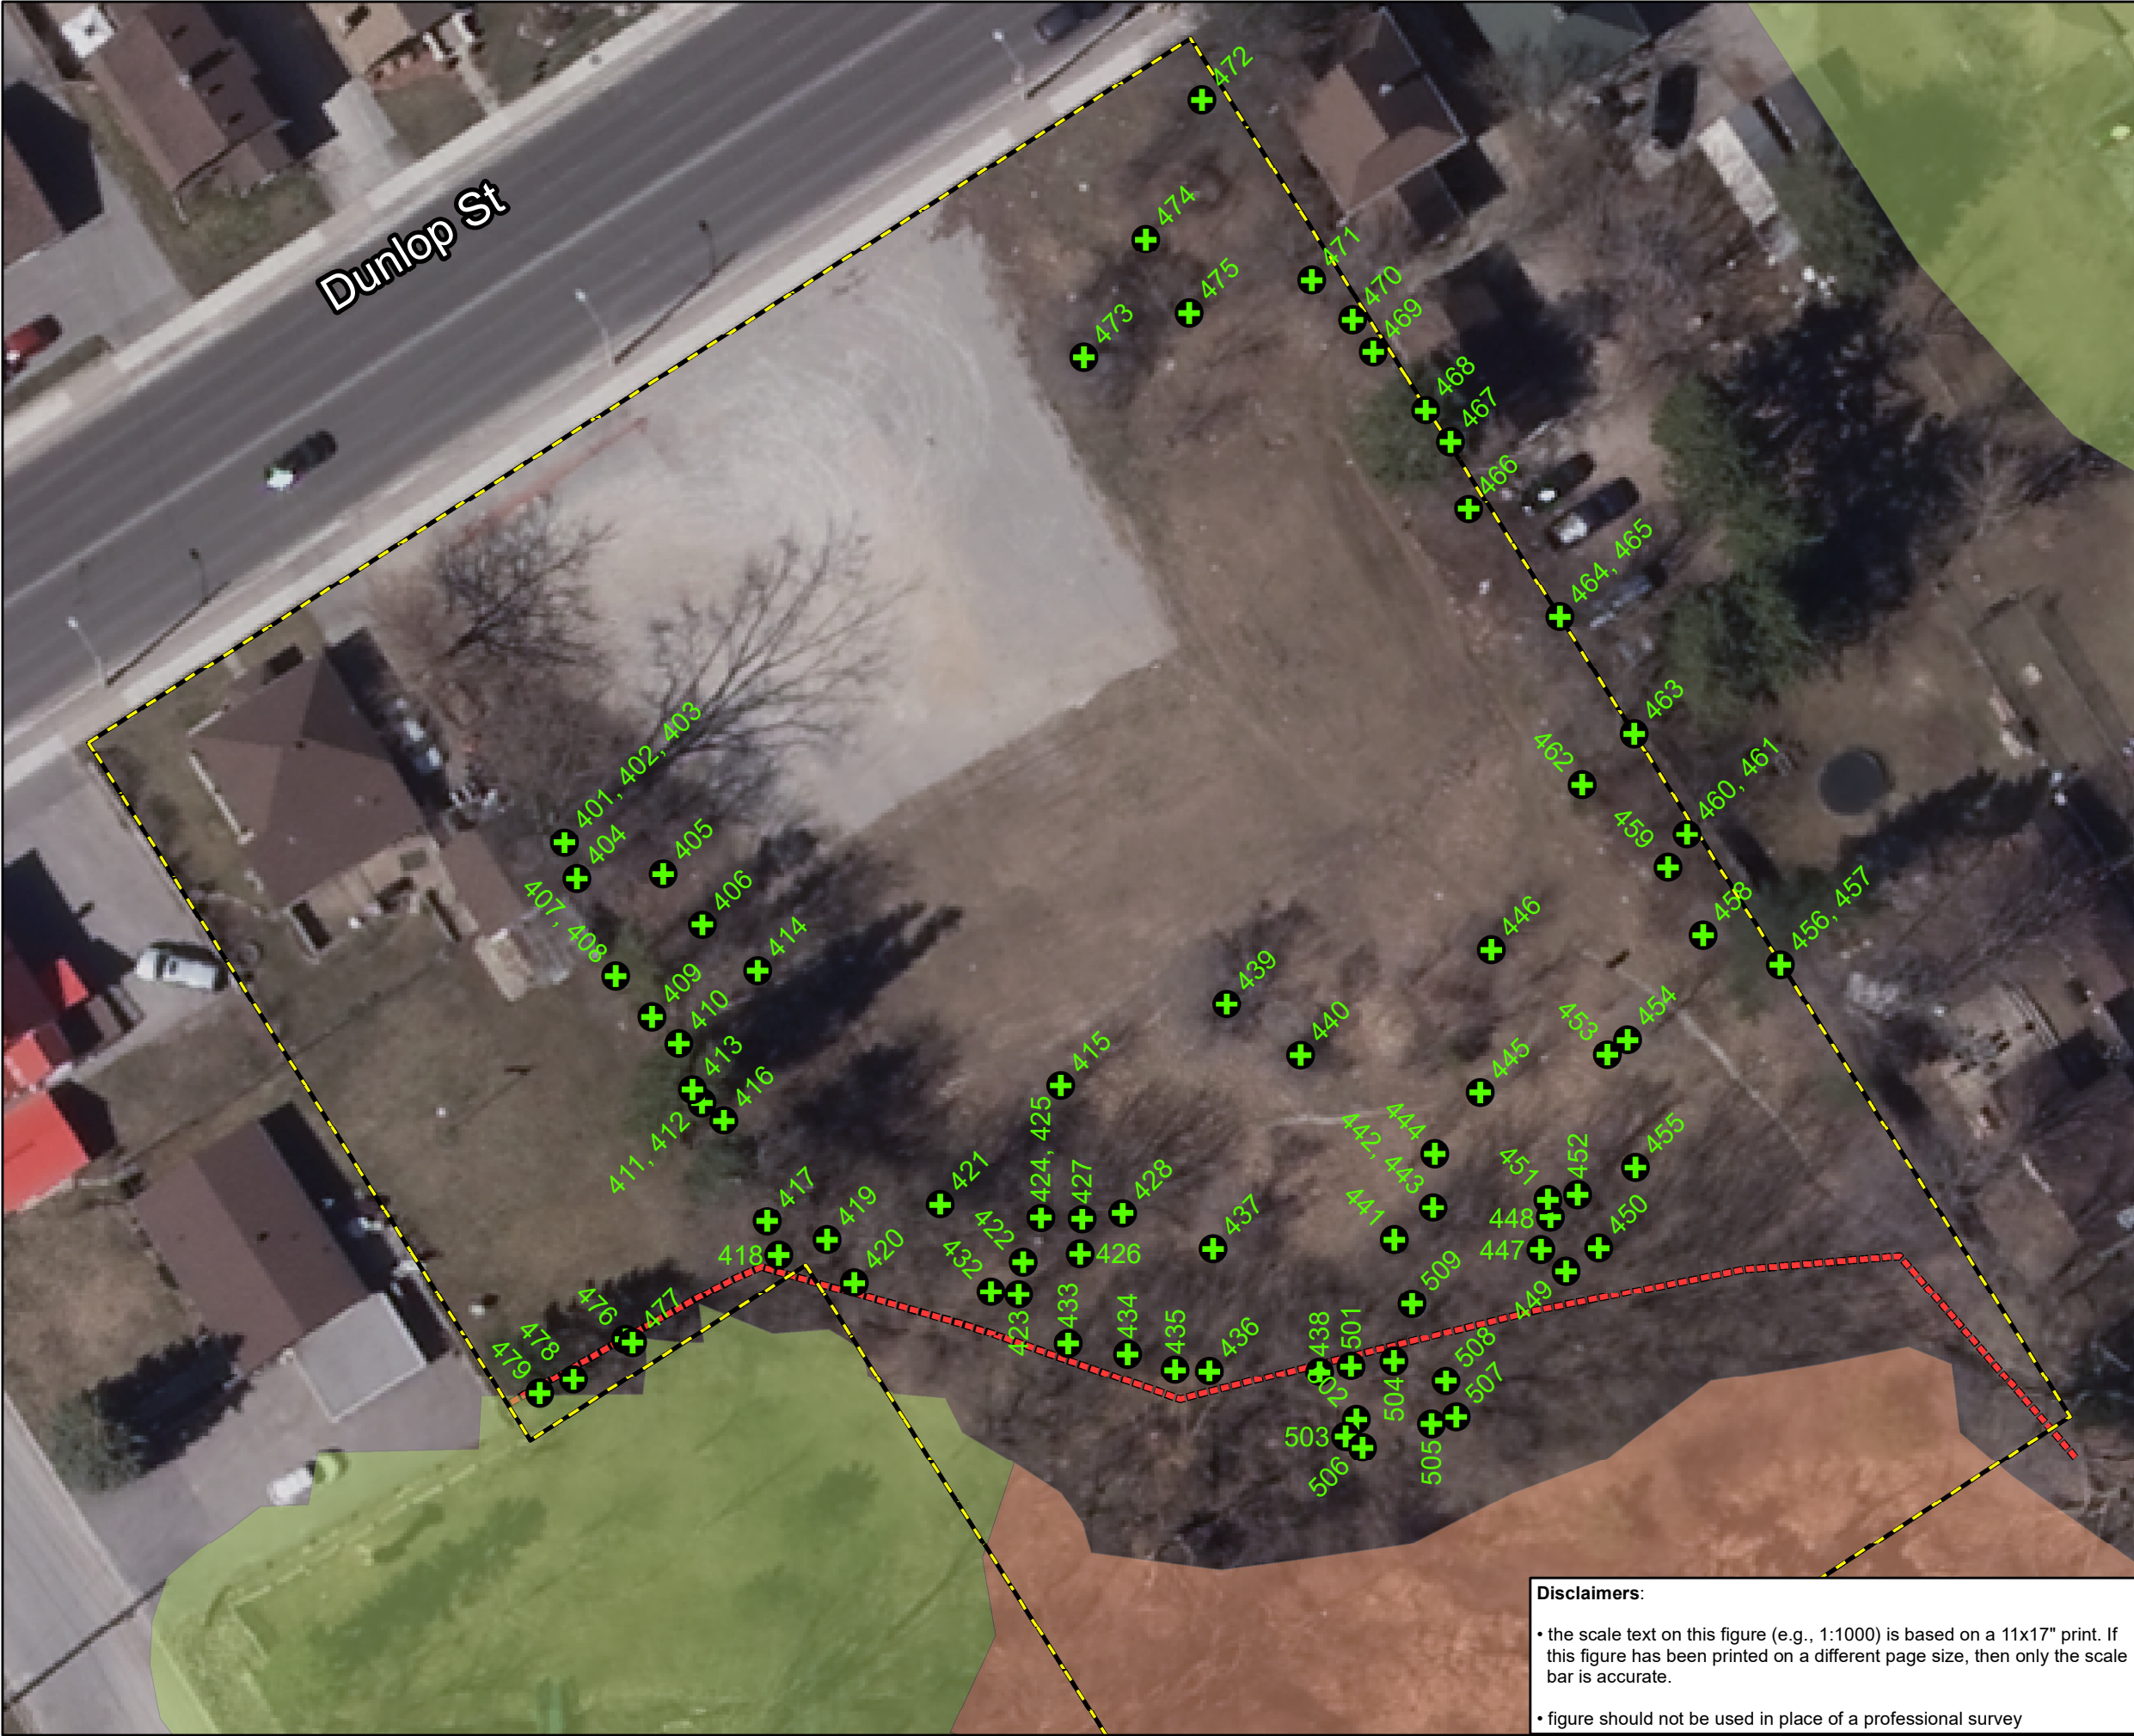
**Figure 2. Tree Inventory:**  
233 and 245 Dunlop Street west, City of Barrie

The results of the tree inventory and health assessment are provided in **Appendix 1**. The locations of all tagged and assessed trees > 10 cm DBH are shown in **Figure 2**. Representative photographs of on-site conditions are provided in **Appendix 2**.

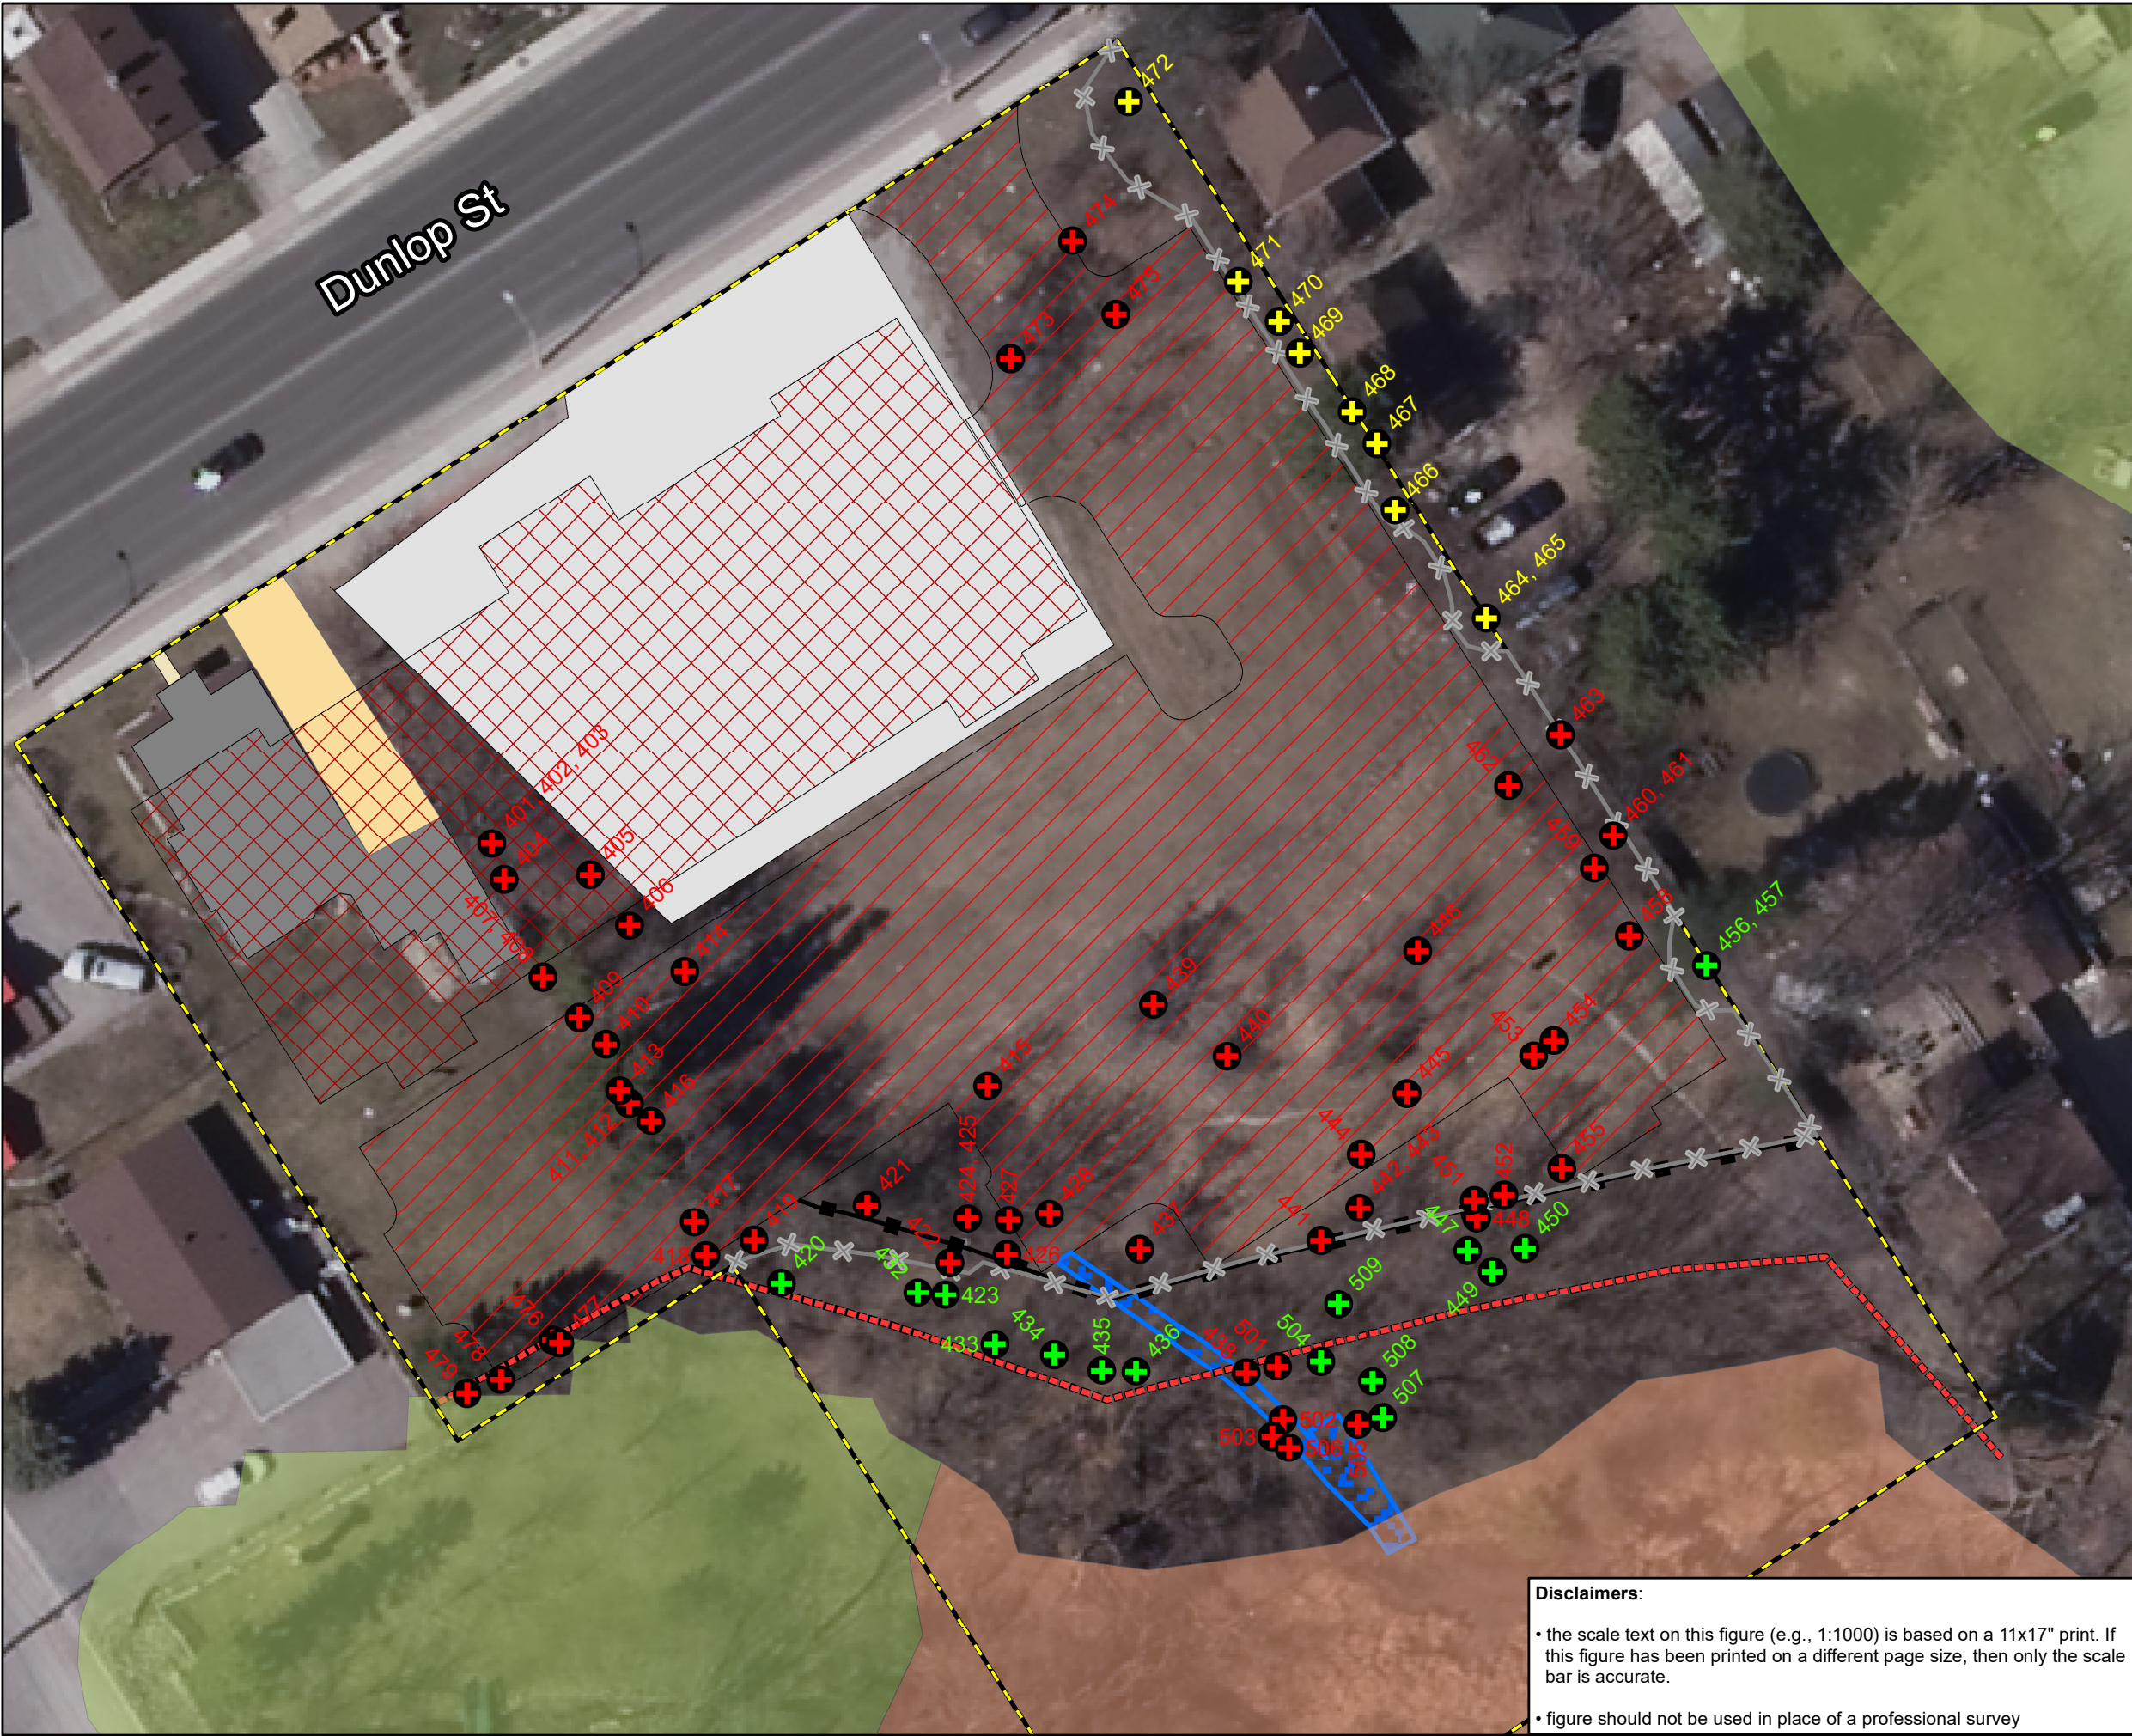
Figure 3. Tree Preservation Plan:

As outlined in **Appendix 1, Figure 3** provides an overlay of the proposed development plan with RiverStone's tree preservation/removal direction. Based on this overlay, RiverStone anticipates that a significant portion of the existing vegetation (including both assessed trees and other vegetation) will require removal in order to facilitate the proposed development. As no grading limit was specifically defined, it was assumed that all trees within the development area and within 3 m of the development are would be removed, trees to be removed and retained are shown on **Figure 3**.

Of the remaining trees, forty-five (45) will require removal for construction of the proposed development. These include Manitoba Maple, Siberian Elm, American Elm, Black Locust, Honey Locust, Black Walnut, Little Leaf Linden, Black Walnut, White Spruce, and Sugar Maple trees. All of the required removal trees are of low or medium preservation value and either no protection value or a value of 3. In the case of Siberian Elm, Little Leaf Linden and Black Locust these species are not native to Ontario and Manitoba Maple are known to be invasive and typically prone to failure; therefore, these species are not required to be retained. The preservation values of the identified American Elm are primarily in the medium range, with one (1) individual classified as having a low value. Branch dieback and leaf blotch was noted on most of the American Elm trees and since this species is highly susceptible to Dutch Elm disease, it is likely these trees will continue to decline.

Located adjacent to the south top of bank and in the vicinity of the storm water outlet, sixteen (16) of the tagged trees are anticipated to be retained. These trees consist al of Manitoba Maple and do not contribute greater to aesthetic or wildlife values.

Along the east property boundary, the majority of boundary trees will be retained. Trees # 465, 466 and 474 are to undergo maintenance with the removal of deadwood and large branching to improve health and structure. Trees #464, 467, 468, 469, 470, 471 and 472 with be retained under conditional preservation. Will trees with have protection measures installed, any maintenance completed with dead

As a means to protect trees recommended for retention as shown on **Figure 3**, RiverStone recommends the following measures:

- **At a minimum, tree preservation fencing is to be installed at the limit of the tree protection zone as indicated on Figure 3.**
- **Fencing is to be installed in accordance with Appendix 2 of the City of Barrie Tree Protection Manual (drawing BSD23-A) as far from the base of the tree as possible. It is recognized that there will only be a limited amount of room between the trees and protection fencing along the east property boundary. The majority of these trees were originally proposed to be removed and are now being retained a conditional preservation trees.**

- **No site alteration activities (e.g., grading, etc.), machinery movement, or storage of any equipment or materials should occur within the tree protection fencing.**

- **Where tree preservation fence cannot be installed at the limit of the tree protection zone for certain trees, tree protection fence should be established as far from the tree as practicable. A further assessment of such trees by a qualified Arborist may be necessary at the detailed design stage to demonstrate that protection can be accommodated.**

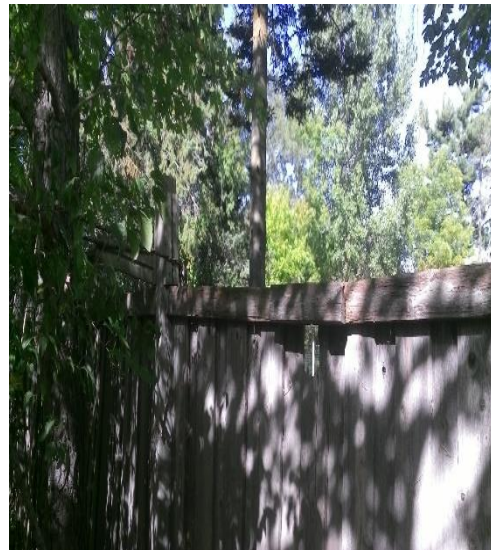
**Photo 4.** Fence along the east property boundary showing attachment to trees along boundary (October 2, 2017).

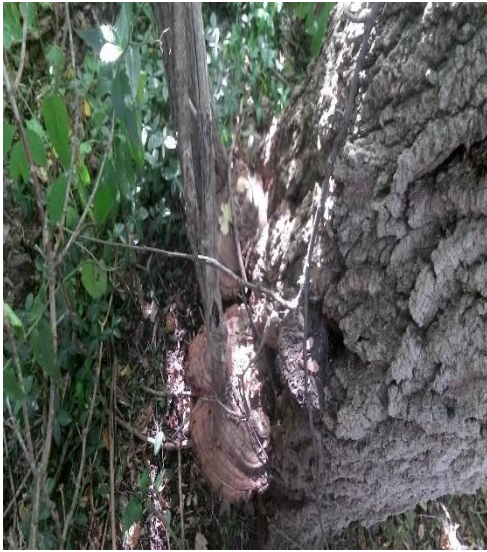
**Photo 5.** Fungal growth at base of tree showing example of poor quality possibly hazard tree (October 2, 2017).

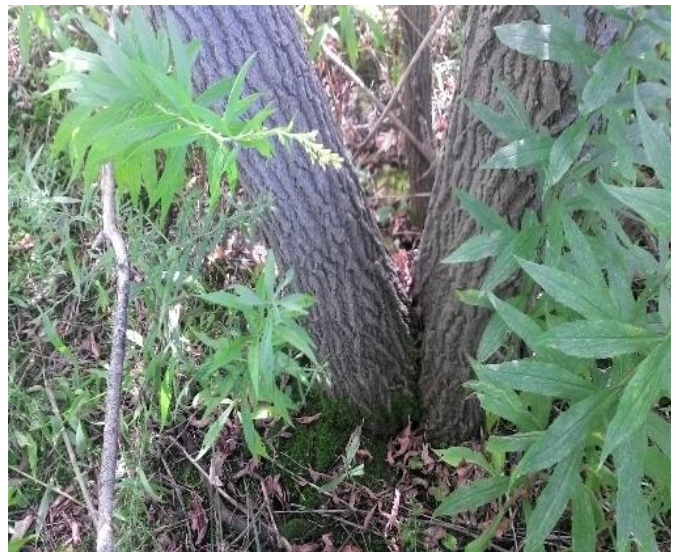
**Photo 6.** Stems split at base with potential weak point; example of poor quality possibly hazard tree (October 2, 2017).
