# 520-526 BIG BAY POINT RD., BARRIE, RESIDENTIAL DEVELOPMENT

## TREE INVENTORY, ANALYSIS, PRESERVATION REPORT (TIPP)

520-526 BIG BAY POINT ROAD,  
BARRIE, ONTARIO, COUNTY OF SIMCOE

DECEMBER 2020 – UPDATED TO APRIL 2021  
CITY OF BARRIE FILE: D28-012-2019  
OUR FILE: LA 494-20

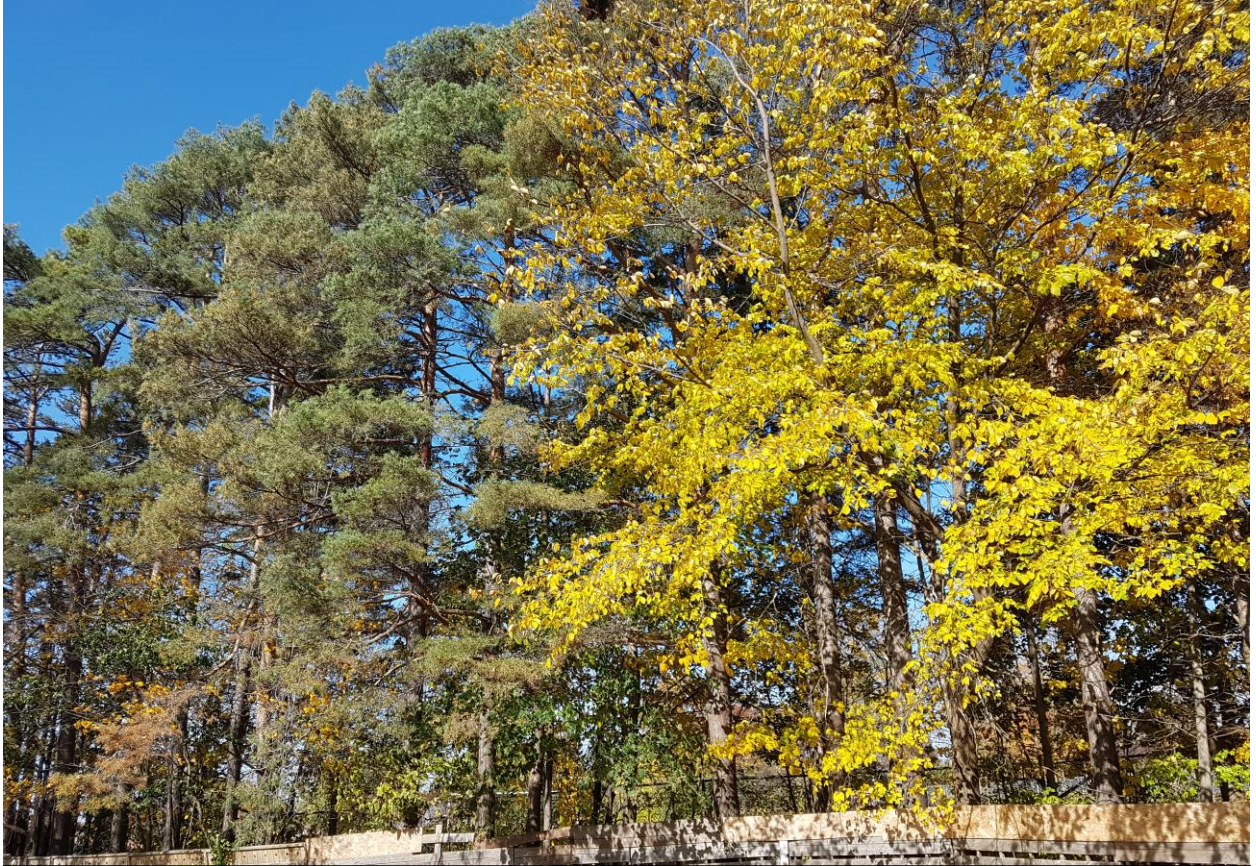
LEGroup Staff observed that the trees appeared to be generally located along the rear of the site (Trees Nos. 15-83), with an additional grouping of trees located along the centre of the site on the boundary between 520 and 526 Big Bay Point Rd (Trees Nos. 1-11, and 85-103). The trees at the rear boundary (Tree Nos. 15-83) are densely spaced and appear to generally be in poor to fair condition with health concerns characteristic of a woodland area including corrected leans, trunk wounds, thin canopies (see **Photo A, Appendix D**). This area largely consists of Scots Pine and White Spruce planted in rows, with other species growing, likely as fly-ins. Many of the trees in this area have embedded screws/nails as it was likely a fence had been formerly attached to several of the trees.

**Photo A:** Showing Trees at rear of site (Trees Nos. 15-82)

Additionally, Tree Nos. 15, 16, 18, 20–24, 26, 27, 29, 31-34, 39, 41, 43, 44, 45-48, 52-54, 56-67, and 60-84 are recommended for removal as they either interfere with the proposed parking lot, or a significant portion of their critical root zone will be impacted by the proposed parking lot and proposed retaining wall and are not expected to survive post-construction. They were found to be generally in poor to fair condition, with several of them having been previously used to support a fence (embedded nails, screws, and sections of chain link fence within their trunks).

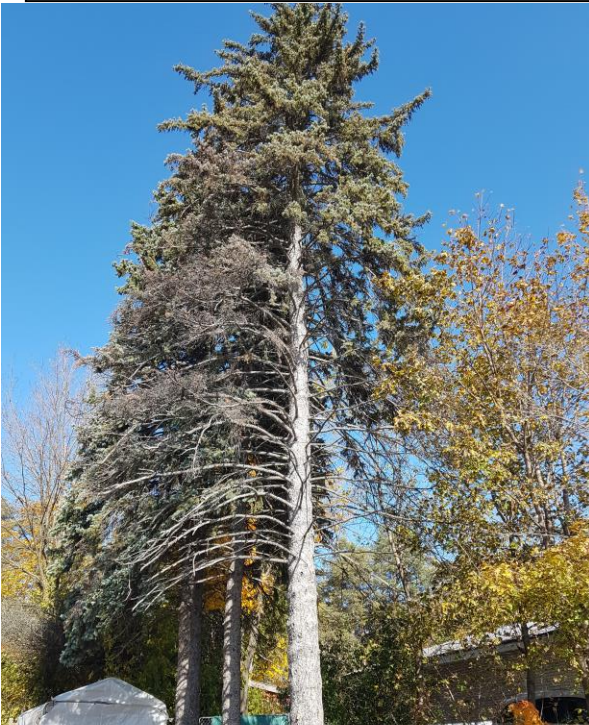
**Photo B:** Showing Tree Nos 6-8,  
Colorado Blue Spruce to be removed

Tree Nos. 1 - 11 and 85 - 103 are located in the middle of the lot and conflict with the proposed building and parking lot. These trees are in poor to fair condition and were found to have multiple leaders, included bark, leans, rubbing/crossing trunks, and compete with adjacent trees for sunlight. For these reasons, LEGroup staff are recommending these trees for removal. Trees Nos 12-14 are located closer to the west side of the site, exhibit health concerns such as exposed roots, branch dieback, suspected interior decay, and are in marginal to fair condition. These trees conflict with the proposed building and parking lot, and for these reasons are recommended for removal.

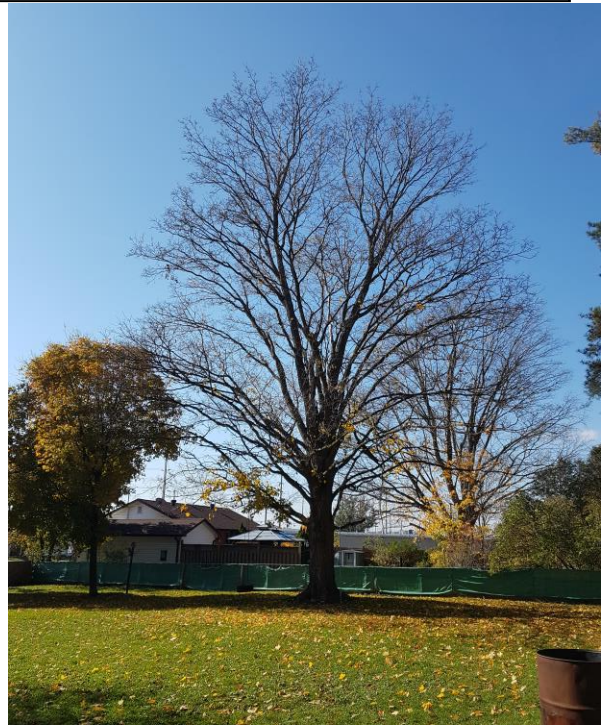
| Key | Latin Name | Common Name | Diameter (cm DBH) | Comments | Assessment | Canopy Radius (m) | Preserve /Remove |
|---|---|---|---|---|---|---|---|
| 13 | <i>Acer saccharum</i> | Sugar Maple | 27.2 | branch dieback, dead/broken branches, included bark, suspected interior decay | 3 Fair | 4.6 | Remove |

**Photo C:** Showing Trees Nos. 13, 14  
to be removed.

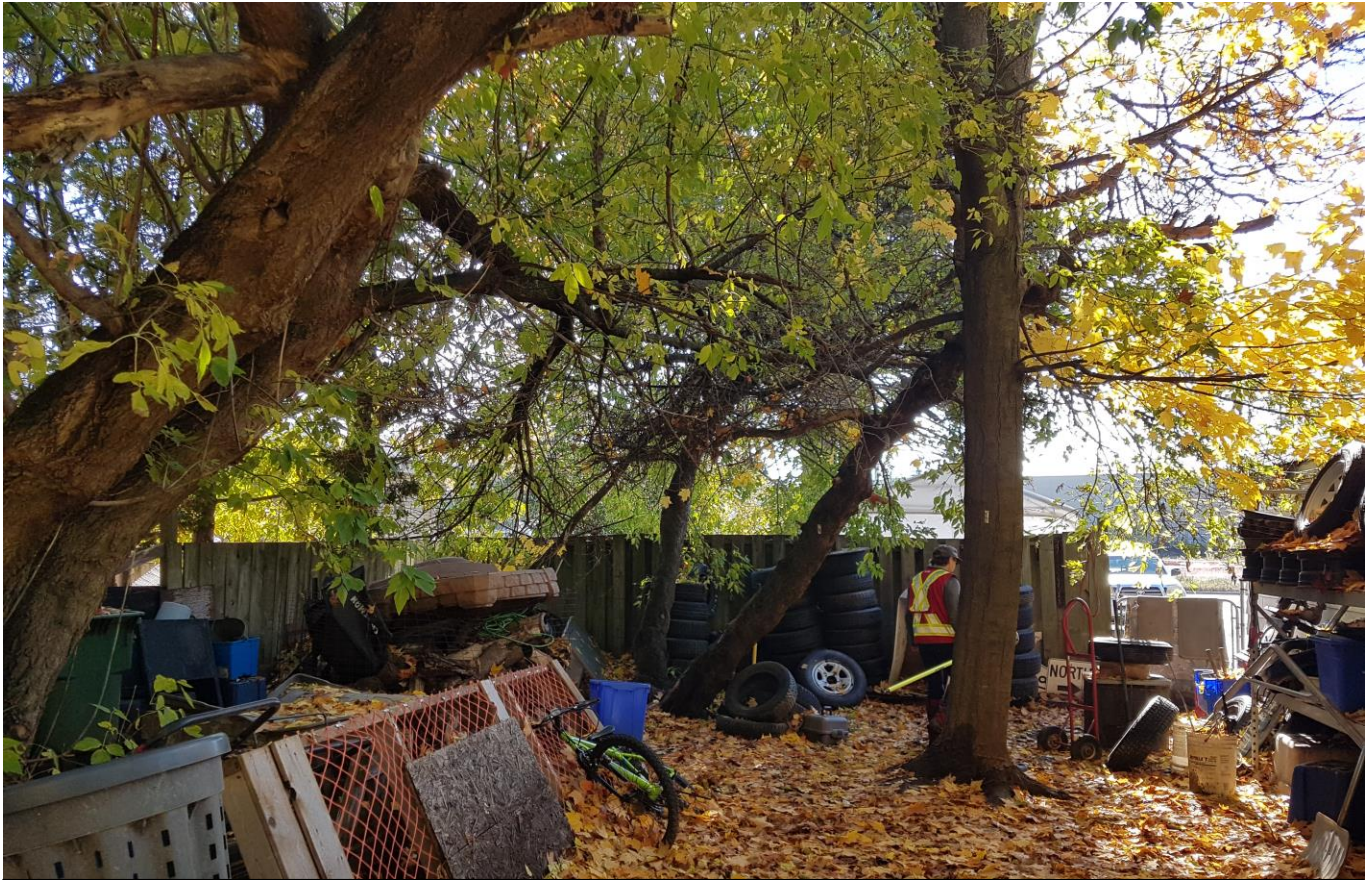
Trees Nos 9 and 11 are both Manitoba Maples with multiple trunks, bark necrosis, dead/broken branches, significant leans, and fungal growth (**See Photo D – Appendix D**).

**Photo E:** Showing Trees Nos 9 (background) & 11 (foreground) with significant leans, dead/broken branches, bark necrosis, epicormic branching, and fungal growth.

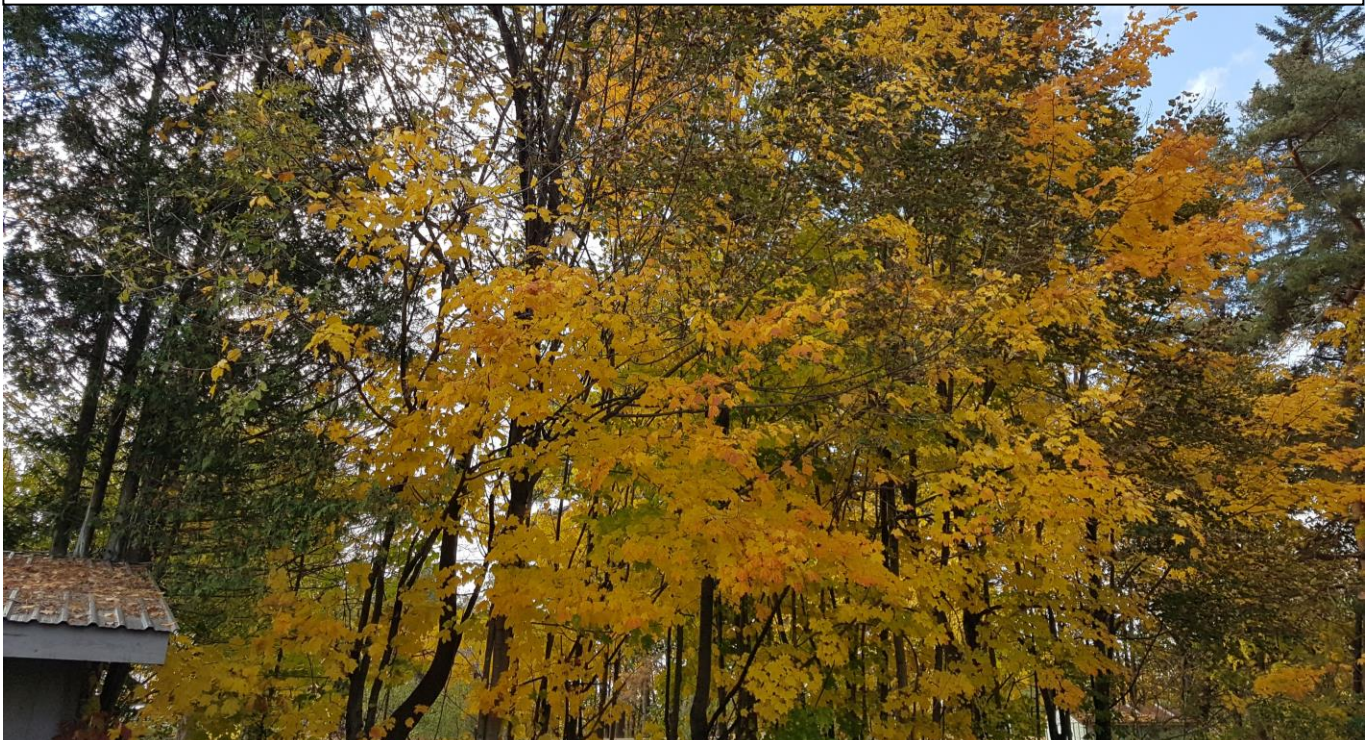
The trees located at the centre of the site (Trees Nos 85-103) are largely Sugar Maple, as well as Eastern White Cedar and Norway Maple and are generally in poor to fair condition with health concerns including multiple leaders, included bark, dead/broken branches and bark necrosis (**See Photo E – Appendix D**). The Cedars in this area exhibit health concerns including multiple leaders/trunks, lower branch pruning, thin canopies, and are located adjacent to an existing shed.

**Photo D:** Showing Tree Nos. 85-103, largely comprised of small-diameter Sugar Maples which conflict with the proposed development and are recommended for removal.
