521-525 ESSA ROAD RESIDENTIAL DEVELOPMENT

TREE INVENTORY, ANALYSIS AND PRESERVATION REPORT

AUGUST, 2017

OUR FILE: LA 265.10-17

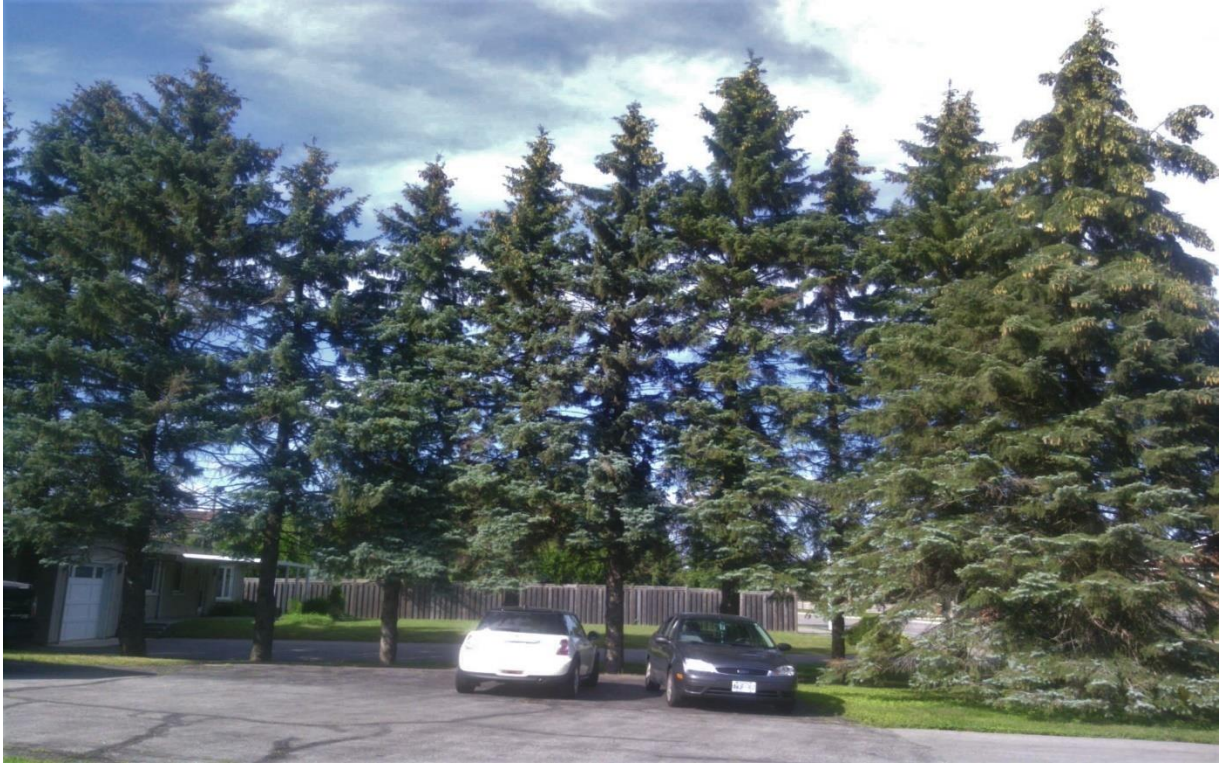
The majority of these trees are Colorado Blue Spruce (*Picea pungens* 'Glauca') and White Spruce (*Picea glauca*) which are located along the mid-section between the two parcels of the subject site and along the rear of both parcels (see **Photos A/B, Appendix D**). These trees appear to be over 40 years of age, are in marginal health and are considered to be at the end of their useful life. Many of the branches of the conifers along the mid-section have been pruned to a height of approximately six (6) feet and continue to discharge sap (suspected *Sirococcus*). The conifers at the rear of the site have extensive lower branch dieback (suspected needlecast disease) and provide minimal live branch buffering between the subject property and the homes along Leslie Avenue (see **Photo H, Appendix D**). Trees # 47-49 have been infected with Riverbank Grape (*Vitis riparia*) a vine that uses host trees to support its growth and has caused considerable weakening and branch dieback.

Photo A-Tree Nos. 3-10 Colorado Blue Spruce (*Picea pungens* 'Glauca') recommended for removal.

We note that there are thirty-three (33) Colorado Blue Spruce (*Picea pungens 'Glauca'*) (Tree Nos. 1, 3-22, 24-32, 47-49), that are recorded that are over 10cm dbh on the subject site. With the exception of Trees No. 1 and 3 which are located along the 525 Essa Road frontage, the remaining are deemed to be in marginal health and are recommended to be removed.

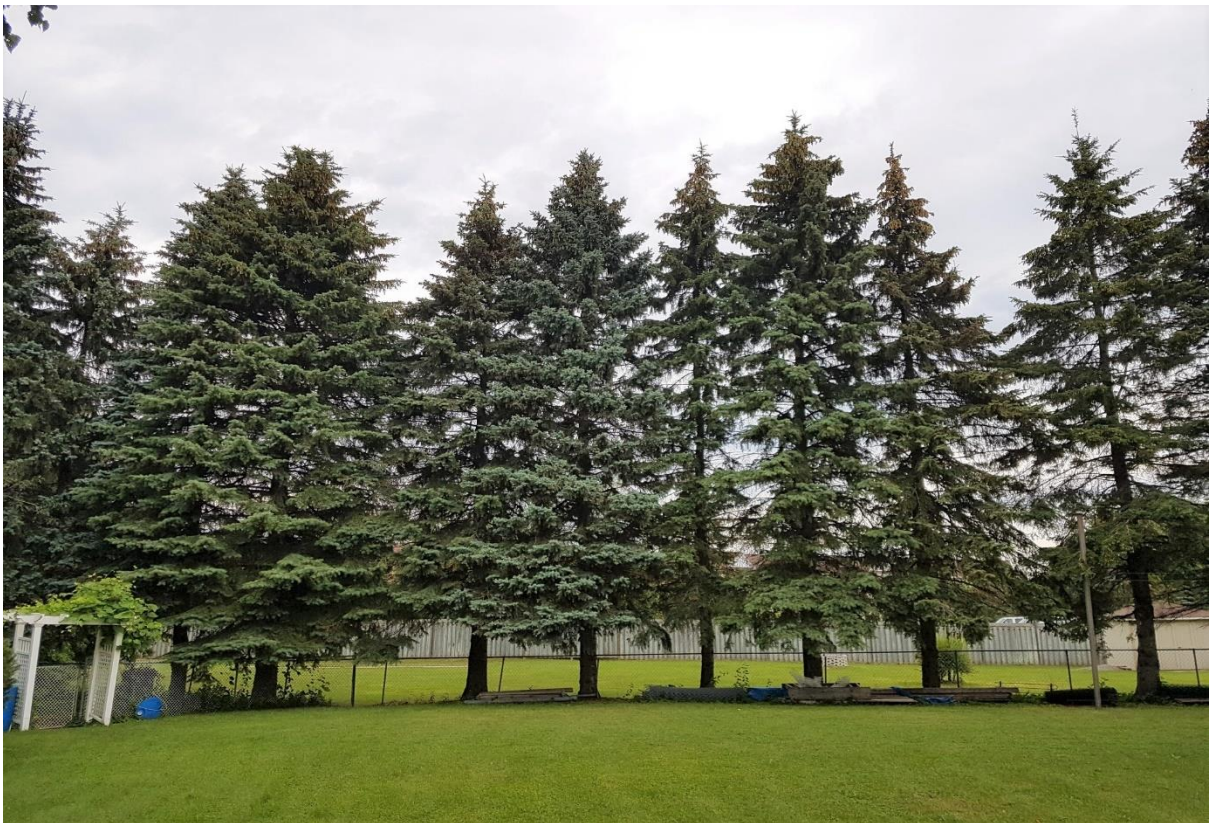
Photo B-Trees Nos. 21-28 Colorado Blue Spruce/White Spruce recommended for removal.

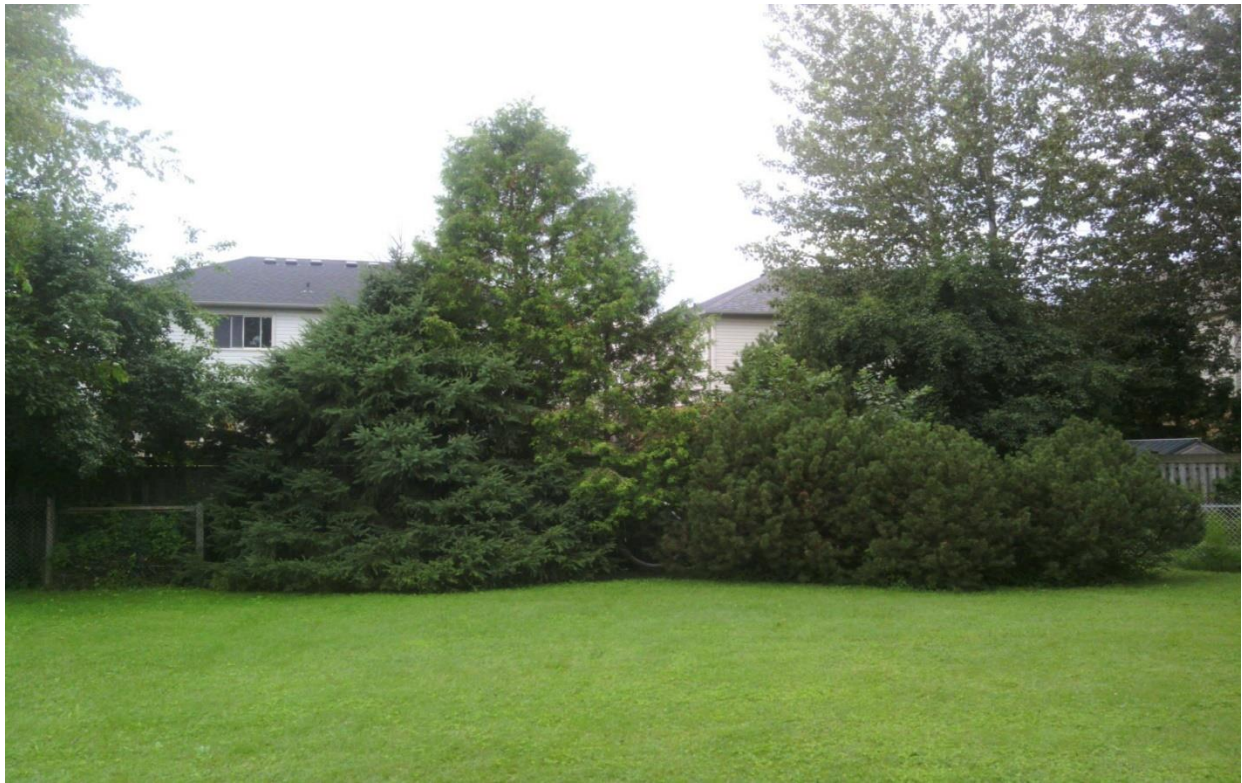
Photo C-Boundary trees Nos. 33-36 at the rear of 525 Essa Road.

A massing of trees and mature shrubs along the west boundary that are comprised of two (2) Austrian pines (*Pinus nigra*) (Trees No. 33 & 39), Eastern White Cedar (*Thuja occidentalis*) (Tree No. 34) and two Buckthorn (*Rhamnus cathartica*) (Trees No. 36 & 40) are deemed to be in marginal to poor condition and are recommended to be removed.

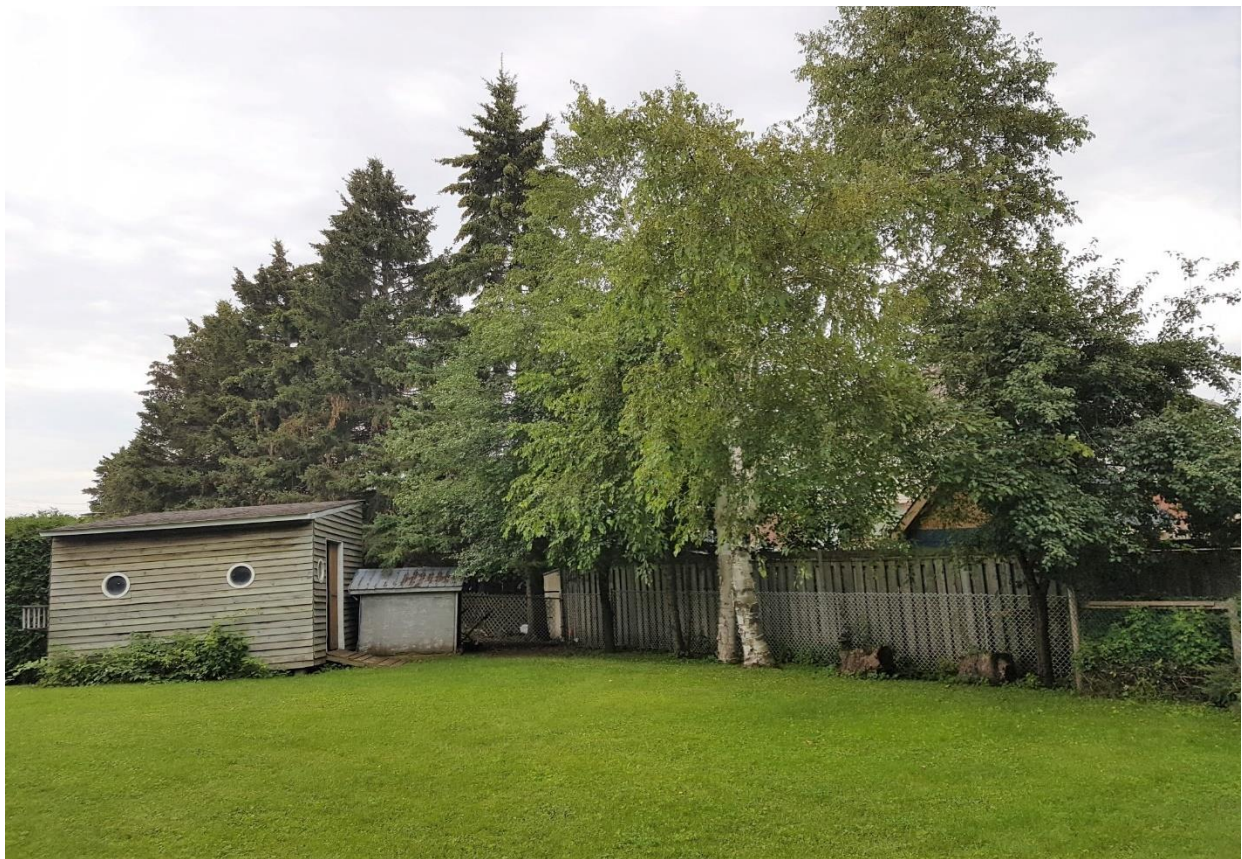
Photo D-Boundary trees Nos. 36-42 at the rear/west side of 525 Essa Road.

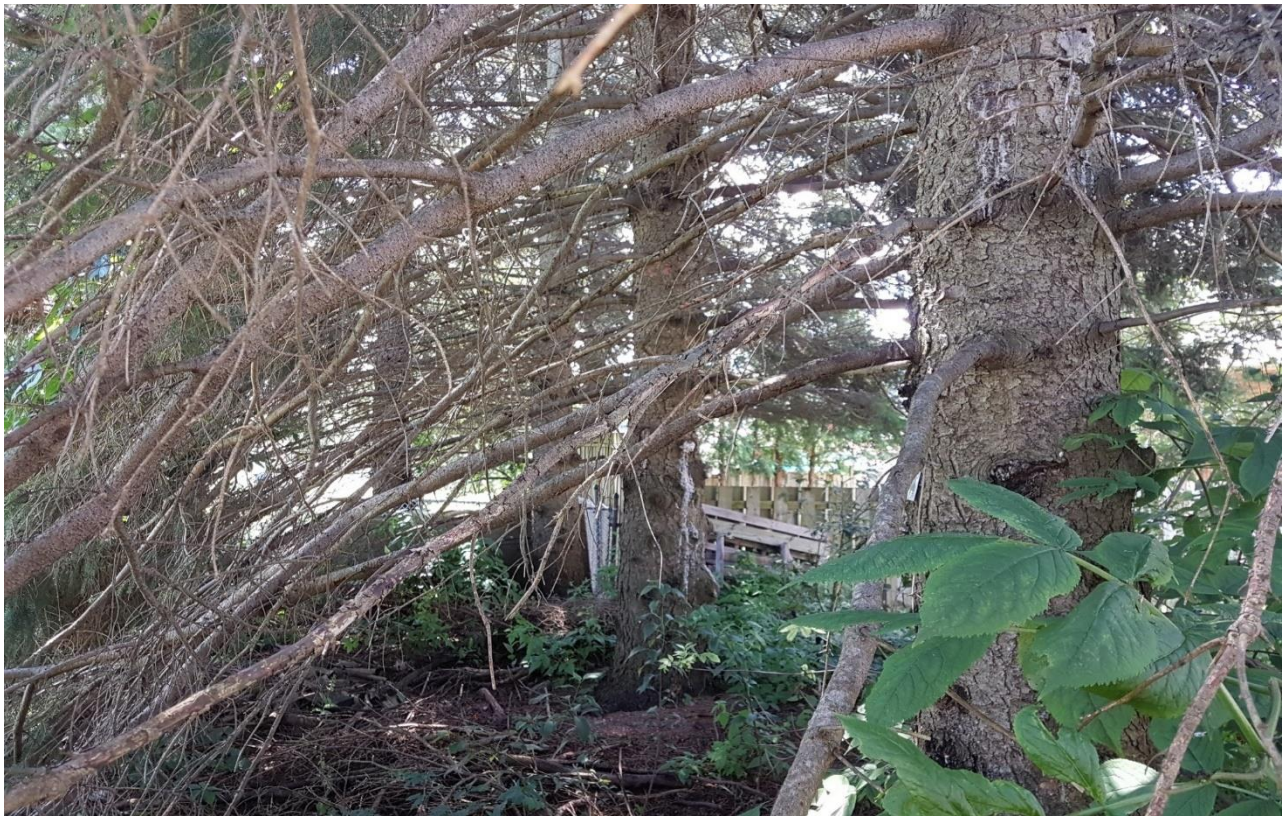
Photo E-Tree Nos. 43-46 White Spruce (*Picea glauca*) showing interior dieback

There are seven (7) White Spruce (*Picea glauca*) recorded that are over 10cm dbh on the site (2, 23, 35, 43-46) many of which are deemed to be in marginal to poor health and are recommended to be removed. However, Tree No. 2 appears to be in fair condition, there is opportunity to retain in-situ and is recommended for retention/protection as shown in **Appendix B**. Although recorded as being in marginal condition, Tree No. 35 as a boundary tree is recommended for retention and protection.

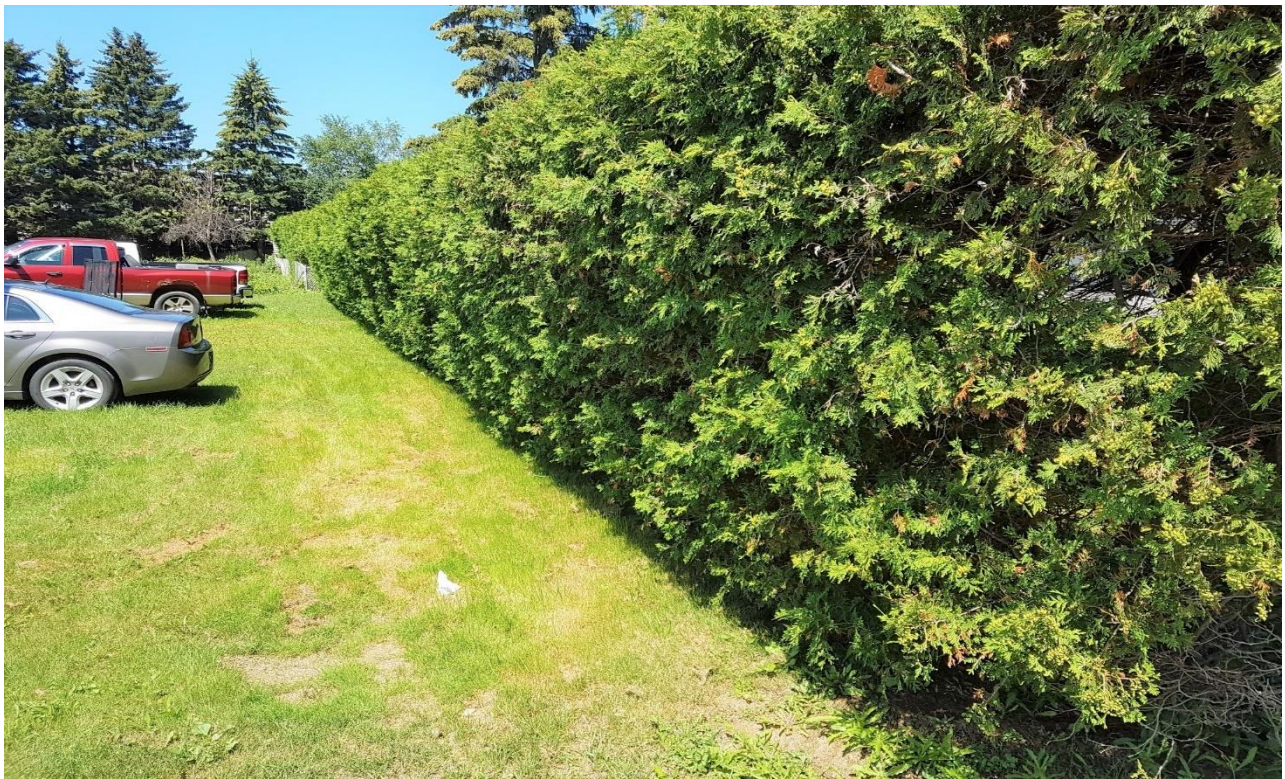
Photo F-No. 42 Eastern White Cedar (*Thuja occidentalis*) along the south property line.

There is a hedge of Eastern White Cedar (*Thuja occidentalis*) along the south property line (No. 42) that was installed as a visual buffer between the commercial and residential use of the subject property. The hedge is recorded as being in fair condition and is recommended to be retained and protected.

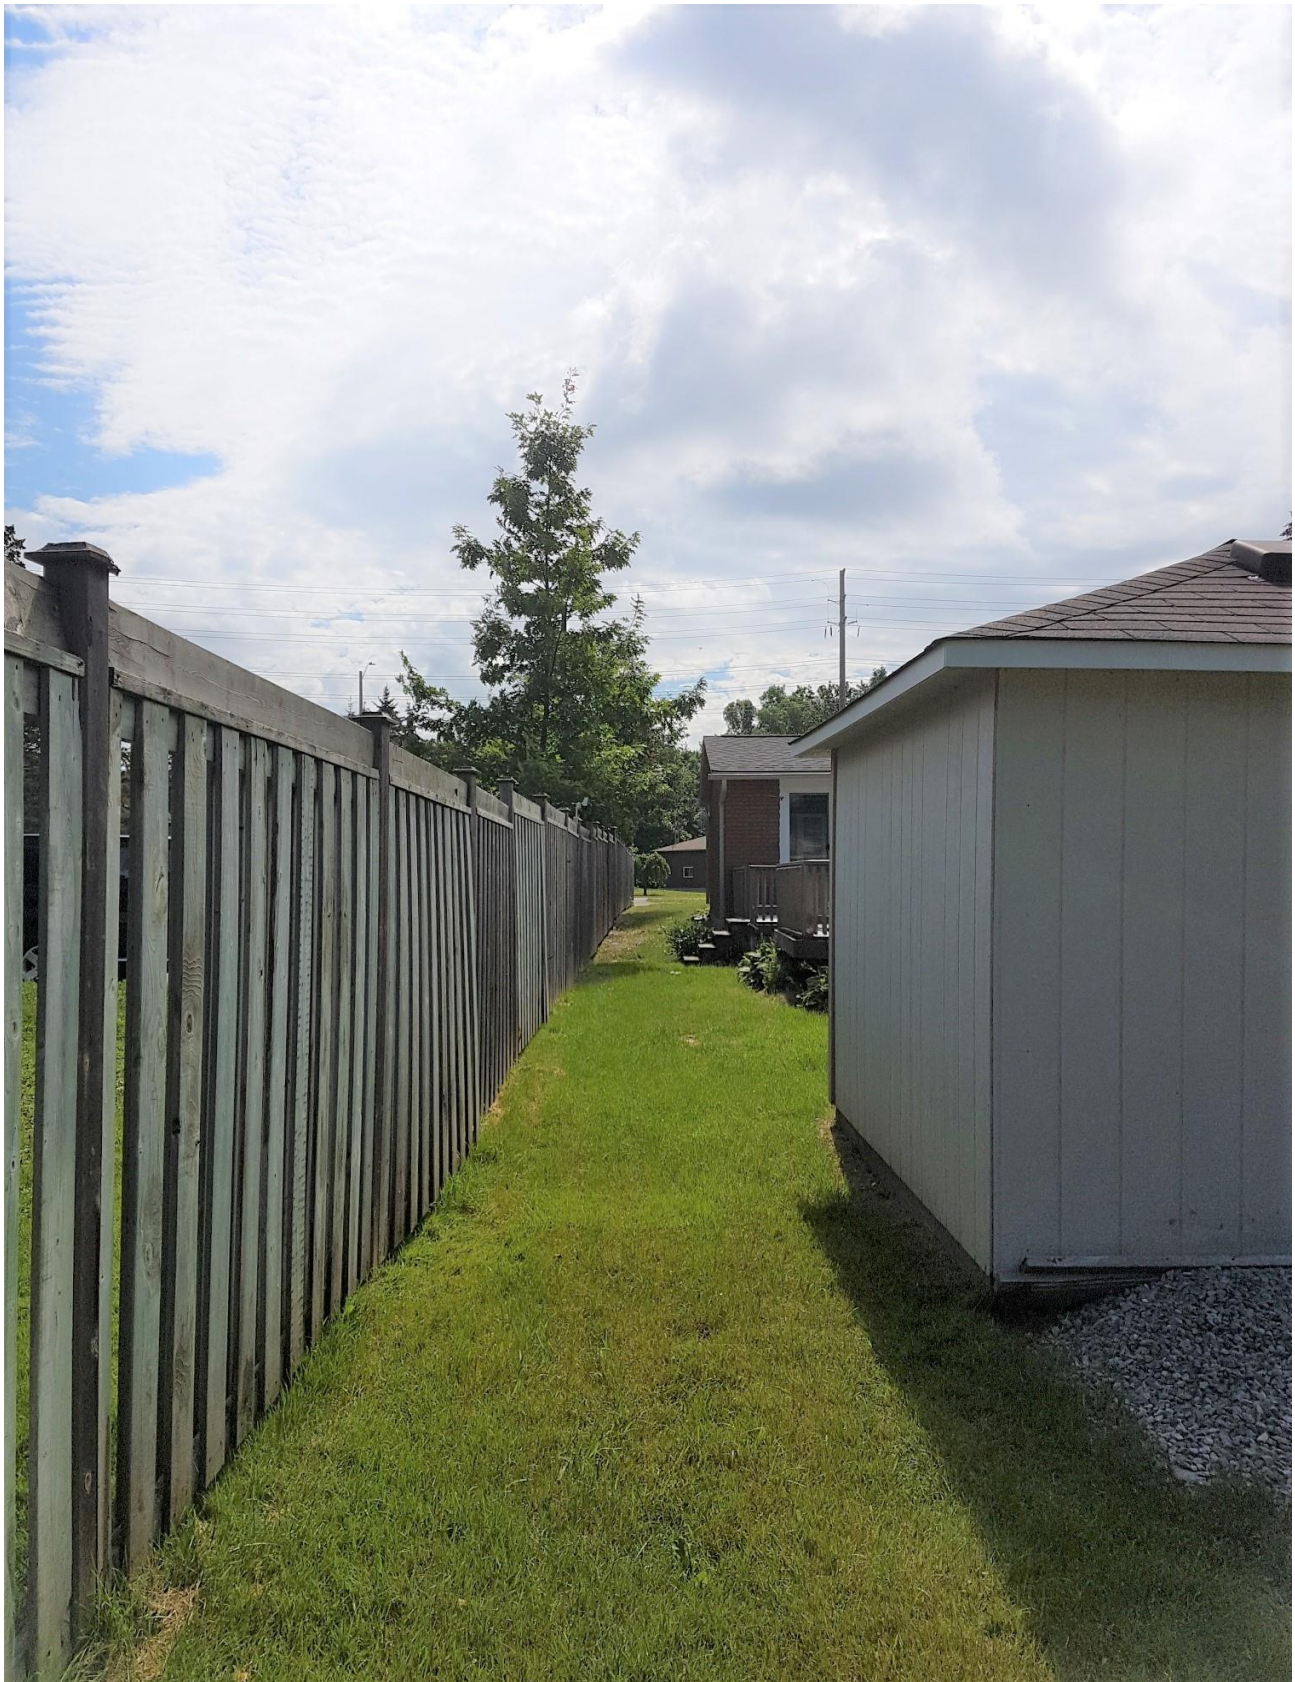
Of the species noted above on the Roberta Place site, only the Red Oak (*Quercus rubra*) has branching that reaches approximately two (2) metres over the boundary into the subject property (**see Photos F & G**).

Photo F-Looking east along the north fenceline showing boundary trees.
