521-525 ESSA ROAD RESIDENTIAL DEVELOPMENT

TREE INVENTORY, ANALYSIS AND PRESERVATION REPORT

AUGUST, 2017
REVISED MARCH 2018

OUR FILE: LA 265.10-17

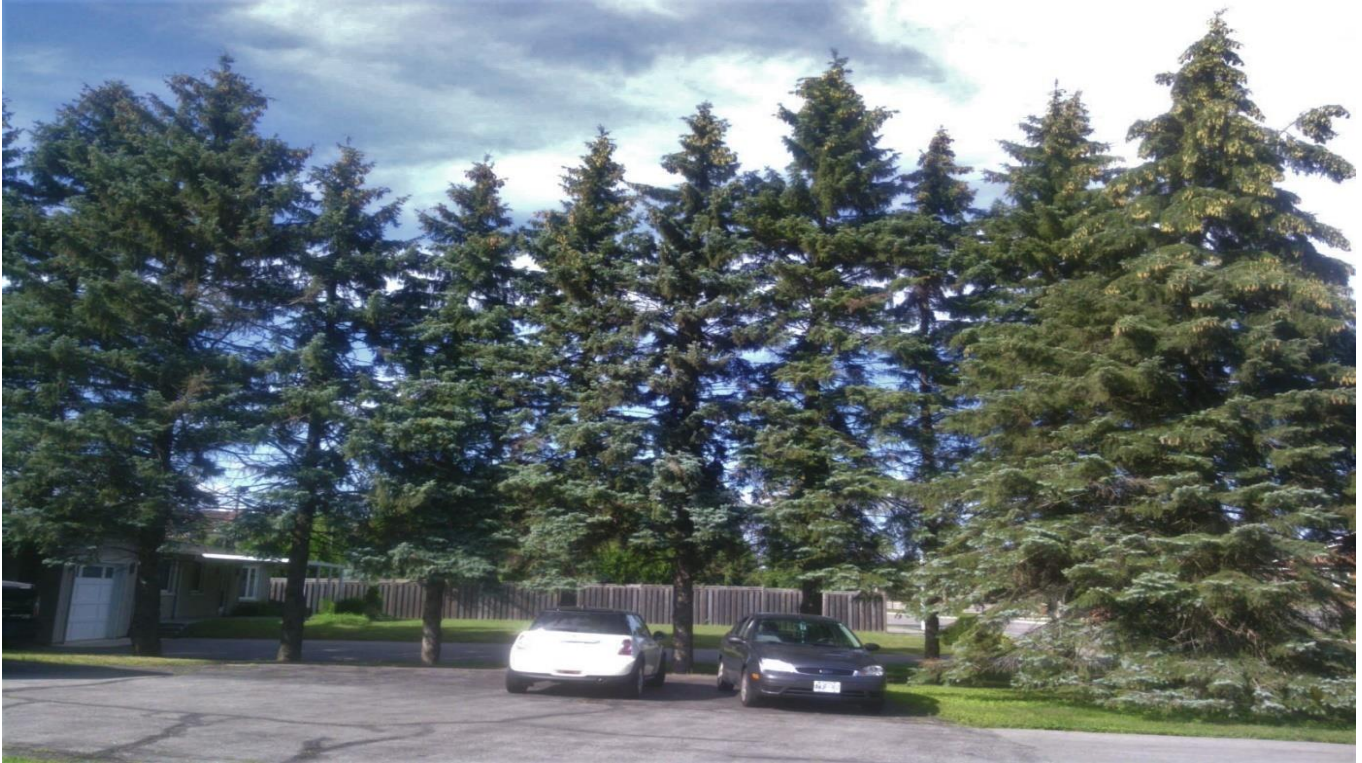
Key	Latin Name	Common Name	Size (dbh)	Rating	Comments	Recommendation
1	<i>Picea pungens glauca</i>	Colorado Blue Spruce	64	2 Marginal	lower branch dieback, great top growth, leans, girdling roots, sap bleed	Remove for development
2	<i>Picea glauca</i>	White Spruce	37	3 Fair	surface roots, triple leader, interior branch dieback, some bleed,	Remove for development
3	<i>Picea pungens glauca</i>	Colorado Blue Spruce	49.3	3 Fair	internal branch dieback, good vigor, some sap bleed	Remove for development
4	<i>Picea pungens glauca</i>	Colorado Blue Spruce	40	2 Marginal	significant sap bleed, interior branch dieback	Remove for development
5	<i>Picea pungens glauca</i>	Colorado Blue Spruce	27.4	2 Marginal	interior branch dieback, small crown	Remove for development
6	<i>Picea pungens glauca</i>	Colorado Blue Spruce	41.9	2 Marginal	root flare, interior branch dieback	Remove for development
7	<i>Picea pungens glauca</i>	Colorado Blue Spruce	38.7	2 Marginal	root flare, interior branch dieback	Remove for development

8	<i>Picea pungens glauca</i>	Colorado Blue Spruce	30.3	2 Marginal	root flare, interior branch dieback	Remove for development
9	<i>Picea pungens glauca</i>	Colorado Blue Spruce	32.8	2 Marginal	fruiting body, sap bleed, interior branch dieback	Remove for development
10	<i>Picea pungens glauca</i>	Colorado Blue Spruce	36.5	2 Marginal	root flare, interior branch dieback	Remove for development
11	<i>Picea pungens glauca</i>	Colorado Blue Spruce	43.7	2 Marginal	trunk bulge-suspected interior decay, sap bleed, interior branch dieback	Remove for development
12	<i>Picea pungens glauca</i>	Colorado Blue Spruce	38.4	2 Marginal	root flare, interior branch dieback	Remove for development
13	<i>Picea pungens glauca</i>	Colorado Blue Spruce	29.5	2 Marginal	root flare, interior branch dieback	Remove for development
14	<i>Picea pungens glauca</i>	Colorado Blue Spruce	38.7	2 Marginal	root flare, interior branch dieback	Remove for development

Photo A-Tree Nos. 3-10 Colorado Blue Spruce (*Picea pungens* 'Glauca') recommended for removal.

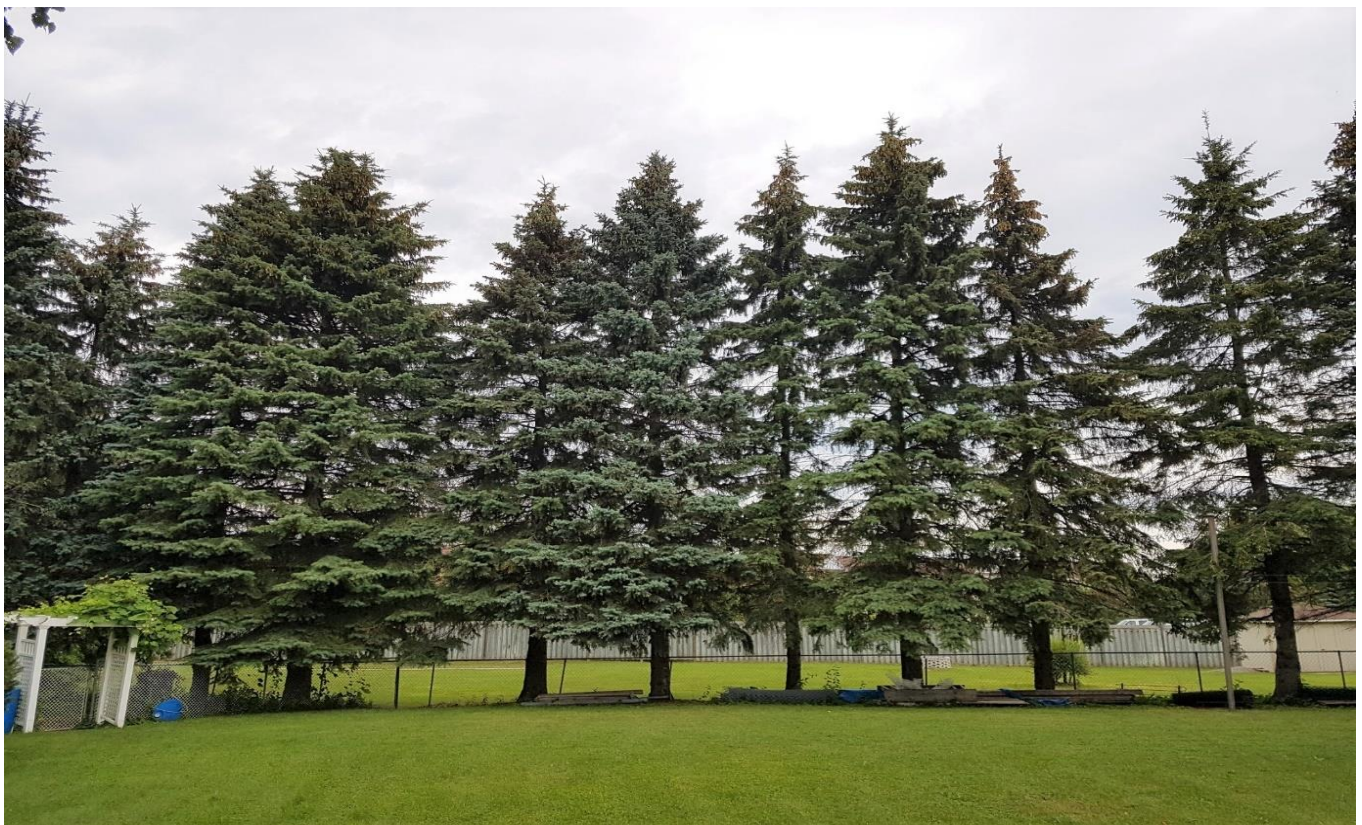
Key	Latin Name	Common Name	Size (dbh)	Rating	Comments	Recommendation
19	<i>Picea pungens glauca</i>	Colorado Blue Spruce	25.4	2 Marginal	exposed root flares, interior branch dieback	Remove for development
20	<i>Picea pungens glauca</i>	Colorado Blue Spruce	33.3	2 Marginal	post in trunk flare, sap bleed, interior branch dieback	Remove for development
21	<i>Picea pungens glauca</i>	Colorado Blue Spruce	35.6	2 Marginal	sap bleed, exposed root flares, interior branch dieback	Remove for development
22	<i>Picea pungens glauca</i>	Colorado Blue Spruce	37.2	2 Marginal	post in trunk flare, sap bleed, interior branch dieback	Remove for development
23	<i>Picea glauca</i>	White Spruce	31.8	1 poor	sap bleed, root girdling, suspected interior decay, exposed root flares, interior branch dieback	Remove for development
24	<i>Picea pungens glauca</i>	Colorado Blue Spruce	30.3	2 Marginal	exposed root flares, sap bleed, branch dieback	Remove for development

25	<i>Picea pungens glauca</i>	Colorado Blue Spruce	35.7	2 Marginal	post in trunk, sap bleed	Remove for development
26	<i>Picea pungens glauca</i>	Colorado Blue Spruce	27.2	2 Marginal	exposed root flares, sap bleed, branch dieback	Remove for development
27	<i>Picea pungens glauca</i>	Colorado Blue Spruce	37.5	2 Marginal	sap bleed, post in trunk, surface roots, lower branch dieback	Remove for development
28	<i>Picea pungens glauca</i>	Colorado Blue Spruce	37.5	2 Marginal	root girdling	Remove for development
29	<i>Picea pungens glauca</i>	Colorado Blue Spruce	45.5	2 Marginal	sap bleed, exposed root flares, post footing in trunk, interior branch dieback	Remove for development
30	<i>Picea pungens glauca</i>	Colorado Blue Spruce	32.7	2 Marginal	sap bleed, suspected interior decay, post footing in trunk, interior branch dieback	Remove for development
31	<i>Picea pungens glauca</i>	Colorado Blue Spruce	30.5	2 Marginal	sap bleed, interior branching dieback	Remove for development

Photo B-Trees Nos. 21-28 Colorado Blue Spruce/White Spruce recommended for removal.

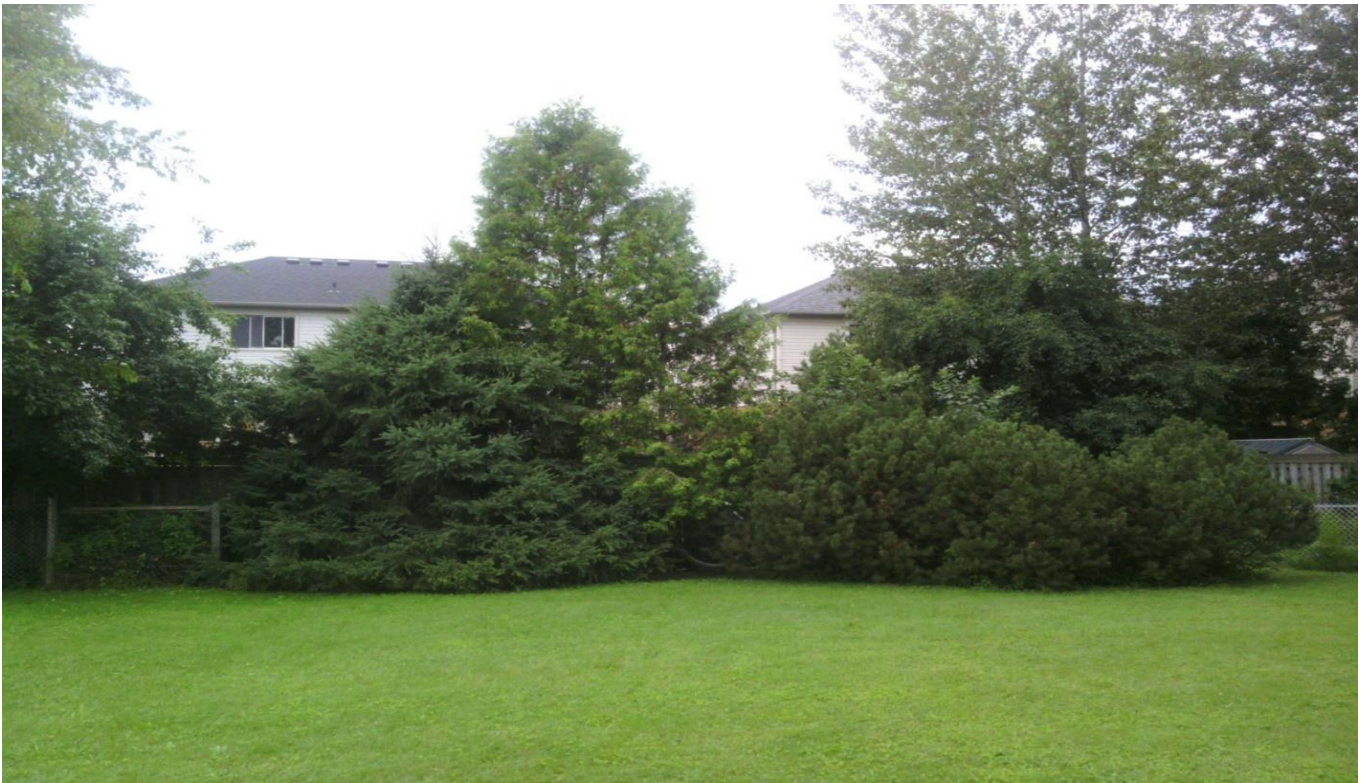
A massing of trees and mature shrubs along the west boundary that are comprised of two (2) Austrian pines (*Pinus nigra*) (Trees No. 33 & 39), Eastern White Cedar (*Thuja occidentalis*) (Tree No. 34) and two Buckthorn (*Rhamnus cathartica*) (Trees No. 36 & 40) are deemed to be in marginal to poor condition and are recommended to be removed.

32	<i>Picea pungens glauca</i>	Colorado Blue Spruce	39.7	2 Marginal	sap bleed, interior branching dieback	Remove for development
33	<i>Pinus nigra</i>	Austrian Pine	12.5	1 poor	boundary tree, twisted trunk, mugo pine, no leader	Remove for health
34	<i>Thuja occidentalis</i>	Eastern White Cedar	28	2 Marginal	y-trunk, boundary tree, riverbank grape	Preserve

Photo C-Boundary Trees Nos. 33-36 at the rear of 525 Essa Road.

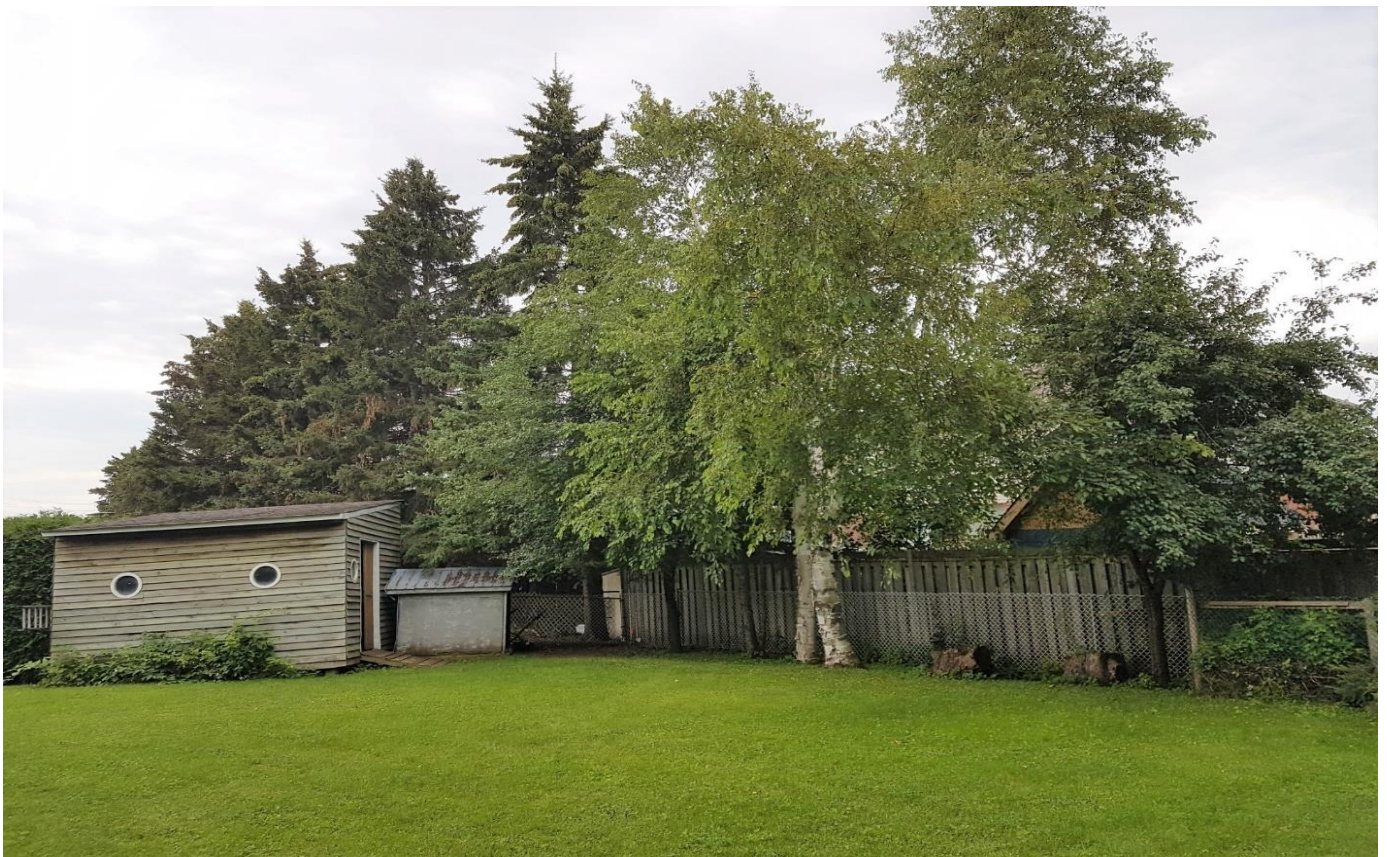
Two (2) Paper Birch trees (*Betula papyrifera*) (Tree No. 37 & 38) are located along the west property line and are recorded to be in fair condition. We recommend that these trees be retained and protected.

There is one Norway Maple (*Acer platanoides*) (Tree No. 41) in the rear-centre of 525 Essa Road that is recorded to be in fair condition however, given its location on the site, is recommended for removal.

Photo D-Boundary Trees Nos. 36-42 at the rear/west side of 525 Essa Road.

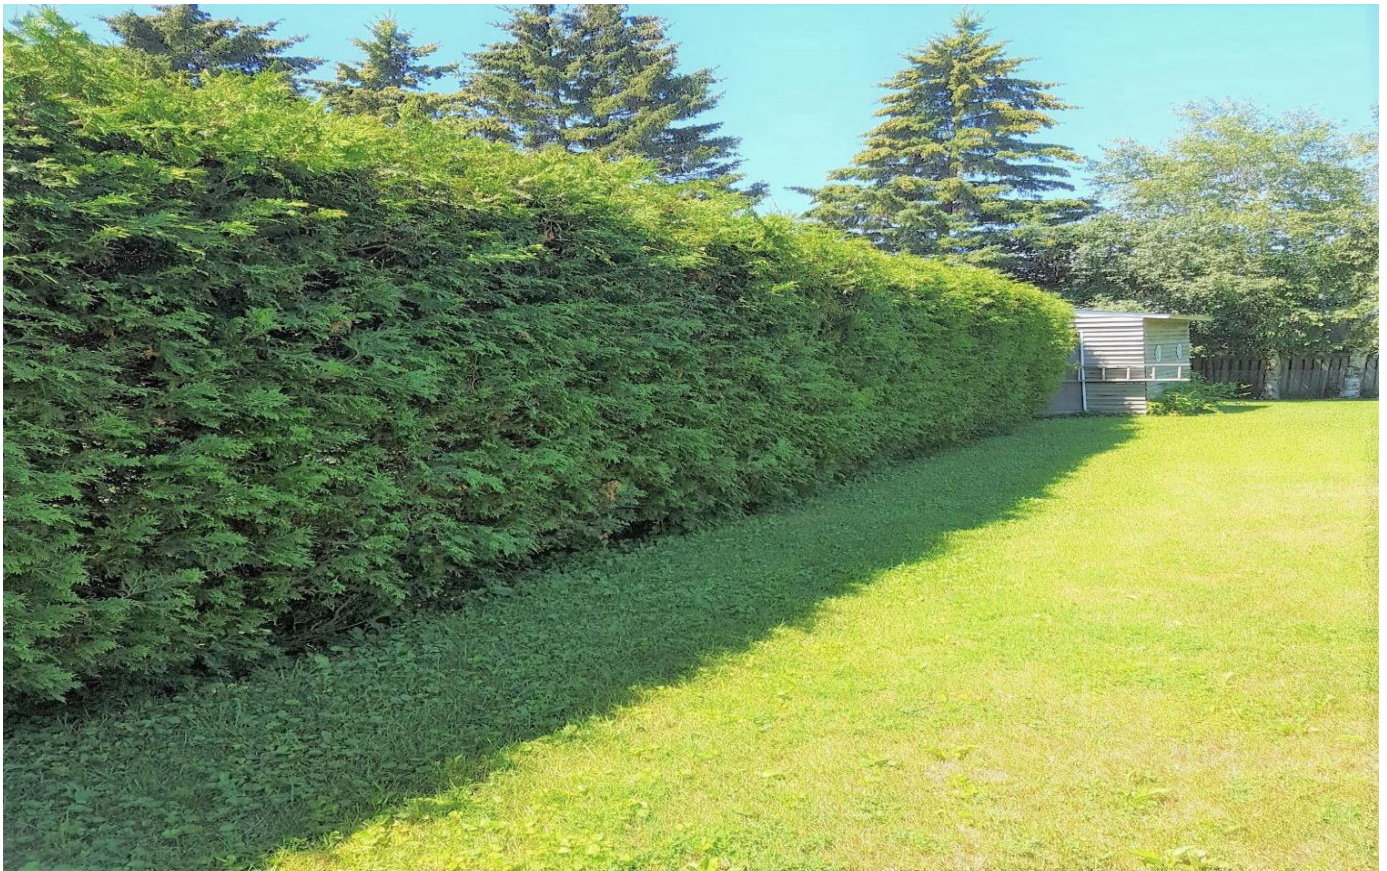
The Eastern White Cedar hedge (*Thuja occidentalis*) along the south property line (Tree No. 42) was installed as a visual buffer between the commercial and residential use of the subject property. The hedge is recorded as being in fair condition and is recommended to be retained and protected. However, the hedge is also recommended to be trimmed to maintain branch density and its continued suitability as a vegetative buffer.

Photo E-Tree No. 42 Eastern White Cedar (*Thuja occidentalis*) along the south property line (subject site).

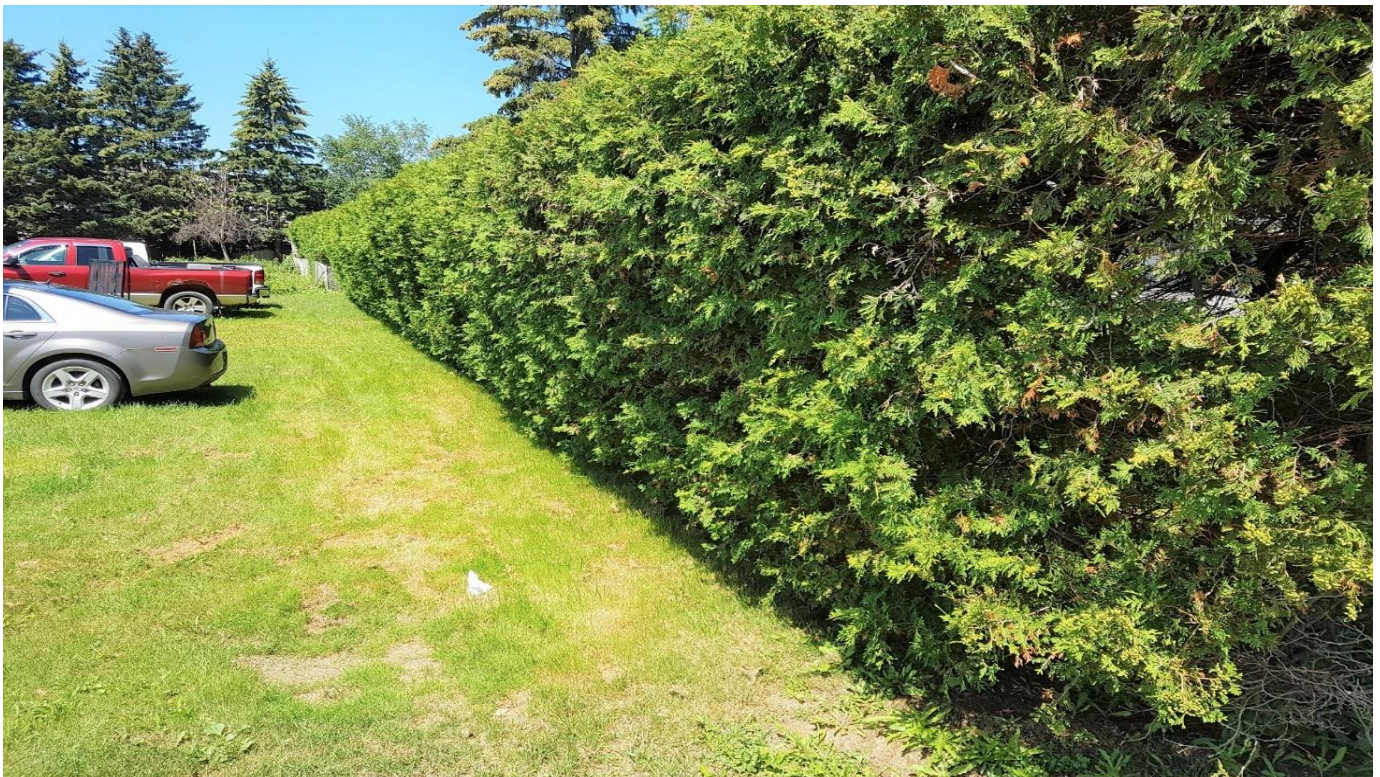
Photo F-No. 42 Eastern White Cedar (*Thuja occidentalis*) along the south property line (commercial side).

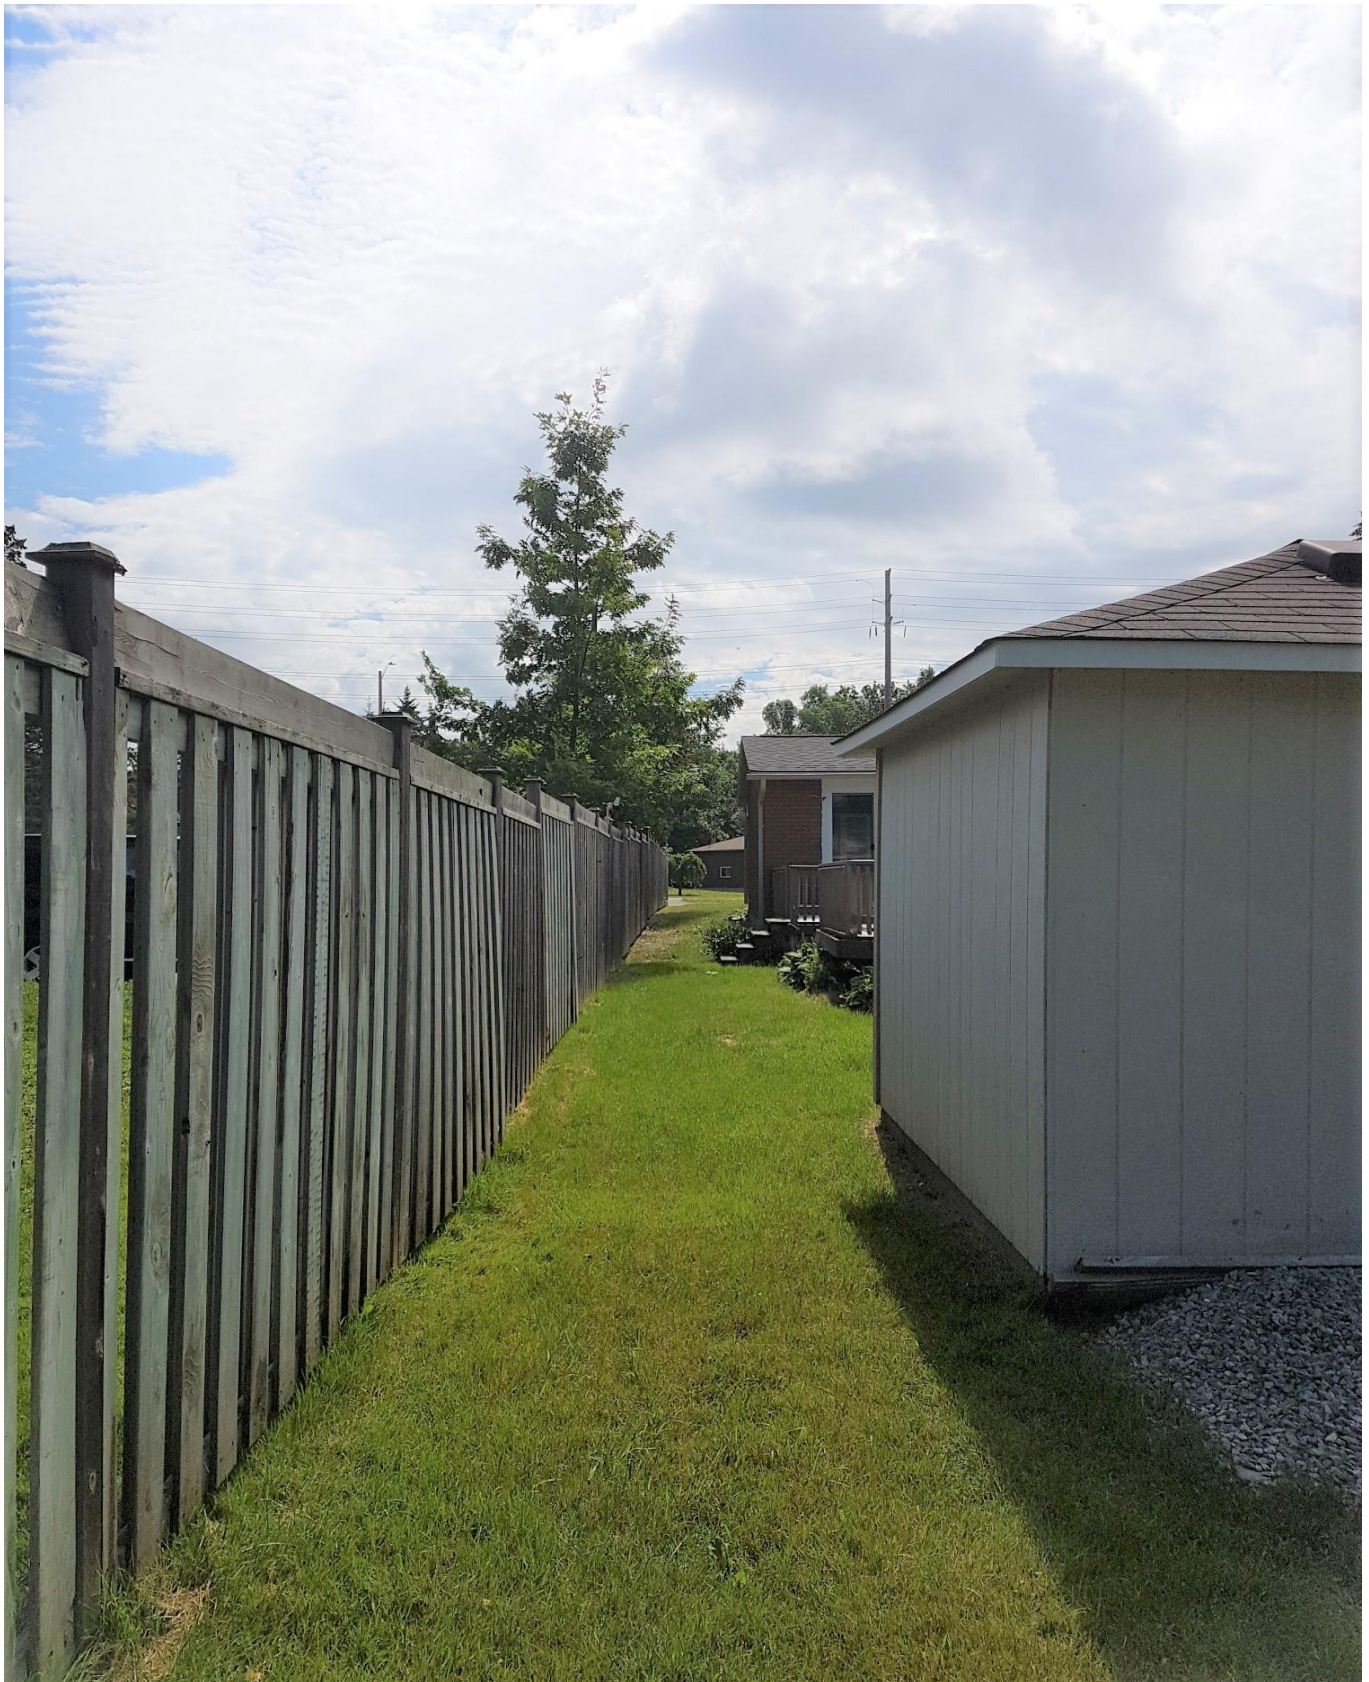
Notably, most of the species observed in the Table above (Serbian Spruce, Cedar hedge and Red Oak), occur on the Roberta Place premises to the north in compliance with the site plan approval for that site (see **Photos G & H, Appendix D**). Two (2) trees (Balsam Poplar) were observed in the adjacent rear yards of the Leslie Avenue that affected the subject site. Only the Northern Catalpa and Colorado Blue Spruce were located in the Holly Auto Service lands to the south; the Catalpa was in poor condition and did not reach across over the fenceline of the subject site; the Colorado Blue Spruce appeared to be in marginal condition and crossed over the fenceline by approximately 1.0 m.

Photo G-Looking east along the north fenceline showing adjacent boundary trees to be protected.

It is also recommended that off-site boundary trees as discussed above, where they cross over the subject site are to be protected with preservation fencing in locations as shown in **ARB-1 in Appendix B** in accordance with the City of Barrie Tree Preservation Detail BSD-1232 (**see D-1 in Appendix B**). Further,

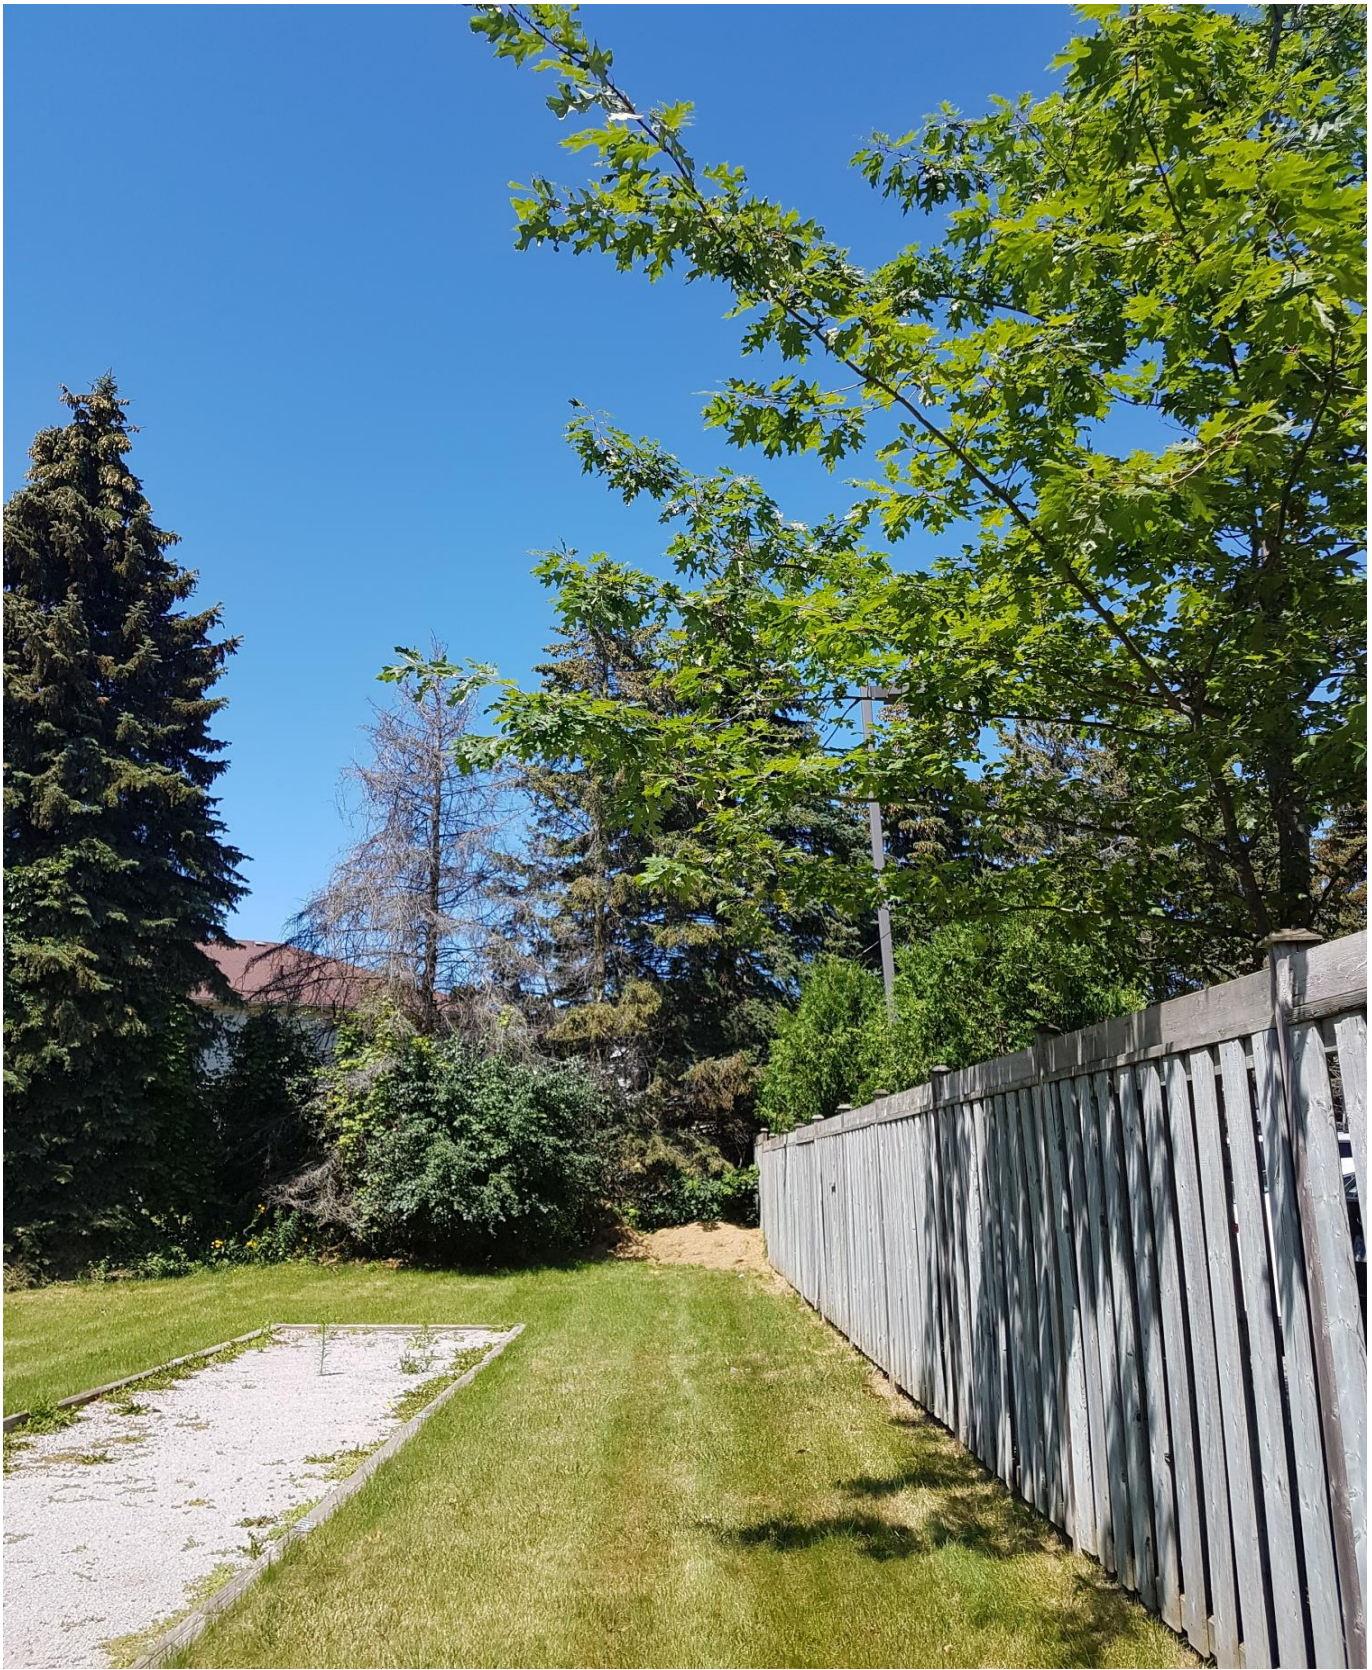
Photo H-Looking west at 521 Essa Road-offsite boundary trees (Red Oak *Quercus rubra*) from Roberta Place that cross over the boundary by approximately 2.0 m.

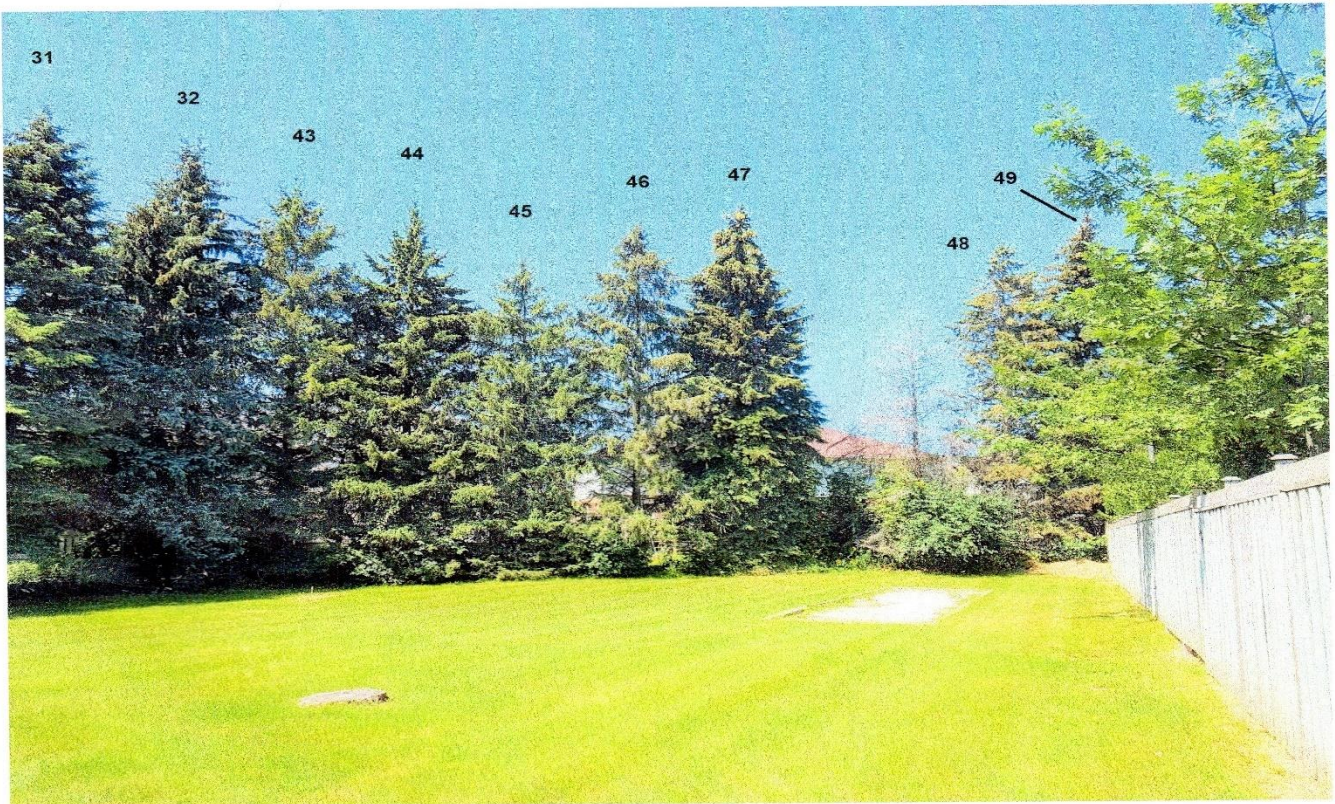
We note that there are thirty-three (33) Colorado Blue Spruce (*Picea pungens* 'Glauca') (Tree Nos. 1, 3-22, 24-32, 47-49), recorded that are over 10cm dbh on the subject site that are described above. Trees No. 1, 3-22, 24-31 are recommended for removal to accommodate the development. While Tree No. 32 is outside of the new build footprint per se, due to its declining health and shallow root system characteristic of Spruces, it is questionable whether there is an ability for this tree to withstand site construction within its root zone. Further, the proposed retaining structure required for this development is suspected to encroach into its root zone. Therefore, we are of the opinion that due to the reasons stated above, Tree No. 32 is not suitable for retention and recommend its removal. We would also recommend that oversized conifers be installed to replace Tree No. 32 to reinforce the vegetative buffer as a sustainable solution.

Further, Colorado Blue Spruce Tree No. 48 has also shown symptoms of accelerated poor health with symptoms including tip dieback, weakened/browning needles, bark blister and root girdle. Its deteriorating health is concerning so as to suspect compromise in its ability to withstand a storm event (eg ice storm) and would recommend that this tree is not a candidate for retention. However, despite health concerns, we would recommend that Tree No. 47 be retained, protected during construction and monitored for ongoing health and mechanical strength. Lastly, we recommend that oversized conifers be installed to replace the removed Colorado Spruce to reinforce the vegetative buffer as a sustainable solution.

Photo I-Looking west at 521 Essa Rd -Tree Nos. 31, 32, 43-49 White Spruce and Colorado Blue Spruce

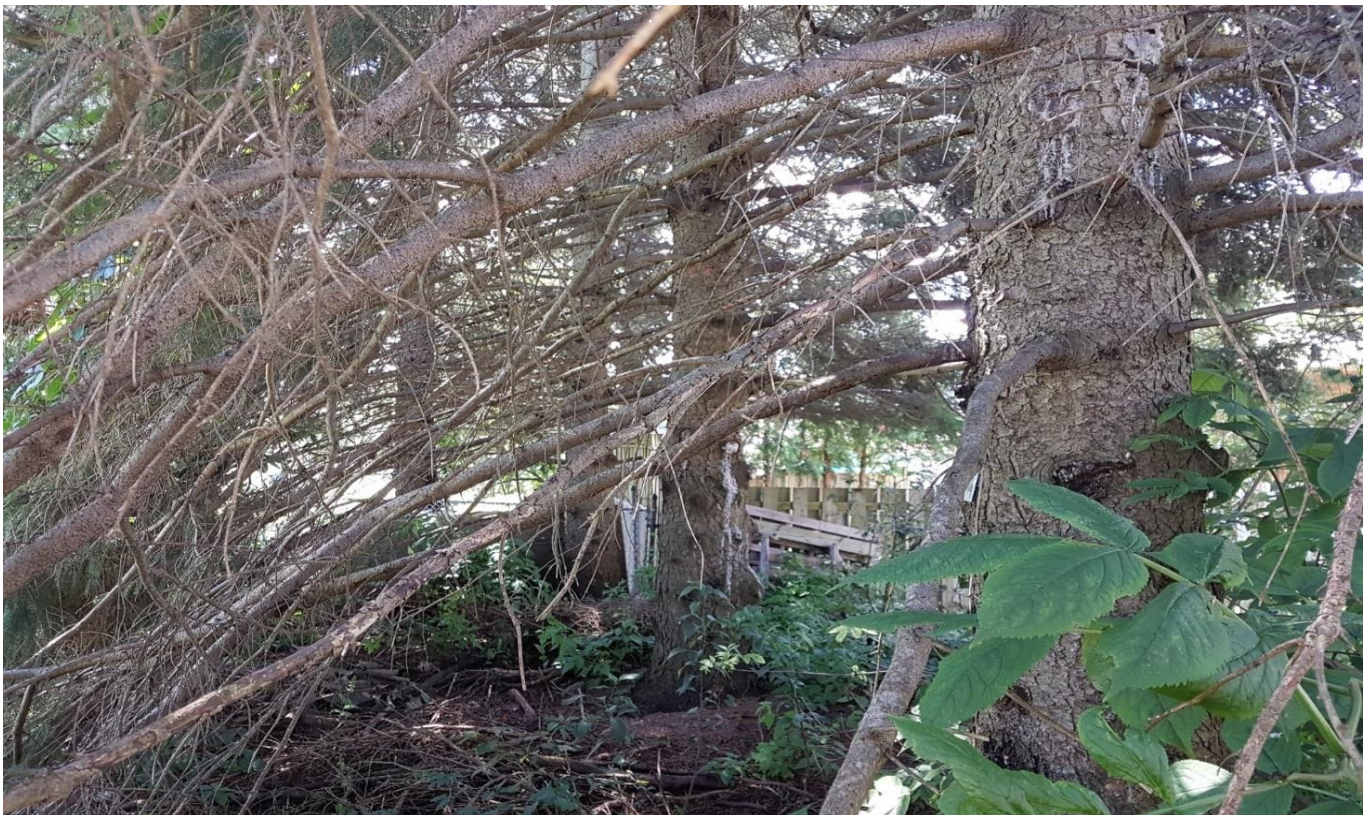
There are seven (7) White Spruce (*Picea glauca*) recorded that are over 10cm dbh on the site (2, 23, 35, 43-46) that are described above. Trees No. 2 and 23 are recommended to be removed to accommodate development. Tree No. 35 at the rear of 521 Essa Road is observed to be in marginal condition adjacent to a proposed driveway feature however, is recommended for retention and protection in order to provide vegetative buffering along the fenceline of the existing boundary homes. White Spruce Trees No. 43, 45 and 46 are showing signs of accelerated deteriorating health with symptoms including weakened/browning needles, tip and interior branch dieback, root girdling and sap bleed. Their deteriorating health is concerning so as to suspect compromise in their ability to withstand a storm event (eg ice storm) and are recommended to be removed. However, we would recommend that Tree No. 44 be retained, protected during construction and monitored for ongoing health and mechanical strength. As noted above, we recommend that oversized conifers be installed to compensate for the recommended removal of Tree Nos. 43, 45 and 46 to enhance the vegetative buffer between the subject site and existing residences.

43	<i>Picea glauca</i>	White Spruce	39.5	2 Marginal	Weak/browning needles, tip dieback, 2m radius TPZ, interior branch dieback, 2 fence posts + debris at base	Remove for health
44	<i>Picea glauca</i>	White Spruce	44.7	2 Marginal	root girdling, sap bleed, interior branch dieback, tip dieback, boundary tree within subject lot	Preserve
45	<i>Picea glauca</i>	White Spruce	35.2	2 Marginal	sap bleed, significant root gird branch dieback, weak/browning needles, black soot fungus, debris piled at roots, boundary tree within subject lot	Remove for health
46	<i>Picea glauca</i>	White Spruce	35	2 Marginal	riverbank grape, sparse interior needles, interior branch dieback, weak/browning needles, tip dieback, boundary tree within subject lot	Remove for health
47	<i>Picea pungens glauca</i>	Colorado Blue Spruce	55.0 est	2 Marginal	significant sap bleed, no pruning, soot fungus, Virginia creeper, tip dieback, boundary tree within subject lot	Preserve

Photo J-Tree Nos. 43-46 White Spruce (*Picea glauca*) showing interior dieback

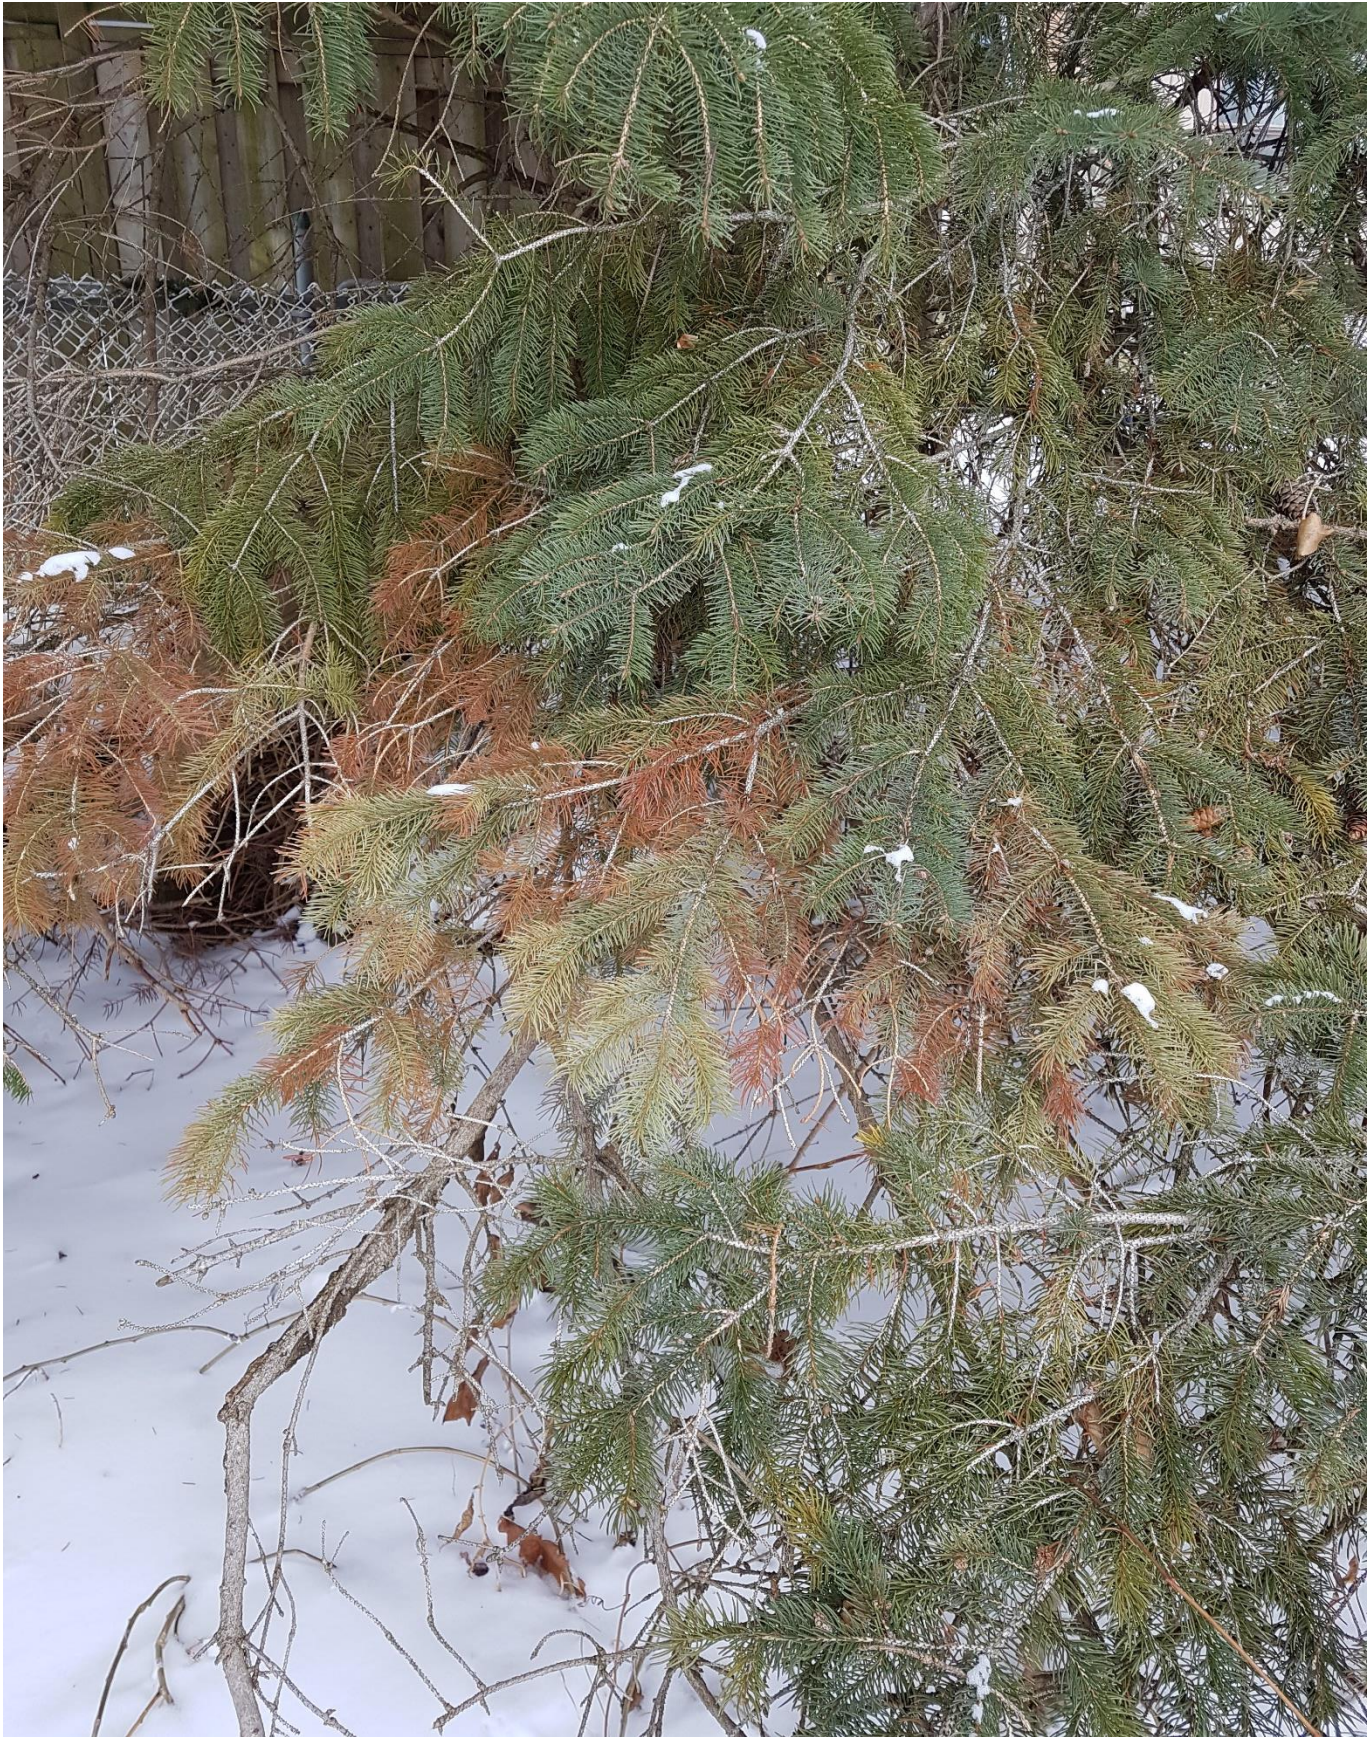
Photo K: Tree No. 43 White Spruce (*Picea glauca*) showing needle browning and tip dieback (typical).

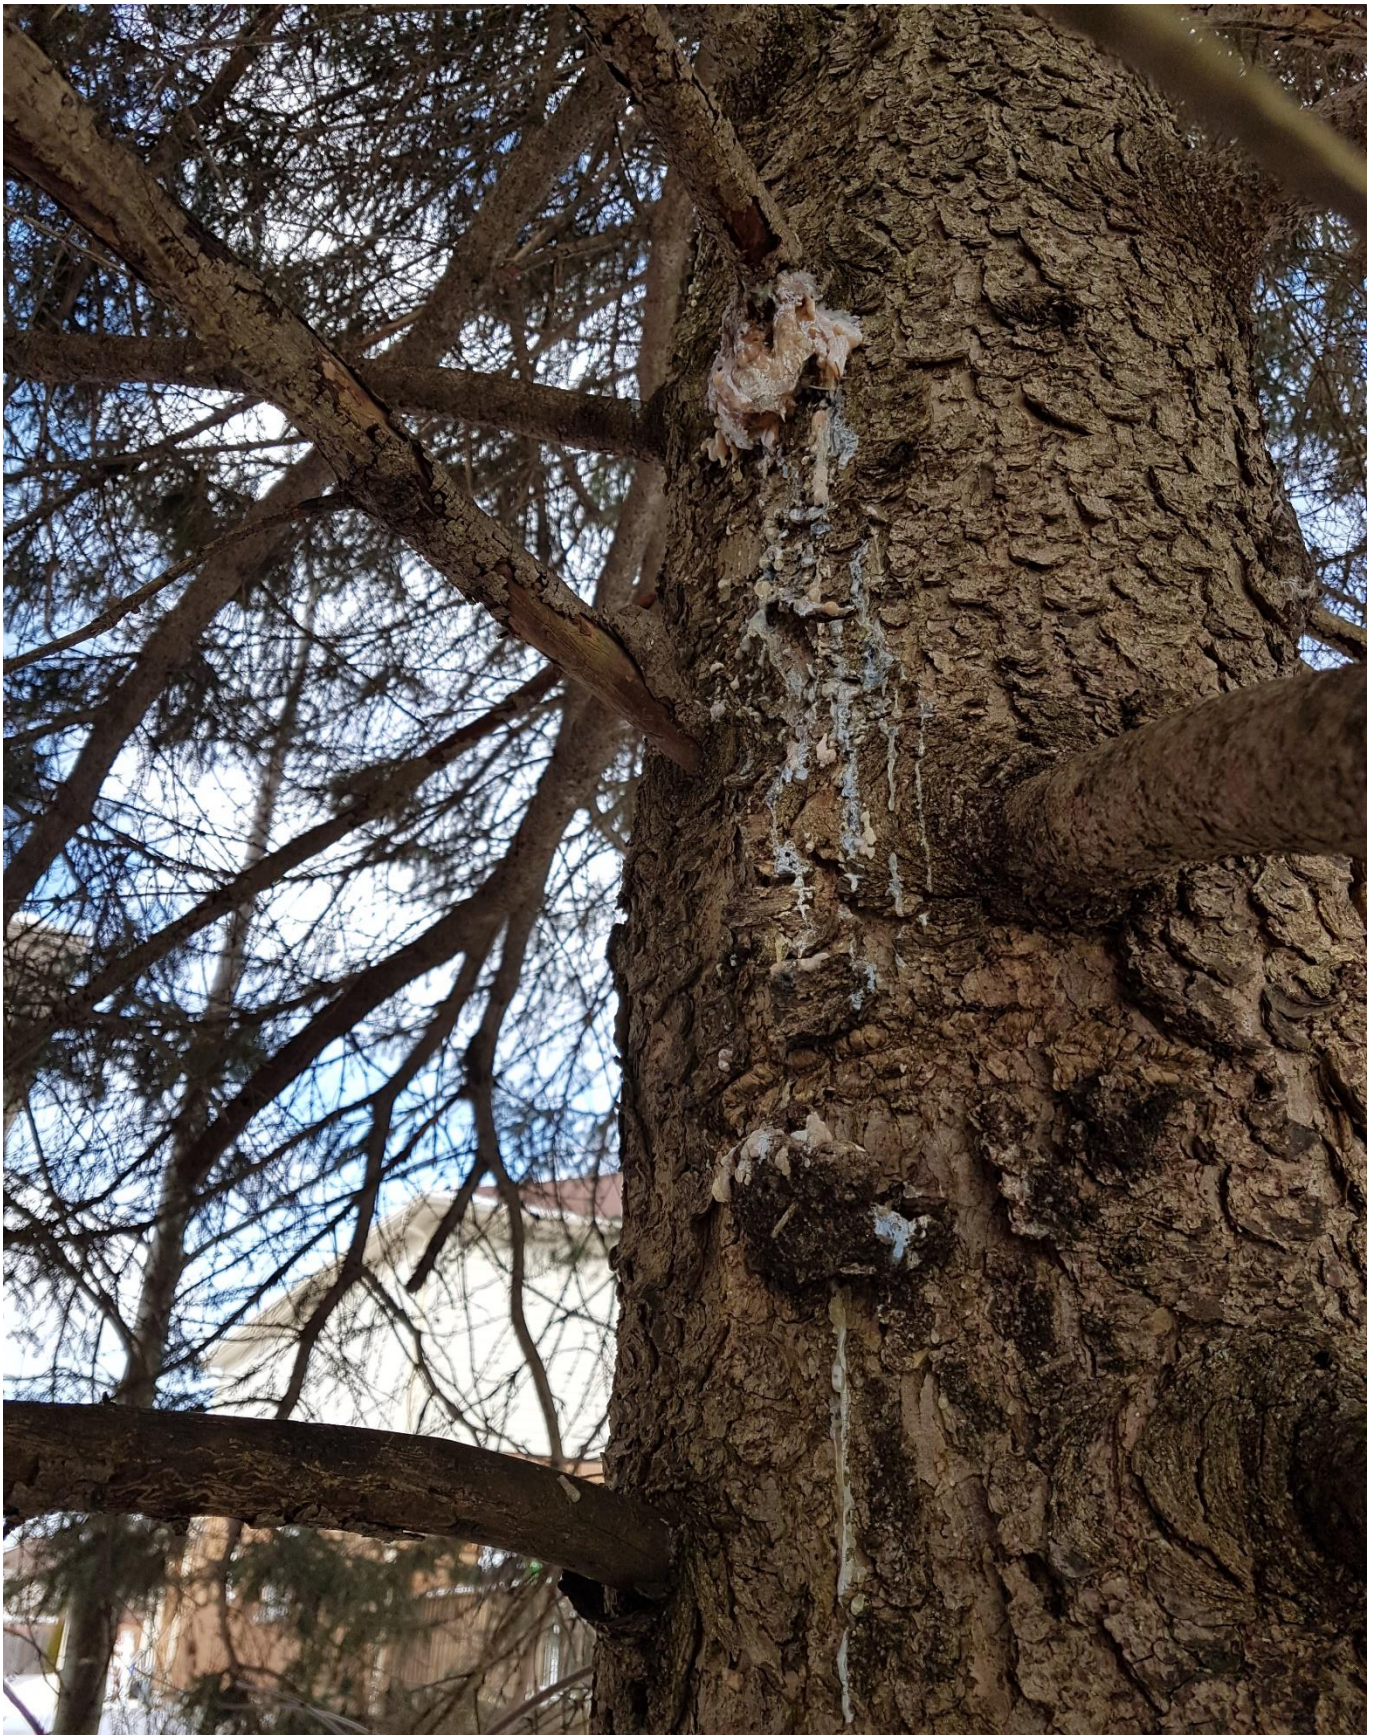
Photo L: - White Spruce (*Picea glauca*) showing sap bleed at the base of an unpruned branch.
