# 403 COX MILL ROAD RESIDENTIAL DEVELOPMENT

## TREE INVENTORY, ANALYSIS, PRESERVATION REPORT

403 COX MILL ROAD, BARRIE  
ONTARIO, COUNTY OF SIMCOE

DECEMBER 2018

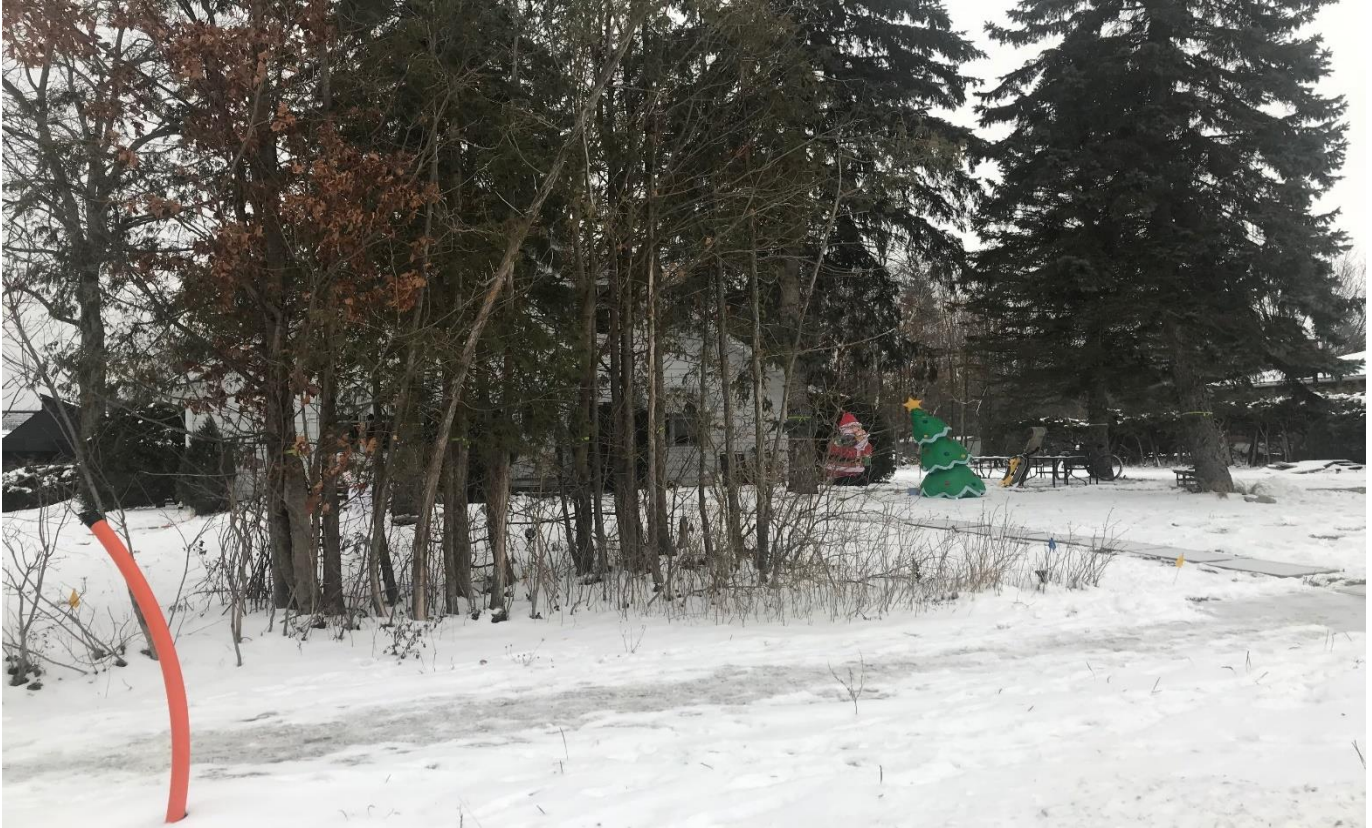
LEGroup staff observed that the highest occurrence of trees on the site were Eastern White Cedar (Tree Nos. 3, 6, 9, 11 & 15) with #15 being a hedge along the common south boundary line. All cedars appeared to be in marginal health. Two cedars (Tree Nos. 9 & 11) were observed to be large and multi-trunked. The cedar hedge along the south boundary line appeared to be pruned but in healthy condition (**see Photo C, Appendix D**). Two cedars (Tree Nos. 3 & 6) were smaller calipre trees located in the front yard (**see Photo A, Appendix D**).

We note that Tree Nos. 3-7 appear to be very close together and it is recommended that Eastern White Cedars (Tree Nos. 3 & 6) be removed to thin the tree grouping and provide a stronger opportunity for the Sugar Maples (Tree Nos. 4 & 5) to thrive in full sunlight.

**Photo A:** Photo of Tree Nos. 4-7 in the front yard area Tree Nos. 1 & 14 in the rear of the photo.

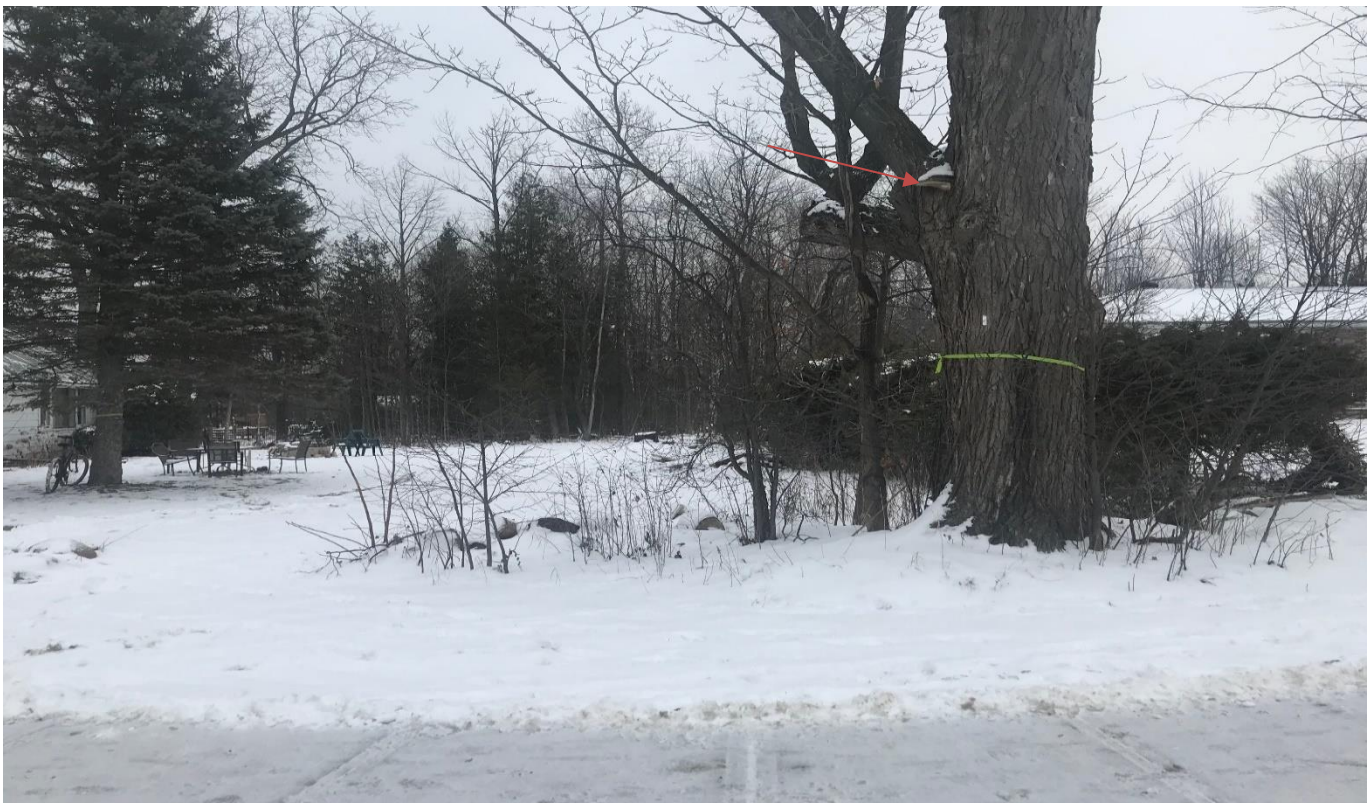
The next frequent tree species observed at the subject site were Sugar Maples (Tree Nos. 4, 5, 7 & 16) and Colorado Blue Spruce (Tree Nos. 1, 2, 8 & 14). The Sugar Maples are mostly young specimens in the front yard area in poor to marginal condition. Tree No. 16 is a large calipre tree observed to be in poor condition with conks (fungus), internal decay and trunk cavities and appeared to be structurally unsafe (**see Photo B, Appendix B**). The Colorado Blue Spruce are observed to be in marginal to fair condition (**see Photo A & B, Appendix D**). These had had lower branches pruned up with some external sap bleed but otherwise healthy.

| Key | Latin Name | Common Name | Tree DIA<br>(cm dbh) | Notes | Assessment | Canopy Radius<br>(m) | Preserve/<br>Remove |
|---|---|---|---|---|---|---|---|
| 16 | <i>Acer saccharum</i> | Sugar Maple | 85.3 | fungal conk, suspected interior decay, significant trunk cavities, trunk wound | 1 Poor | 8.2 | Remove |

**Photo B:** Photo of Tree No. 16 along street frontage-fungal conk, suspected interior decay, significant trunk cavities  
403 Cox Mill Road, Barrie, ON  
Landmark Environmental Group Ltd.

The large Sugar Maple (Tree No. 16) is in poor health and structurally unsound and it is recommended that this tree be removed. Alternatively, this tree will need to be monitored annually for structural decline and removed when deemed a hazard tree.

- Should Tree No. 16 not be permitted to be removed, LEGroup recommend monitoring this tree on an annual basis for declining health and structural integrity;

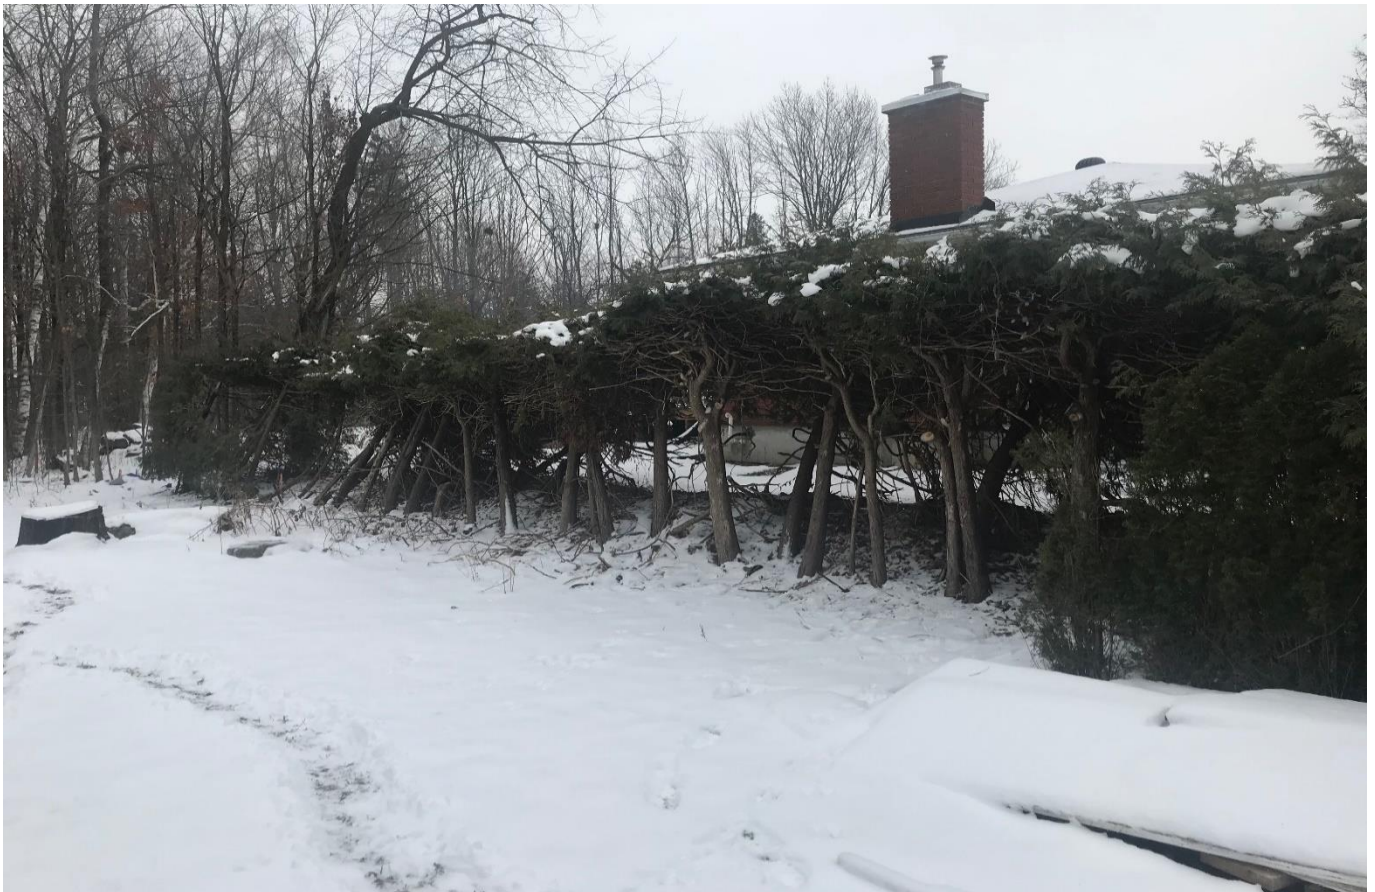
| Key | Latin Name | Common Name | Tree DIA<br>(cm dbh) | Notes | Assessment | Canopy Radius<br>(m) | Preserve/<br>Remove |
|---|---|---|---|---|---|---|---|
| 15 | <i>Thuja occidentalis</i> | Eastern White Cedar | 10.2 | pruning, boundary tree | 2 Marginal | 1 | Preserve |

**Photo D:** Cedar hedge row, Tree No. 15 along south property line  
403 Cox Mill Road, Barrie, ON  
Landmark Environmental Group Ltd.

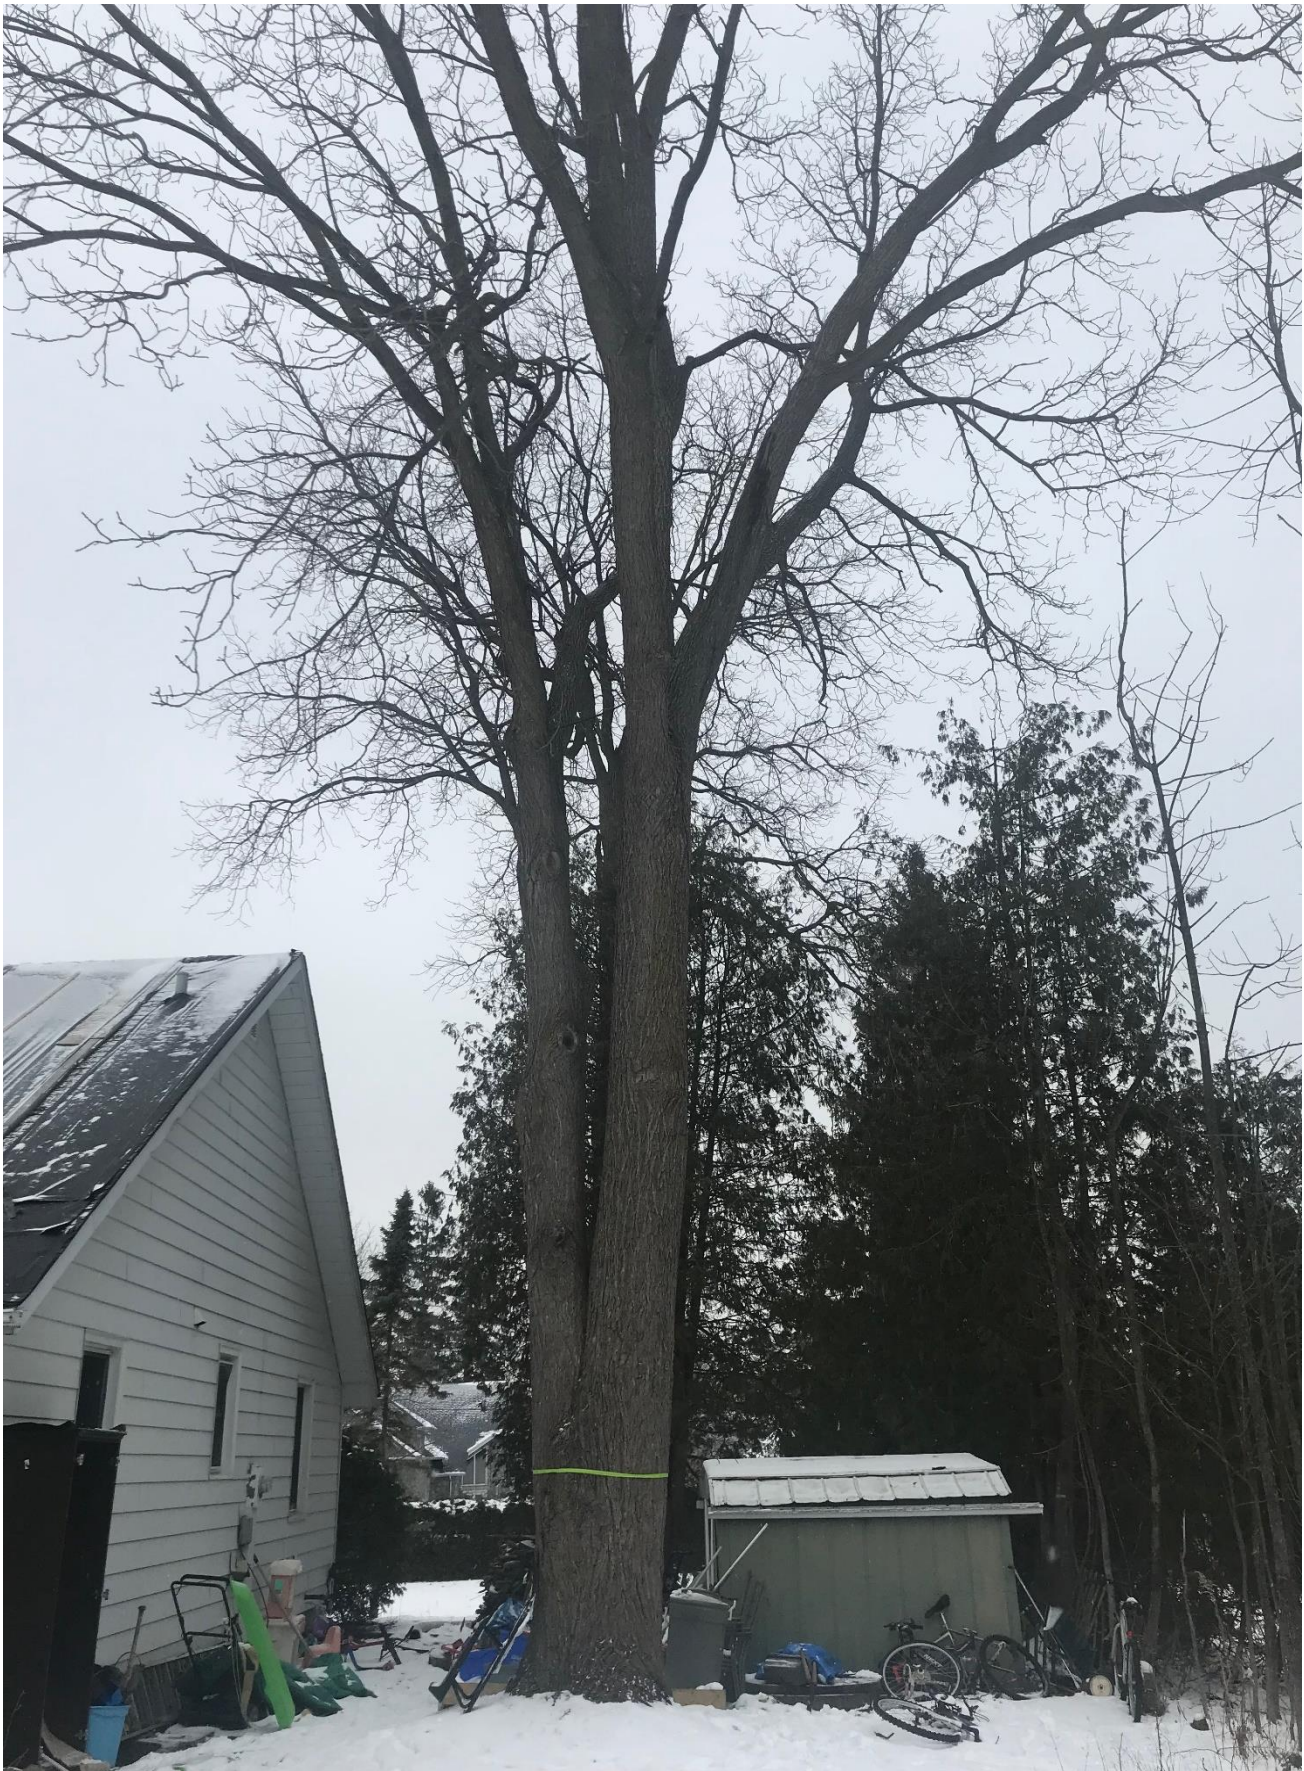
Lastly, the single largest calipre tree on site is a Black Walnut (Tree No. 10) and is observed to be in marginal health. This tree has dual trunks, common to many Black Walnut trees and appears to have bracing applied in an effort to keep the trunks from splitting. The Black Walnut also observed to have broken scaffold branching and trunk wounds.

| Key | Latin Name | Common Name | Tree DIA<br>(cm dbh) | Notes | Assessment | Canopy Radius<br>(m) | Preserve/<br>Remove |
|---|---|---|---|---|---|---|---|
| 10 | <i>Juglans nigra</i> | Black Walnut | 95.3 | dual trunk, dual leaders, broken scaffold branch, trunk wounds, epicormic shoots, braced | 2 Marginal | 9.2 | Preserve |

**Photo E:** Photo of tree No.10, bracing structure in canopy, otherwise healthy and in good condition

The remaining nine (9) trees (Tree Nos. 5, 6, 7, 9, 10, 11, 12, 13, & 15) can be retained and preserved in-situ and protected in accordance with tree preservation notes and preservation fencing (**see Detail D1 in Appendix B**). We note that the canopy for Tree No. 10 extends into the footprint of the proposed new home. LEGGroup staff recommend that this tree be monitored for health and structural stability on a bi-annual basis by a qualified professional arborist.
