# 79 GOWAN ST. BARRIE, RESIDENTIAL DEVELOPMENT

## TREE INVENTORY, ANALYSIS, PRESERVATION REPORT (TIPP)

79 GOWAN STREET,  
BARRIE, ONTARIO, COUNTY OF SIMCOE

JANUARY 2020  
CITY OF BARRIE FILE: D28-018-2019  
OUR FILE: LA 429-19

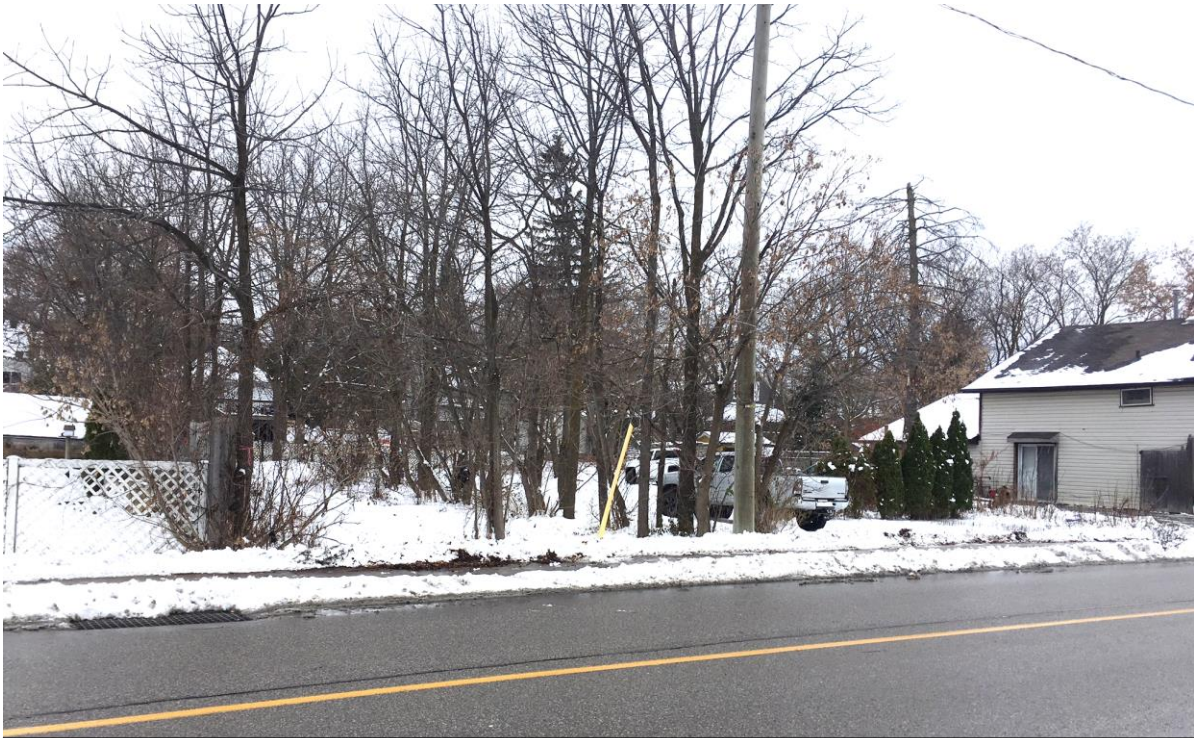
**Photo A:** Looking Southwest from Gowan St into the site, showing two distinct 'rows' of trees, their canopies and spacing.

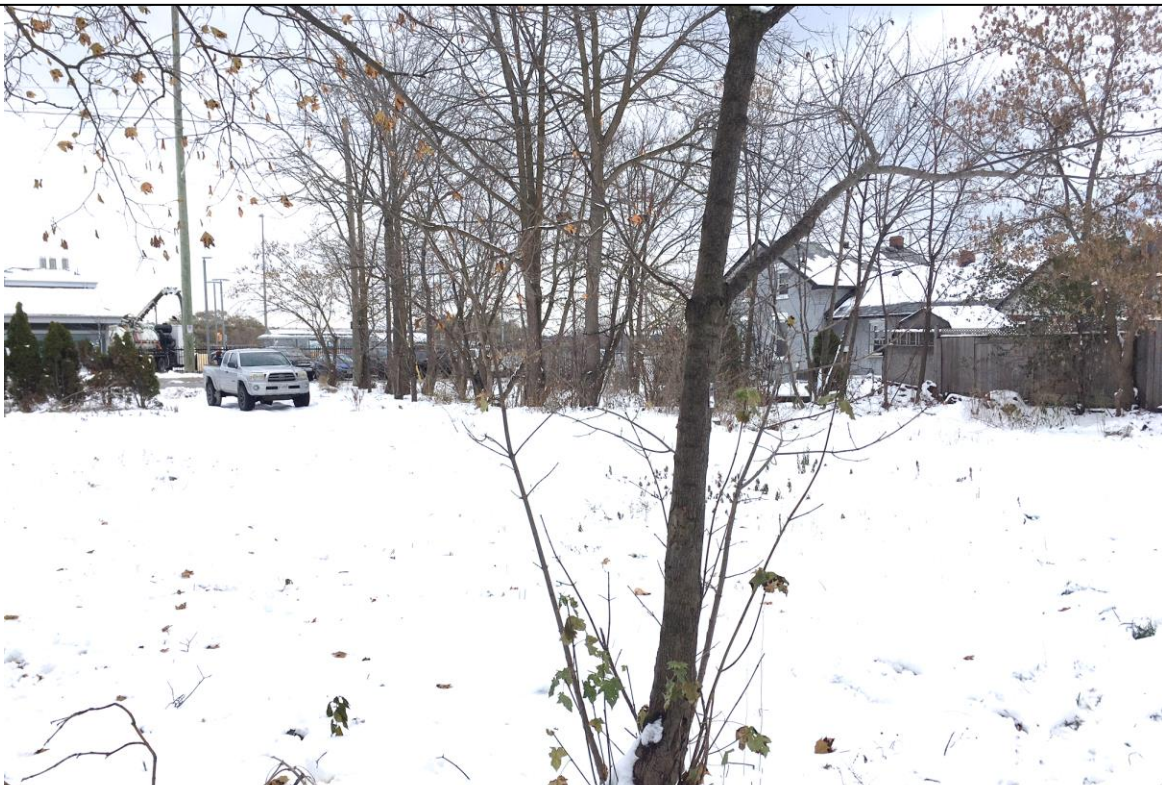
| KEY | Latin Name | Common Name | DBH (cm) | Notes | Assessment | Canopy (Radius) | Preserve /Remove |
|---|---|---|---|---|---|---|---|
| 23 | <i>Acer platanoides</i> | Norway Maple | 11.4 | wounded basal flare, minor corrected lean, epicormic shoots | 2 Marginal | 3.6 | Preserve |

**Photo B:** Looking Northeast from the rear of the site showing tree canopies and spacing. Tree No. 23 (Norway Maple) in foreground.

We note that Tree Nos. 23 (Norway Maple) and 24 (Black Walnut) located on the south border along with two offsite trees, encroach over the south and west property lines however are in minimal conflict with the proposed development. Their canopies are located outside of the building footprint of the proposed structure. However, Tree Nos. 23 & 24 have a minor conflict with a proposed soak-away pit in the amenity area south of the proposed building. It is recommended that Tree Nos. 23 & 24 and the two offsite trees be preserved to the extent possible accordance with City detail BSD 1232 (see **Dwg D-1**, in **Appendix B**).

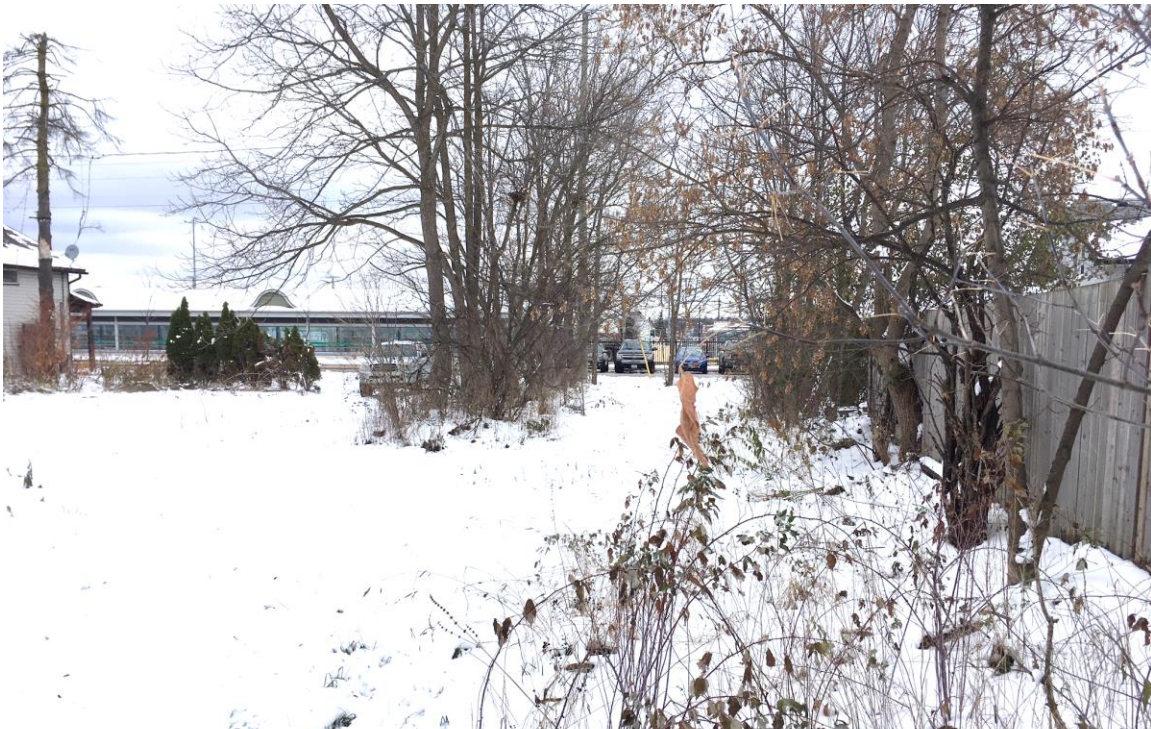
LEGroup Staff observed that the trees appeared to be generally located in two distinct rows oriented north-south at the centreline and east boundaries of the site. The trees at the centre/north end of the site (Tree Nos. 1-22) appear to be in poor to marginal condition with health concerns including corrected leans, trunk wounds, interior decay and cavities (see **Photo D** in **Appendix D**). Trees along the east boundary (Tree Nos. 26-34) are also in poor to marginal health with health concerns including dieback, included bark, growth into the existing board/chain link fence fabric and presence of Riverbank Grape vines (*Vitis riparia*) spreading through their canopies (see **Photos C & E** in **Appendix D**) contributing to their dieback and health condition.

**Photo C:** Showing several trees to be removed (Nos. 30, 32, 34) on the right, and trees to be removed (No. 1-22) in the centre of photo. Trees to remain (Nos. 31, 33) shown among grouping on the right.

- Trees 1-22, 26-30, 32, 35 on the Project Site are to be removed as shown on **ARB-2 and ARB-3 in Appendix B**. and Trees No. 23-25, 31 & 33 are to be retained for reasons set out in the Report above;

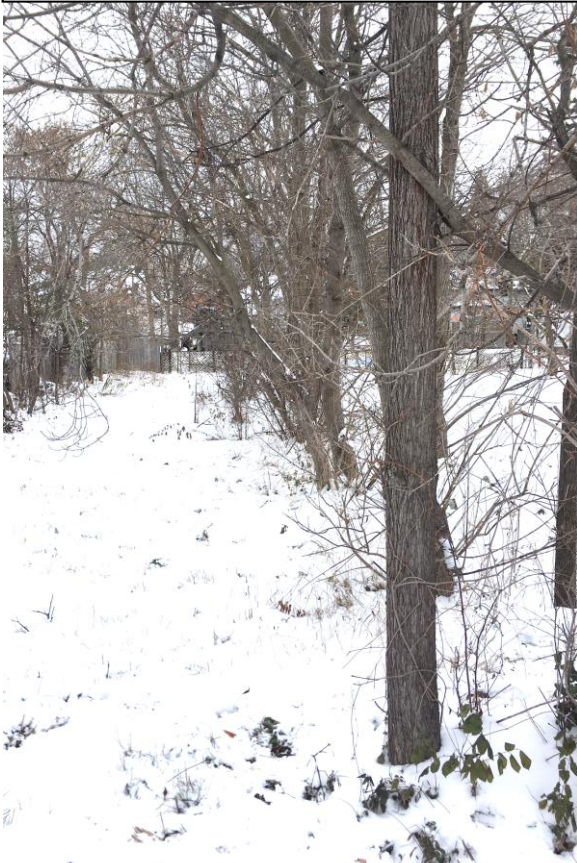
**Photo D:** Showing row of trees along centre of property from the west side.

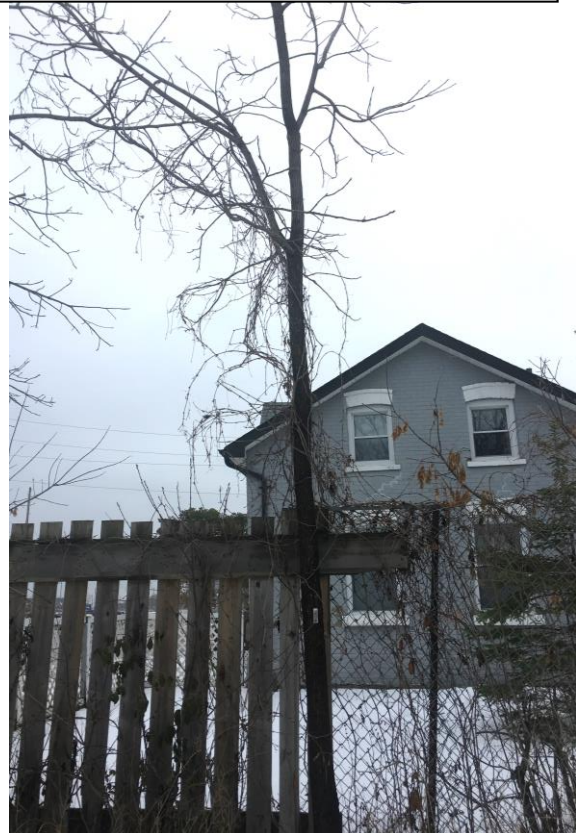
**Photo E:** Showing vines in tree, typical for trees No 33-35.
