ARBORIST REPORT

PROPOSED INDUSTRIAL SUBDIVISION **80 BIG BAY POINT ROAD CITY OF BARRIE, ONTARIO**

> **OUR PROJECT NO:** 21-5602

August 27, 2021

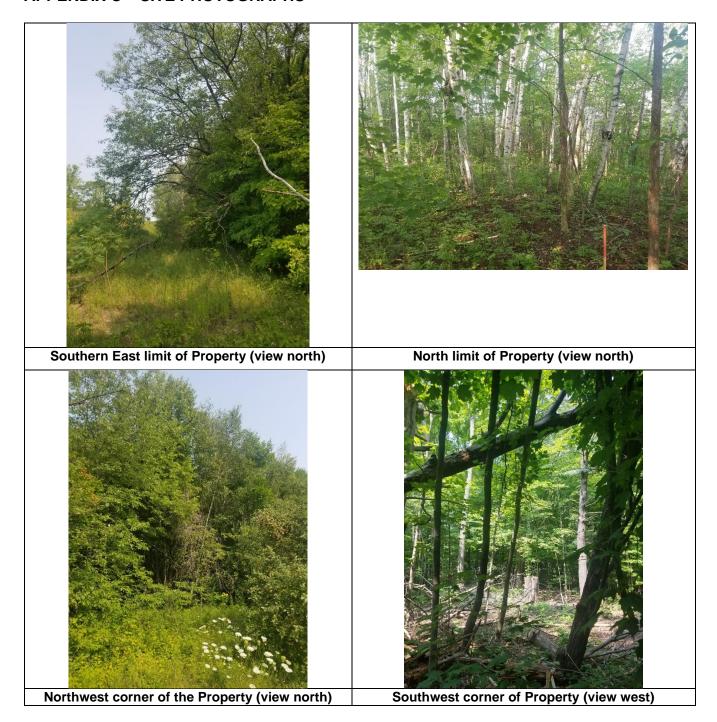
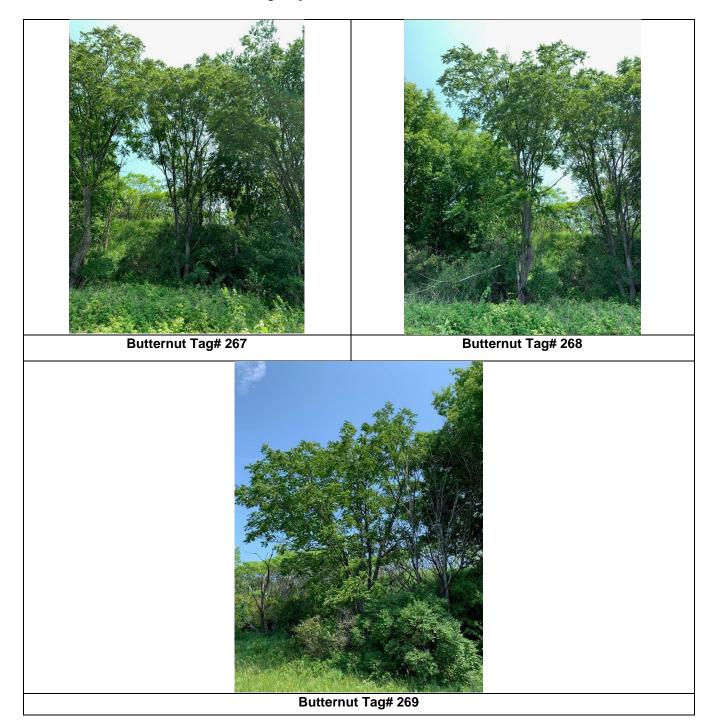
APPENDIX C - SITE PHOTOGRAPHS

An existing naturalized wooded area occurs on a slope immediately adjacent to the east limit of the property. Most of the trees along this slope include Red Oak, Black Cherry, White Elm, Paper Birch White Pine and Sugar Maple. Three semi-mature Butternut trees also occur along this limit, adjacent to the site. A Butternut Health Assessment has been prepared for these trees and is referenced in this report. Overall, the trees along this slope are in generally fair to good health and condition.

The cultural meadow gives way to mixed wooded areas along the north and northwest area of the site. The development limits adjacent to the north and northwest limit of the site are defined by the Environmental Protection Block 33. This area is dominated by naturalized stands of Poplar trees to the north. Several Butternut plantings (part of former Butternut compensation works) occur within the north property limit. Although mainly composed of Poplar, the edge of Block 33 is also composed of immature to semi-mature Sugar Maple, Birch, Basswood, Eastern White Pine, and Scots Pine, with an understory and edge mix of Hawthorn, Buckthorn, and Crabapple. Overall, the trees along the edge of Block 33 are in generally good health and condition.

The southwest corner of the property currently contains a portion of a wooded area composed of semi-mature to mature White Pine, Scots Pine, Sugar Maple, and White Elm. The wooded area continues into the property to the west. Overall, the trees within this wooded area are in generally good health and condition.
