GUIDING SOLUTIONS IN THE
NATURAL ENVIRONMENT

Geomorphic Assessment 664, 674, & 692 Essa Road & 320 Mapleview Drive West Barrie, Ontario

Updated November 2022 22212

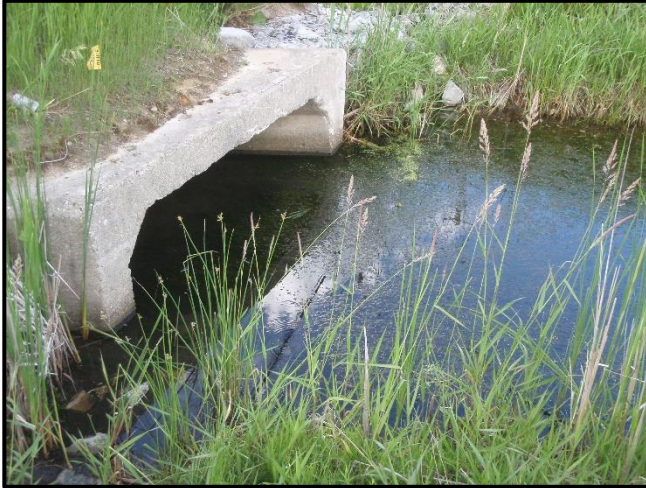
Photograph 1. Location 1.
Box culvert at Essa Road, at the downstream extent of the assessed reach. Note the presence of gabion baskets (top of photo). Also note backwatering.

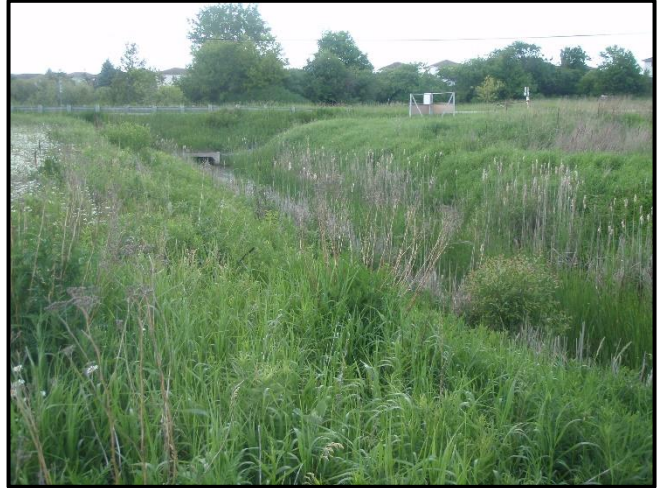
Photograph 2. Location 2.
Looking downstream towards Essa Road. The channel was found within a narrow corridor.

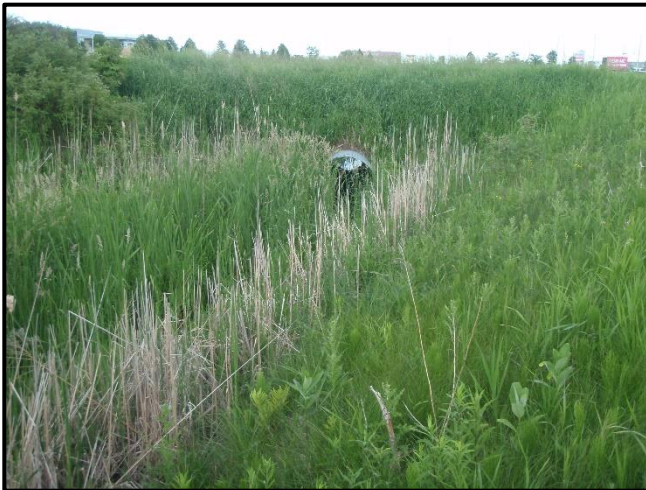
Photograph 3. Location 3.
Looking upstream towards a 1200 mm diameter CSP at an old crossing.

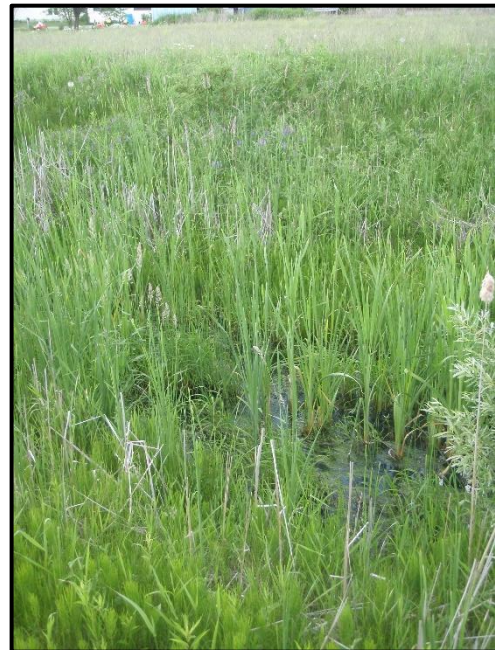
Photograph 4. Location 4.
View of the channel upstream of the old crossing. Note the presence of cattails and other instream vegetation.

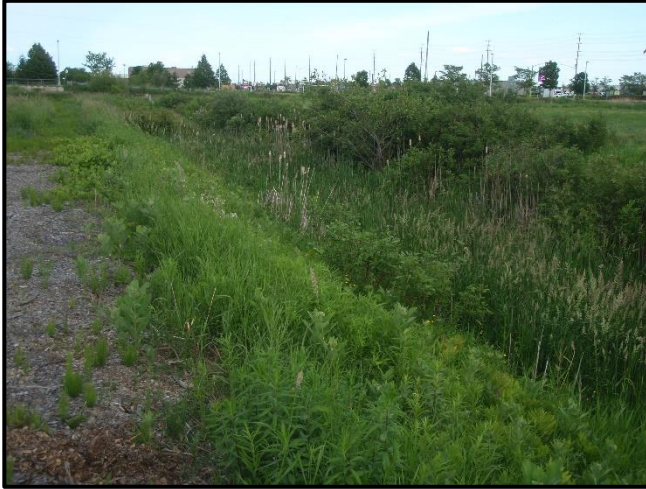
Photograph 5. Location 5.
Looking upstream towards the upstream limit of the reach. Note the vegetation encroachment into the channel.

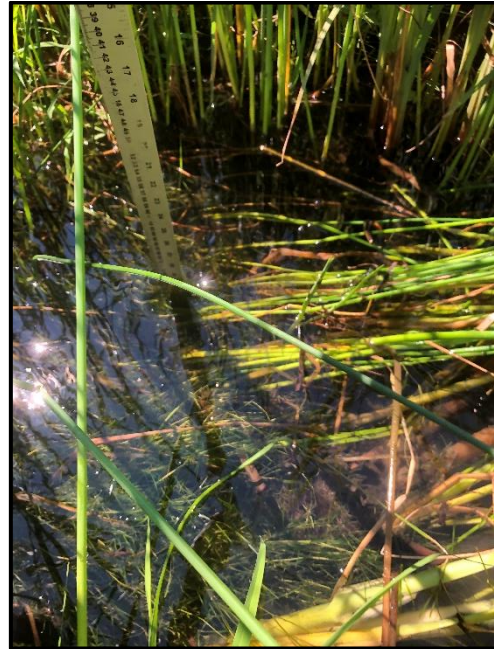
Photograph 6. Location 5.
General channel conditions in the reach. Note the vegetation encroachment into the channel and a narrow open water component.

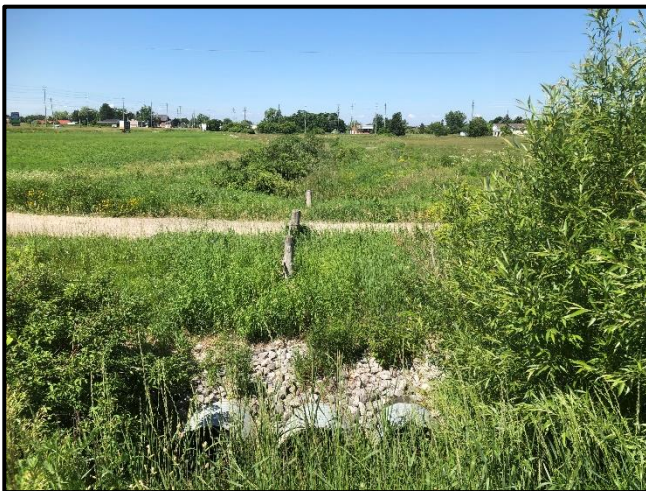
Photograph 7. Location 6.
Looking downstream towards the three 1000 mm diameter CSPs at the upstream extent of the reach.

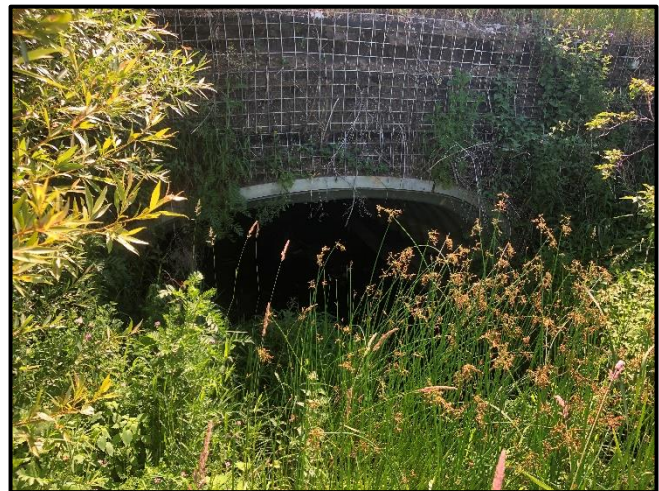
Photograph 8. Location 6.
Looking upstream towards the crossing at Hollyholme Farm Road.
