VICTORIA VILLAGE
PROPOSED DEVELOPMENT
150 Toronto St. & 54 Ross St.
City of Barrie

Tree Management Plan

Tree Management Details

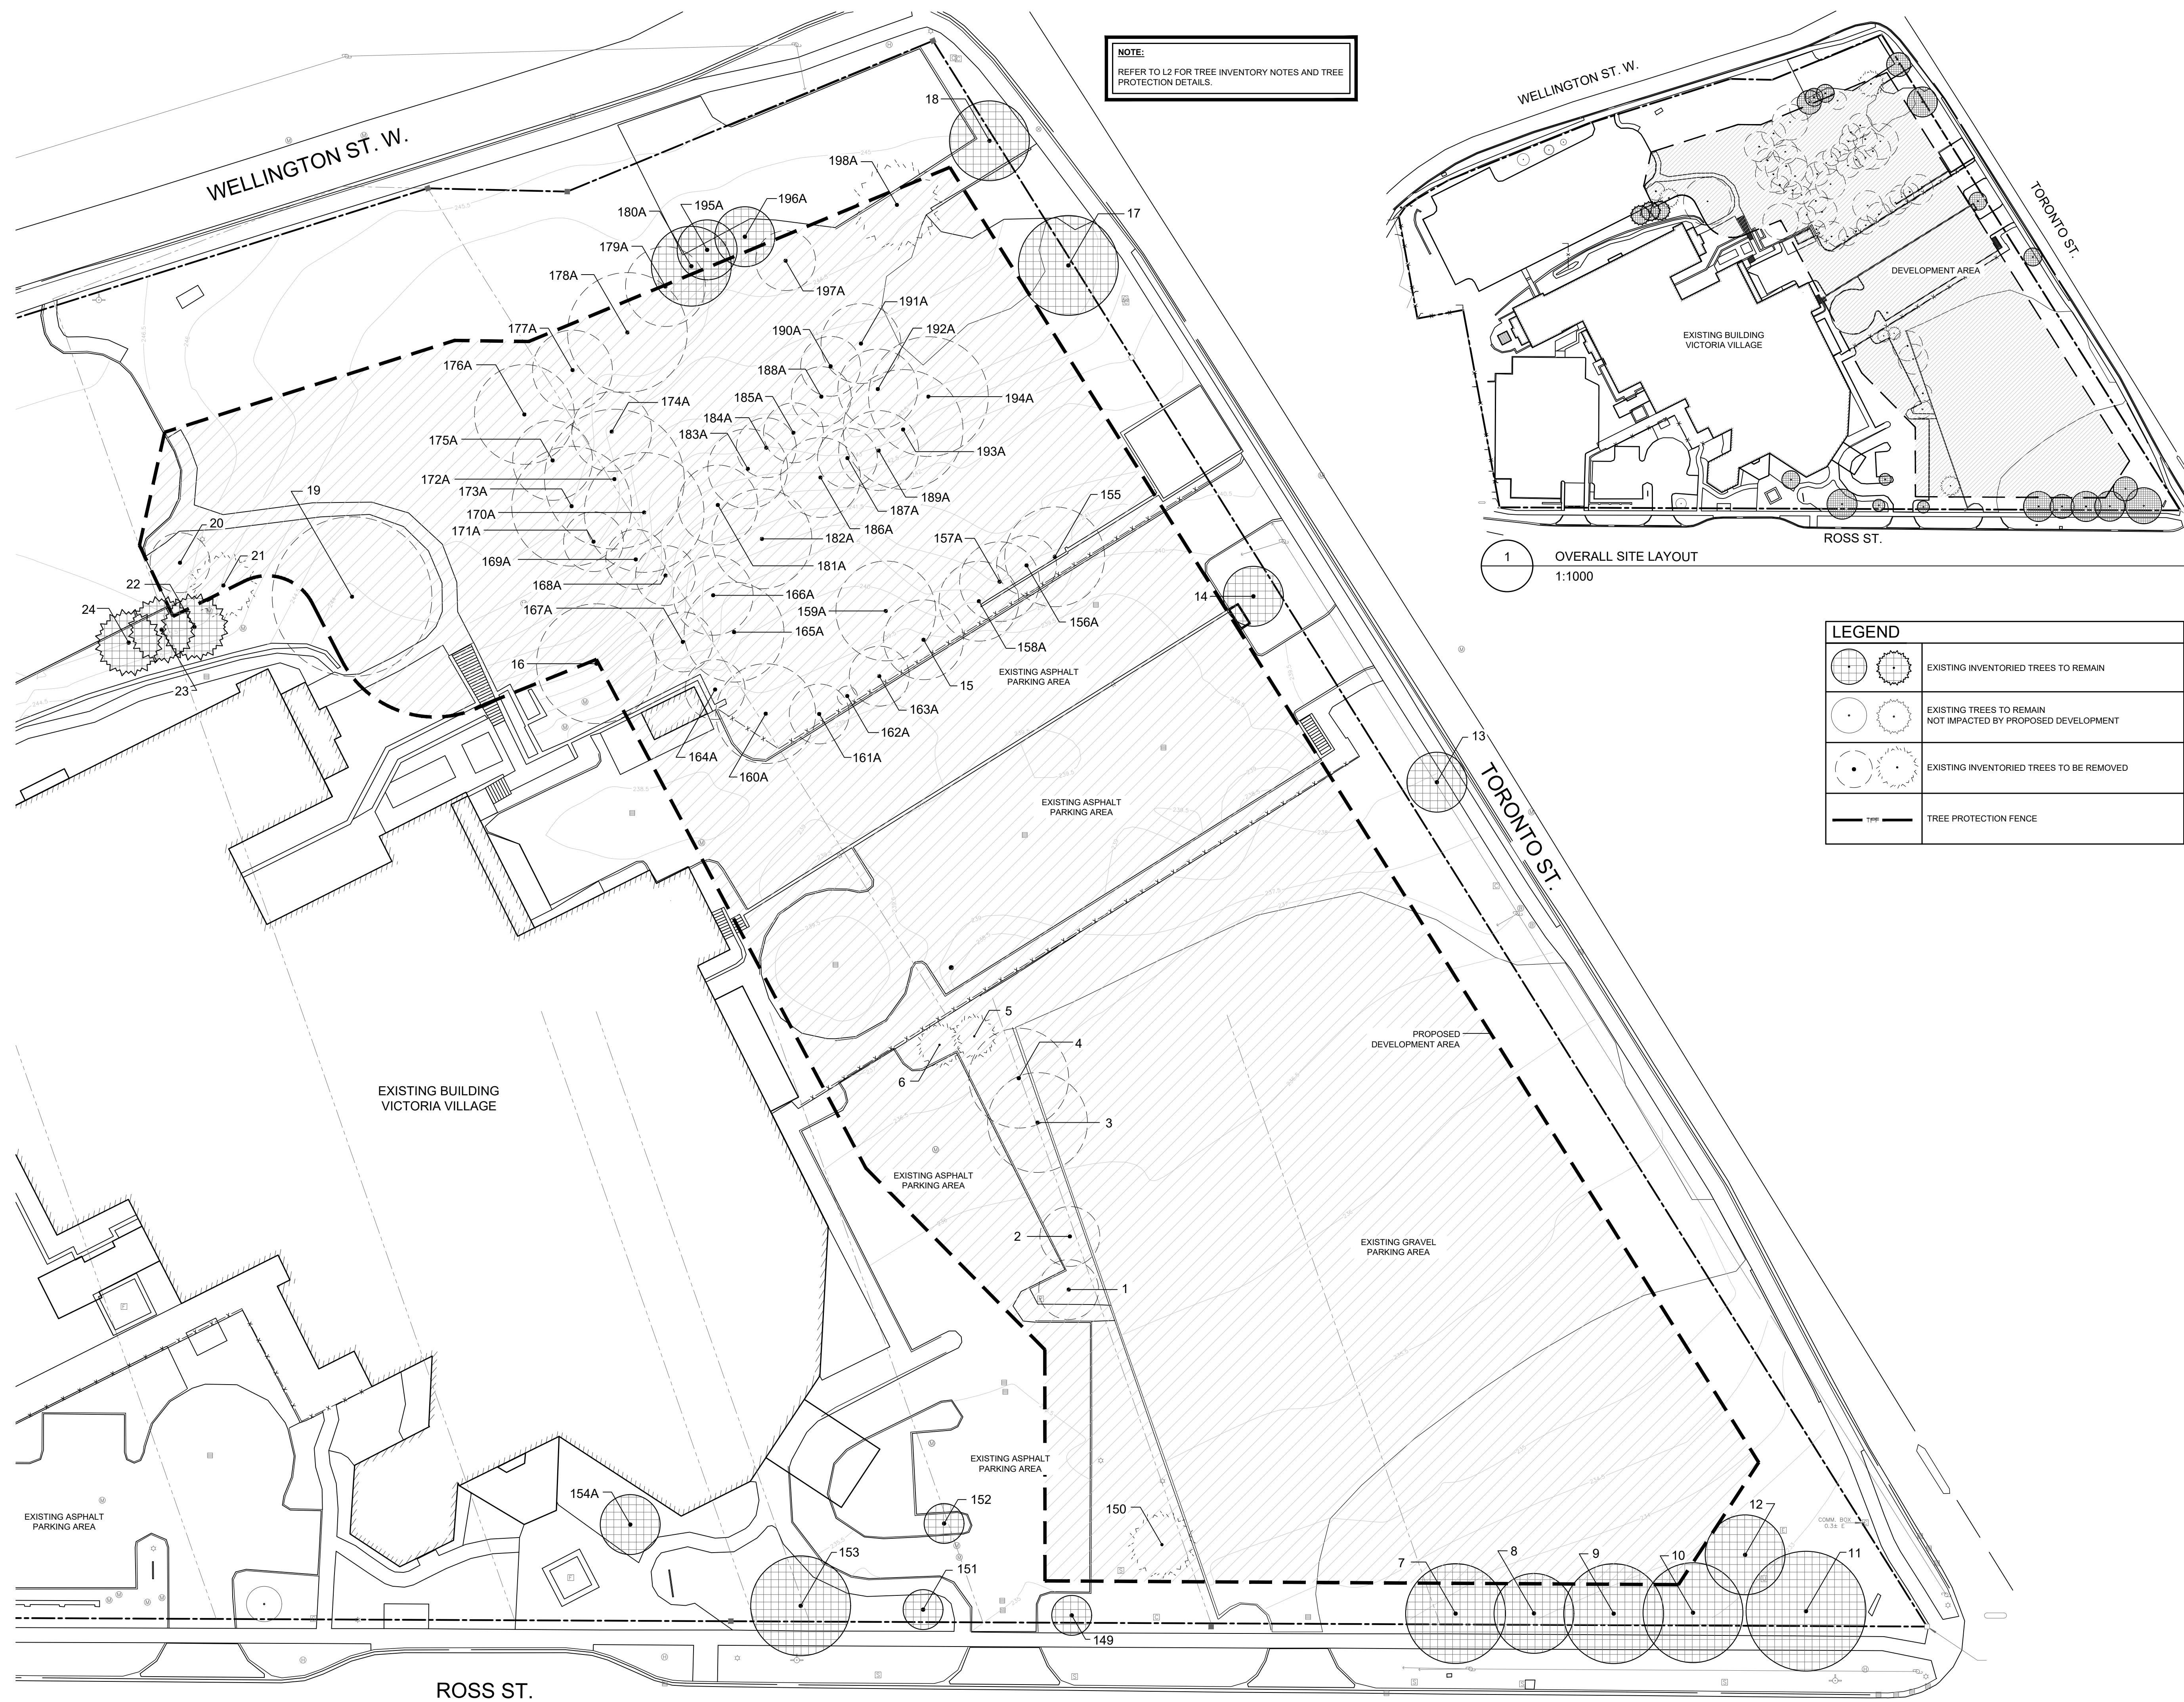
1 OVERALL SITE LAYOUT
1:1000

SITE VISIT DATE: OCTOBER 6, 2022
 TREE INVENTORY COMPLETED BY ISA CERTIFIED ARBORIST CATHERINE HODGINS #0N-2258A
 TREE LOCATIONS AND DRIFLINES BASED ON RUDY MAK SURVEYING LTD. SURVEYOR'S REAL PROPERTY REPORT DATED SEPTEMBER 20, 2022 AND HILL DESIGN STUDIO FIELD SURVEY ON OCTOBER 6, 2022.
 NA DENOTES APPROXIMATE LOCATION OF TREE BASED ON HILL DESIGN STUDIO FIELD SURVEY.

| ID # | Tree Species | D.B.H (cm) | Condition | Status | Comments |
|---|---|---|---|---|---|
| 4 | Acer platanoides | 42 | Fair | Remove | Leaning, trunk issues |
| 19 | Acer platanoides | 60 | Fair | Remove | 50% dead |
| 162A | Ulmus pumila | 40 | Very Poor | Remove | 95% dead |
| 163A | Ulmus pumila | 25/25 | Poor | Remove | 80% dead |
| 175A | Fraxinus sp. | 12/22/22/25/21 | Dead | Remove | Evidence of E.A.B. |
| 185A | Fraxinus sp. | 22 | Poor | Remove | Evidence of E.A.B., horizontal lean |
