# **Preliminary Geotechnical Investigation Report - 505 Yonge Street, Barrie, Ontario, Revision 1**

September 22, 2023

Prepared for:  
Renaissance Barrie Retirement Trust

Cambium Reference No.: 9574-004

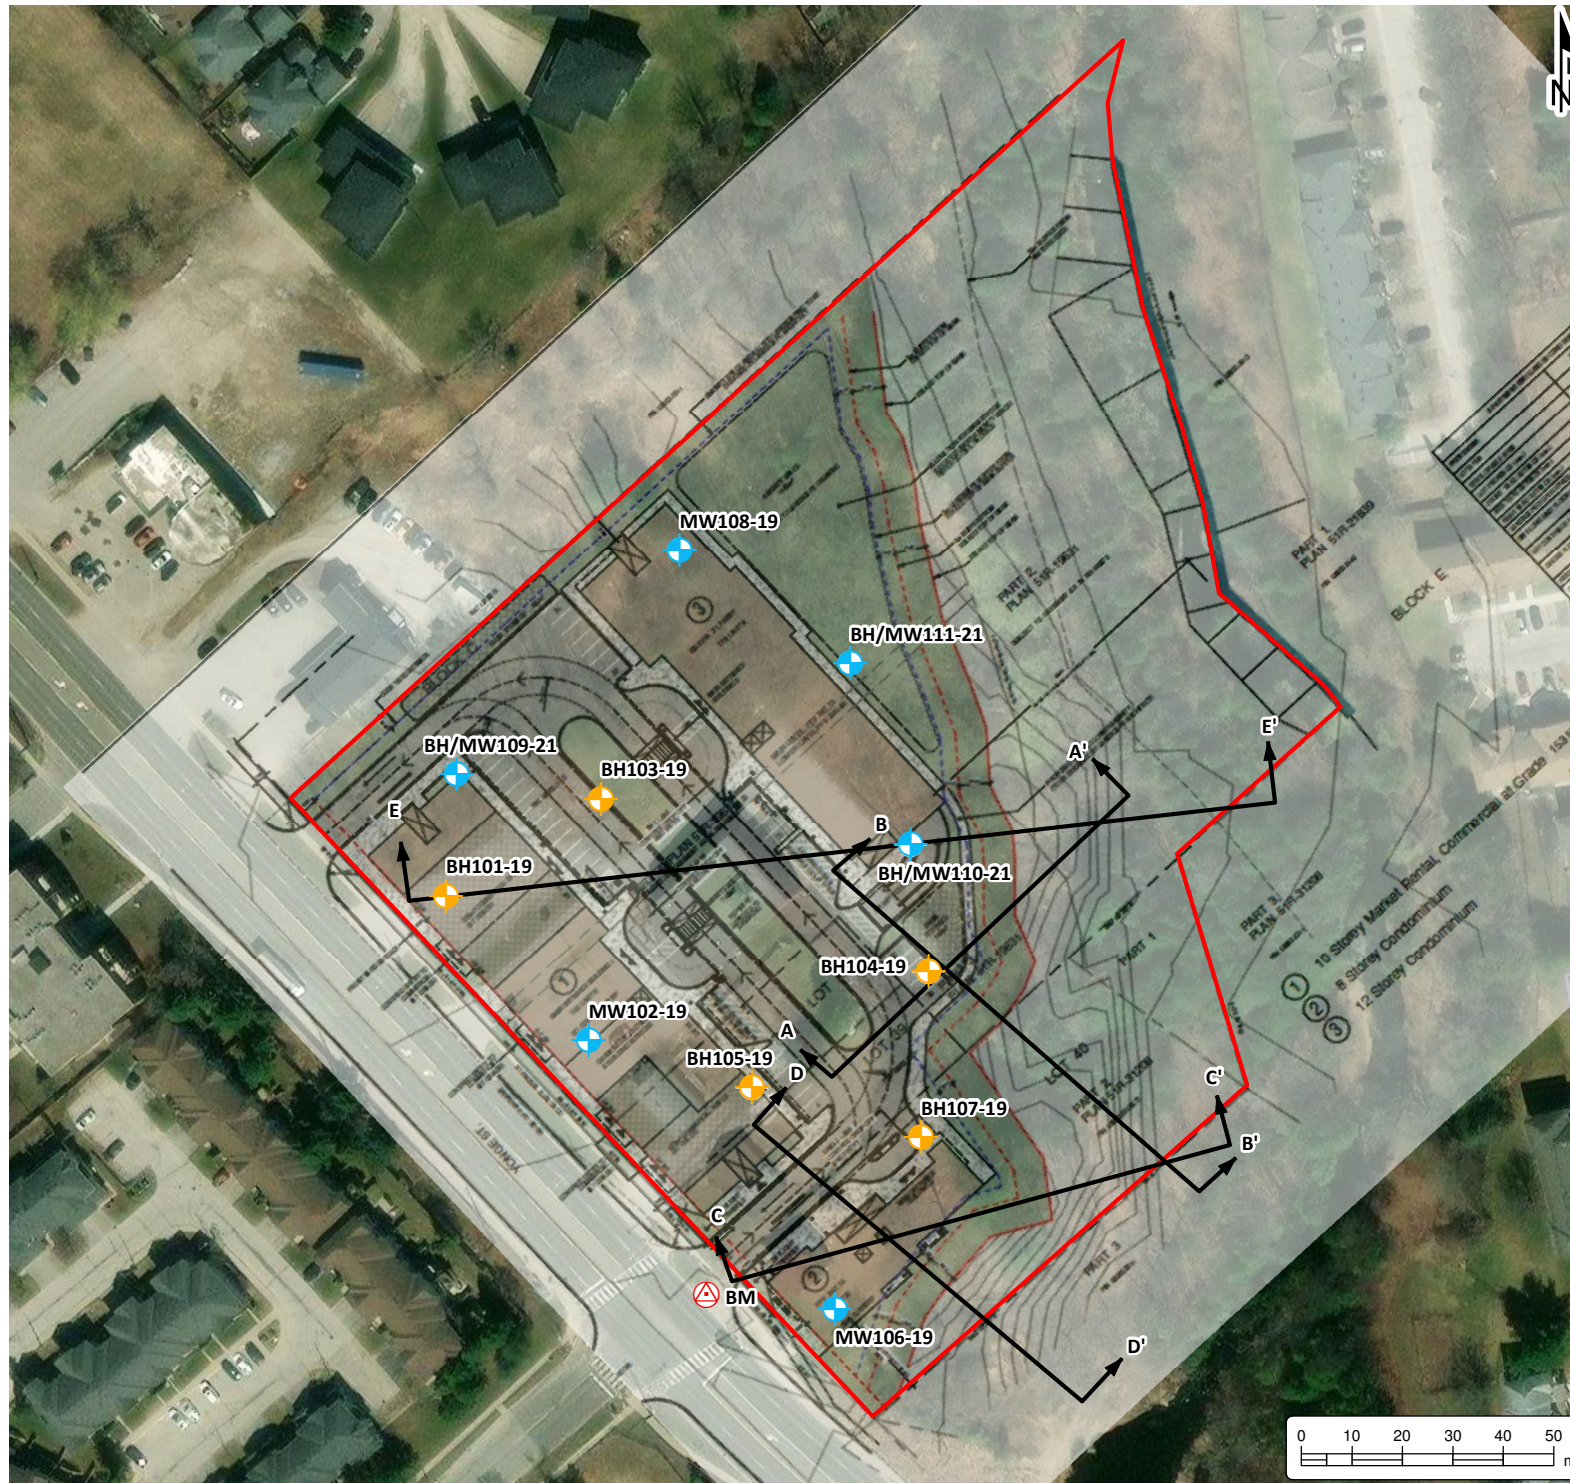
| Checked by:<br>RG | Figure:<br><b>2</b> |

A topographic survey was provided by the Client and produced by the surveying contractor, JoeTOPO. The slope of interest is the native slope on the property instead of the fill embankment placed during the previous development of site as it is understood that much of the fill embankment is to be replaced with the proposed underground parking garage and that in order to achieve the design bearing capacities recommended within this report the building(s) will need to be founded on competent native soils. The native slope appears to have an approximate top of stable slope elevation of ~240.0 mASL, with southwest to northeast strike and dip ranging from 3H:1V to 1.5H:1V downslope towards the east. Sections A-A,' B-B,' and E-E' have been situated through the proposed Building 3, and Section C-C' and D-D' through the proposed Building 2, as shown on Figure 2.
