**CULTURAL HERITAGE REPORT:  
EXISTING CONDITIONS AND PRELIMINARY IMPACT ASSESSMENT**

**BRADFORD STREET AND ADJACENT ROADWAYS  
MUNICIPAL CLASS ENVIRONMENTAL ASSESSMENT**

**CITY OF BARRIE  
SIMCOE COUNTY, ONTARIO**

**FINAL REPORT**

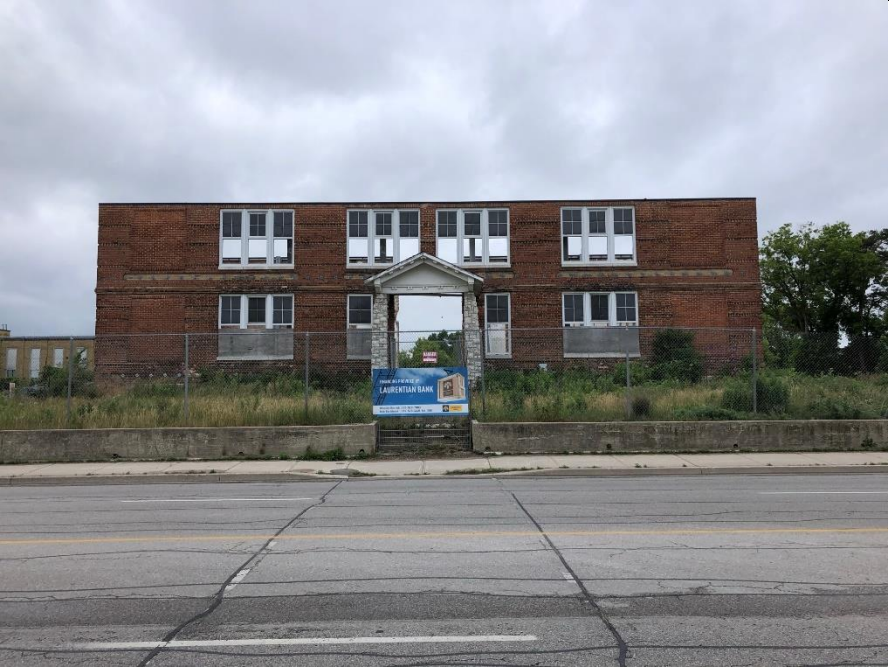
| Feature ID | Type of Property | Address or Location | Heritage Status and Recognition | Description of Property and Known or Potential CHVI | Photographs/ Digital Image |
|---|---|---|---|---|---|
| BHR 1 | Educational | 50 Bradford Street | Known BHR – Listed on Municipal Heritage Register | <p>This BHR contains the exterior elevations of a late nineteenth-century brick elementary school. The Prince of Wales Public School was built in 1876 as West Ward School and is the oldest elementary school in the Simcoe County District School Board. The two-storey building was constructed with a red brick exterior, large window openings, and central entrance covered by a porch supported by stone piers. The school was deemed ‘Prohibitive to Repair’ and officially closed in 2011. Only a portion of this building remains as the property is under development with plans to redevelop with a YMCA facility and three residential apartment buildings. Elements of the former Public School are planned to be retained and incorporated into the development (MacNaughton Hermesen Britton Clarkson Planning Limited 2019). Heritage attributes include the remaining elements of the former school.</p> | <p>Plate 9: 50 Bradford Street (ASI 2021).</p> |

- 50 Bradford Street (BHR 1)
  - 48 Dunlop Street West (BHR 2)
  - 50 John Street (BHR 3)
  - 35 John Street (BHR 4)
  - 285 Bradford Street (BHR 7)
  - 34-46 (west side) and 27-31 (east side) Toronto Street (CHL 1)

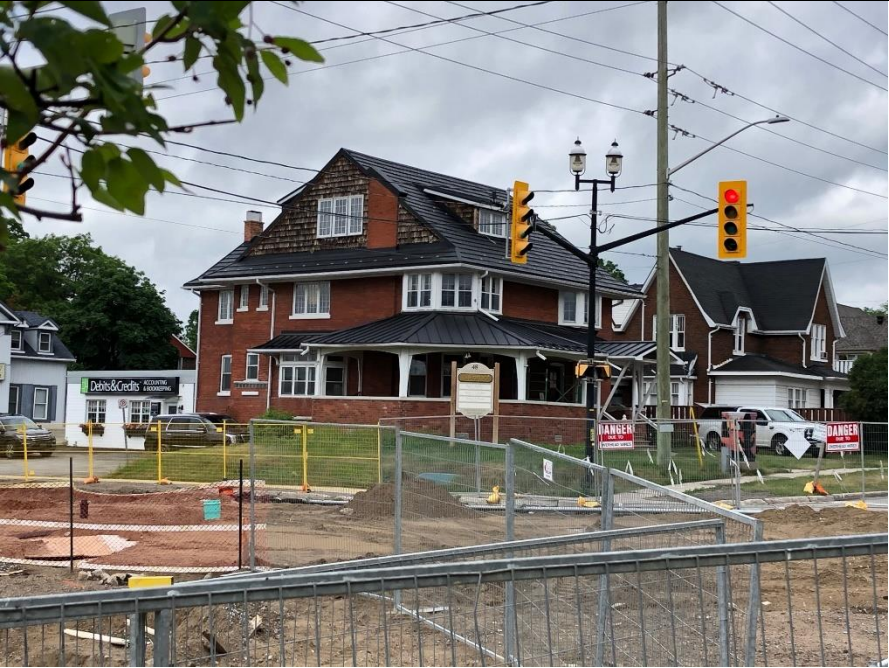
| Feature ID | Type of Property | Address or Location | Heritage Status and Recognition | Description of Property and Known or Potential CHVI | Photographs/ Digital Image |
|---|---|---|---|---|---|
| BHR 2 | Commercial (former residential) | 48 Dunlop Street West | Potential BHR – Identified during field review | <p>This BHR contains a red brick, 2.5 storey former residence located on the northwest corner of Dunlop Street West and High Street. The former residential building has been converted to commercial use. The early twentieth-century building features elements of the Arts and Crafts style. Potential attributes include the 2.5 storey massing, red brick exterior, wood shingle gable ends, shed dormer, bay windows, and wrap around porch.</p> <p>The 1928 topographic map illustrates a structure in this location (Figure 4). Previous mapping shows only density and no specific structures or property owners. Based on the Arts and Crafts style elements, such as the wood shingled gable ends, shed dormer, and asymmetrical arrangement, utilized in the construction of the building it is likely to have been built in the early twentieth century when that style was popular in use. The property is located in an area that historically has been part of the density and development of the downtown core of the City of Barrie. In this area there are both single detached residential buildings and commercial buildings, with many of the residential built form having been subsequently converted to commercial use.</p> | <p>Plate 10: 48 Dunlop Street (ASI 2021).</p> |

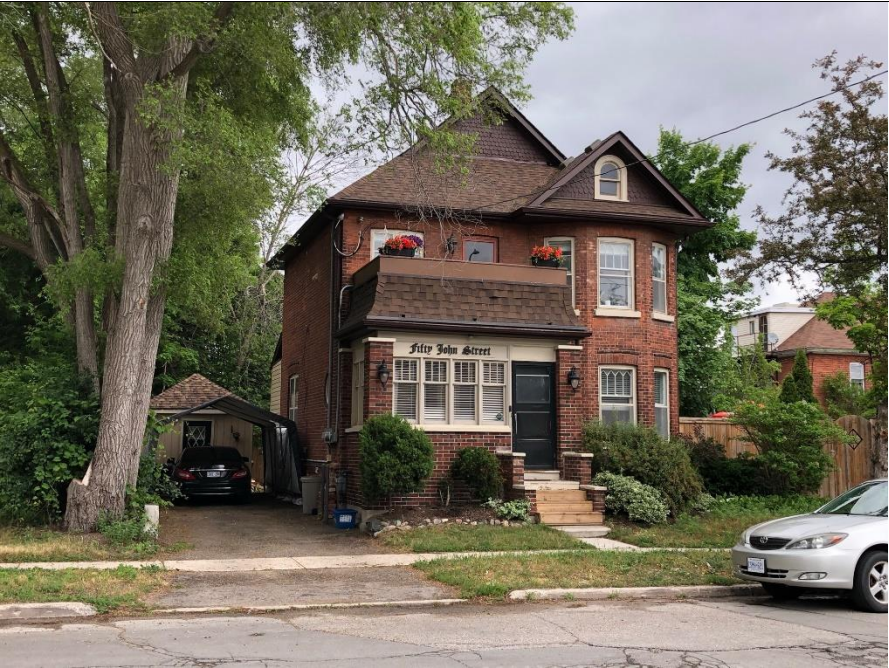
| Feature ID | Type of Property | Address or Location | Heritage Status and Recognition | Description of Property and Known or Potential CHVI | Photographs/ Digital Image |
|---|---|---|---|---|---|
| BHR 3 | Residential | 50 John Street | Potential BHR – Identified during field review | <p>This BHR contains a red brick, 2.5 storey residence located on the north side of John Street. The early twentieth-century building features elements of the Queen Anne style. Potential attributes include the 2.5 storey massing, red brick exterior, combination hipped and gable roof, enclosed porched, bay window, and original window sash.</p> <p>The 1928 topographic map illustrates a structure in this location (Figure 4). Previous mapping shows only density and no specific structures or property owners. Based on the Queen Anne style elements, such as the combination roof, two-storey bay window, and asymmetrical arrangement, of the building it is likely to have been constructed in the late nineteenth or early twentieth century when that style was popular in use. The residence is located on a historically residential street that was part of the density of the settlement of the City of Barrie that encircled the tip of Kempenfelt Bay.</p> | <p>Plate 11: 50 John Street (ASI 2021).</p> |

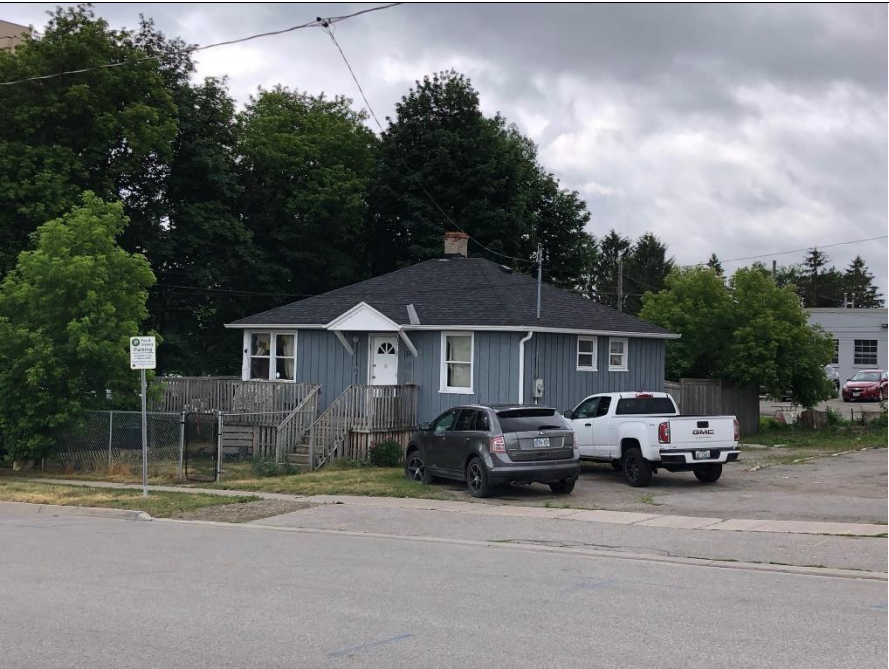
| Feature ID | Type of Property | Address or Location | Heritage Status and Recognition | Description of Property and Known or Potential CHVI | Photographs/ Digital Image |
|---|---|---|---|---|---|
| BHR 4 | Residential | 35 John Street | Potential BHR – Identified during field review | <p>This BHR contains a one-storey residence located on the south side of John Street. Potential attributes include the one-storey height, wood board-and-batten siding, and hipped roof.</p> <p>The 1928 topographic map does not illustrate a structure in this location (Figure 4), however a structure is visible in 1954 aerial photography (Figure 5). The modest residence may have been constructed between 1928 and 1954 or deemed too minor to be included on the 1928 mapping. Based on its restrained expression of style and form which is typical of some interwar and postwar residential architecture, it is likely the residence was constructed in the first half of the twentieth century. The residence is located on a historically residential street that was part of the density of the settlement of the City of Barrie that encircled the tip of Kempenfelt Bay.</p> | <p>Plate 12: 35 John Street (ASI 2021).</p> |

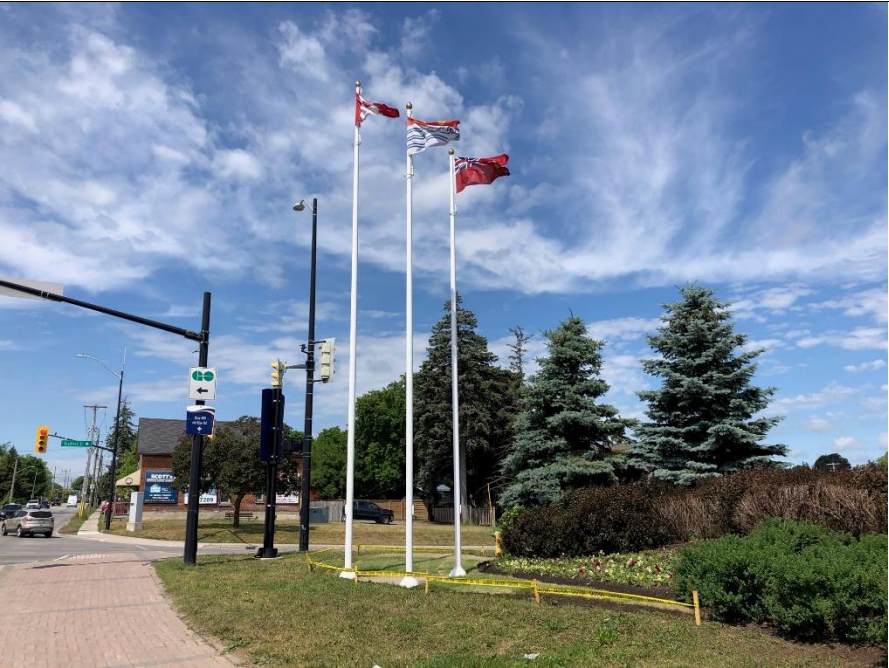
| Feature ID | Type of Property | Address or Location | Heritage Status and Recognition | Description of Property and Known or Potential CHVI | Photographs/ Digital Image |
|---|---|---|---|---|---|
| BHR 5 | Memorial | Intersection of Essa Road and Tiffin Street | Known BHR – Identified by Heritage Barrie in Guide to Plaques and Markers | <p>This memorial was erected June 11, 1967 as a Centennial project by the members of Barrie Unit 365 (Army, Navy and Air Force Veterans in Canada) and is dedicated to the City of Barrie in memory of all veterans of the Army, Navy, and Airforce. The memorial features three flagstaff poles and a commemorative stone marker within a landscaped boulevard at the intersection of Essa Road and Tiffin Street (Heritage Barrie 2006).</p> | <div></div> <p>Plate 13: Veteran’s Memorial Flag Pole (ASI 2021).</p> |

4. Recommendations for BHR 5 include removal of the flag poles/flags, commemorative marker, and other items from the memorial prior to construction and storage in a secure facility to prevent damage. Removal, storage, and future placement should all be done in consultation with the City of Barrie and Barrie Unit 365 of the Army, Navy and Air Force Veterans in Canada.

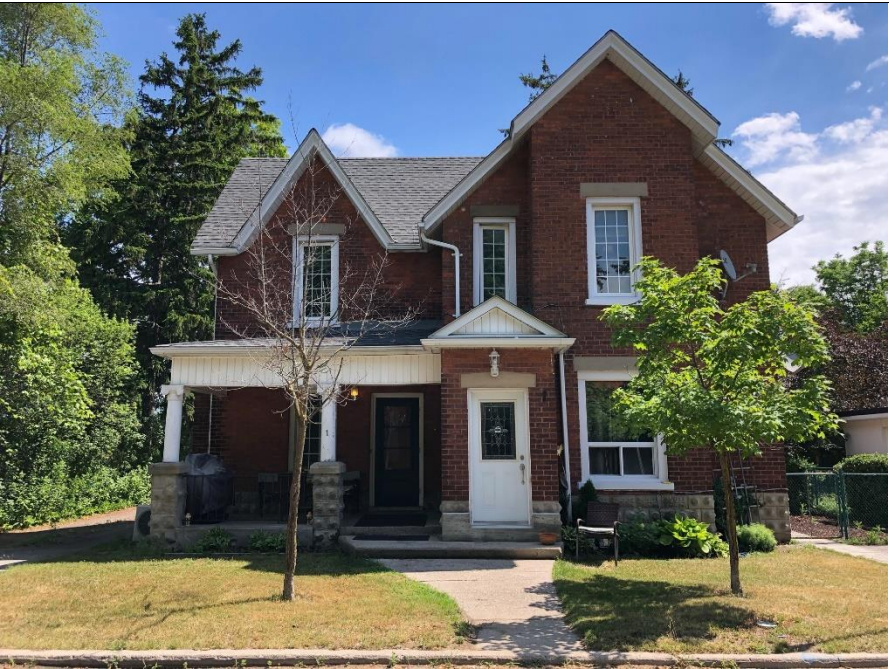
| Feature ID | Type of Property | Address or Location | Heritage Status and Recognition | Description of Property and Known or Potential CHVI | Photographs/ Digital Image |
|---|---|---|---|---|---|
| BHR 6 | Residential | 1 Short Street | Potential BHR – Identified during field review | <p>This BHR contains a vernacular red brick, 1.5 storey residence located on the east side of Short Street at the northern terminus of the dead-end roadway. Potential attributes include the 1.5 storey massing, red brick exterior, cross gable roof and gable feature, masonry lintels, cast concrete foundation and porch piers, enclosed entrance, and L-shaped footprint.</p> <p>Short Street, a minor roadway, is not depicted on 1928 topographic mapping (Figure 4), however, the residential street is visible in 1954 aerial photography. Based on the vernacular style and materials used, such as the gable roof and gable feature, red brick exterior, rectangular masonry lintels, and cast concrete foundation, the residence was likely to have been constructed in the late nineteenth or early twentieth century when these elements were popular in use. The residence is located on a historically residential street that was part of the density of the settlement of the City of Barrie that encircled the tip of Kempenfelt Bay.</p> | <div></div> <p>Plate 14: 1 Short Street (ASI 2021).</p> |

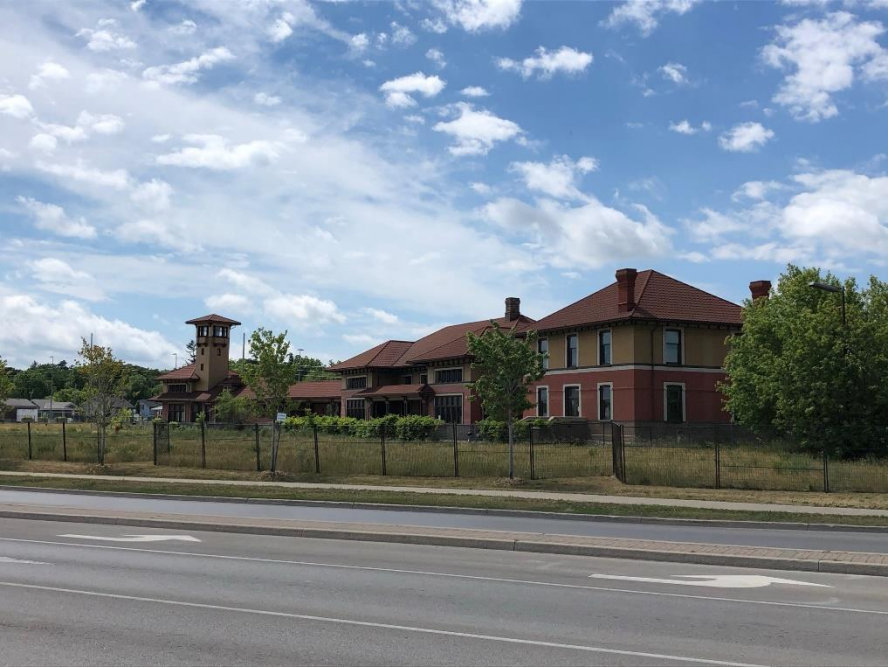
| Feature ID | Type of Property | Address or Location | Heritage Status and Recognition | Description of Property and Known or Potential CHVI | Photographs/ Digital Image |
|---|---|---|---|---|---|
| BHR 7 | Transportation | 285 Bradford Street | Known BHR – Designated under Part IV of the Ontario Heritage Act; Listed on the Canadian Register; Designated under the Federal Heritage Railway Stations Protections Act; Ontario Heritage Trust Cultural Easement | <p>The Allandale Train Station was constructed in 1890 and served as a significant transportation hub in the early 1900s for the Grand Truck Railway (GTR)(Canada’s Historic Places 2019). The station is valued for its historical associations and physical design. The station was constructed in an Italianate Villa style. Attributes include its picturesque massing, composition of elevations, and residential scale. For a full list of attributes and character defining elements of the property, please consult the Part IV designation By-law (<a href="#">By-law 2009-144</a>) or visit <a href="https://www.historicplaces.ca/en/rep-reg/place-lieu.aspx?id=8884">https://www.historicplaces.ca/en/rep-reg/place-lieu.aspx?id=8884</a>.</p> <p>“Allandale” is labelled on mapping from 1871 and 1881 , indicating the area was already established prior to the construction of the Allandale Train Station (Figure 2 and Figure 3). Topographic mapping from 1928 illustrates that convergence of rail lines in the location of the station (Figure 4). At the height of its activity in the early 1900s the Italianate Villa style building contained a passenger depot, restaurant and two-storey office building (City of Barrie). Following the bankruptcy of the GTR in 1919, the station then came under ownership of the Canadian National Railway (CNR). A decline in ridership and freight traffic led to a diminished role for the station, with the passenger depot and restaurant eventually closing in the 1980s. VIA Rail and GO Transit used the office building as a passenger waiting room briefly in the early 1990s. The Allandale Train Station is currently undergoing restoration under the guidance of the Ontario Heritage Trust (City of Barrie).</p> | <p>Plate 15: Allandale Train Station (ASI 2021).</p> |

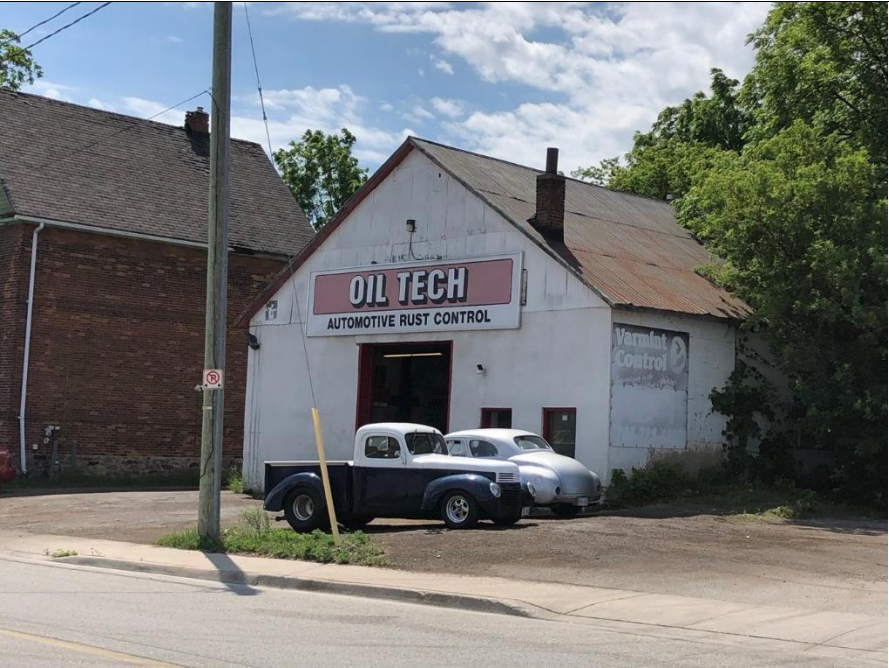
| Feature ID | Type of Property | Address or Location | Heritage Status and Recognition | Description of Property and Known or Potential CHVI | Photographs/ Digital Image |
|---|---|---|---|---|---|
| BHR 8 | Commercial | 9 Gowan Street | Potential BHR – Identified during field review | <p>This BHR contains a one-storey commercial building located on the north side of Gowan Street. The early to mid twentieth-century auto garage is modest and utilitarian in design. Potential attributes include the one storey massing, metal roof, large garage door opening on the street-facing elevation, metal siding, and front facing gable roof.</p> <p>The 1928 topographic map illustrates a structure in this location (Figure 4). Previous mapping shows only density and no specific structures or property owners. Based on the simple frame construction and utilitarian materials used, such as metal siding and metal roof, it is likely that this structure was constructed after the establishment of the neighboring late nineteenth- and early twentieth-century buildings along this stretch of road. The auto garage is located on a historically residential street indicating a transition that occurred in the area, likely influenced by the presence of the rail line on the north side of Gowan Street in this area.</p> | <p>Plate 16: 9 Gowan Street (ASI 2021).</p> |

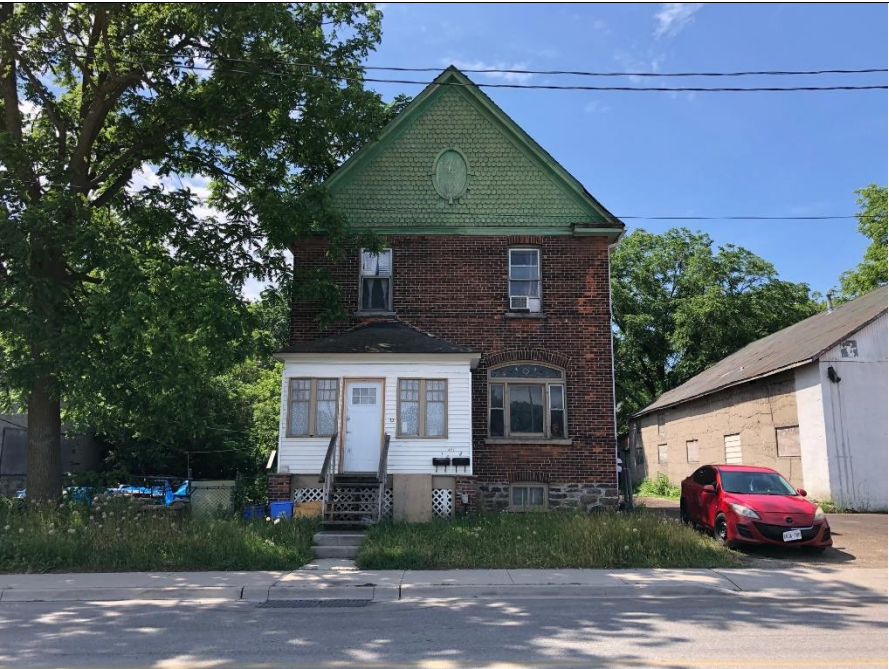
| Feature ID | Type of Property | Address or Location | Heritage Status and Recognition | Description of Property and Known or Potential CHVI | Photographs/ Digital Image |
|---|---|---|---|---|---|
| BHR 9 | Residential | 13 Gowan Street | Potential BHR – Identified during field review | <p>This BHR contains a red brick, 2.5 storey residence located on the south side of Gowan Street. The vernacular building features elements of the Queen Anne style. Potential attributes include the 2.5 storey massing, red brick exterior, front facing gable roof with return eaves and wood shingles cladding the gable face, oval window with ornamental surround, enclosed porched, art glass transom, and stone foundation.</p> <p>The 1928 topographic map illustrates a structure in this location (Figure 4). Previous mapping shows only density and no specific structures or property owners. Based on the Queen Anne style elements, such the wood shingle siding in the gable end, oval window, and art glass transom, it is likely the building was constructed in the late nineteenth or early twentieth century when that style was popular in use. The residence is located on a historically residential street, however, the introduction of a rail line on the north side of the roadway has altered the character of the street.</p> | <p>Plate 17: 13 Gowan Street (ASI 2021).</p> |

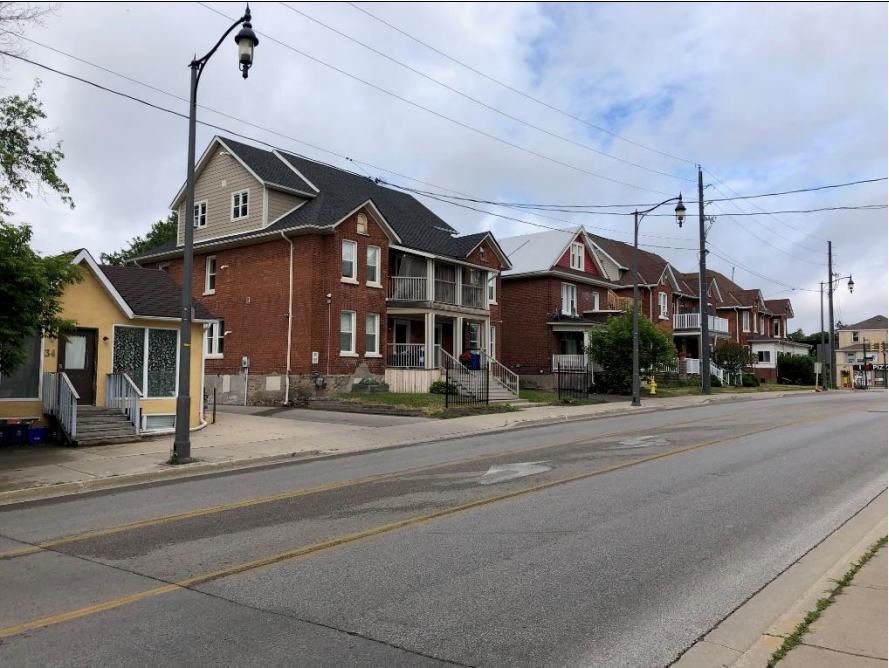
| Feature ID | Type of Property | Address or Location | Heritage Status and Recognition | Description of Property and Known or Potential CHVI | Photographs/ Digital Image |
|---|---|---|---|---|---|
| CHL 1 | Residential Streetscape | 34-46 (west side) and 27-31 (east side) Toronto Street | Potential CHL – Identified during field review | <p>This CHL contains nine residential properties that are located on the east and west side of Toronto Street. The properties are residential in use and are either single detached or semi-detached homes. The properties within this CHL represent a range of styles and materials, however, all are typical of the late nineteenth and early twentieth century. There are several properties (36, 42-44, and 46-48 Bradford Street) that are similar in design, indicating these were likely constructed simultaneously by the same builder.</p> <p>The 1928 topographic map illustrates a row of structures in the location of the CHL (Figure 4). Previous mapping shows only density and no specific structures or property owners. Based on the styles of the included residential properties, such as Edwardian Classical and Ontario Cottage, which are typical of the late nineteenth and early twentieth century, it is likely that the 1928 mapping is depicting the extant structures. Toronto Street has maintained its residential use in this area.</p> | <p>Plate 18: Looking northwest on Toronto Street (ASI 2021).</p> |

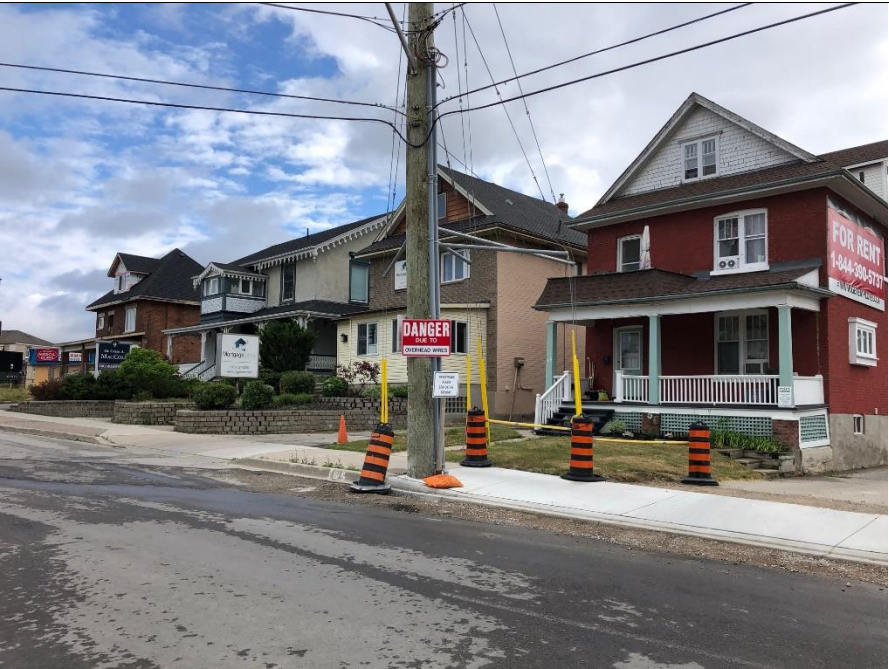
| Feature ID | Type of Property | Address or Location | Heritage Status and Recognition | Description of Property and Known or Potential CHVI | Photographs/ Digital Image |
|---|---|---|---|---|---|
| CHL 2 | Former Residential Streetscape | 5-13 Bradford Street | Potential CHL – Identified during field review | <p>This CHL contains four residential properties that are located on the east side of Bradford Street. The properties are historically residential in use though they have since been converted to commercial use and single detached homes. The properties vary in form but are generally a vernacular expression of the Edwardian Classical style. Three of the four properties are 2.5 storeys in height, with the fourth rising to two storeys. All have front porches (one enclosed) and are generally contain a brick or stucco exterior.</p> <p>The 1928 topographic map does not show any structures in the location of the CHL, however, structures are visible in 1954 aerial photography (Figure 4 and Figure 5). Based on the mapping and vernacular Edwardian Classical style of the included residential properties, it is likely they were constructed in the early twentieth century. Bradford Street in this area has transitioned from residential land use to commercial, reflected in the conversion of the residential built forms to commercial use.</p> | <p>Plate 19: Looking northeast on Bradford Street (ASI 2021).</p> |

- 5-13 Bradford Street (CHL 2)
  - 101 Bradford Street + 28, 31, and 34 Vespra Street (CHL 3)
  - 112 and 118 Bradford Street (CHL 4)
  - 28, 29, 48, 50 and 51 Victoria St (CHL 5)

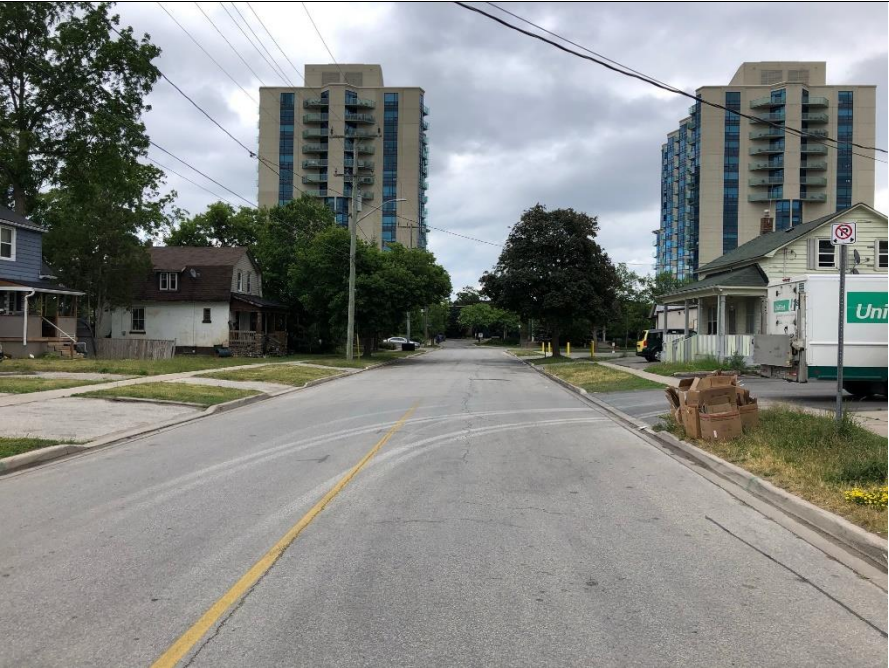
| Feature ID | Type of Property | Address or Location | Heritage Status and Recognition | Description of Property and Known or Potential CHVI | Photographs/ Digital Image |
|---|---|---|---|---|---|
| CHL 3 | Residential Streetscape | 101 Bradford Street + 28, 31, and 34 Vespra Street | Potential CHL – Identified during field review | <p>This CHL contains four residential properties that are located on the north and south sides of Vespra. The properties are residential in use and are single detached homes. The properties represent a range of styles and materials, however, all are typical of the late nineteenth and early twentieth century. Potential attributes include the single detached form, similar scale and massing, setback from the road, and mature trees.</p> <p>The 1928 topographic map illustrates a collection of structures in the location of the CHL (Figure 4). Previous mapping shows only density and no specific structures or property owners. Based on the architectural styles of the included residential properties, such as Dutch Colonial Revival, which are typical of the early to mid twentieth century, it is likely that residences were constructed in the first half of the twentieth century. Vespra Street has maintained its residential use in this area.</p> | <p>Plate 20: Looking east on Vespra Street from Bradford Street (ASI 2021).</p> |

3. Given the potential cultural heritage value of CHL 3, CHL 4, CHL 6, CHL 8, CHL 9 and CHL 11, a resource-specific CHER for each should be conducted to determine their CHVI. However, details of encroachment are not known at this time. The long-range corridor protection plan represents the ultimate corridor state, and will be used to guide re-development along the corridor. As such, the City of Barrie has no plans to acquire property or expropriate property at this time. Cultural heritage requirements, including recommended CHERs and heritage impact assessments will be met as the corridor redevelops and will be the responsibility of the developer. In the future, when the City of Barrie decides to reconstruct Bradford Street, an Addendum to this study will be required to develop an optimized design plan that fully considers the transportation and land use planning context at that time coupled with mitigation measures to minimize impacts to in-situ corridor constraints including BHRs and CHLs based on best practices in place at that time.

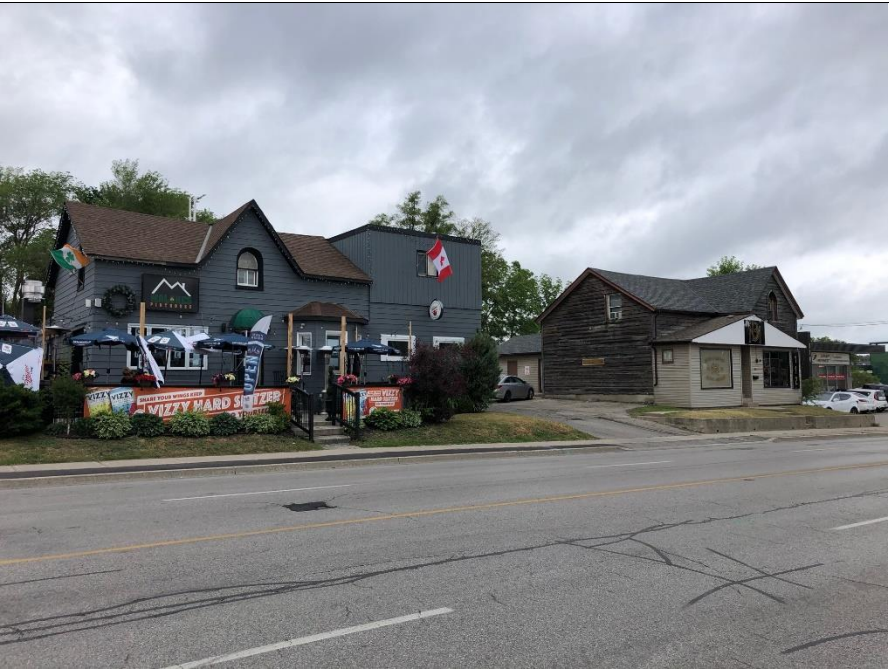
| Feature ID | Type of Property | Address or Location | Heritage Status and Recognition | Description of Property and Known or Potential CHVI | Photographs/ Digital Image |
|---|---|---|---|---|---|
| CHL 4 | Former Residential Streetscape | 112 and 118 Bradford Street | Potential CHL – Identified during field review | <p>This CHL contains two former residential properties that are located on the west side of Bradford Street. The detached residential built forms have been converted to commercial land use. The properties feature a vernacular Italianate architectural style, typical of the late nineteenth century. Potential attributes include the similar scale and massing, gable roof configurations, rounded arch window located within a gable end, and wood siding.</p> <p>These houses were constructed between before 1928. The 1928 topographic map illustrates houses in the location of these residences. Previous mapping shows only density and no specific structures or property owners.</p> | <p>Plate 21: Looking northwest from Bradford Street (ASI 2021).</p> |

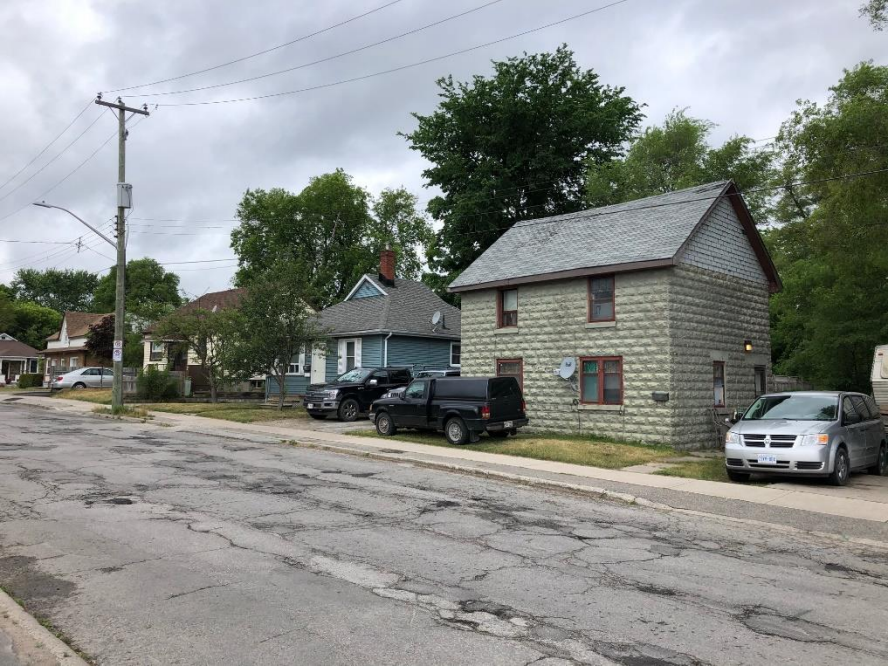
| Feature ID | Type of Property | Address or Location | Heritage Status and Recognition | Description of Property and Known or Potential CHVI | Photographs/ Digital Image |
|---|---|---|---|---|---|
| CHL 5 | Former Residential Streetscape | 28, 29, 48, 50 and 51 Victoria St | Potential CHL – Identified during field review | <p>This CHL contains five residential properties that are located on both sides of Victoria Street, spanning across Bradford Street. The detached residential built forms have been converted to commercial land use. The properties feature a variety of styles and materials, primarily vernacular expressions or Edwardian Classical. They also represent a range in the period of construction, though confined to the early twentieth century. Potential attributes include the similar scale and massing, setback from the roadway, masonry exterior (where currently applied), and detached arrangement.</p> <p>The houses located west of Bradford Street were likely constructed after 1928, as they are not shown on topographic mapping from that year, however, there are structure depicted on the east side (Figure 4). All residences in this CHL are shown to be extant in 1954 aerial photography (Figure 5).</p> | <p>Plate 22: Looking northwest on Victoria Street (ASI 2021).</p> |

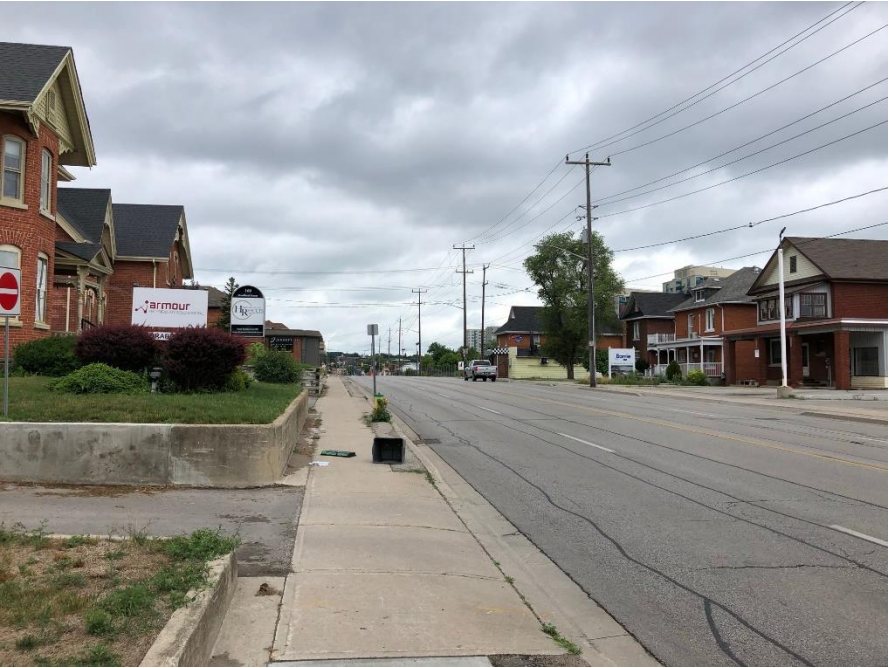
| Feature ID | Type of Property | Address or Location | Heritage Status and Recognition | Description of Property and Known or Potential CHVI | Photographs/ Digital Image |
|---|---|---|---|---|---|
| CHL 6* | Former Residential Streetscape | 146-218 (west side) and 151-161 (east side) Bradford Street | <p>Potential CHL – Identified during field review</p> <p>*Includes 168-170 Bradford Street – Known BHR – Listed on the municipal Heritage Register</p> | <p>This CHL contains 25 residential properties that are located on the east and west sides of Brock Street. The properties are residential built forms that primarily have been converted to commercial use. They are single detached and semi-detached in form. The properties feature primarily the Edwardian Classical architectural style, typical of the early twentieth century. There are also a few Italianate style and foursquare homes. Potential attributes include the similar scale and massing, red brick construction, and Edwardian Classicism architectural elements such as square footprint; either a hipped roof with a large centred dormer or gable roof, typically with a pediment style front gable with double hung windows; large porch with classically inspired columns; decorative millwork; and flat arches made with bricks standing on end or large plain stone lintels accentuate windows and doors</p> <p>The residences located in the north half of the CHL are depicted in topographic mapping from 1928, however, the land on the west side of the street between the watercourse and Brock Street is undeveloped. Aerial photography from 1954 indicates the extant structures in this south half were constructed by that date. As a result, the date of construction for the north half of the CHL is generally before 1928, and the south half between 1928 and 1954.</p> | <p>Plate 23: Looking north on Bradford Street (ASI 2021).</p> |

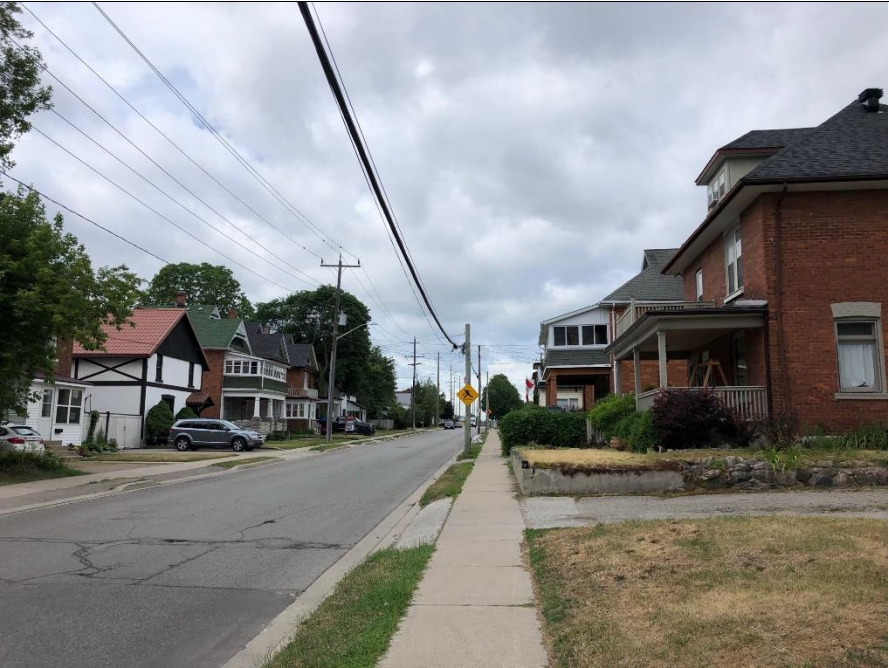
| Feature ID | Type of Property | Address or Location | Heritage Status and Recognition | Description of Property and Known or Potential CHVI | Photographs/ Digital Image |
|---|---|---|---|---|---|
| CHL 7 | Residential Streetscape | 36-43 Brock Street | Potential CHL – Identified during field review | <p>This CHL contains seven residential properties that are located on the north and south sides of Brock Street. The properties are residential in use and are single detached homes. The properties feature primarily the Edwardian Classicism architectural style, typical of the early twentieth century. Potential attributes include the similar scale and massing, red brick construction, and Edwardian Classicism architectural elements such as square footprint; either a hipped roof with a large centred dormer or gable roof, typically with a pediment style front gable with double hung windows; large porch with classically inspired columns; and flat arches made with bricks standing on end or large plain stone lintels accentuate windows and doors.</p> <p>These houses were constructed between 1928 and 1954. The 1928 topographic map does not illustrate houses in the location of these residences but the 1954 aerial photograph shows the street has been developed.</p> | <p>Plate 24: Looking southwest on Brock Street (ASI 2021).</p> |

- 146-218 (west side) and 151-161 (east side) Bradford Street (CHL 6)
  - 36-43 Brock Street (CHL 7)
  - 244-252 Bradford Street (CHL 8)
  - 30-50 (north side) and 47 (south side) Tiffin Street (CHL 9)

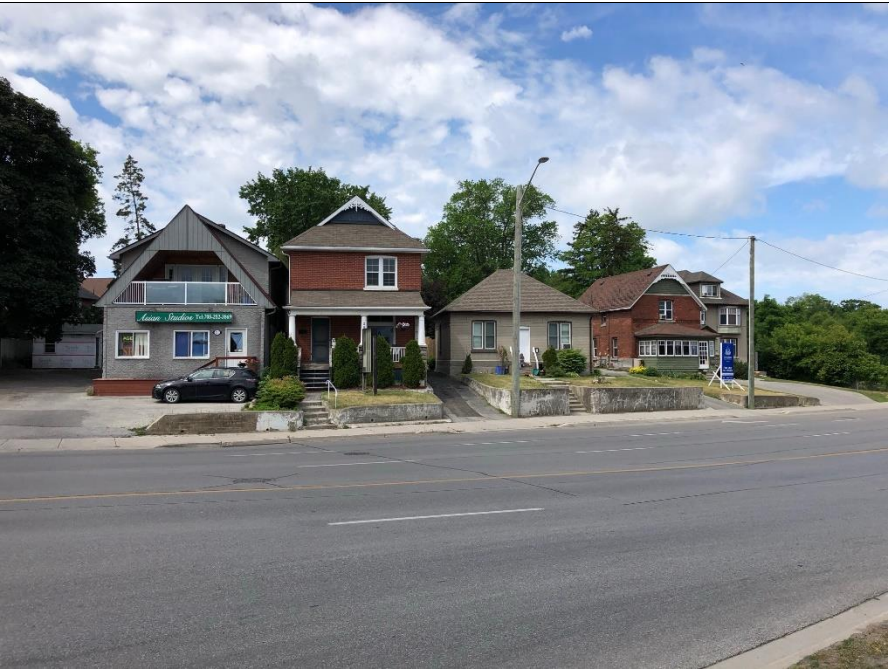
| Feature ID | Type of Property | Address or Location | Heritage Status and Recognition | Description of Property and Known or Potential CHVI | Photographs/ Digital Image |
|---|---|---|---|---|---|
| CHL 8 | Residential Streetscape | 244-252 Bradford Street | Potential CHL – Identified during field review | <p>This CHL contains five residential built forms that are located on the west side of Bradford Street. The properties are residential and converted residential to commercial in use and are single detached buildings. The properties represent a range of styles and some have been altered, but the original form and detailing of the buildings are typical of vernacular residential construction dating to the early twentieth century. Potential attributes include the similar scale and massing, setback following the angle of the roadway, and detached structures.</p> <p>Topographic mapping from 1928 illustrates structures along this section of Bradford Street (Figure 4), indicating that they were likely constructed in the early twentieth century prior to the realignment of Bradford Street.</p> | <p>Plate 25: Looking east on Bradford Street (ASI 2021).</p> |

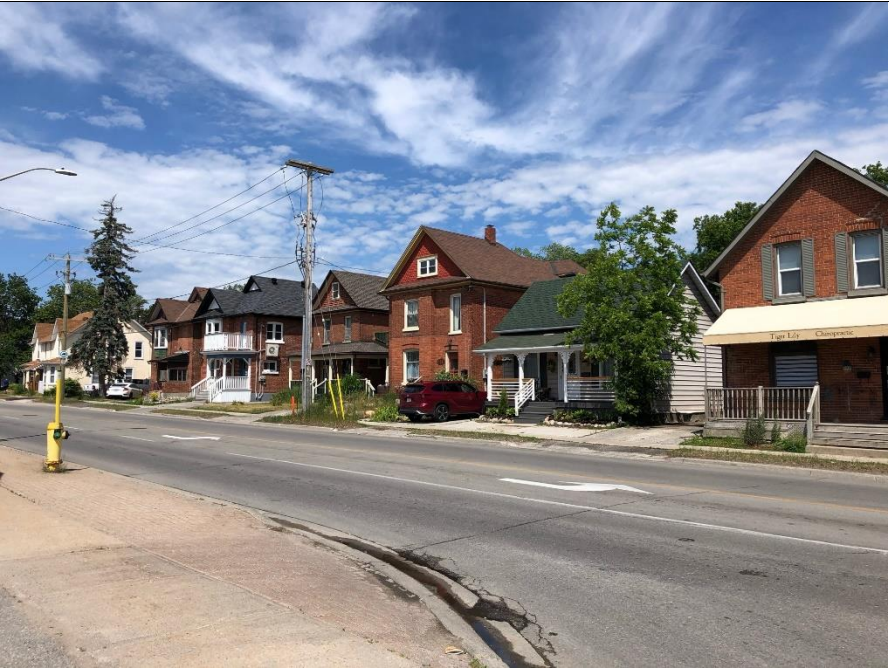
| Feature ID | Type of Property | Address or Location | Heritage Status and Recognition | Description of Property and Known or Potential CHVI | Photographs/ Digital Image |
|---|---|---|---|---|---|
| CHL 9* | Residential Streetscape | 30-50 (north side) and 47 (south side) Tiffin Street | Potential CHL – Identified during field review<br><br>*Includes 50 Tiffin Street – Known BHR – Listed on the municipal Heritage Register | <p>This CHL contains eight residential properties that are located primarily on the north side of Tiffin Street, with one property located on the south side. The properties are residential in use and are single detached homes. The properties feature primarily the Edwardian Classicism architectural style, typical of the early twentieth century. Potential attributes include the similar scale and massing, red brick construction, and Edwardian Classicism architectural elements such as square footprint; either a hipped roof with a large centred dormer or gable roof, typically with a pediment style front gable with double hung windows; large porch with classically inspired columns; and flat arches made with bricks standing on end or large plain stone lintels accentuate windows and doors.</p> <p>There are structures depicted in this area of Tiffin Street in 1928 topographic mapping. The mapping in addition to the general style an materials of the residences suggests they were constructed in the early twentieth century.</p> | <p>Plate 26: Looking northwest from the intersection of Tiffin Street and Essa Road (ASI 2021).</p> |

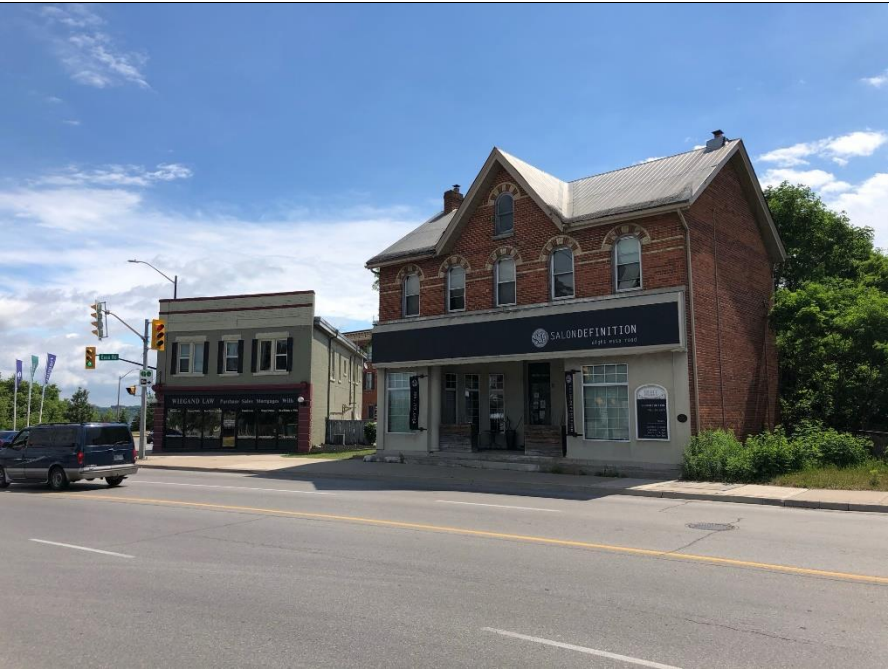
| Feature ID | Type of Property | Address or Location | Heritage Status and Recognition | Description of Property and Known or Potential CHVI | Photographs/ Digital Image |
|---|---|---|---|---|---|
| CHL 10 | Mixed Use (Residential and Commercial) Streetscape | 268 Bradford St, 4 Essa Rd/5-7 Tiffin St + 8-10 Essa Rd | Potential CHL – Identified during field review | <p>This CHL contains three mixed-used commercial/residential properties that are located on the south side of the intersection of Tiffin Street and Essa Road. The properties are generally commercial on the ground floor with residential units in the upper levels. One property was solely residential use that has been converted to commercial. The properties feature primarily the Italianate architectural style, typical of the late nineteenth century. Potential attributes include close setting to the roadway, brick construction, commercial storefronts, and Italianate architectural elements such as ornamental cornices; decorative brickwork; and segmental or rounded arch windows.</p> <p>These commercial properties are illustrated and visible in 1928 topographic mapping and 1954 aerial photography. The style materials used in their construction suggest they were constructed in the late nineteenth century. Their proximity to the rail line likely supported the commercial development in CHL.</p> | <p>Plate 27: Looking east from Essa Road (ASI 2021).</p> |

- 268 Bradford St, 4 Essa Rd/5-7 Tiffin St + 8-10 Essa Rd (CHL 10)
  - 27-35 (west side) and 28-34 (east side) Essa Rd (CHL 11)

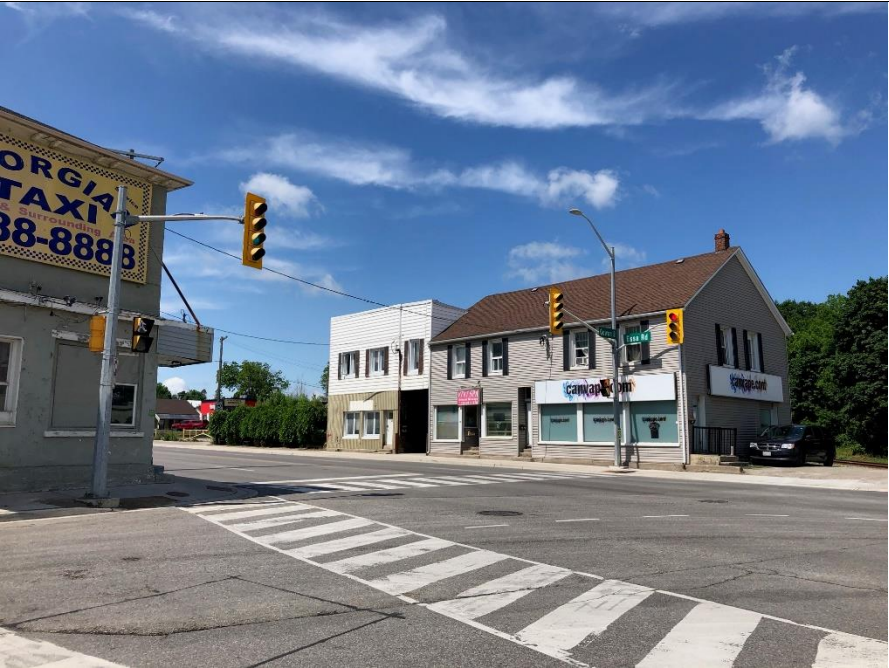
| Feature ID | Type of Property | Address or Location | Heritage Status and Recognition | Description of Property and Known or Potential CHVI | Photographs/ Digital Image |
|---|---|---|---|---|---|
| CHL 11 | Mixed Use (Residential and Commercial) Streetscape | 27-35 (west side) and 28-34 (east side) Essa Rd | Potential CHL – Identified during field review | <p>This CHL contains four mixed-used commercial/residential properties that are located on Essa Road, south of the roadway’s intersection with Gowan Street. The properties are generally commercial on the ground floor with residential units in the upper levels. The properties have been altered and few original elements are visible and/or extant, though the general forms and massing are typical of commercial buildings from the late nineteenth and early twentieth century. Potential attributes include close setting to the roadway, commercial storefronts, and similar scale and massing.</p> <p>These commercial properties are illustrated and visible in 1928 topographic mapping and 1954 aerial photography. The style materials used in their construction suggest they were constructed in the late nineteenth and early twentieth century. Their proximity to the rail line likely supported the commercial development in CHL.</p> | <p>Plate 28: Looking southwest from the intersection of Essa Road and Gowan Street (ASI 2021).</p> |

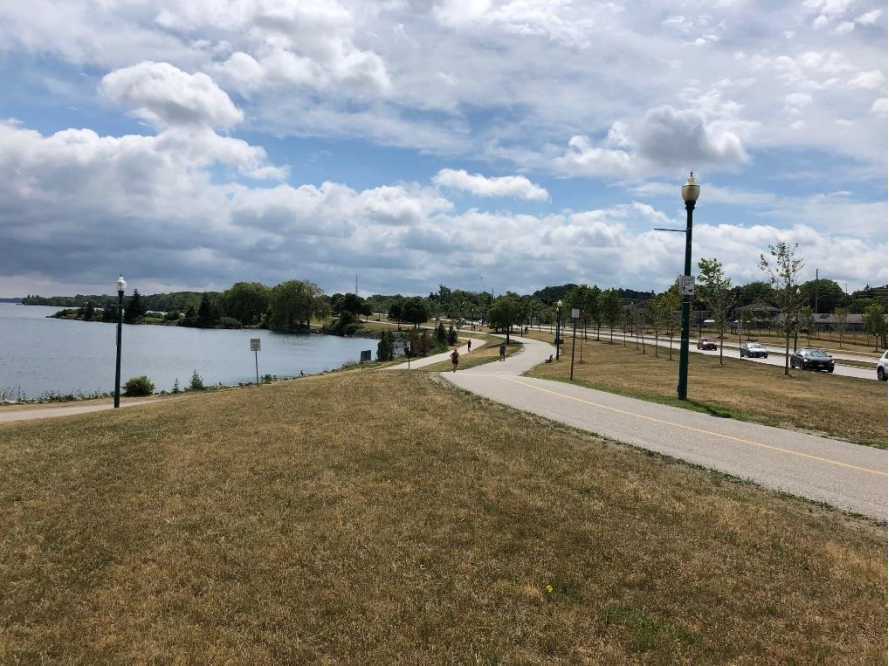
| Feature ID | Type of Property | Address or Location | Heritage Status and Recognition | Description of Property and Known or Potential CHVI | Photographs/ Digital Image |
|---|---|---|---|---|---|
| CHL 12 | Recreational Trail | Waterfront Heritage Trail – Shoreline of Kempenfelt Bay | Potential CHL – Identified during field review | <p>This CHL extends the length of Barrie’s waterfront, from the east end of Allandale Station Park to the end of the North Short Trail at Penetanguishene Road, and features 11 interpretive stations to create a ‘historical experience’ (City of Barrie n.d.). Each station provides information and context on a different historical theme and together they tell the story of the City of Barrie’s past from the last ice age to the present. Each station is arranged thematically, rather than chronologically, and they are linked to nearby walking tour districts (City of Barrie 2017). Potential attributes include the location of the trail along the shoreline, the information plaques/stations individually and as a collection which provides a historical experience, and the link between the interpretive stations to the surrounding walking tour districts.</p> | <p>Plate 29: Looking southeast towards the Waterfront Heritage Trail (ASI 2021).</p> |
