# Hydrogeological Investigation – 152 & 156 Miller Drive, City of Barrie, ON – Revision 1

May 15, 2024

Prepared for:  
2609216 Ontario Inc.

Cambium Reference: 9089-002

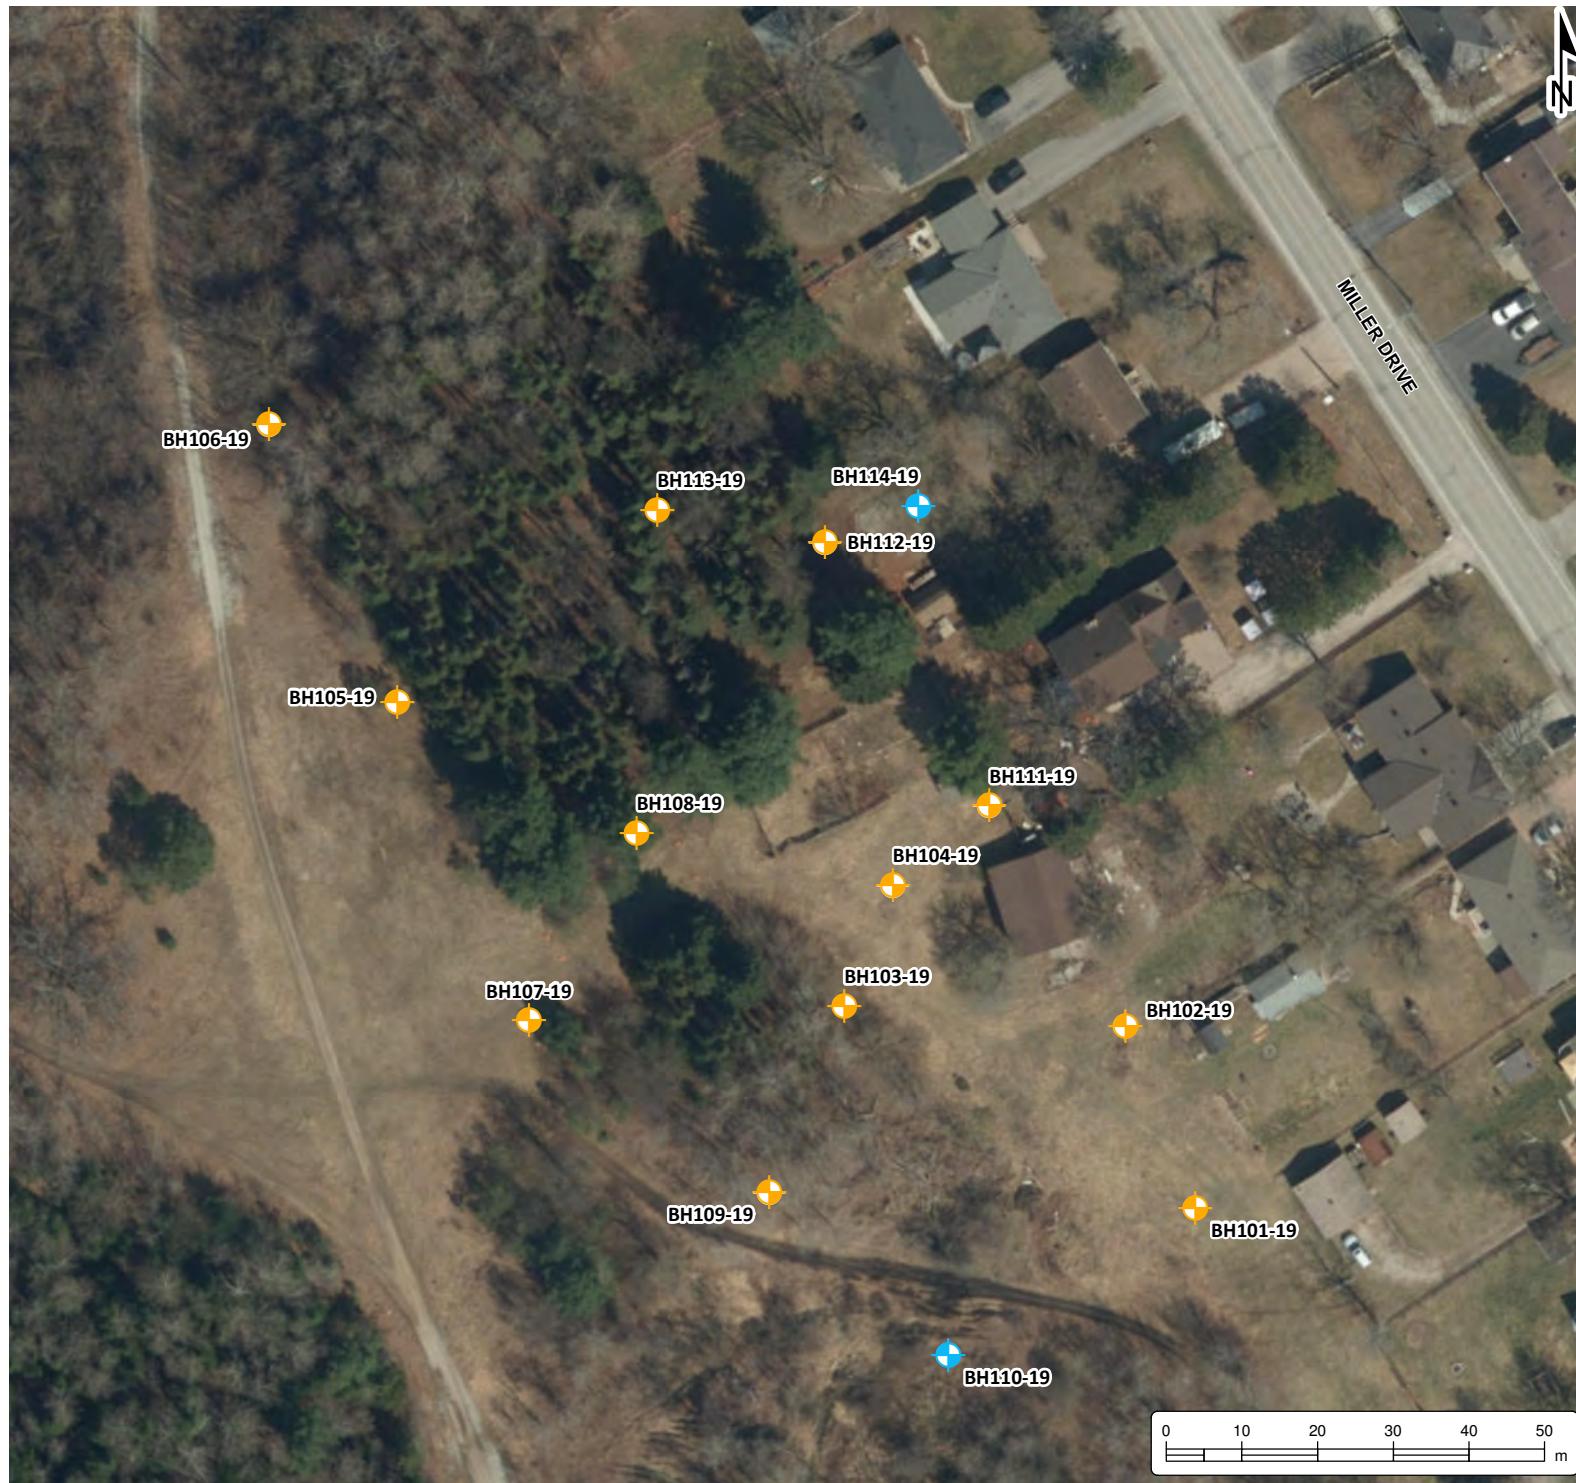
**BOREHOLE LOCATION PLAN**

Figure 5 depicts the locations of boreholes and monitoring wells completed by Cambium. The observed soil stratigraphy and the details of monitoring wells installed by Cambium are presented in the borehole logs included in Appendix C. The subsurface conditions at the Site consist of a surficial layer of topsoil overlying brown sandy deposits with trace amounts of silt, clay, and gravel to the termination depths of 5.0 mbgs. The boreholes were terminated in native soils and bedrock was not encountered within the explored depths.

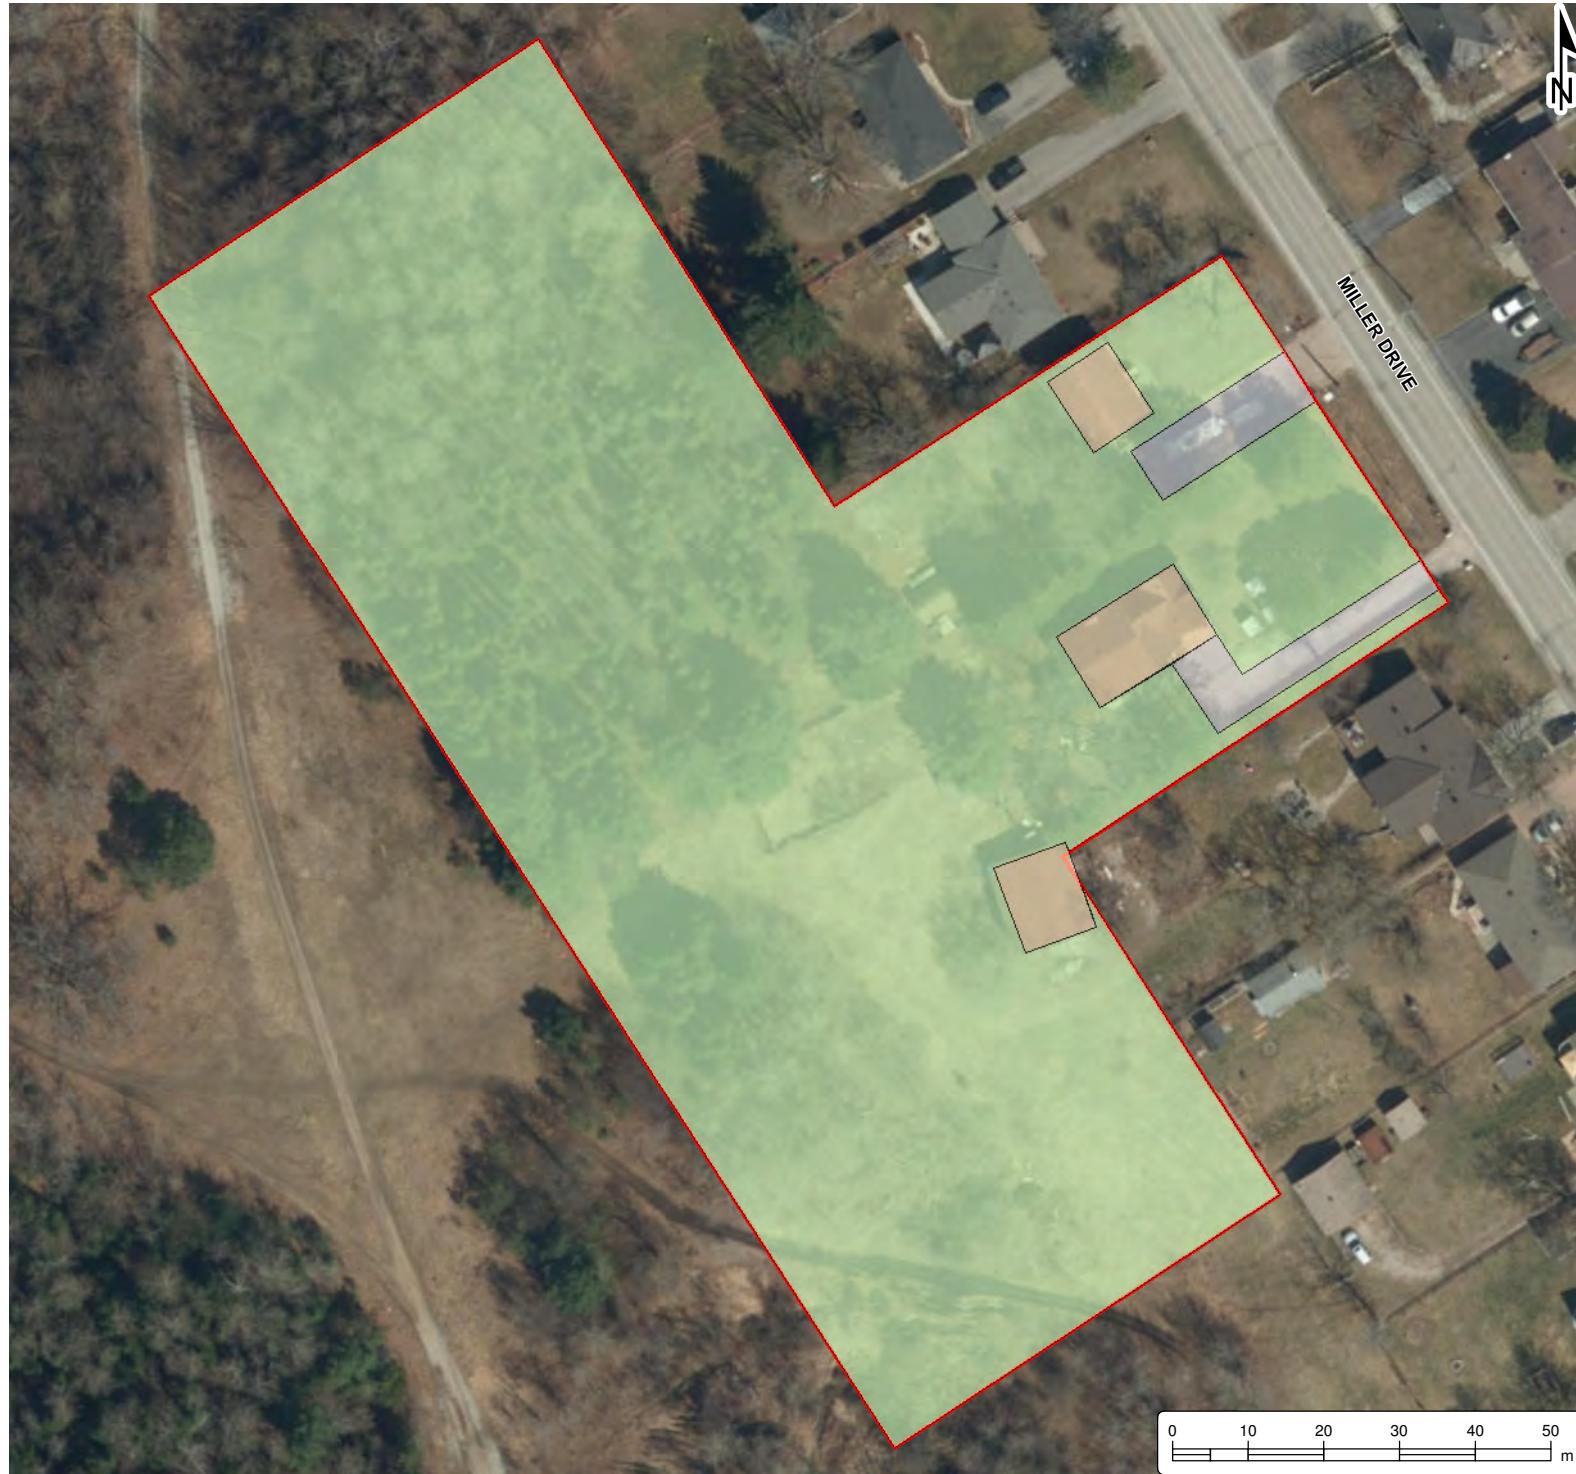
**PRE DEVELOPMENT PLAN**

The water balance for the existing conditions of the Site is summarized in Table 5. The pre-development infiltration rate was calculated to be 3,793 m<sup>3</sup>/yr and the runoff rate was 2,312 m<sup>3</sup>/yr.

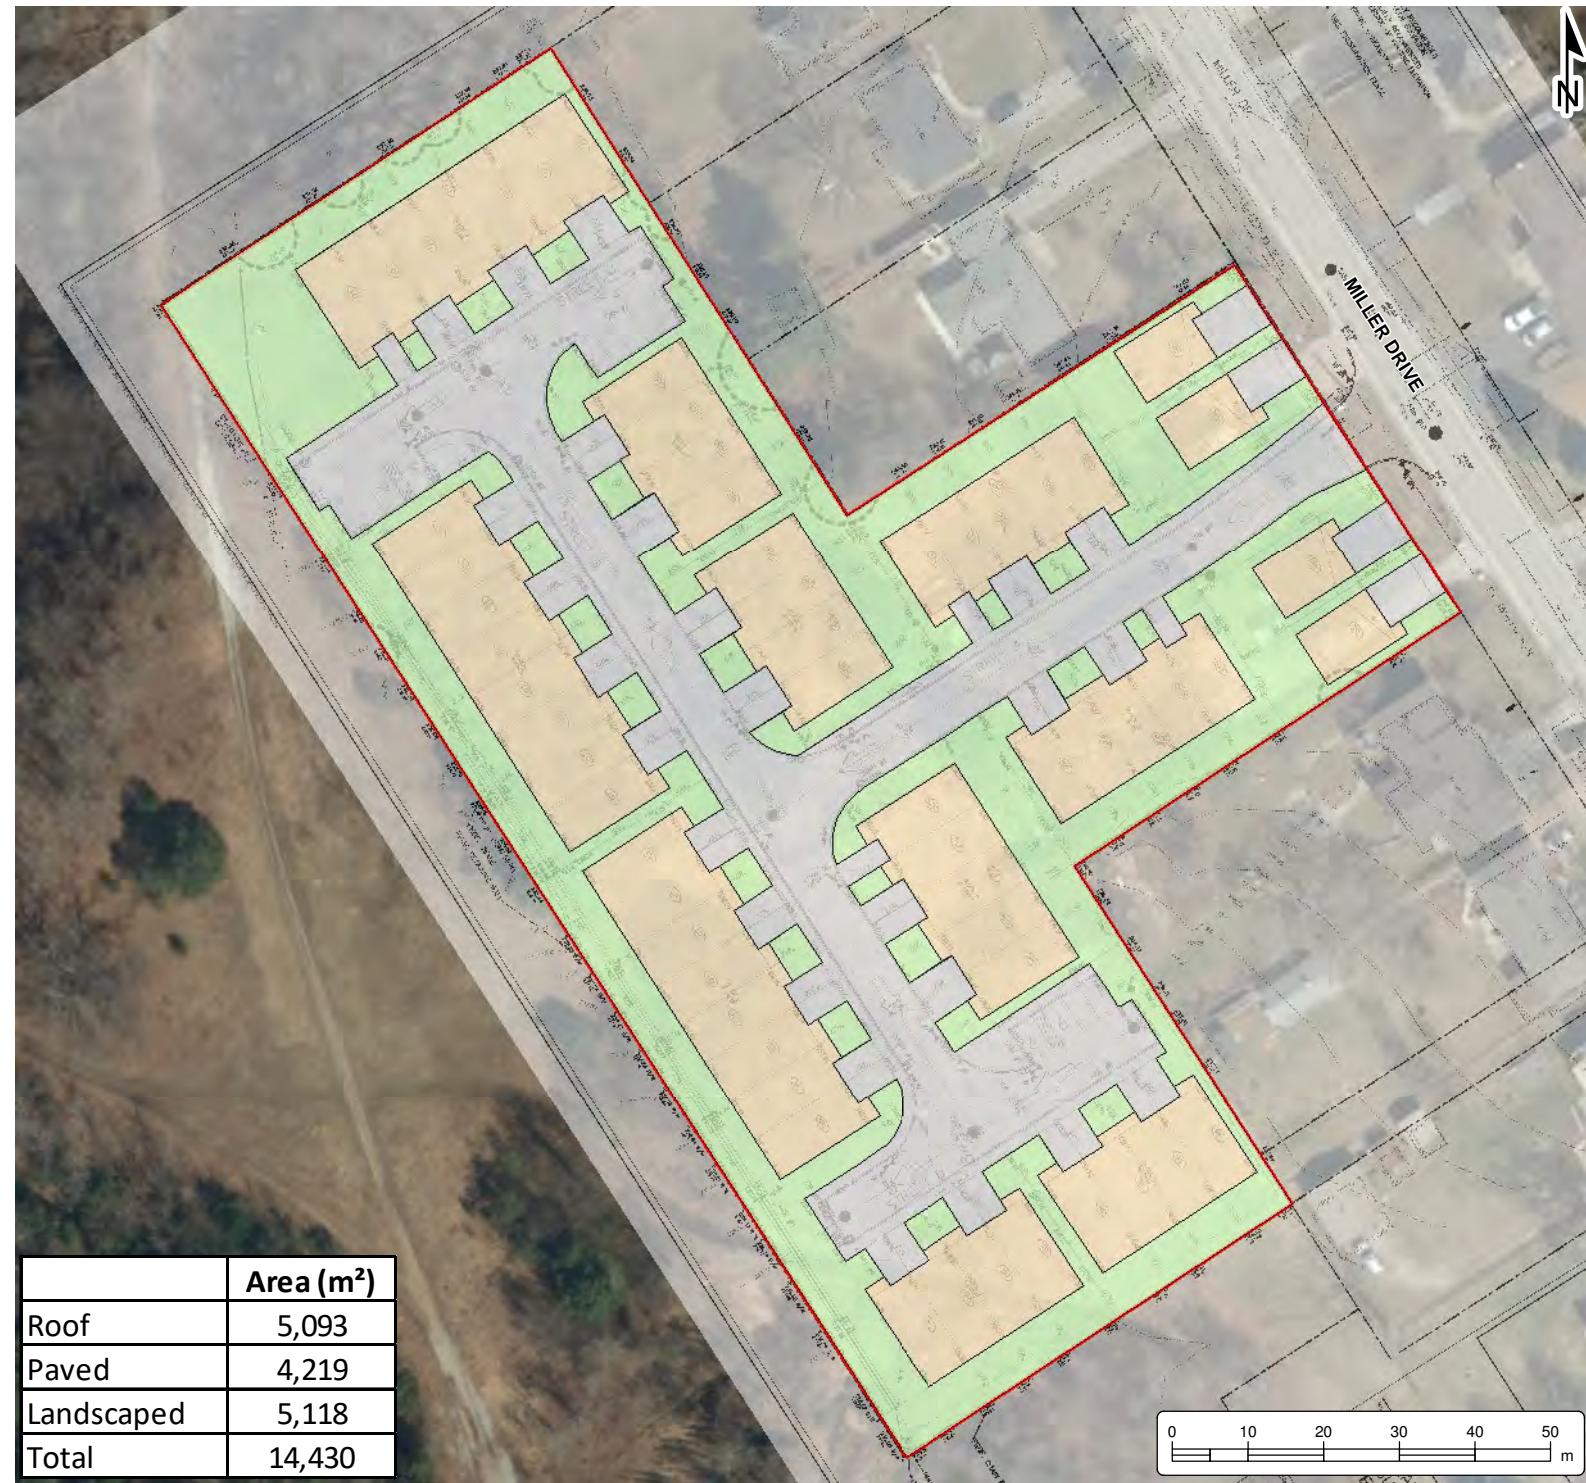
### POST DEVELOPMENT PLAN

The post-development water balance is summarized in Table 6. The post-development infiltration rate was calculated to be 1,426 m<sup>3</sup>/yr and the runoff volume was 8,431 m<sup>3</sup>/yr.

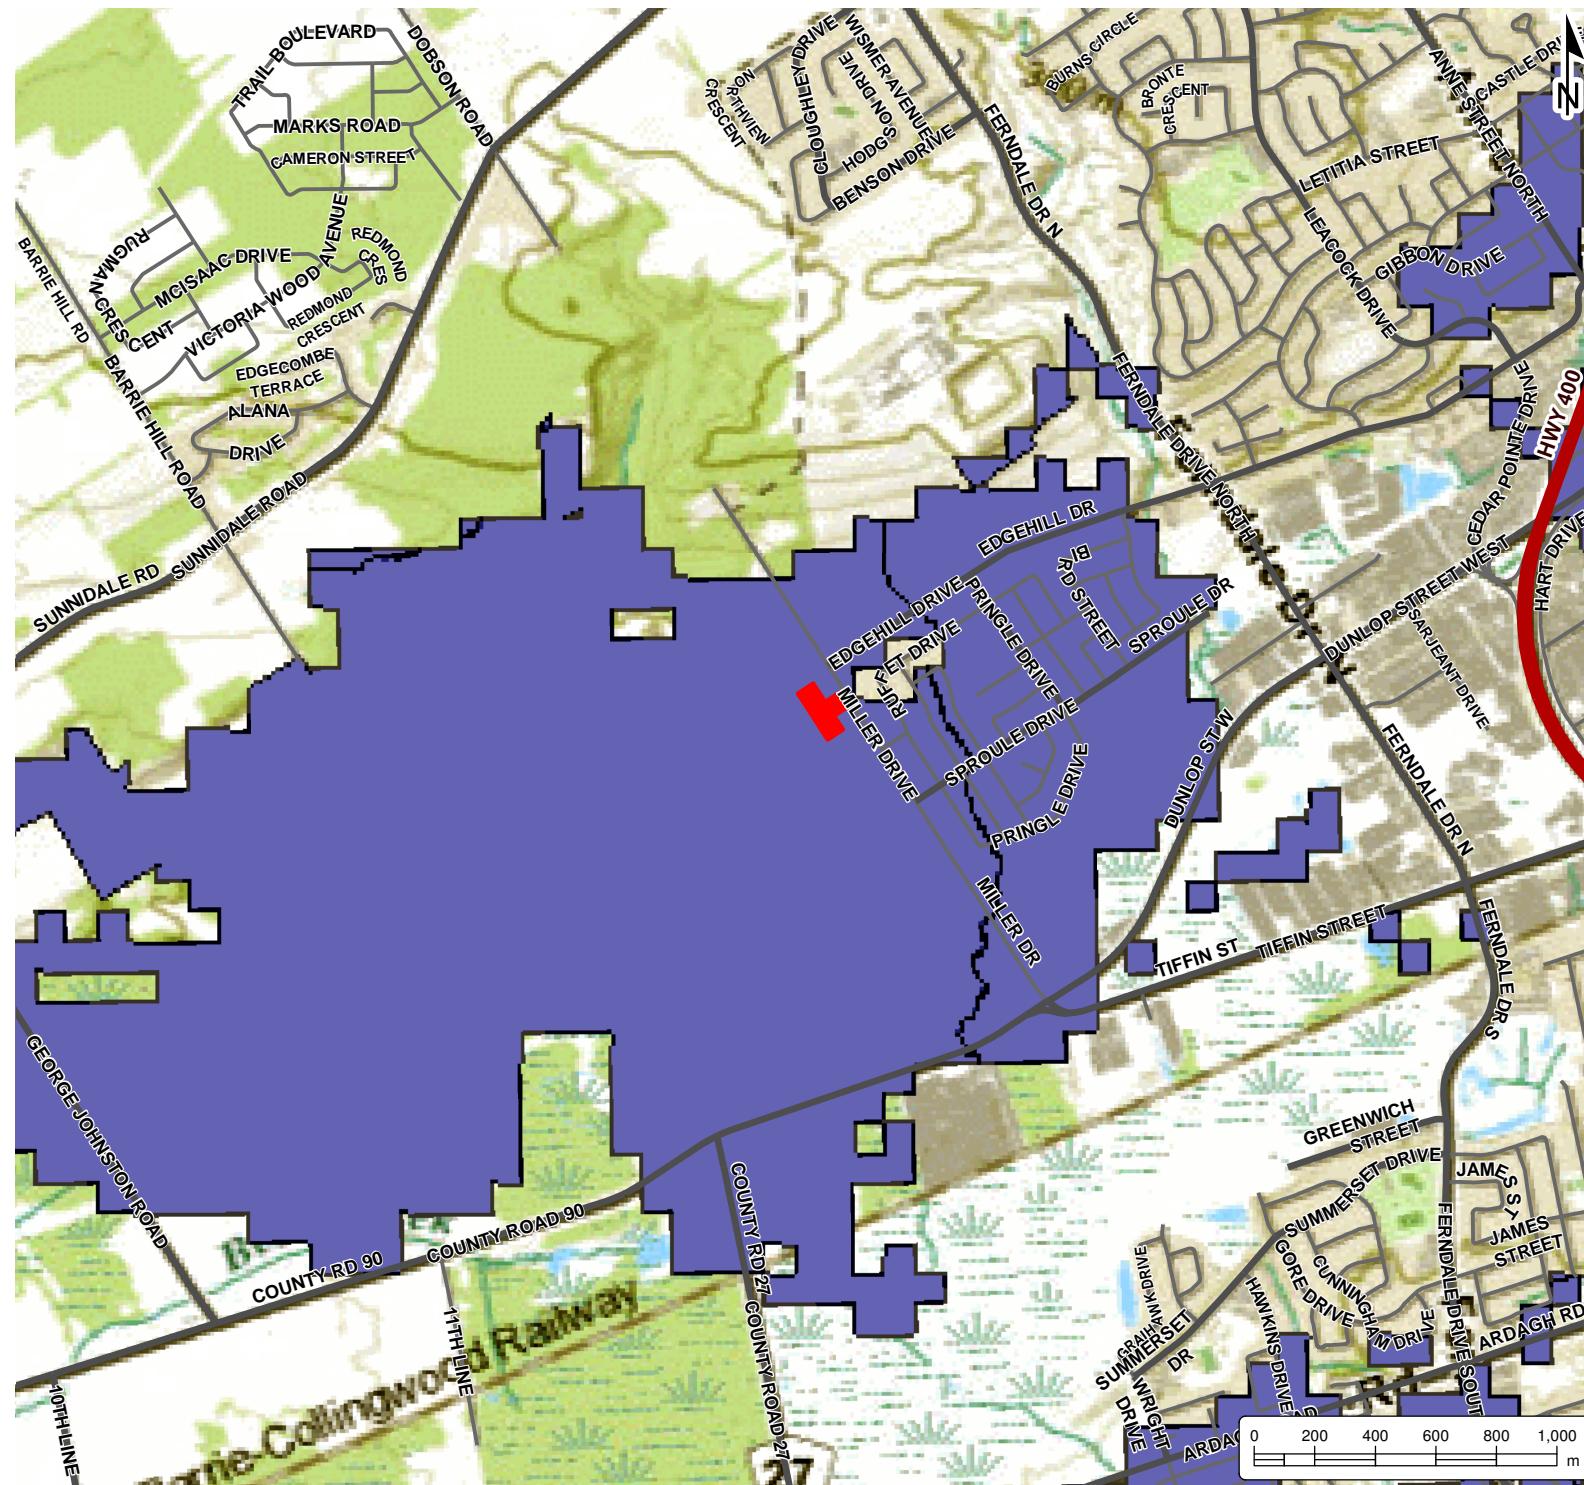
**HIGHLY VULNERABLE AREAS MAP**

Highly Vulnerable Aquifer (HVA) are aquifers that are more sensitive to contamination. In general, a HVA will consist of granular materials (e.g., sand and/or gravel) or fractured rock that has a high permeability and is near the surface of the ground.

Site exists in an area of groundwater vulnerability with a score of 6 and threat activities are moderate, but not significant. Therefore, the land use practices at the proposed development Site are not expected to cause any contamination to the potable ground supplies. The Site will be under municipal sewage service and as such is not expected to cause any groundwater contamination by nitrates.

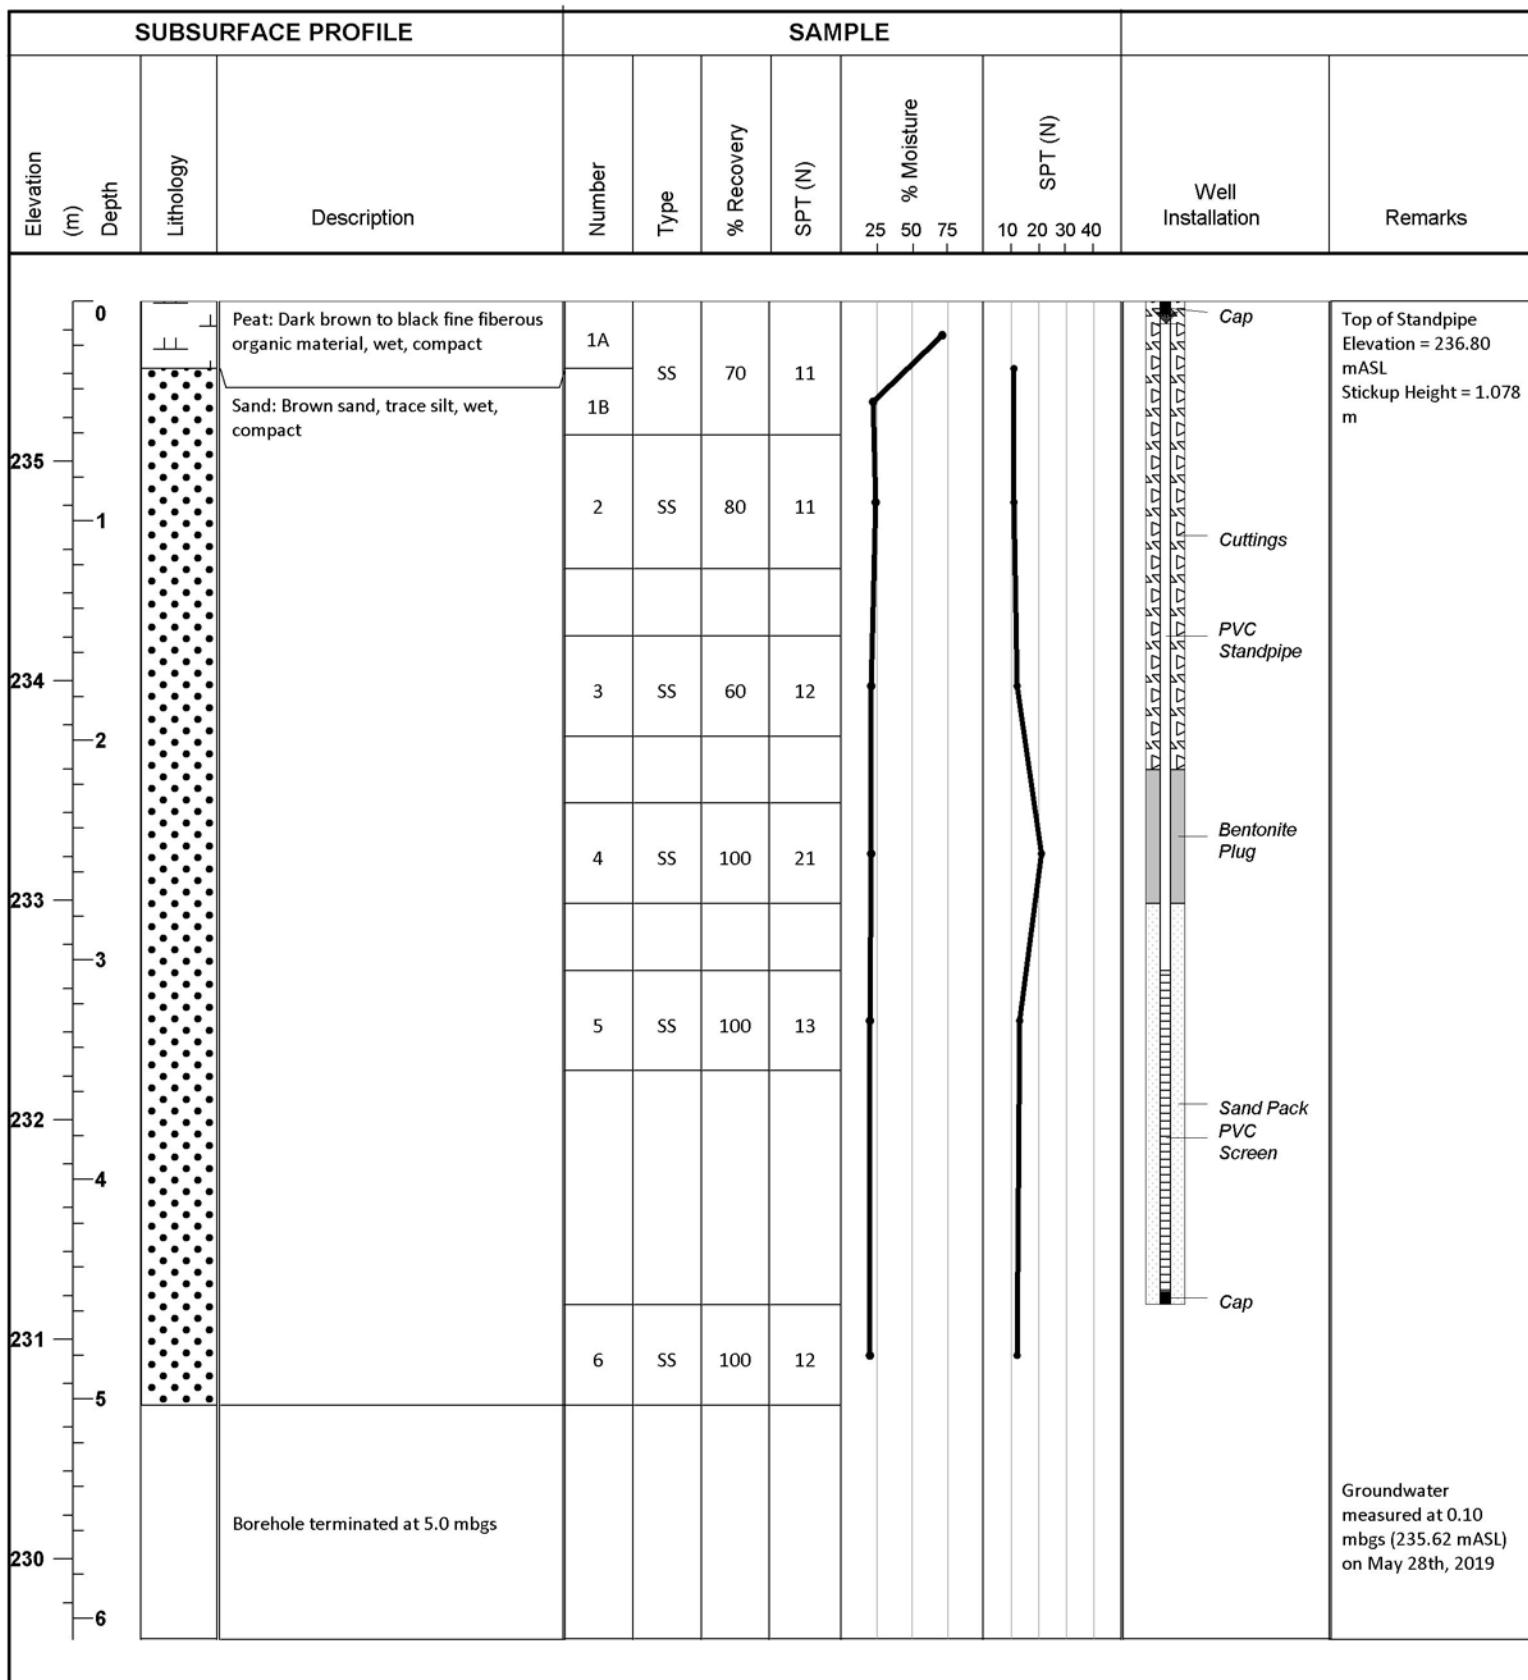
**Project Name:** Geotechnical Investigation - Miller Drive  
**Method:** Hollow Stem Augers  
**UTM:** 17T, 4914173.24, 600325.53

**Project No.:** 9089-001  
**Date Completed:** May 22, 2019  
**Elevation:** 235.73 mASL

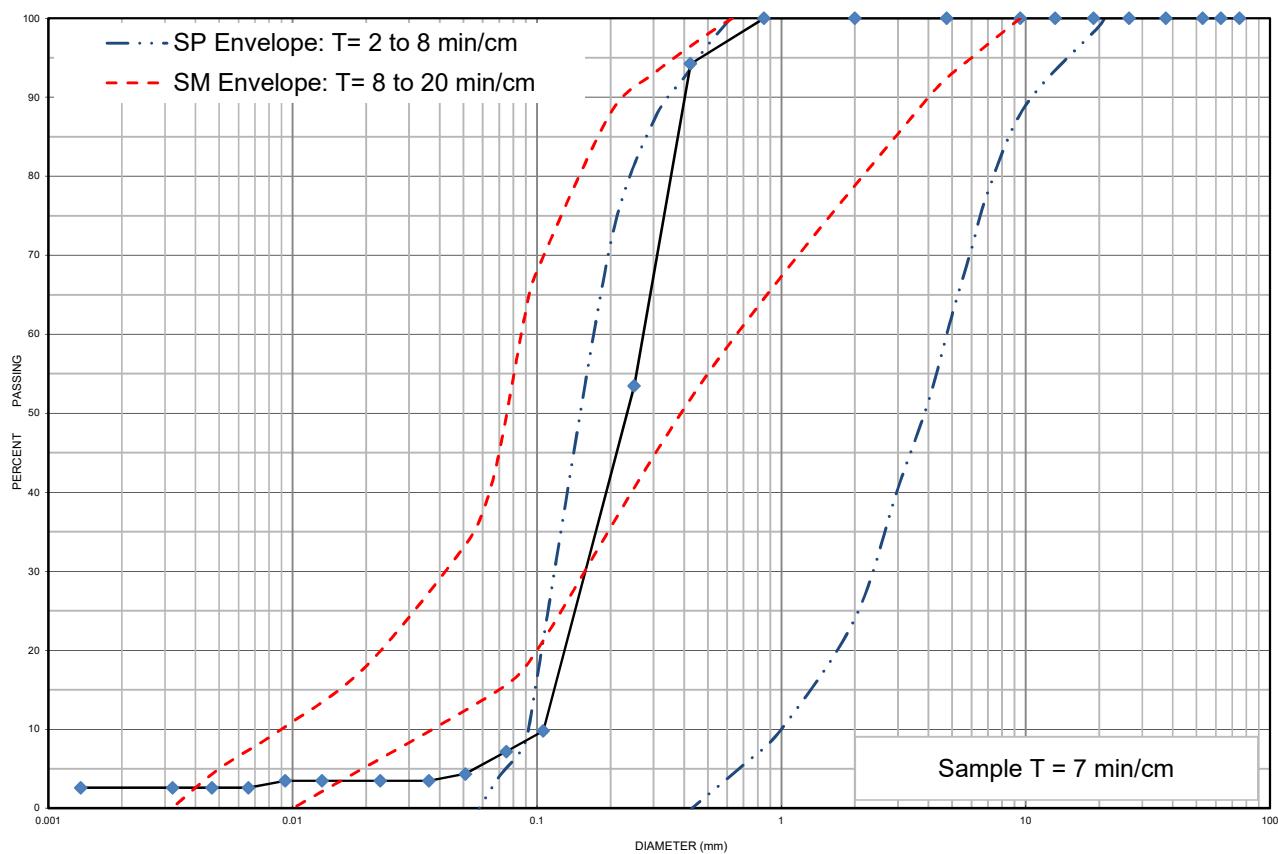
Lab Sample No: S-19-0334

Borehole No.	Sample No.	Depth	Gravel	Sand	Silt	Clay	Moisture
BH 101-19	SS 3	1.5 m to 2 m	0	93	7		22.4
Description	Classification	D <sub>60</sub>	D <sub>30</sub>	D <sub>10</sub>	C <sub>u</sub>	C <sub>c</sub>	
Sand trace Silt trace Clay	SP	0.270	0.1600	0.1	2.45	0.86

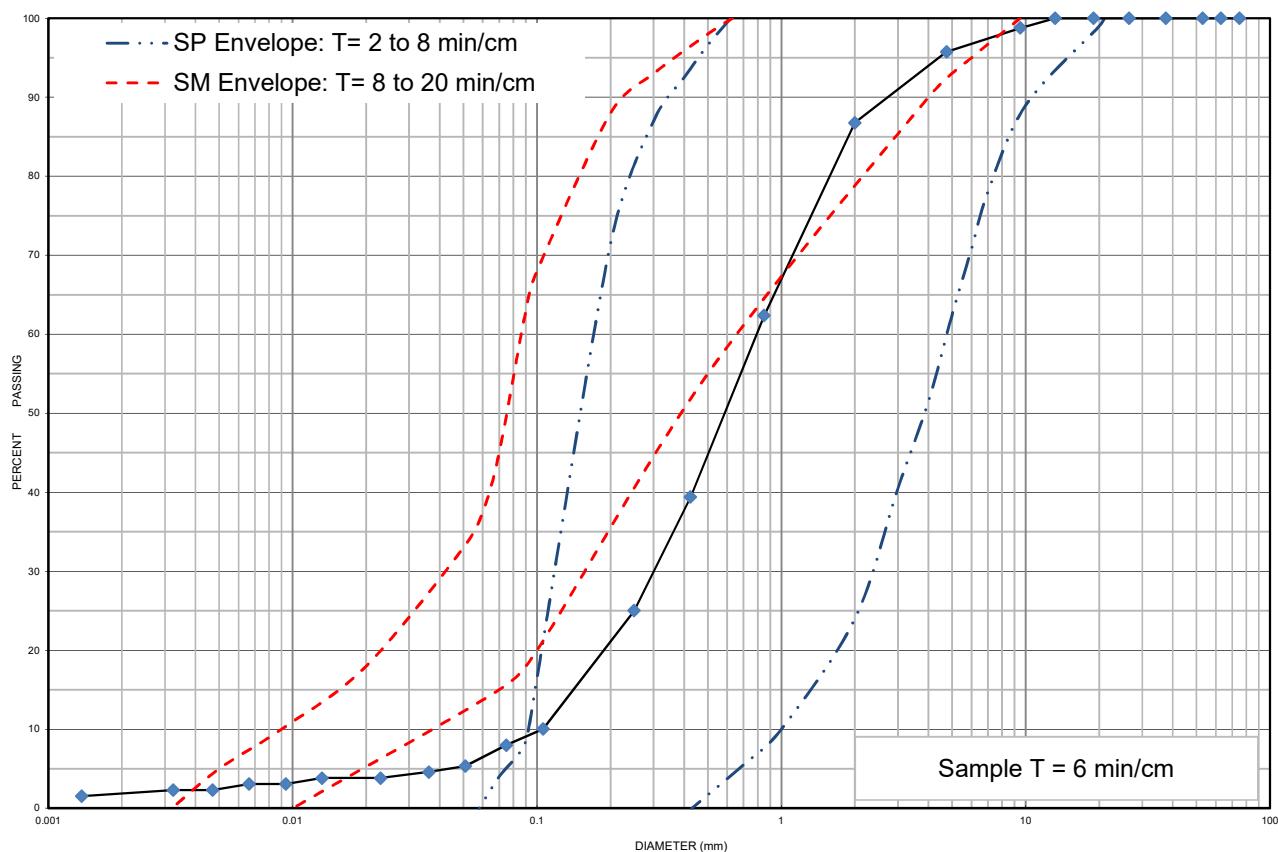
Lab Sample No: S-19-0335

Borehole No.	Sample No.	Depth	Gravel	Sand	Silt	Clay	Moisture		
BH 108-19	SS 4	2.3 m to 2.7 m	4	88	8		10.7		
			<b>Description</b>	<b>Classification</b>	<b>D<sub>60</sub></b>	<b>D<sub>30</sub></b>	<b>D<sub>10</sub></b>		
			Sand trace Silt trace Gravel trace Clay	SP	0.790	0.3000	0.1	C <sub>u</sub>	C <sub>c</sub>
								7.18	1.04

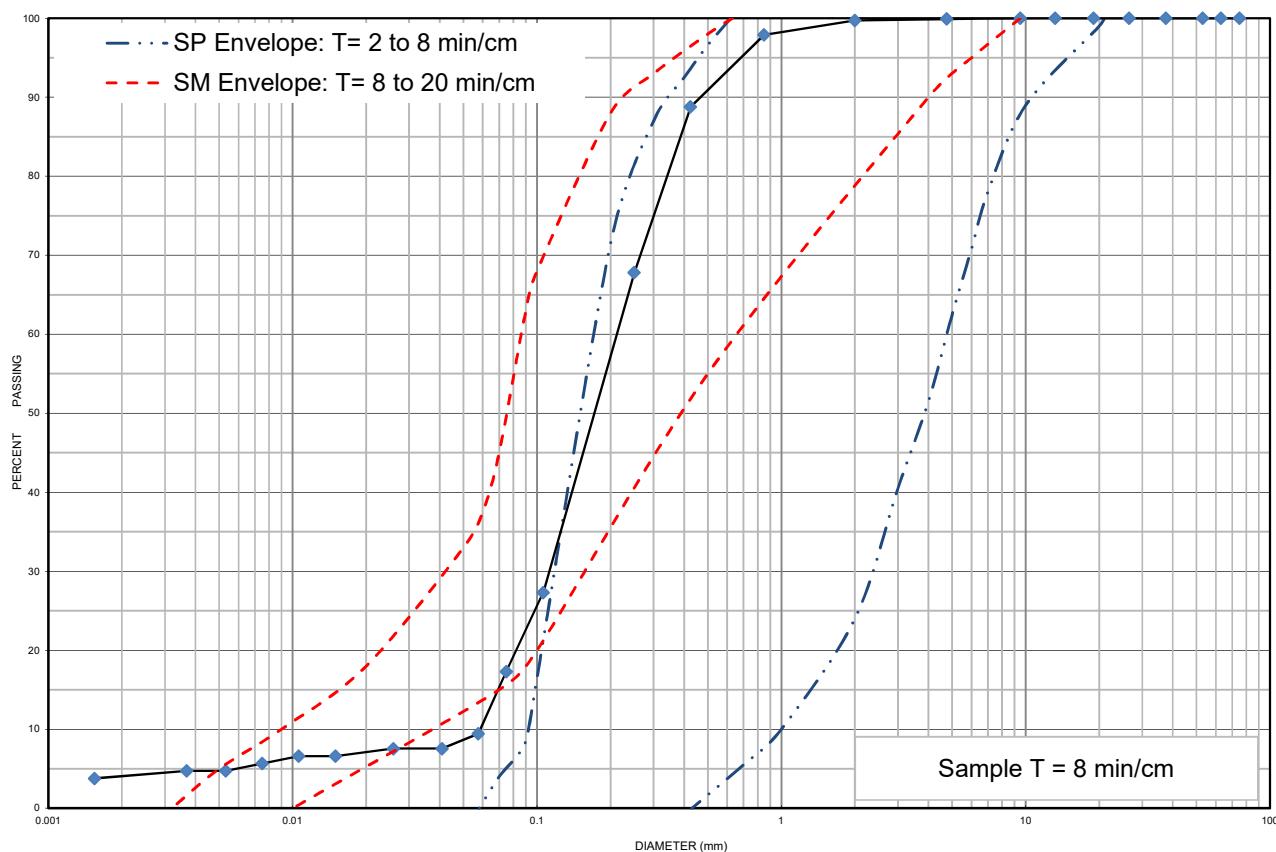
Borehole No.	Sample No.	Depth	Gravel	Sand	Silt	Clay	Moisture
BH 114-19	SS 2	0.6 m to 1.2 m	0	83	17		7.2
Description	Classification	D <sub>60</sub>	D <sub>30</sub>	D <sub>10</sub>	C <sub>u</sub>	C <sub>c</sub>	
Sand some Silt trace Clay	SP	0.220	0.1200	0.1	4.15	1.23

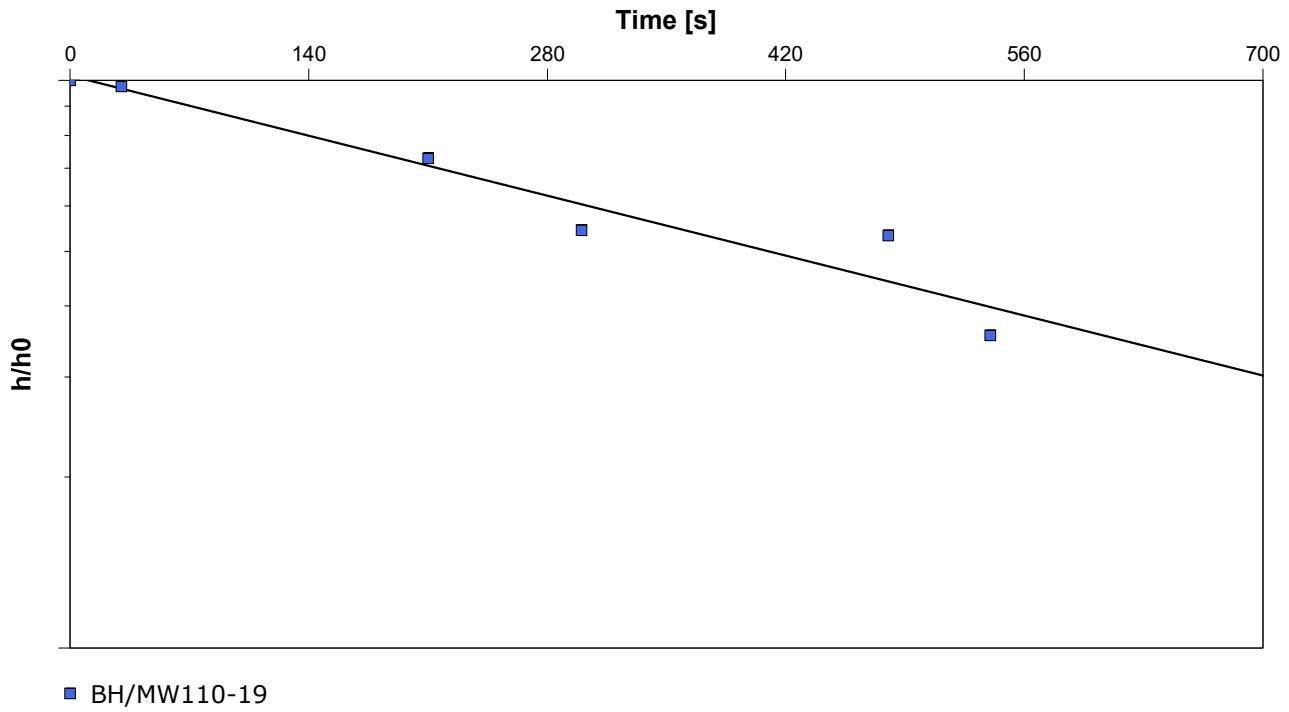
Calculation using Hvorslev

Analysis Performed by: Sudhakar Kurli      Hvorslev      Analysis Date: 6/25/2021

Aquifer Thickness: 3.64 m

Observation Well	Hydraulic Conductivity [m/s]
BH/MW110-19	$1.24 \times 10^{-6}$
