## Phase One Environmental Site Assessment

20 Rose Street, Barrie, Ontario

June 20, 2024

Project 2305493

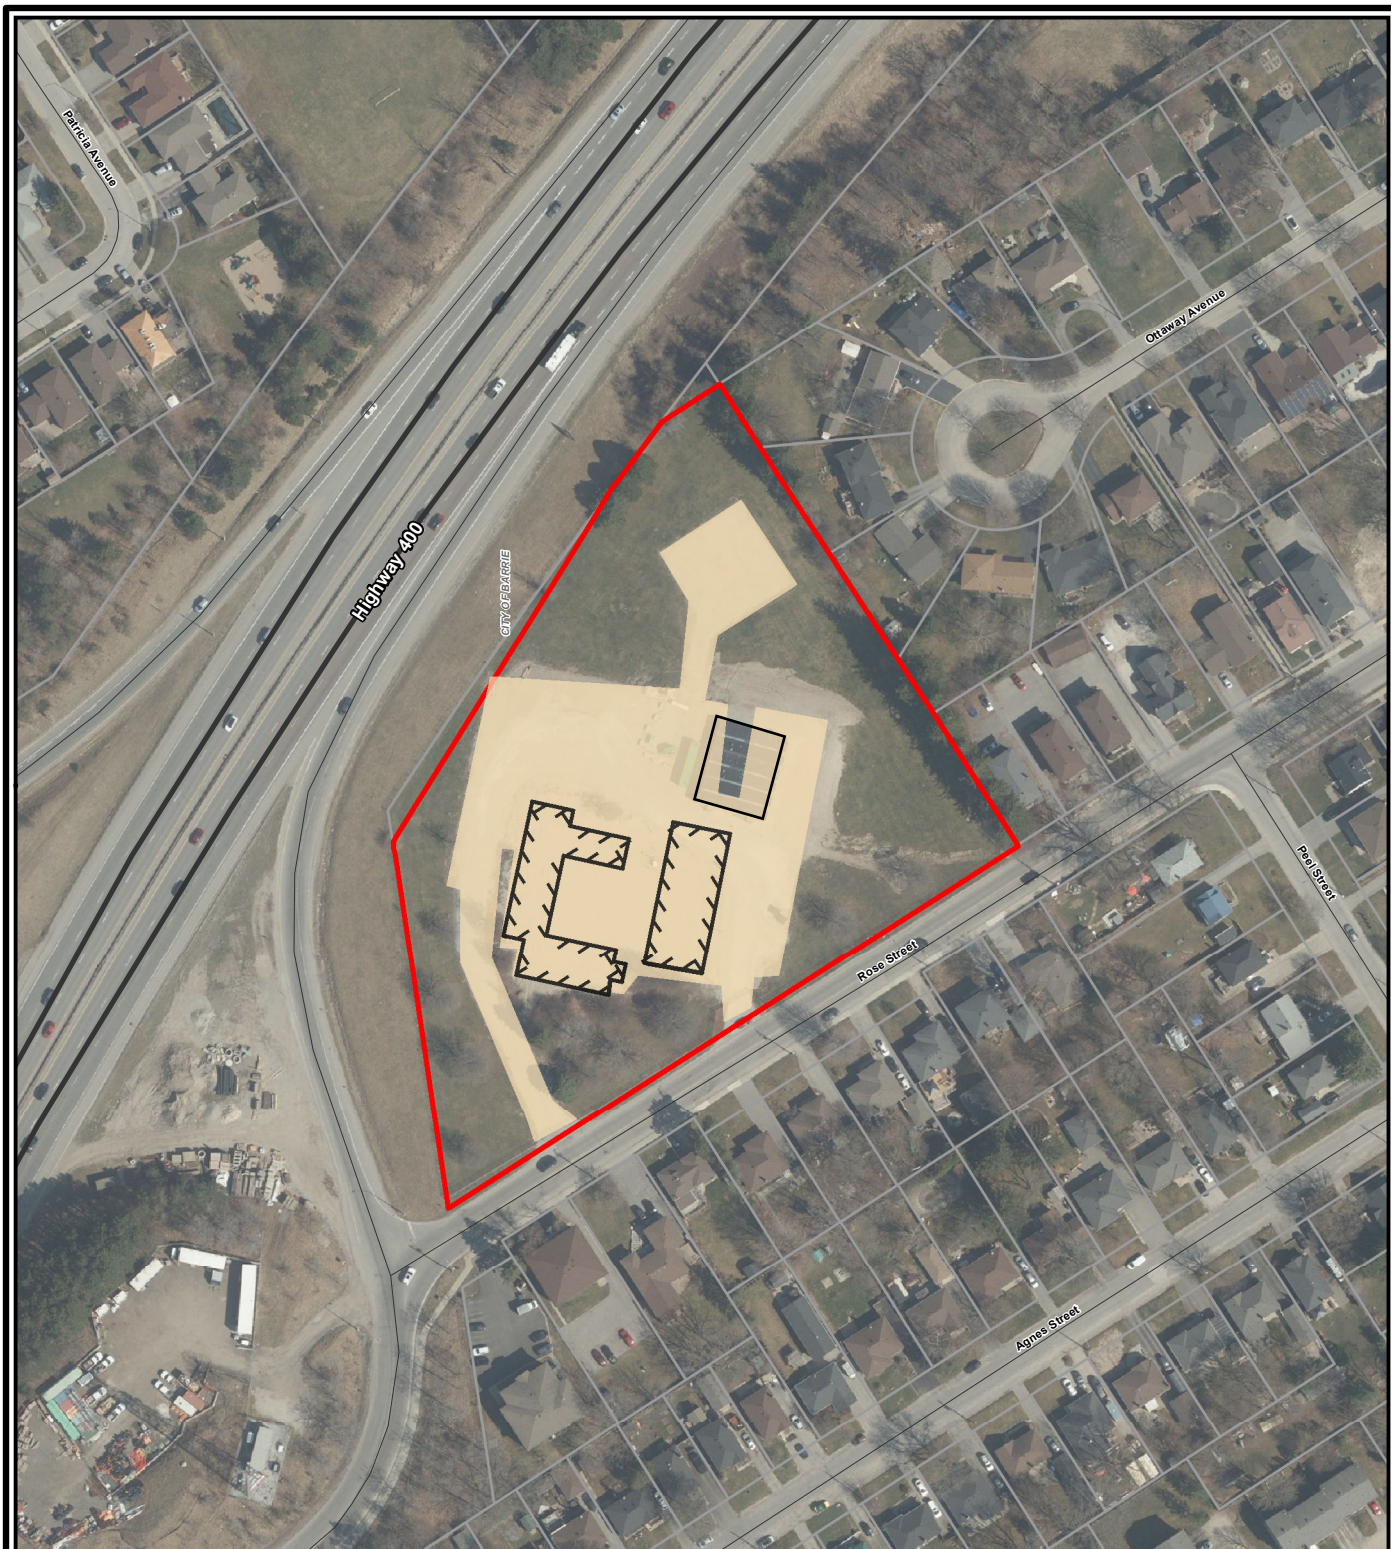
Fig. 1

The Site is located south adjacent to Highway 400, east of Bayfield Street, and north of Rose Street in Barrie, Ontario, as shown on Figure 1. The Site is irregular in shape and measures approximately 4.7 acres (1.9 hectares) in size. At the time of this assessment, the majority of the site was vacant, except for a modular structure erected in 2023 in the middle portion of the site. This temporary structure, managed by the Simcoe County Housing Corporation, provides emergency shelter for homeless individuals.

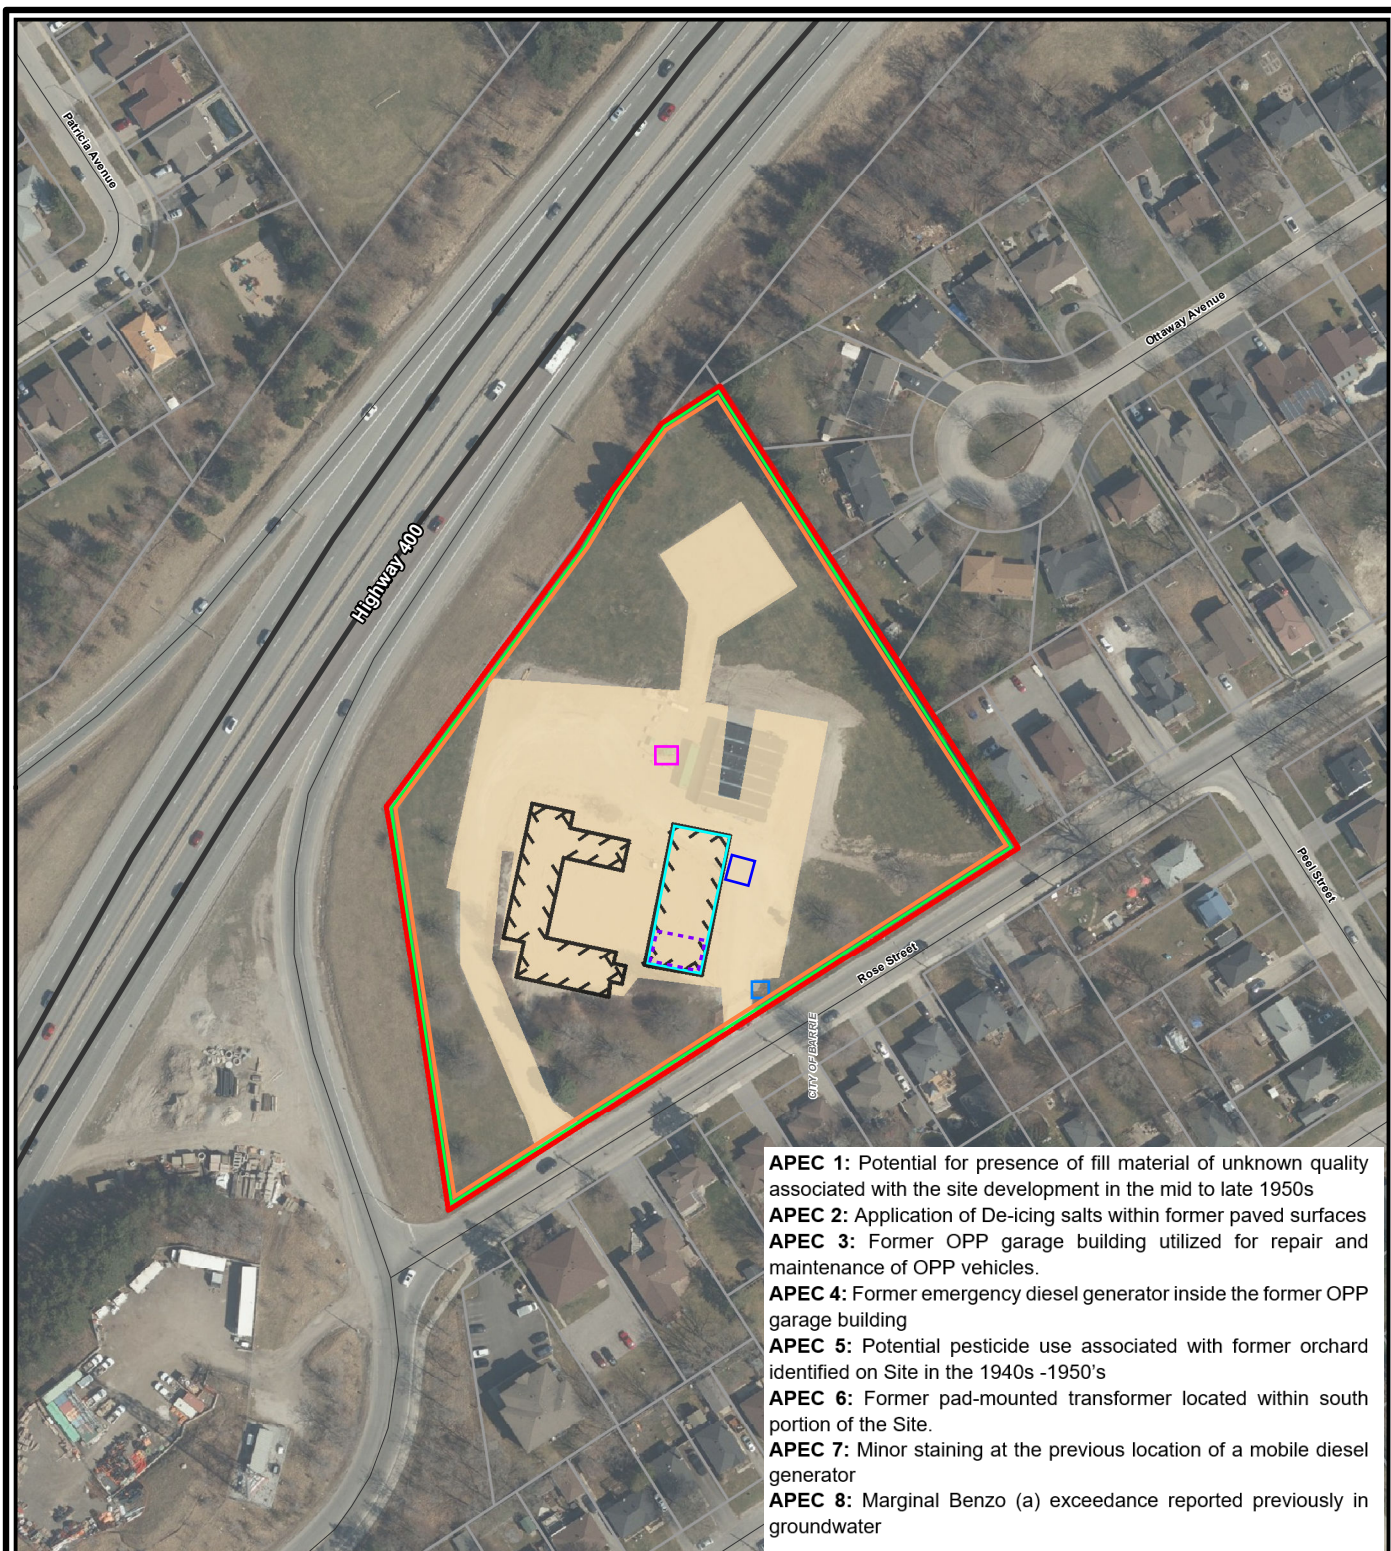
Fig. 3

The Phase One Study Area consists of properties within a distance of 250 m from the Site boundaries. All properties wholly or partly within 250 m from the Site boundaries consist of residential, institutional, community, commercial and parkland use properties. Additionally, an industrial use property at 92 Davidson Street, occupied by Jeff's Junk- Junk removal and Bin rental company is located northeast portion of the Phase One Study Area. The surrounding properties use are shown on Figure 3.

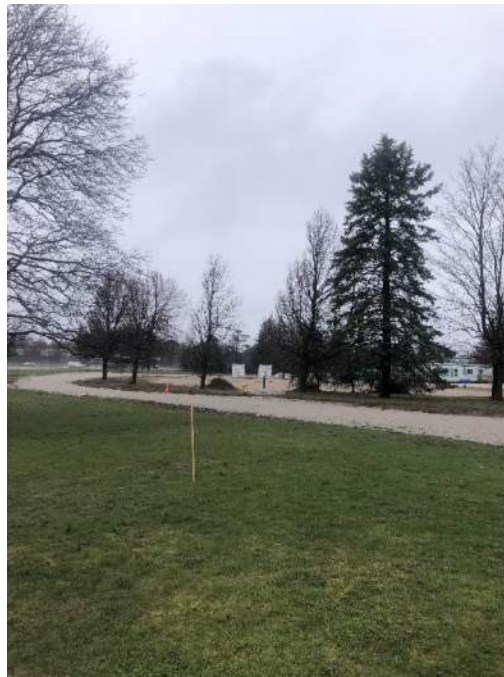
**Photo 1:** A view of the Site at 20 Rose Street, picture facing north.

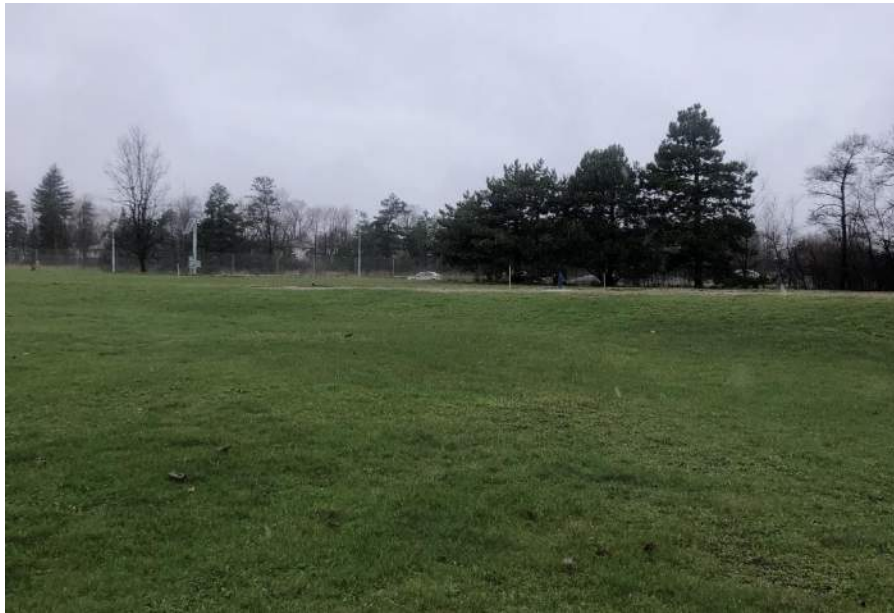
**Photo 2:** A view of the northern portion of the Site, picture facing north.

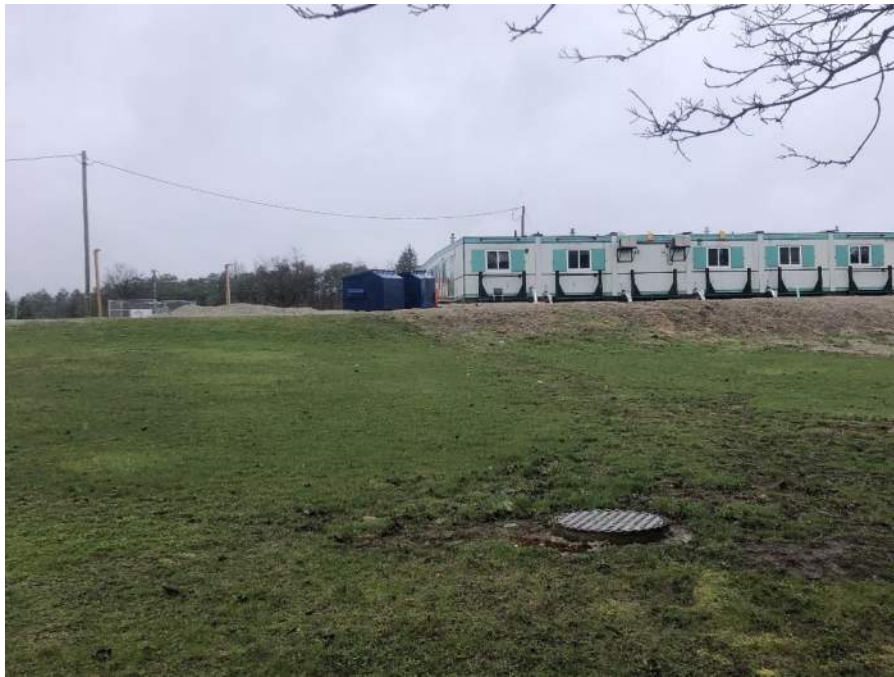
**Photo 3:** A view of the Site from the southeastern portion of the property with temporary mobile housing units, picture facing west.

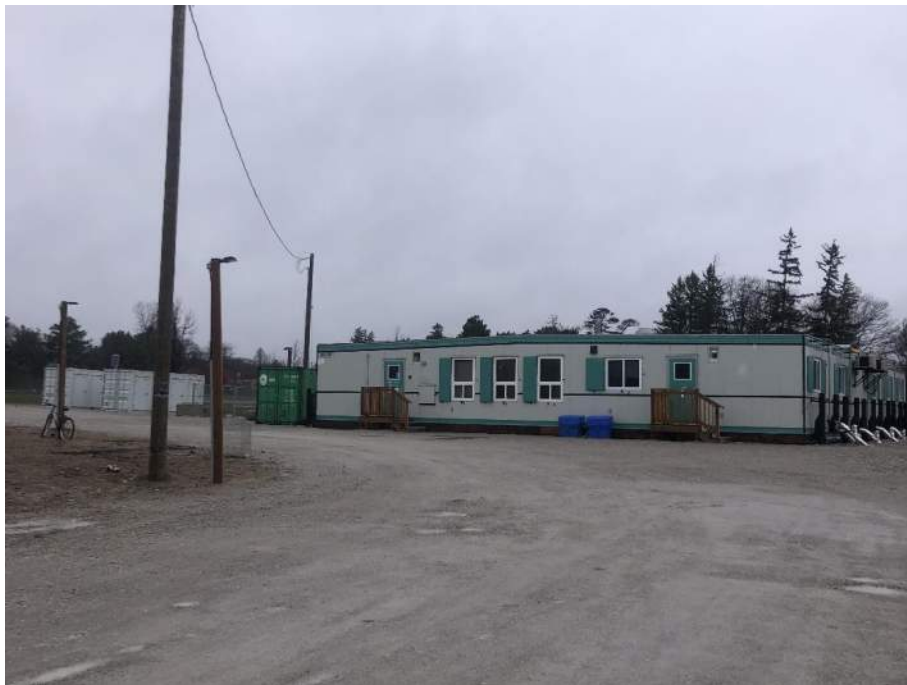
**Photo 4:** A view of the central portion of the Site with temporary diesel generator west of the temporary housing, picture facing north.

| <b>APEC</b> | <b>Location of APEC on Phase One Property</b> | <b>PCA</b> | <b>Location of PCA (On-Site or Off-Site)</b> | <b>COPCs</b> | <b>Media Potentially Impacted (Groundwater, soil and/or sediment)</b> |
|---|---|---|---|---|---|
| <b>APEC 7:</b><br>Minor staining at the previous location of a mobile diesel generator | Central portion of the Phase One Property | #Other –<br>Staining<br><b>(PCA 7)</b> | On-Site | BTEX, PHC | Soil |

The presence/absence and condition (if present) of ASTs at the Site was assessed during the Site reconnaissance. A rectangular metal AST storing diesel for a mobile generator was observed within the central portion of the Site, west of the temporary shelter structure. Minor staining was observed around this AST. The AST is associated with PCA#28 – Gasoline and Associated Products Storage in Fixed Tanks.

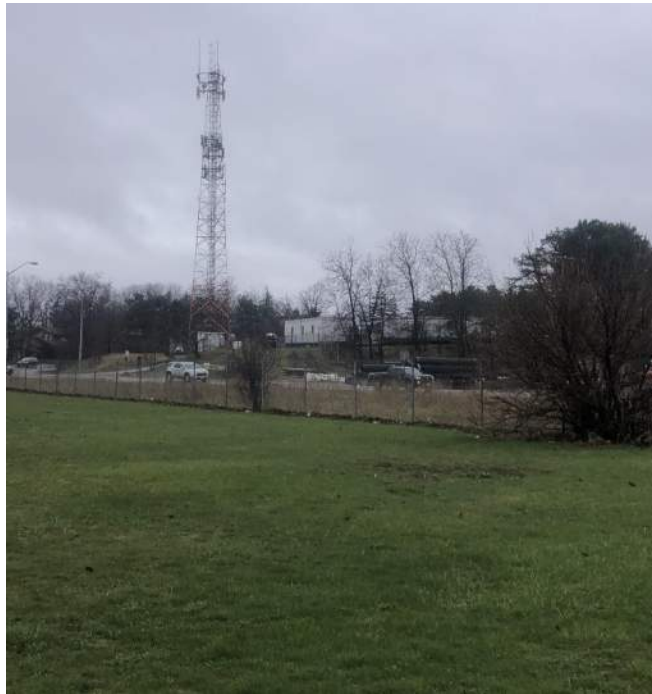
**Photo 5:** A view of Highway 400, northwest adjacent to the Site, picture facing northwest.

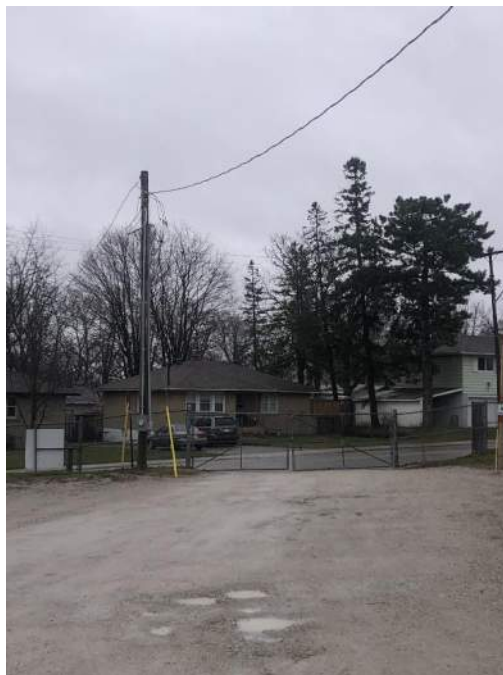
**Photo 6:** A view of Rose Street, picture facing south from southern portion of the Site.
