Phase One Environmental Site Assessment

1080 Lockhart Road, Barrie, Ontario

WSP Canada Inc.

May 13, 2024

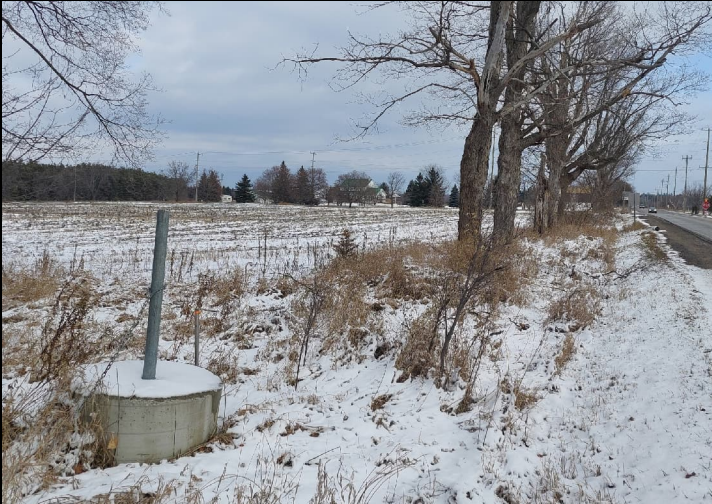
Photo 1: View of the southern portion of the Phase One Property at 1080 Lockhart Road in Innisfil, Ontario, facing northwest.

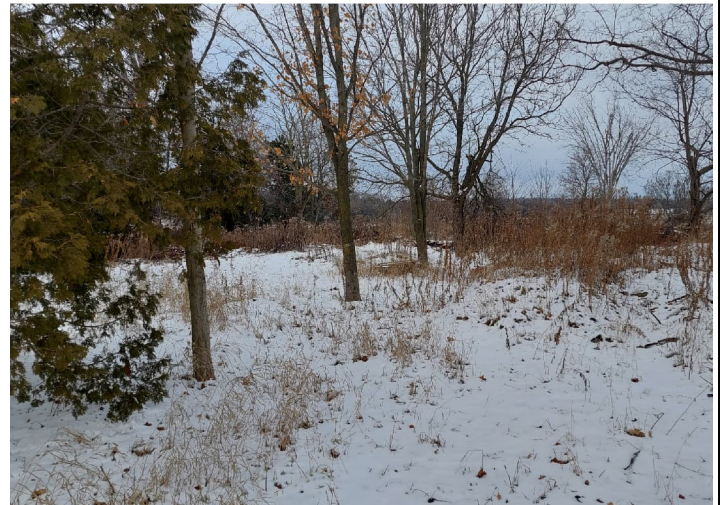
Photo 2: View of the southern portion of the Phase One Property, facing north.

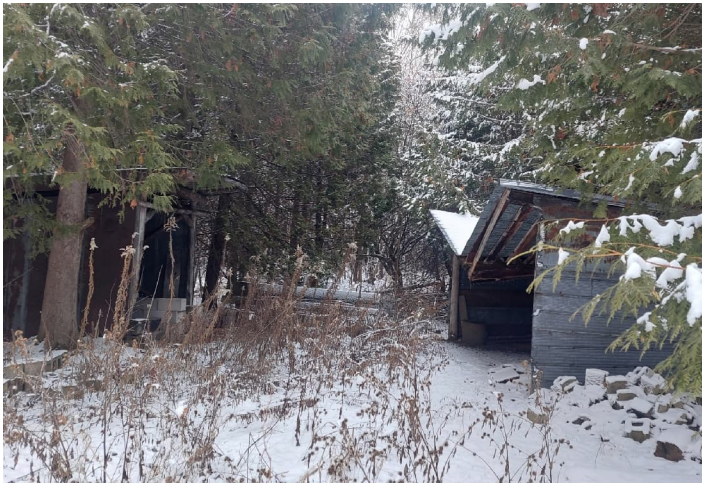
Photo 3: View of the decrepit structures located at the southern-central portion of the Site.

Topic	Observations	Source
Building Areas	No buildings were identified on Site at the time of the site reconnaissance. Two three-walled dilapidated sheds were identified at the northern-central portion of the Site	Site observations
Number of Floors (include all levels, whether above or below ground)	None were identified at the time of the site visit.	Site observations
Number, Age, and Depth of Levels Below Ground Level	None were identified at the time of the site visit.	Site observations
Number and Details of all ASTs	No ASTs were observed or reported on the Phase One Property.	Site observations and Site Representatives 2016 Phase One ESA
Number and Details of all Underground Storage Tanks (USTs)	No USTs were observed or reported on the Phase One Property.	Site observations and Site Representatives
Underground Utilities		
Potable and Non-Potable Water Sources	Potable water was previously supplied to the former residence by a drilled well (MECP Well ID 5701424). The well was drilled to a depth of 12.8 metres below ground surface on November 21, 1964. There is no decommissioning record filed with the MECP and thus, it is anticipated that the well remains on-Site. Per O.Reg.903, a licensed well technician will be required to decommission the well prior to Site development.	Site Representatives

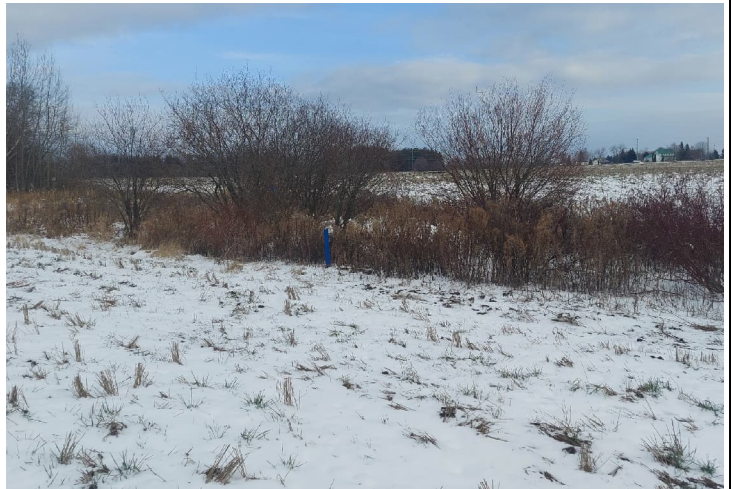
Photo 4: View of the central portion of the Site, facing north.

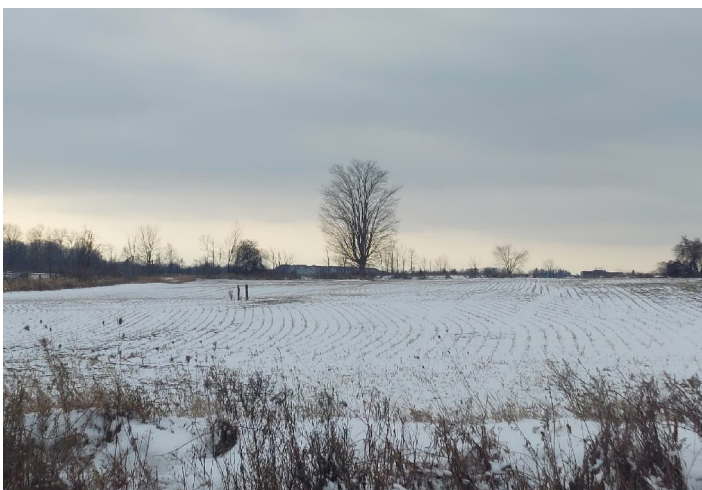
Photo 5: View of the northern portion of the Site, facing northwest.

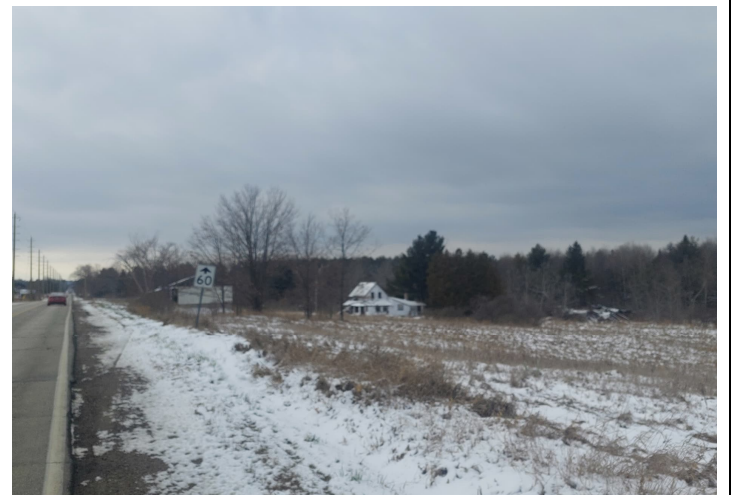
Photo 6: View of the residential and agricultural land use to the north east of the Site.

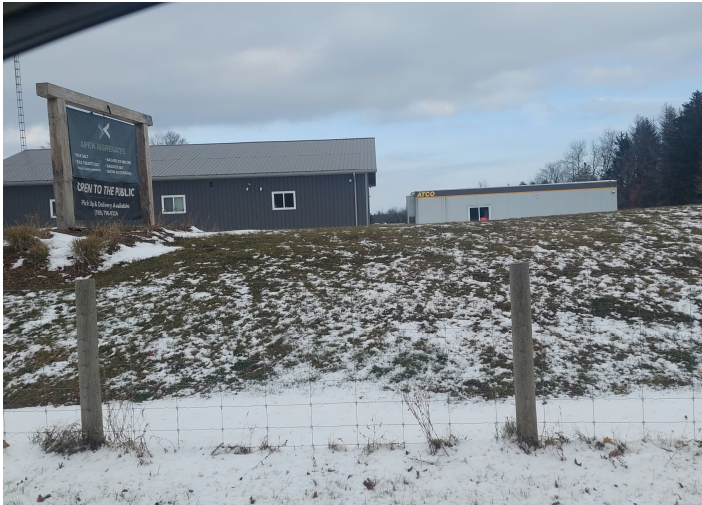
Photo 7: View of the APEX Aggregates facility located east of the Phase One Property.

Year	Phase One Property	Surrounding Area
1997	Generally, as per the 1989 aerial photograph.	Generally, as per the 1989 aerial photograph.
2012	Generally, as per the 1997 aerial photograph.	Generally, as per the 1997 aerial photograph.
2023	The Site appears to be comprised of agricultural land; no buildings or structures are noted to be present. Forested areas are noted to be present at the central portion of the Site and the tributary remains evident in the northern portion of the Site.	Generally, as per the 2012 aerial photograph, with the exception of construction for residential development noted to be present northwest of the Site and the presence of industrial use (APEX Aggregates) to the east of the Site.

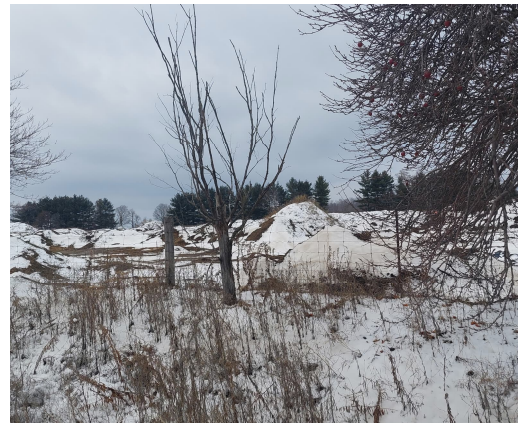
Photo 8: View of the fill piles to the north of the Phase One Property.

#30. Importation of Fill Material of Unknown Quality – Fill piles were noted on the property to the north, across Mapleview Drive.	Site visit	Based on the distance of this PCA and the direction of groundwater flow, this PCA is not anticipated to result in an APEC.
	N/S. Application of De-Icing Agents – Several roadways adjacent to the perimeter of the Phase One Property.	Site visit	Based on the type of contaminants associated with this PCA and proximity to the Phase One Property, this PCA is identified as an APEC.
