# 518-524 TIFFIN STREET, BARRIE, ON

MUNICIPAL FILE: D28-082-2021

LANDMARK ENVIRONMENTAL GROUP LTD.

PROJECT NO. LA 656-22

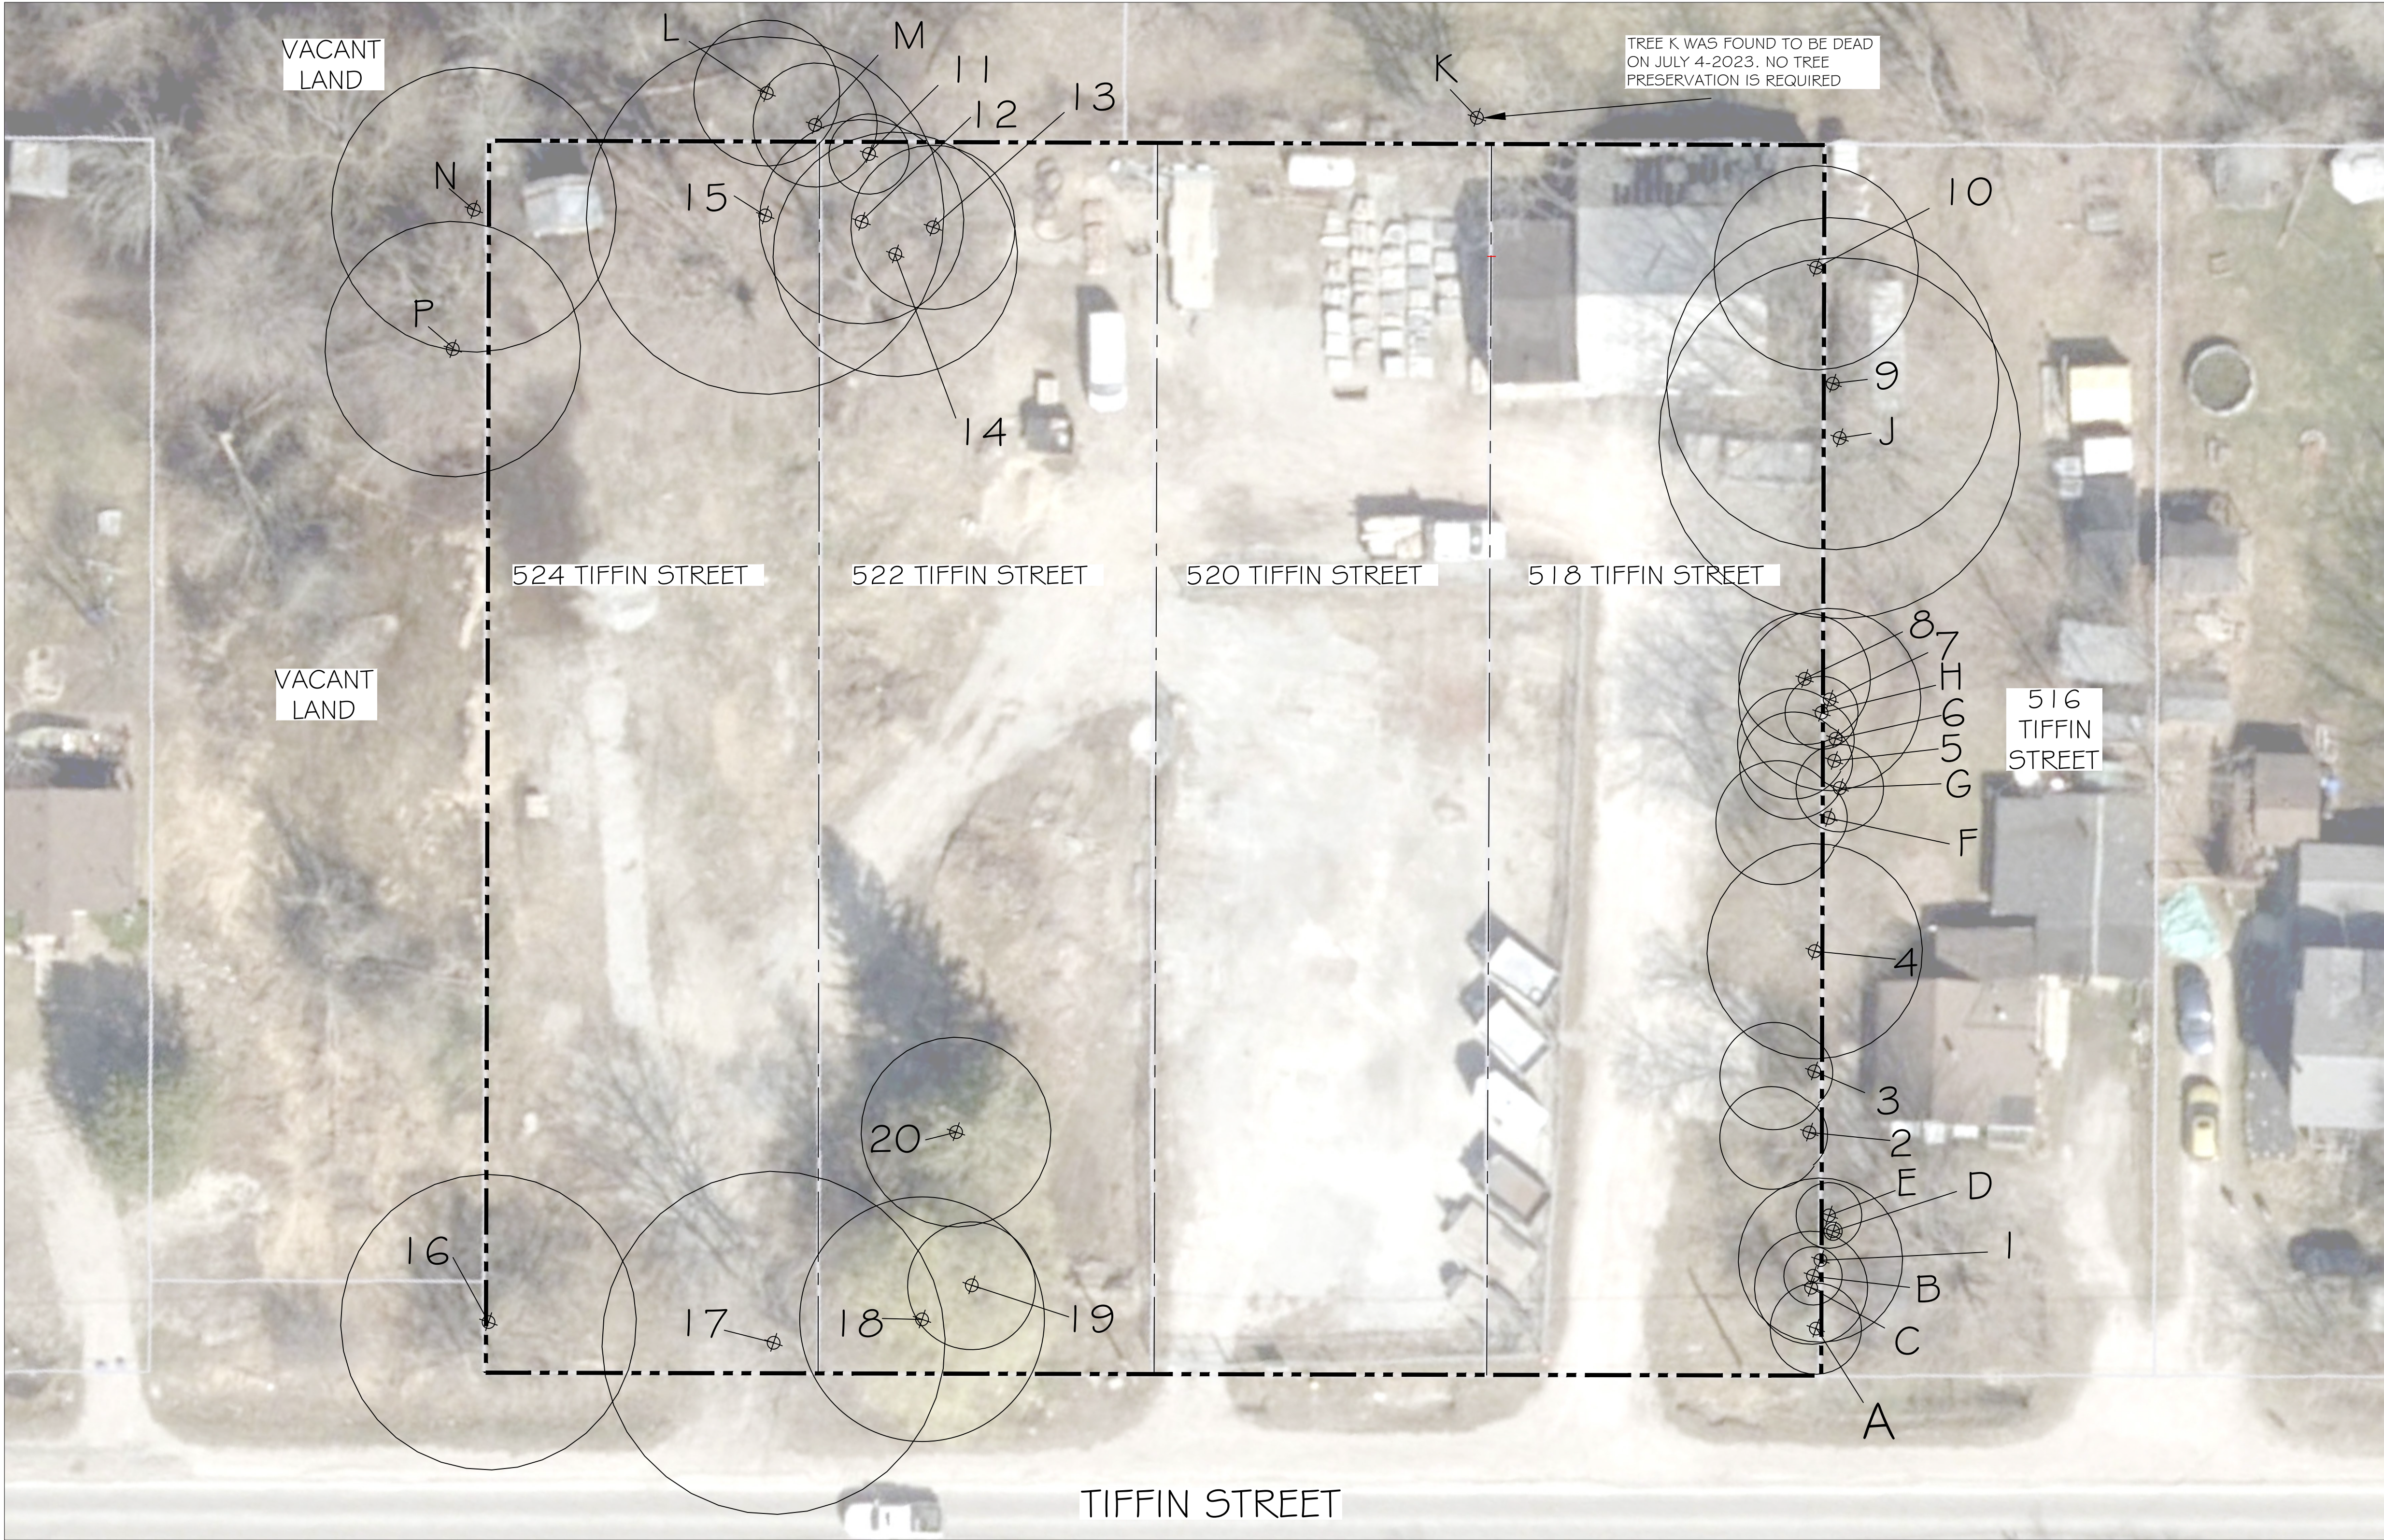
| | | DRAWING No.:<br>EX-1 | |

| DRAWING: | | EXISTING CONDITIONS | |

\*\*TREE LOCATIONS CAPTURED USING TRIMBLE GNSS UNITS AND ARCGIS SOFTWARE

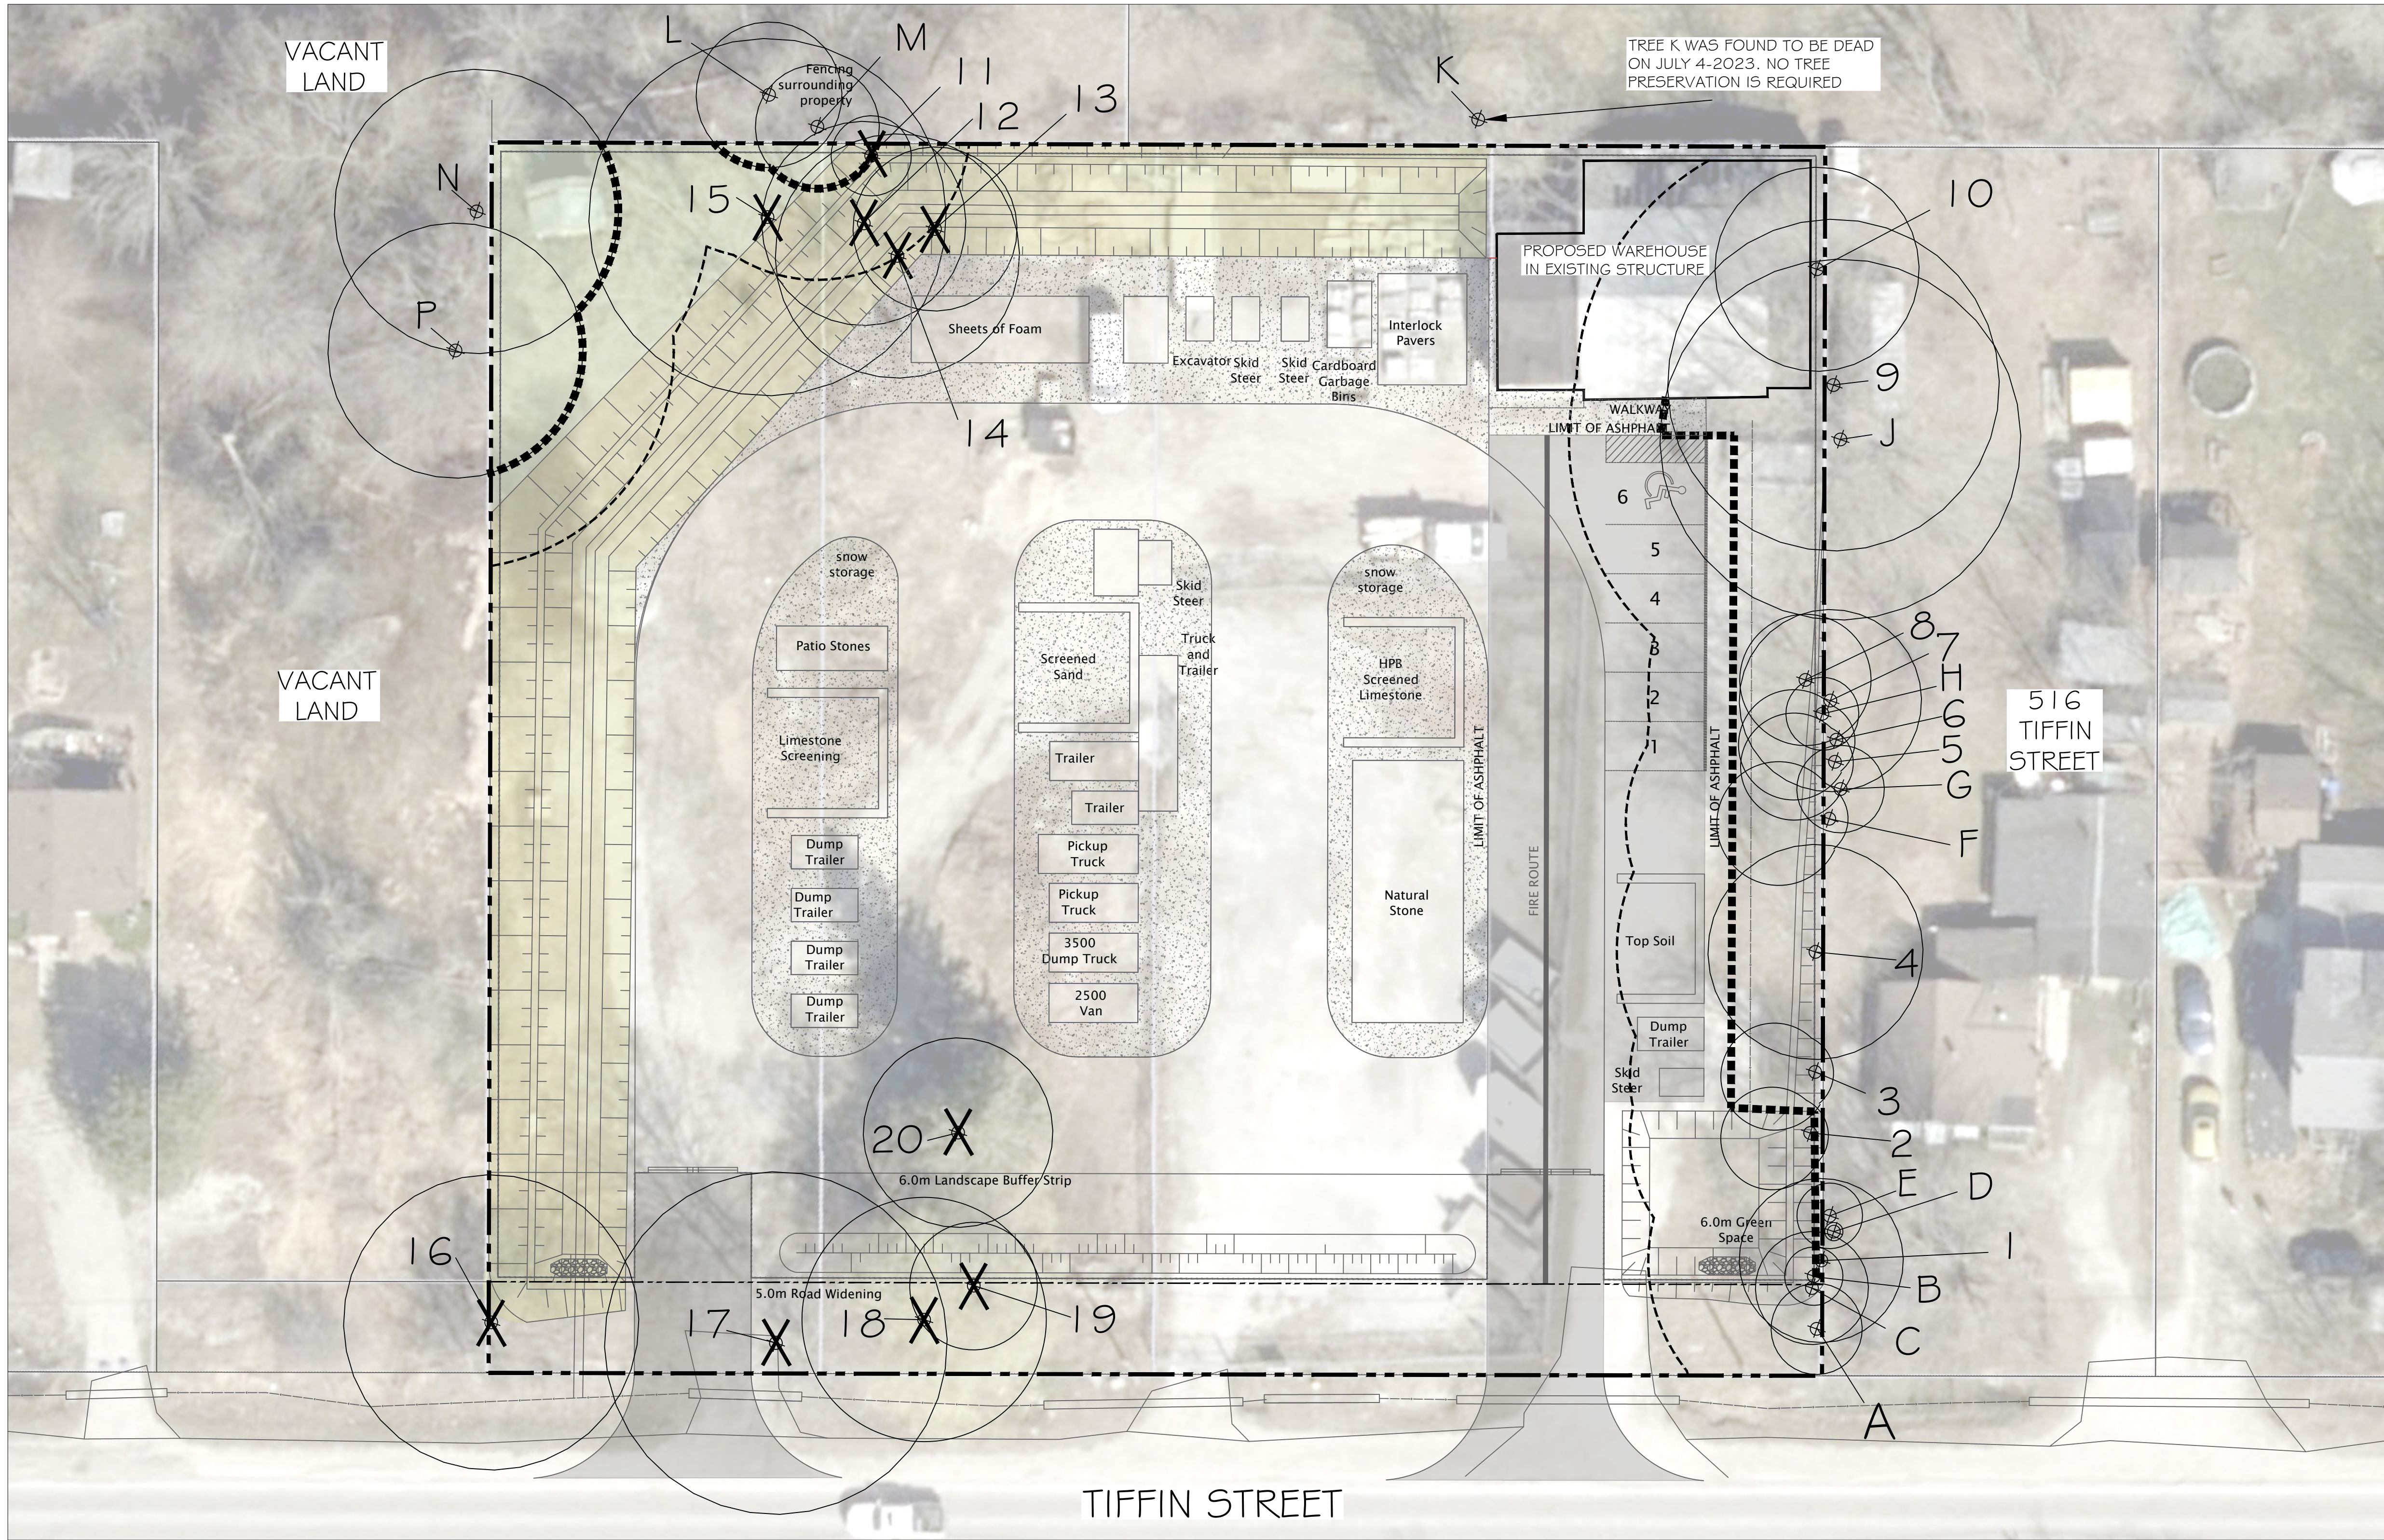
TP-1

\*\*TREE LOCATIONS CAPTURED USING TRIMBLE GNSS UNITS AND ARCGIS SOFTWARE

TREE PRESERVATION PLAN 1

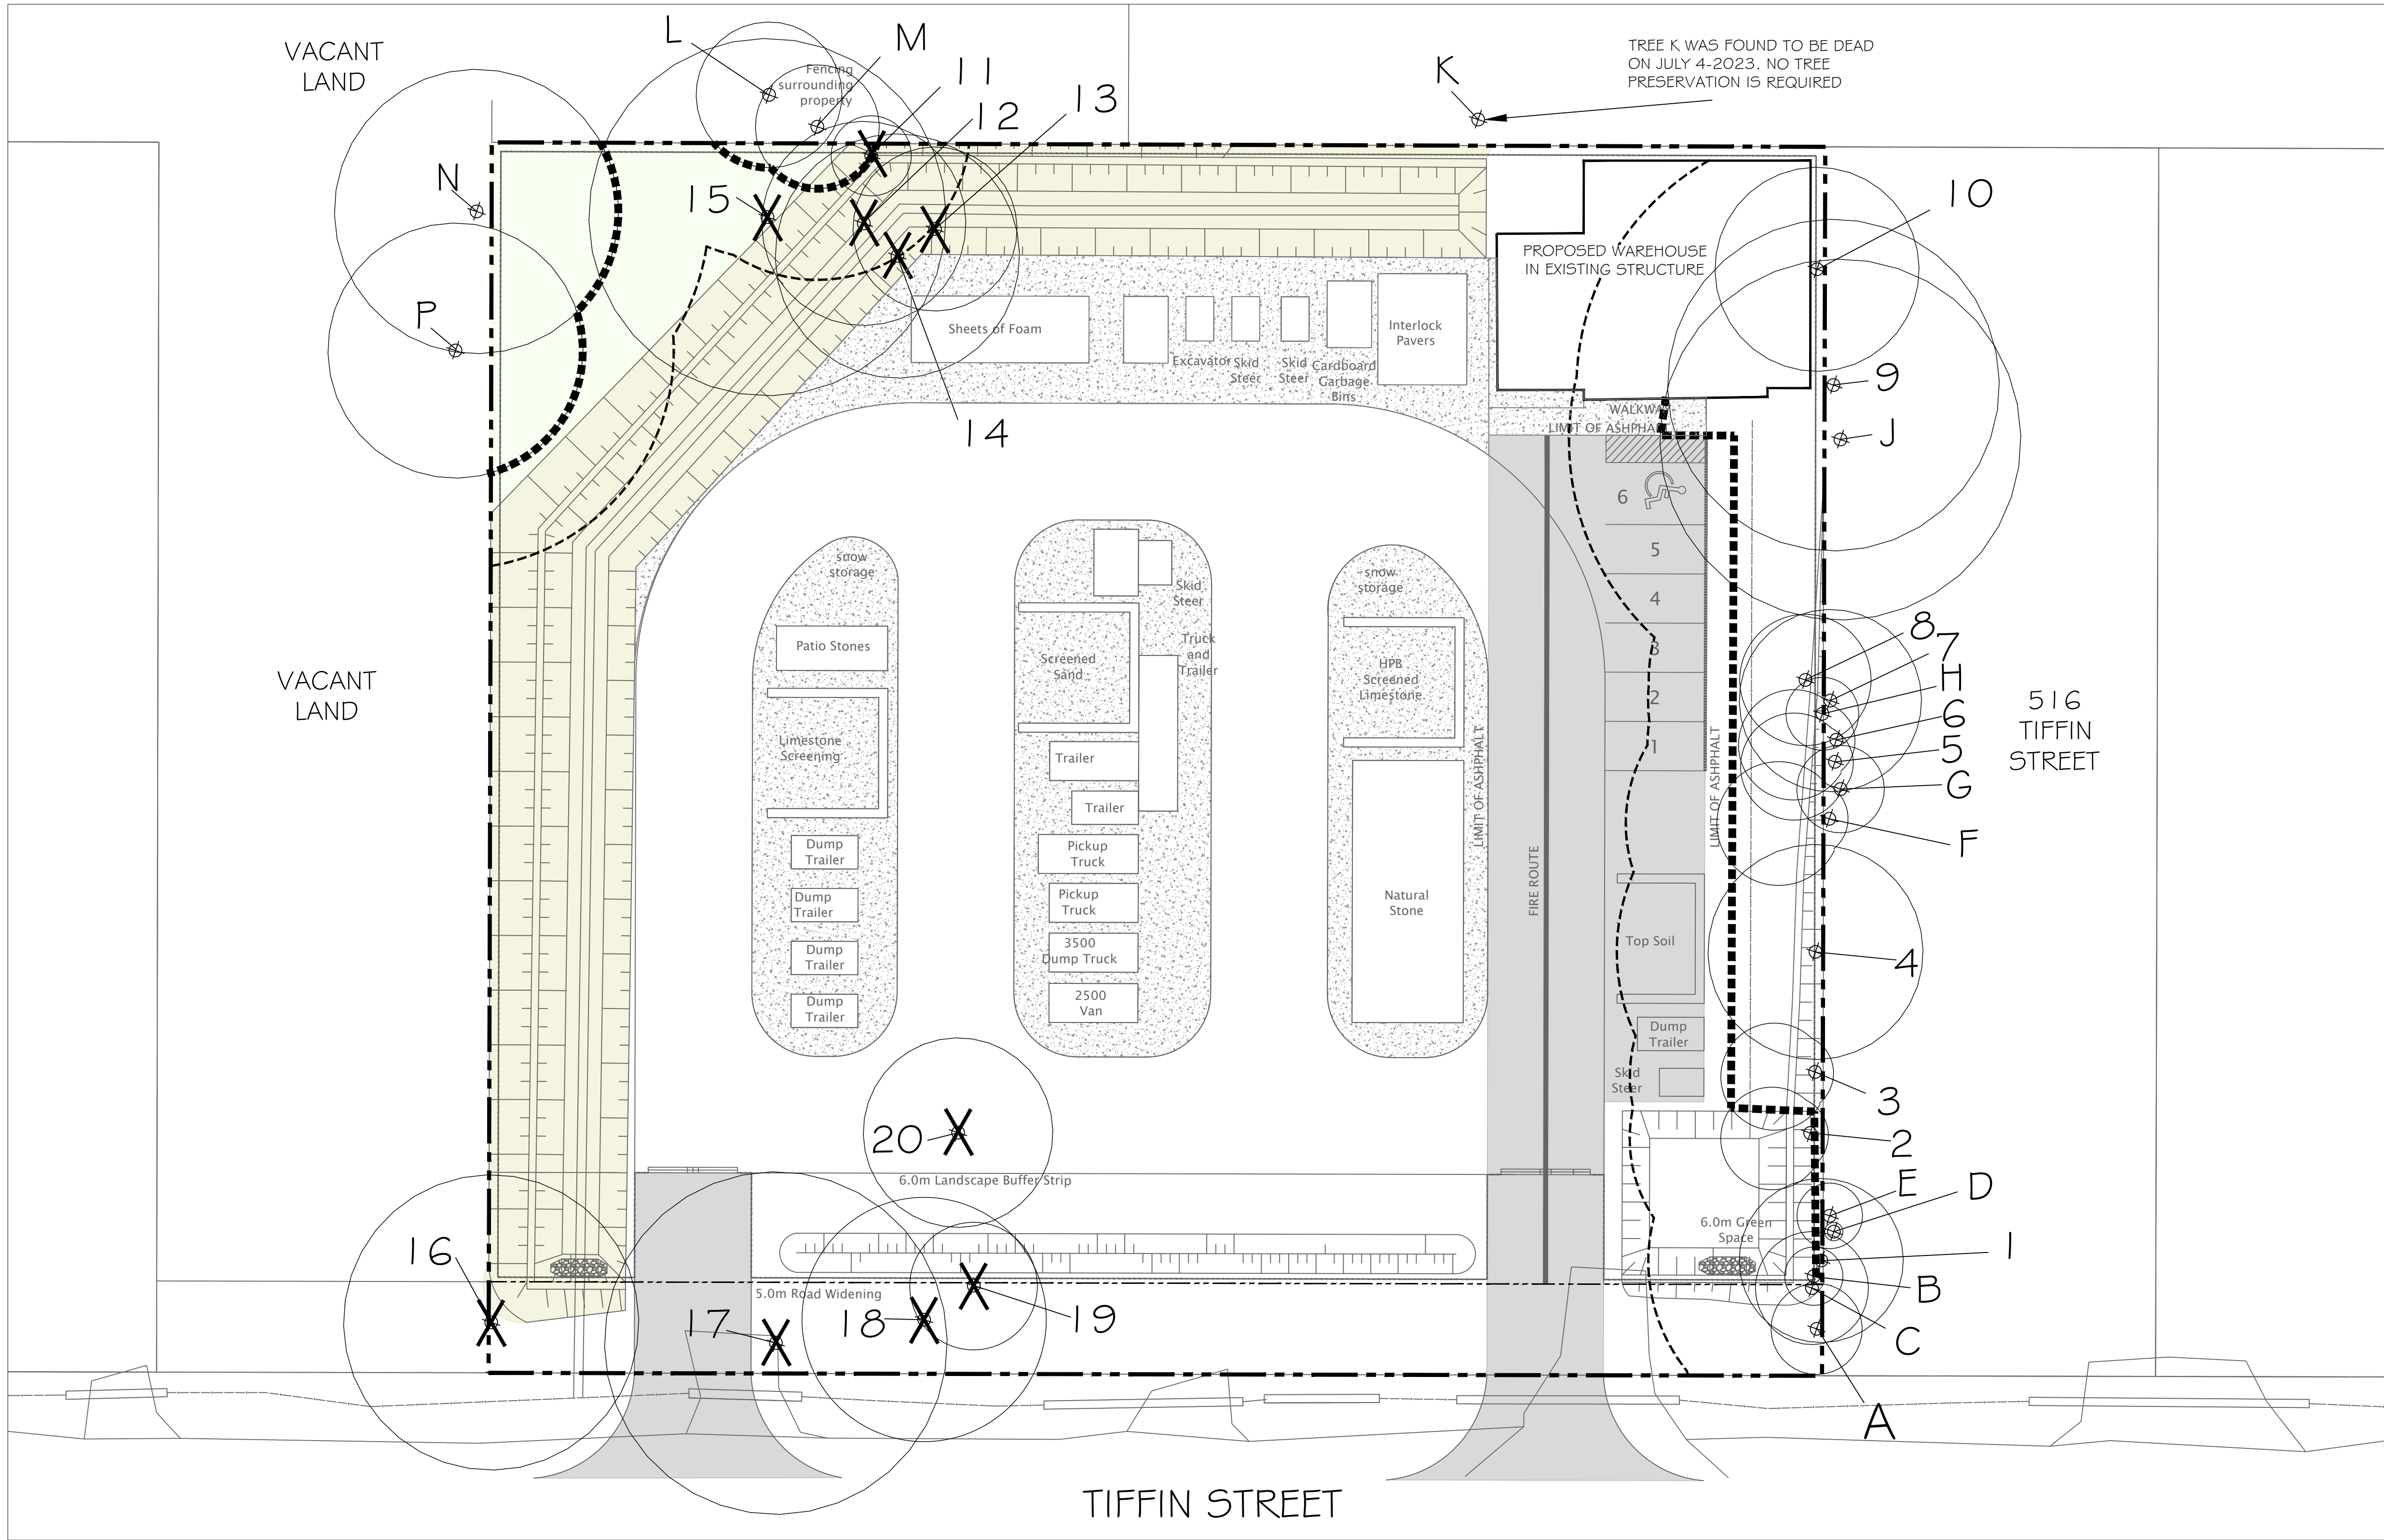
DRAWN BY: L.O/B.B. CHECKED BY: J.H. DRAWING No.: TP-2

DRAWING: TREE PRESERVATION PLAN 2

\*\*TREE LOCATIONS CAPTURED USING TRIMBLE GNSS UNITS AND ARCGIS SOFTWARE
