## Phase I Environmental Site Assessment

127 & 131 Ardagh Road, Barrie, Ontario

June 28, 2024  
Project 2403866

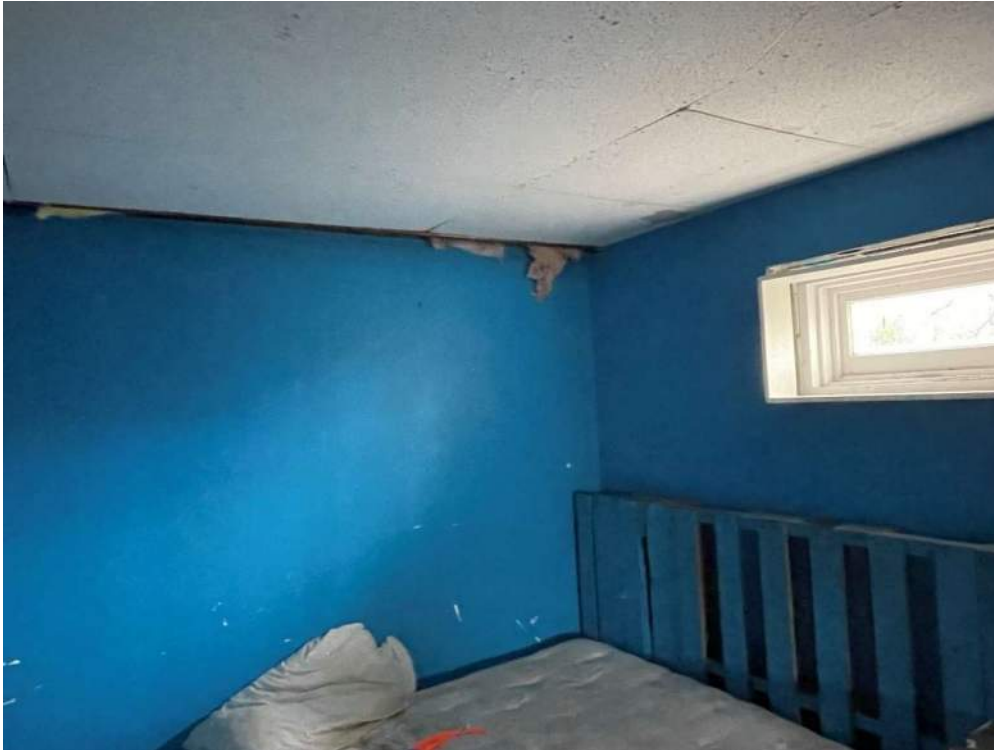
**PHOTOGRAPH 8**

View of fiberglass insulation from the ceiling in bedroom of 131 Ardagh Road, picture facing east.

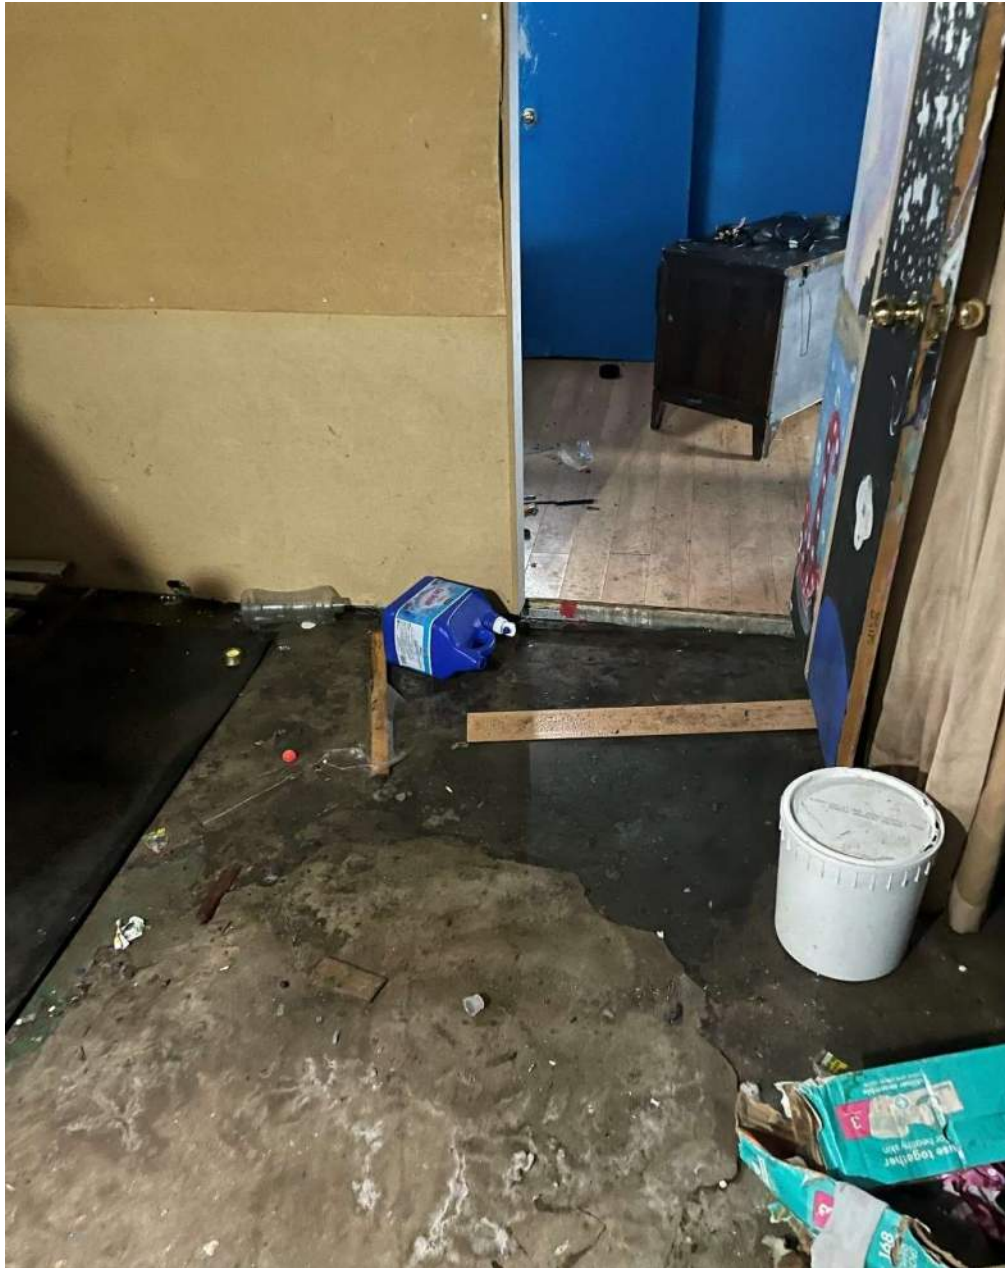
**PHOTOGRAPH  
10**

Debris and outdoor storage were observed around the Site building at 131 Ardagh Road during Site reconnaissance. Debris and outdoor storage were observed in the driveway and along southern wall off the Site building. The Site building at 131 Ardagh Road appeared to be poorly maintained. The interior of the residential dwelling appeared to be filled with debris and detritus and the basement showed evidence of water damage likely originating from a laundry machine

and leaking pipes. The southeastern exterior of the Site building at 131 Ardagh Road has been boarded up with plywood. The remainder of the Site appears to be well maintained.

View of the  
basement floor at  
131 Ardagh Road,  
washer leak from  
the laundry,  
picture facing  
west.

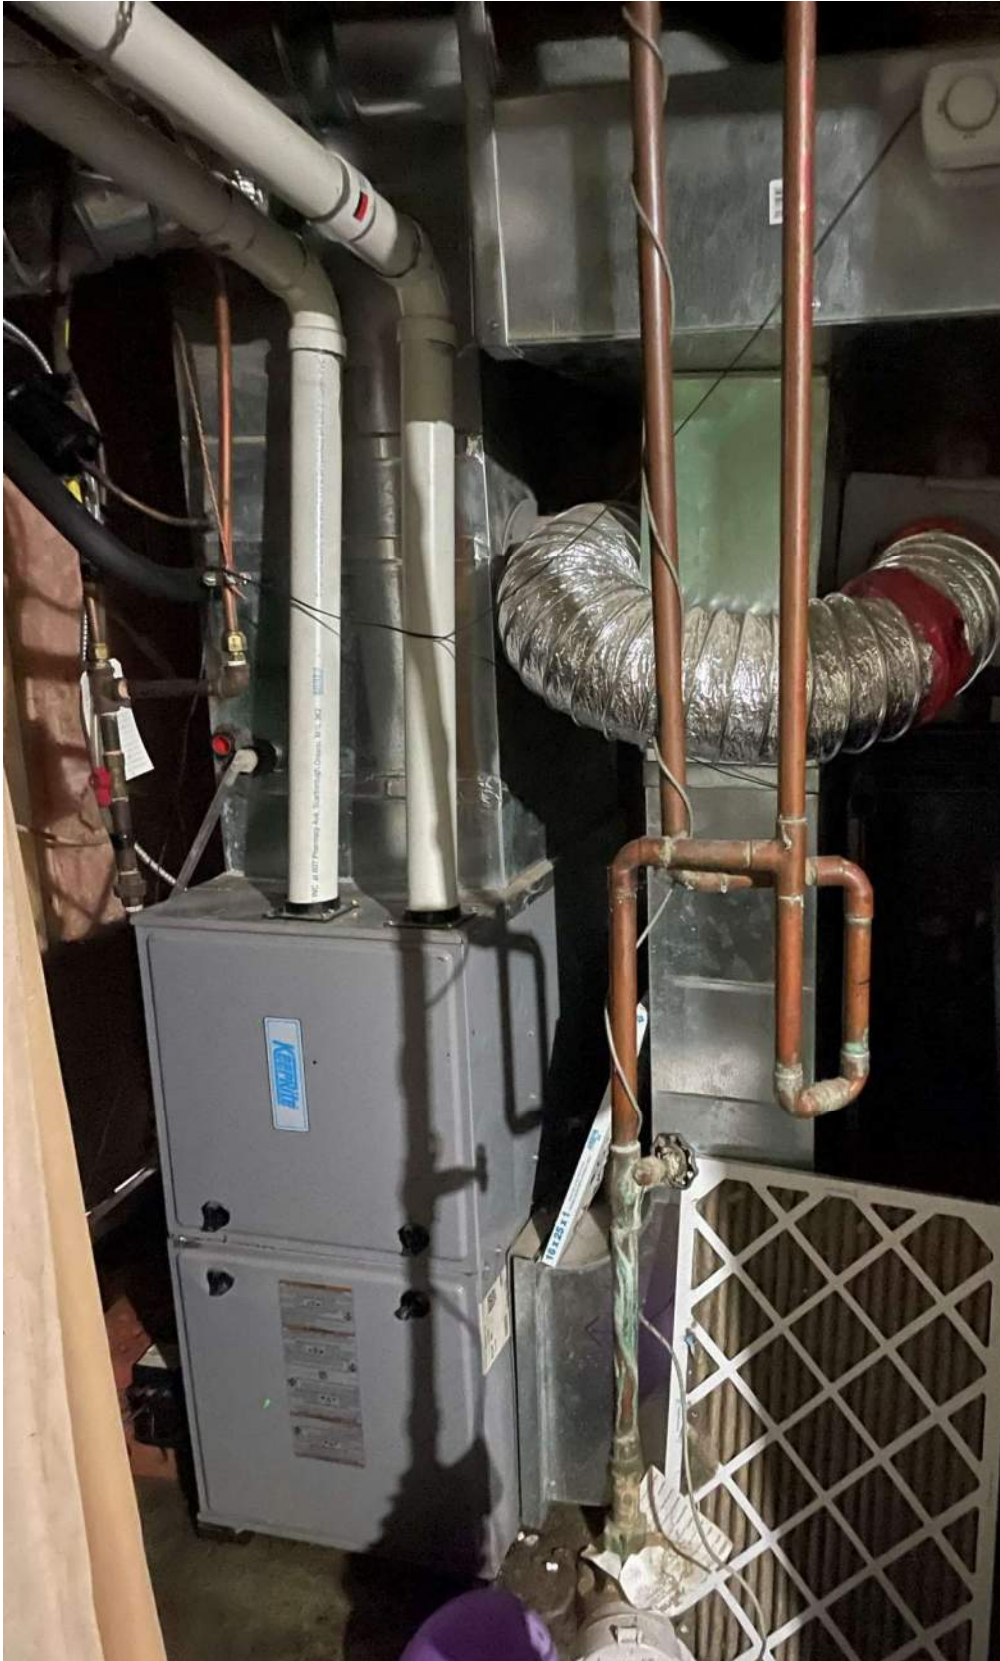
**PHOTOGRAPH**  
**11**

The Site building located at 131 Ardagh Road is heated by a wood stove, located on the southwest wall on the first floor and a gas furnace, located in the basement of the northwest corner of the Site building, and is cooled by an outdoor air conditioning unit, located near the northwest corner of the Site building. The Site building located at 127 Ardagh Road is heated by a gas furnace, located in the basement of the southeast corner of the Site building.

**Description:**  
View of the gas  
furnace located in  
the basement of  
131 Ardagh Road,  
picture facing  
northwest.

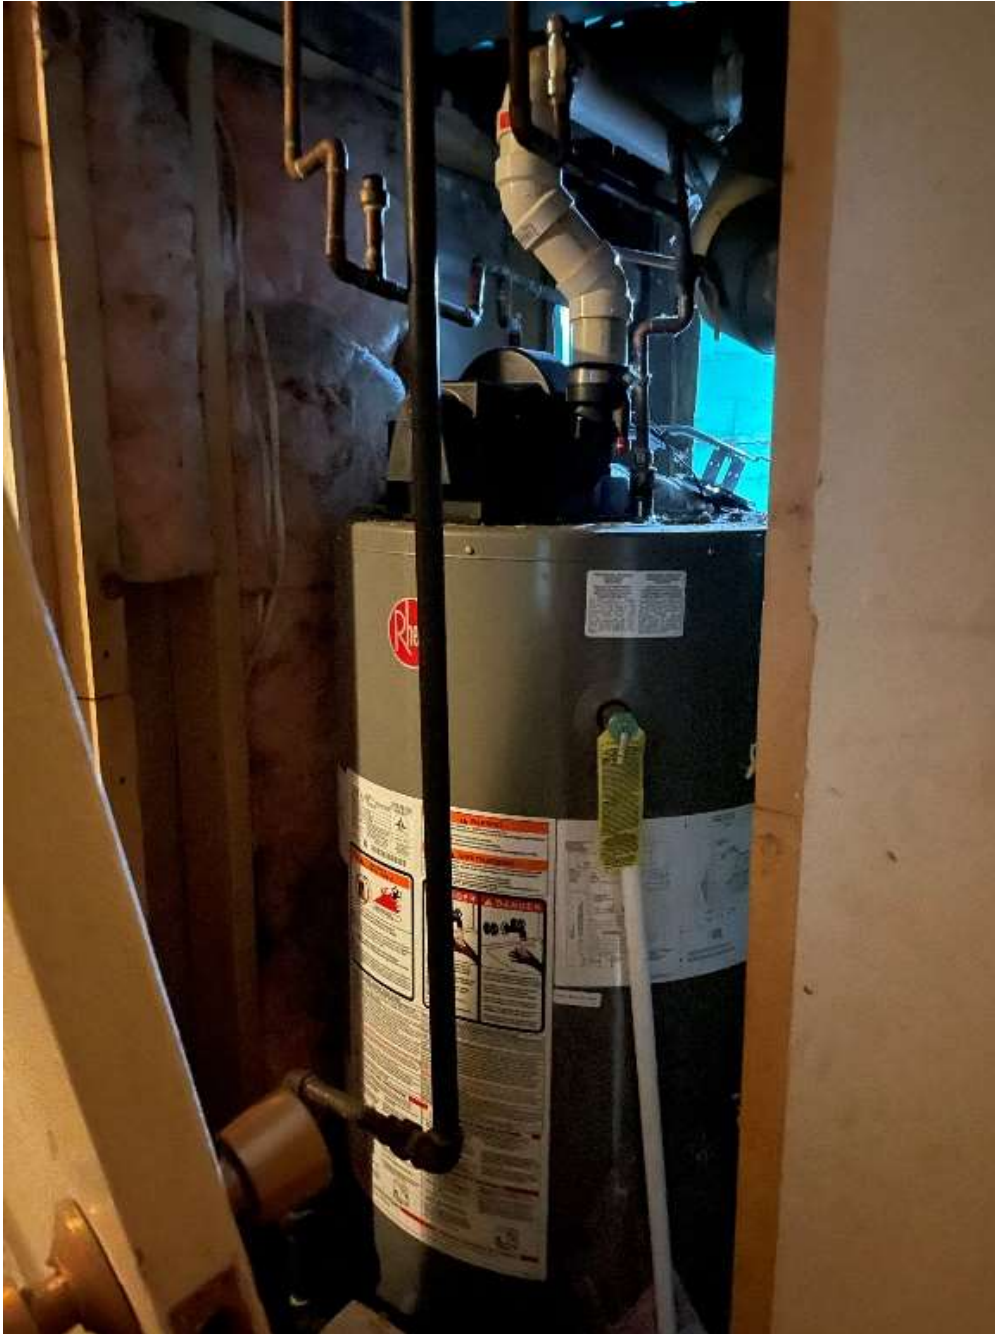
**PHOTOGRAPH  
13**

**Description:**  
View of the hot water tank from the back in the basement of 131 Ardagh Road, picture facing south.

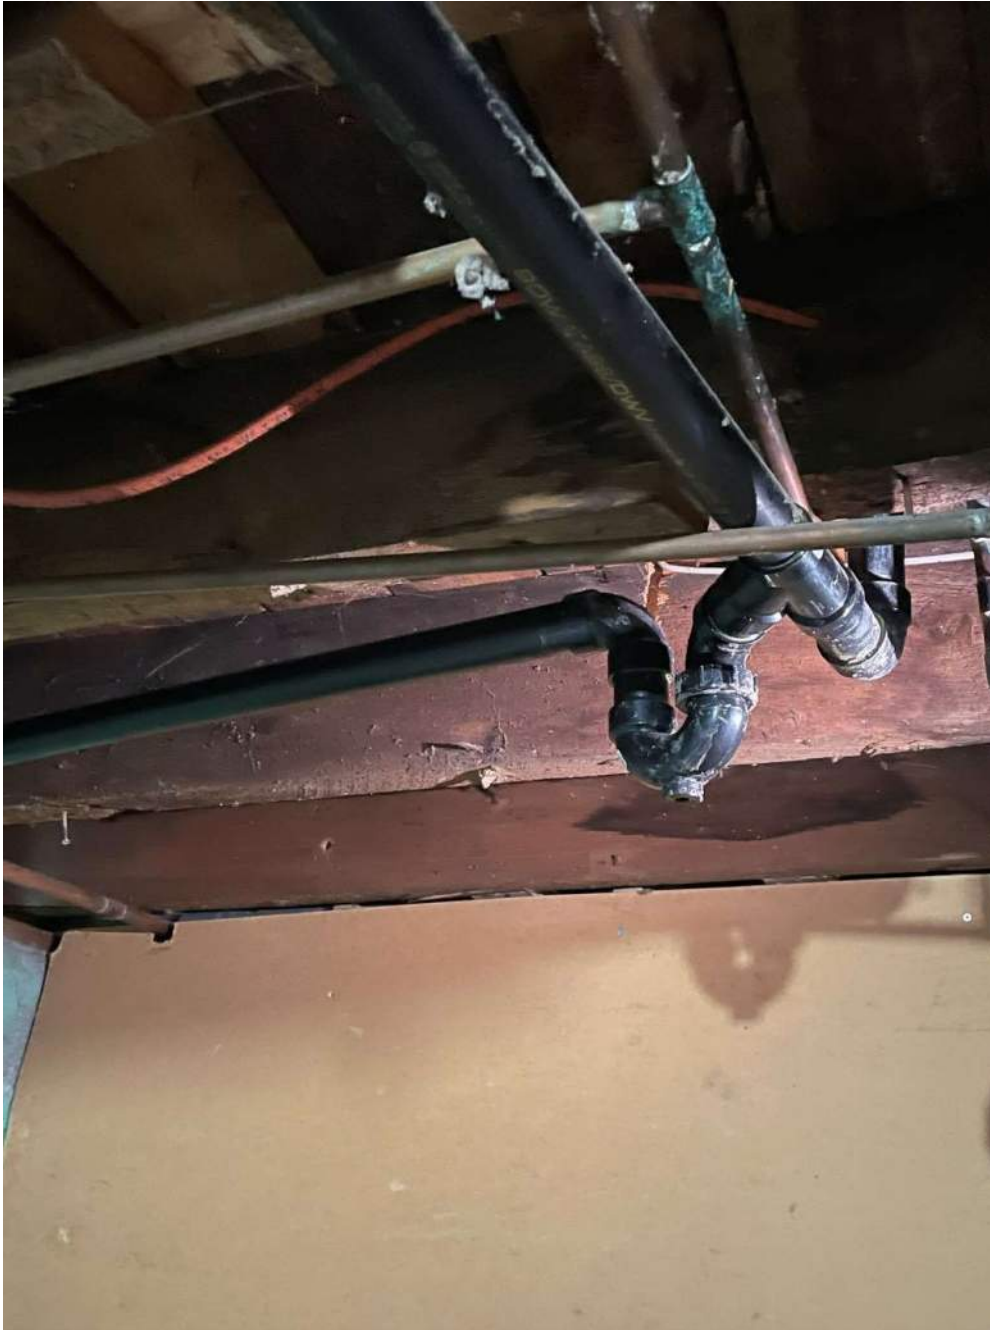
**PHOTOGRAPH**  
**14**

**Description:**  
View of leaking  
pipes in the  
basement ceiling  
of 131 Ardagh  
Road, picture  
facing southwest.

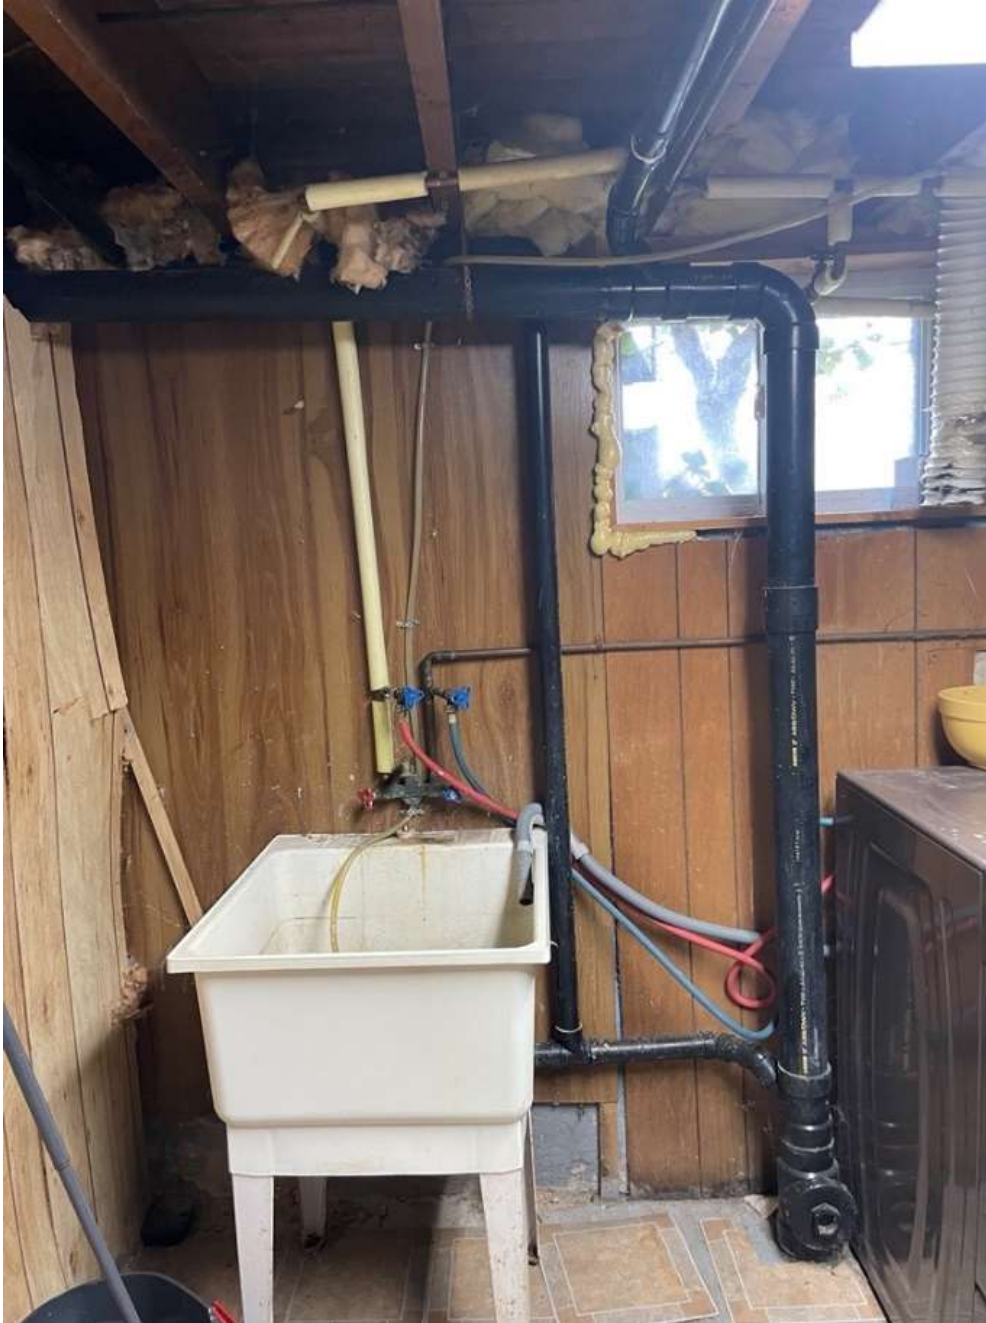
**PHOTOGRAPH**  
**38**

**Description:**  
View of the hot  
water tank in the  
basement of 127  
Ardagh Road.

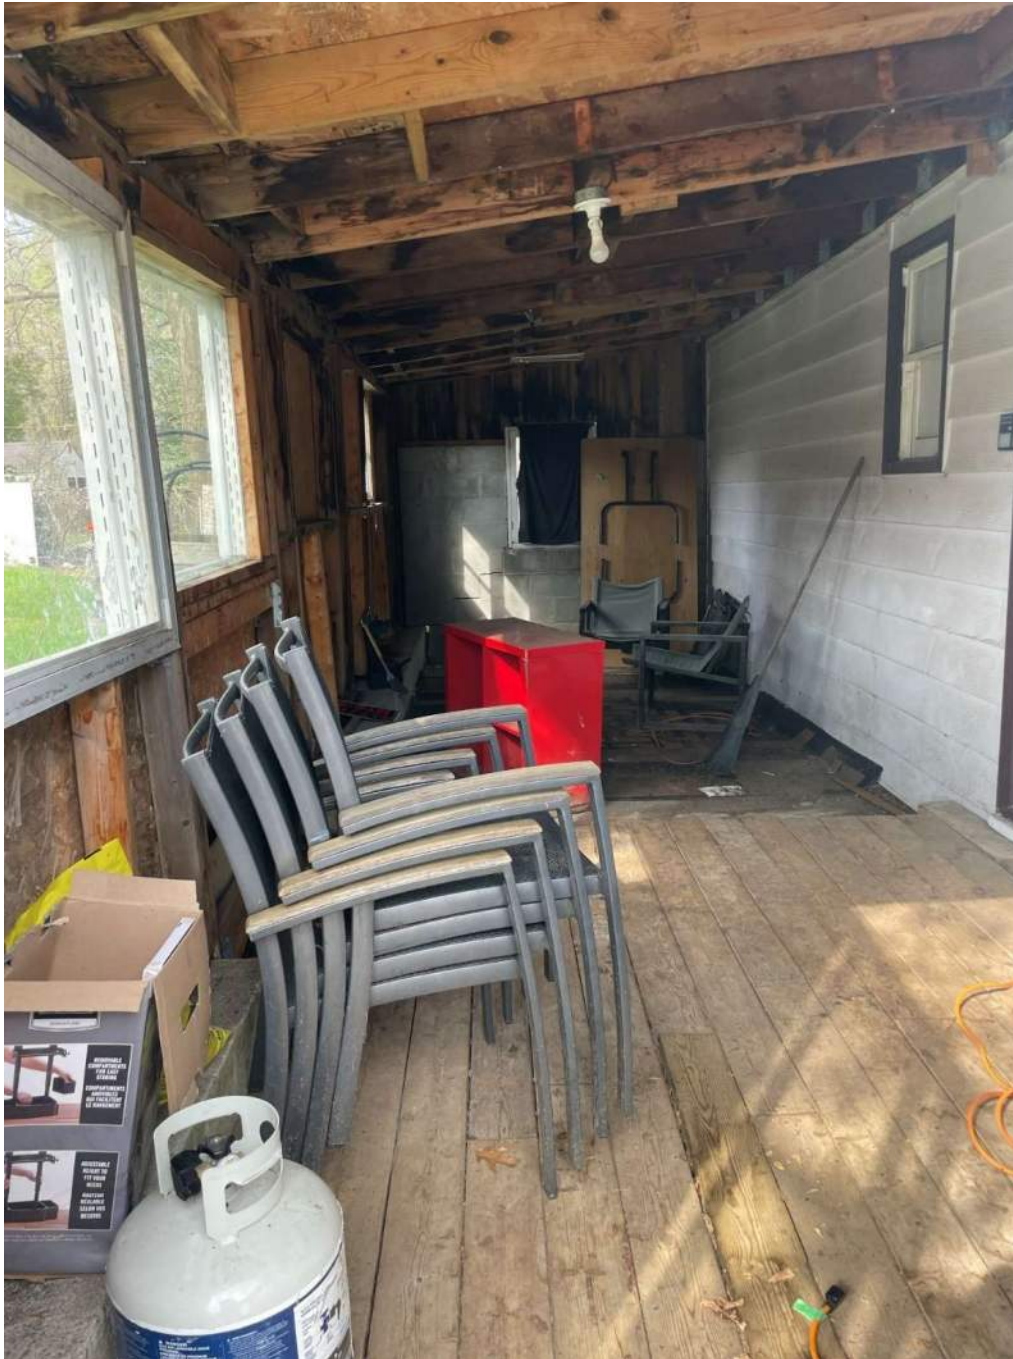
**PHOTOGRAPH**  
**39**

The Site building at 127 Ardagh Road appeared to be well maintained. The attached shed on the south side of the residential dwelling appeared to show evidence of water leaks and water damage. The remainder of the Site appears to be well maintained.

**Description:**  
View of the shed  
attached to the  
building of 127  
Ardagh Road,  
picture facing  
west.
