## Phase One Environmental Site Assessment

894 Lockhart Road, Innisfil, Ontario

June 12, 2024  
Project 2403777

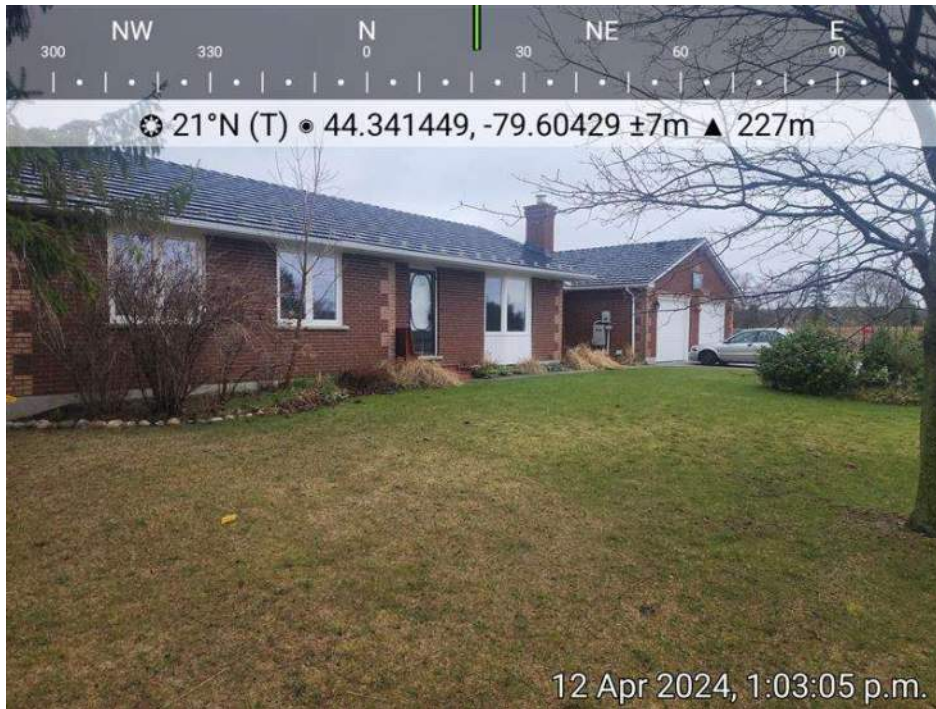
**PHOTOGRAPH 1**

**Description:**  
Frontage of the residential dwelling at 894 Lockhart Road (Site) in Innisfil. Picture facing northeast.

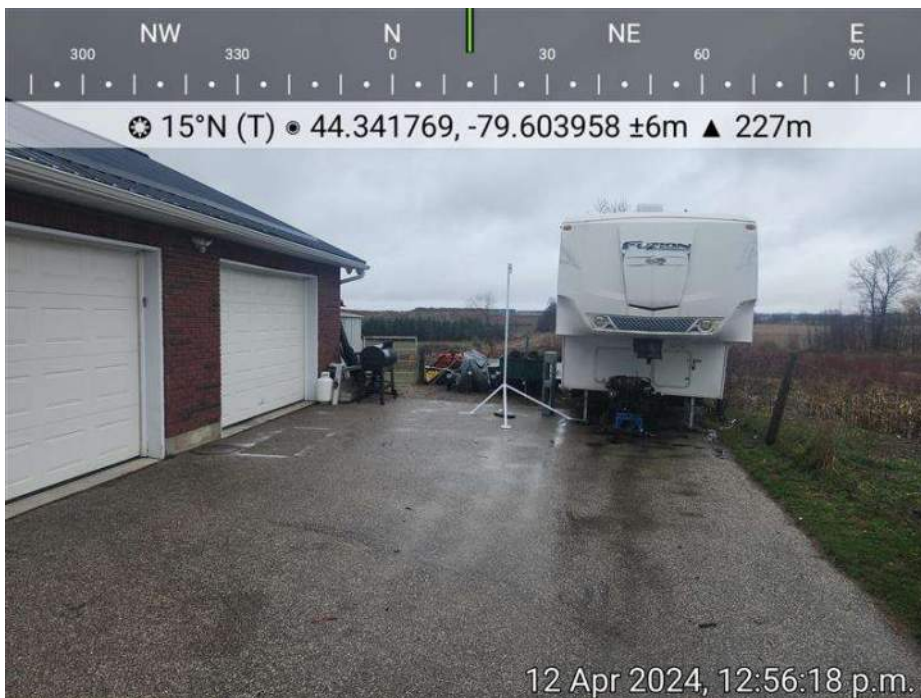
**PHOTOGRAPH 2**

**Description:**  
Detached garage and a trailer situated north of the residential dwelling at the Site. Picture facing northeast

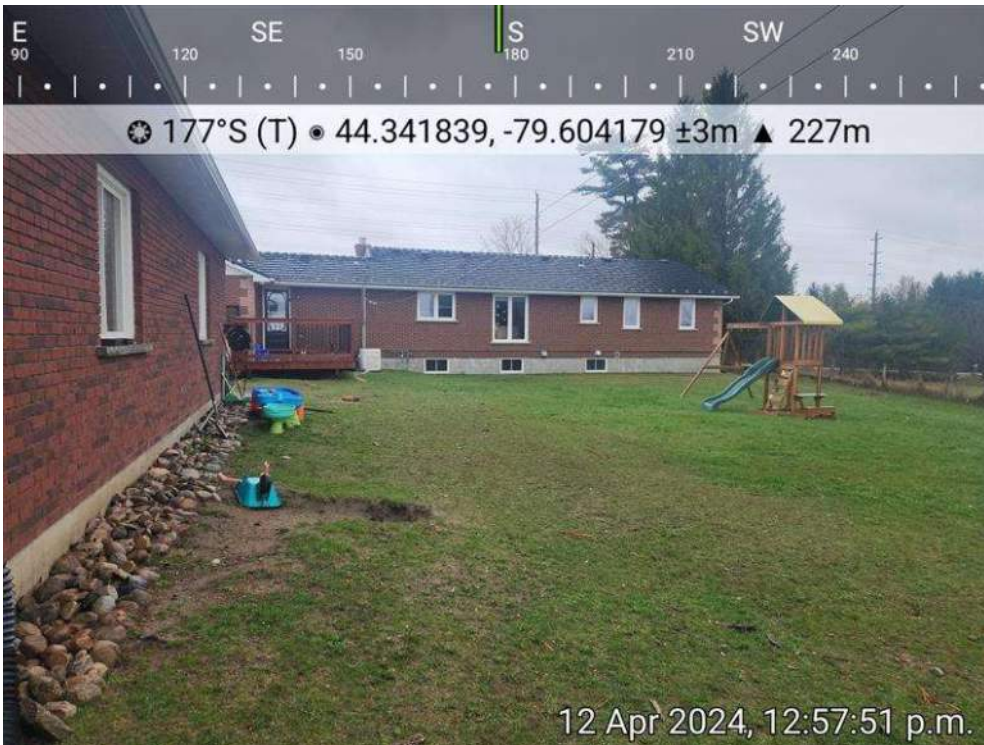
### **PHOTOGRAPH 3**

**Description:**  
Backyard of the  
residential dwelling.  
Picture facing  
south.

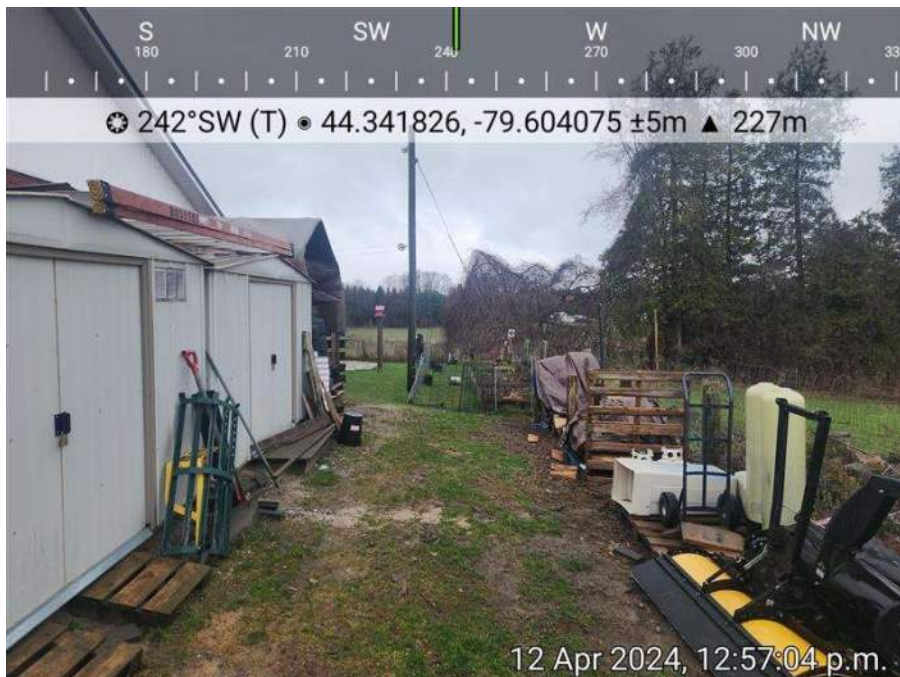
### **PHOTOGRAPH 4**

**Description:**  
Additional storage  
sheds and  
miscellaneous  
equipment situated  
north of the garage.  
Picture facing  
west/southwest.

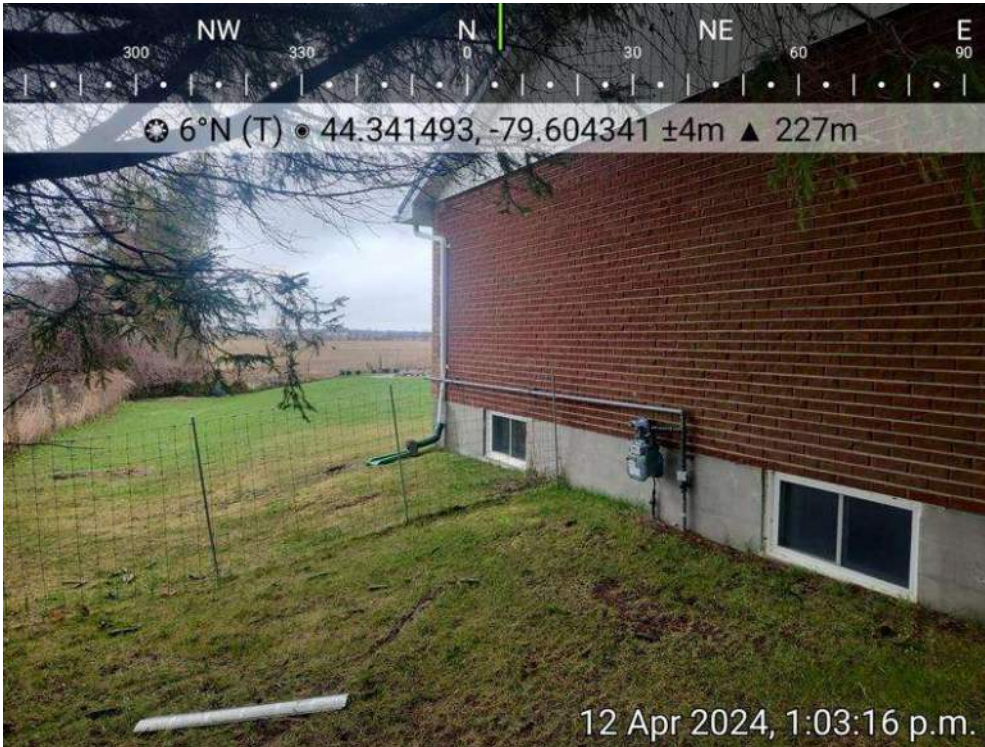
**PHOTOGRAPH 5**

**Description:** The house is heated by natural gas with gas meter observed on the eastern wall.
