Scoped Environmental Impact Study 105 – 111 Edgehill Drive City of Barrie

1980168 Ontario Inc.

Beacon Environmental Limited

June 2018 217408

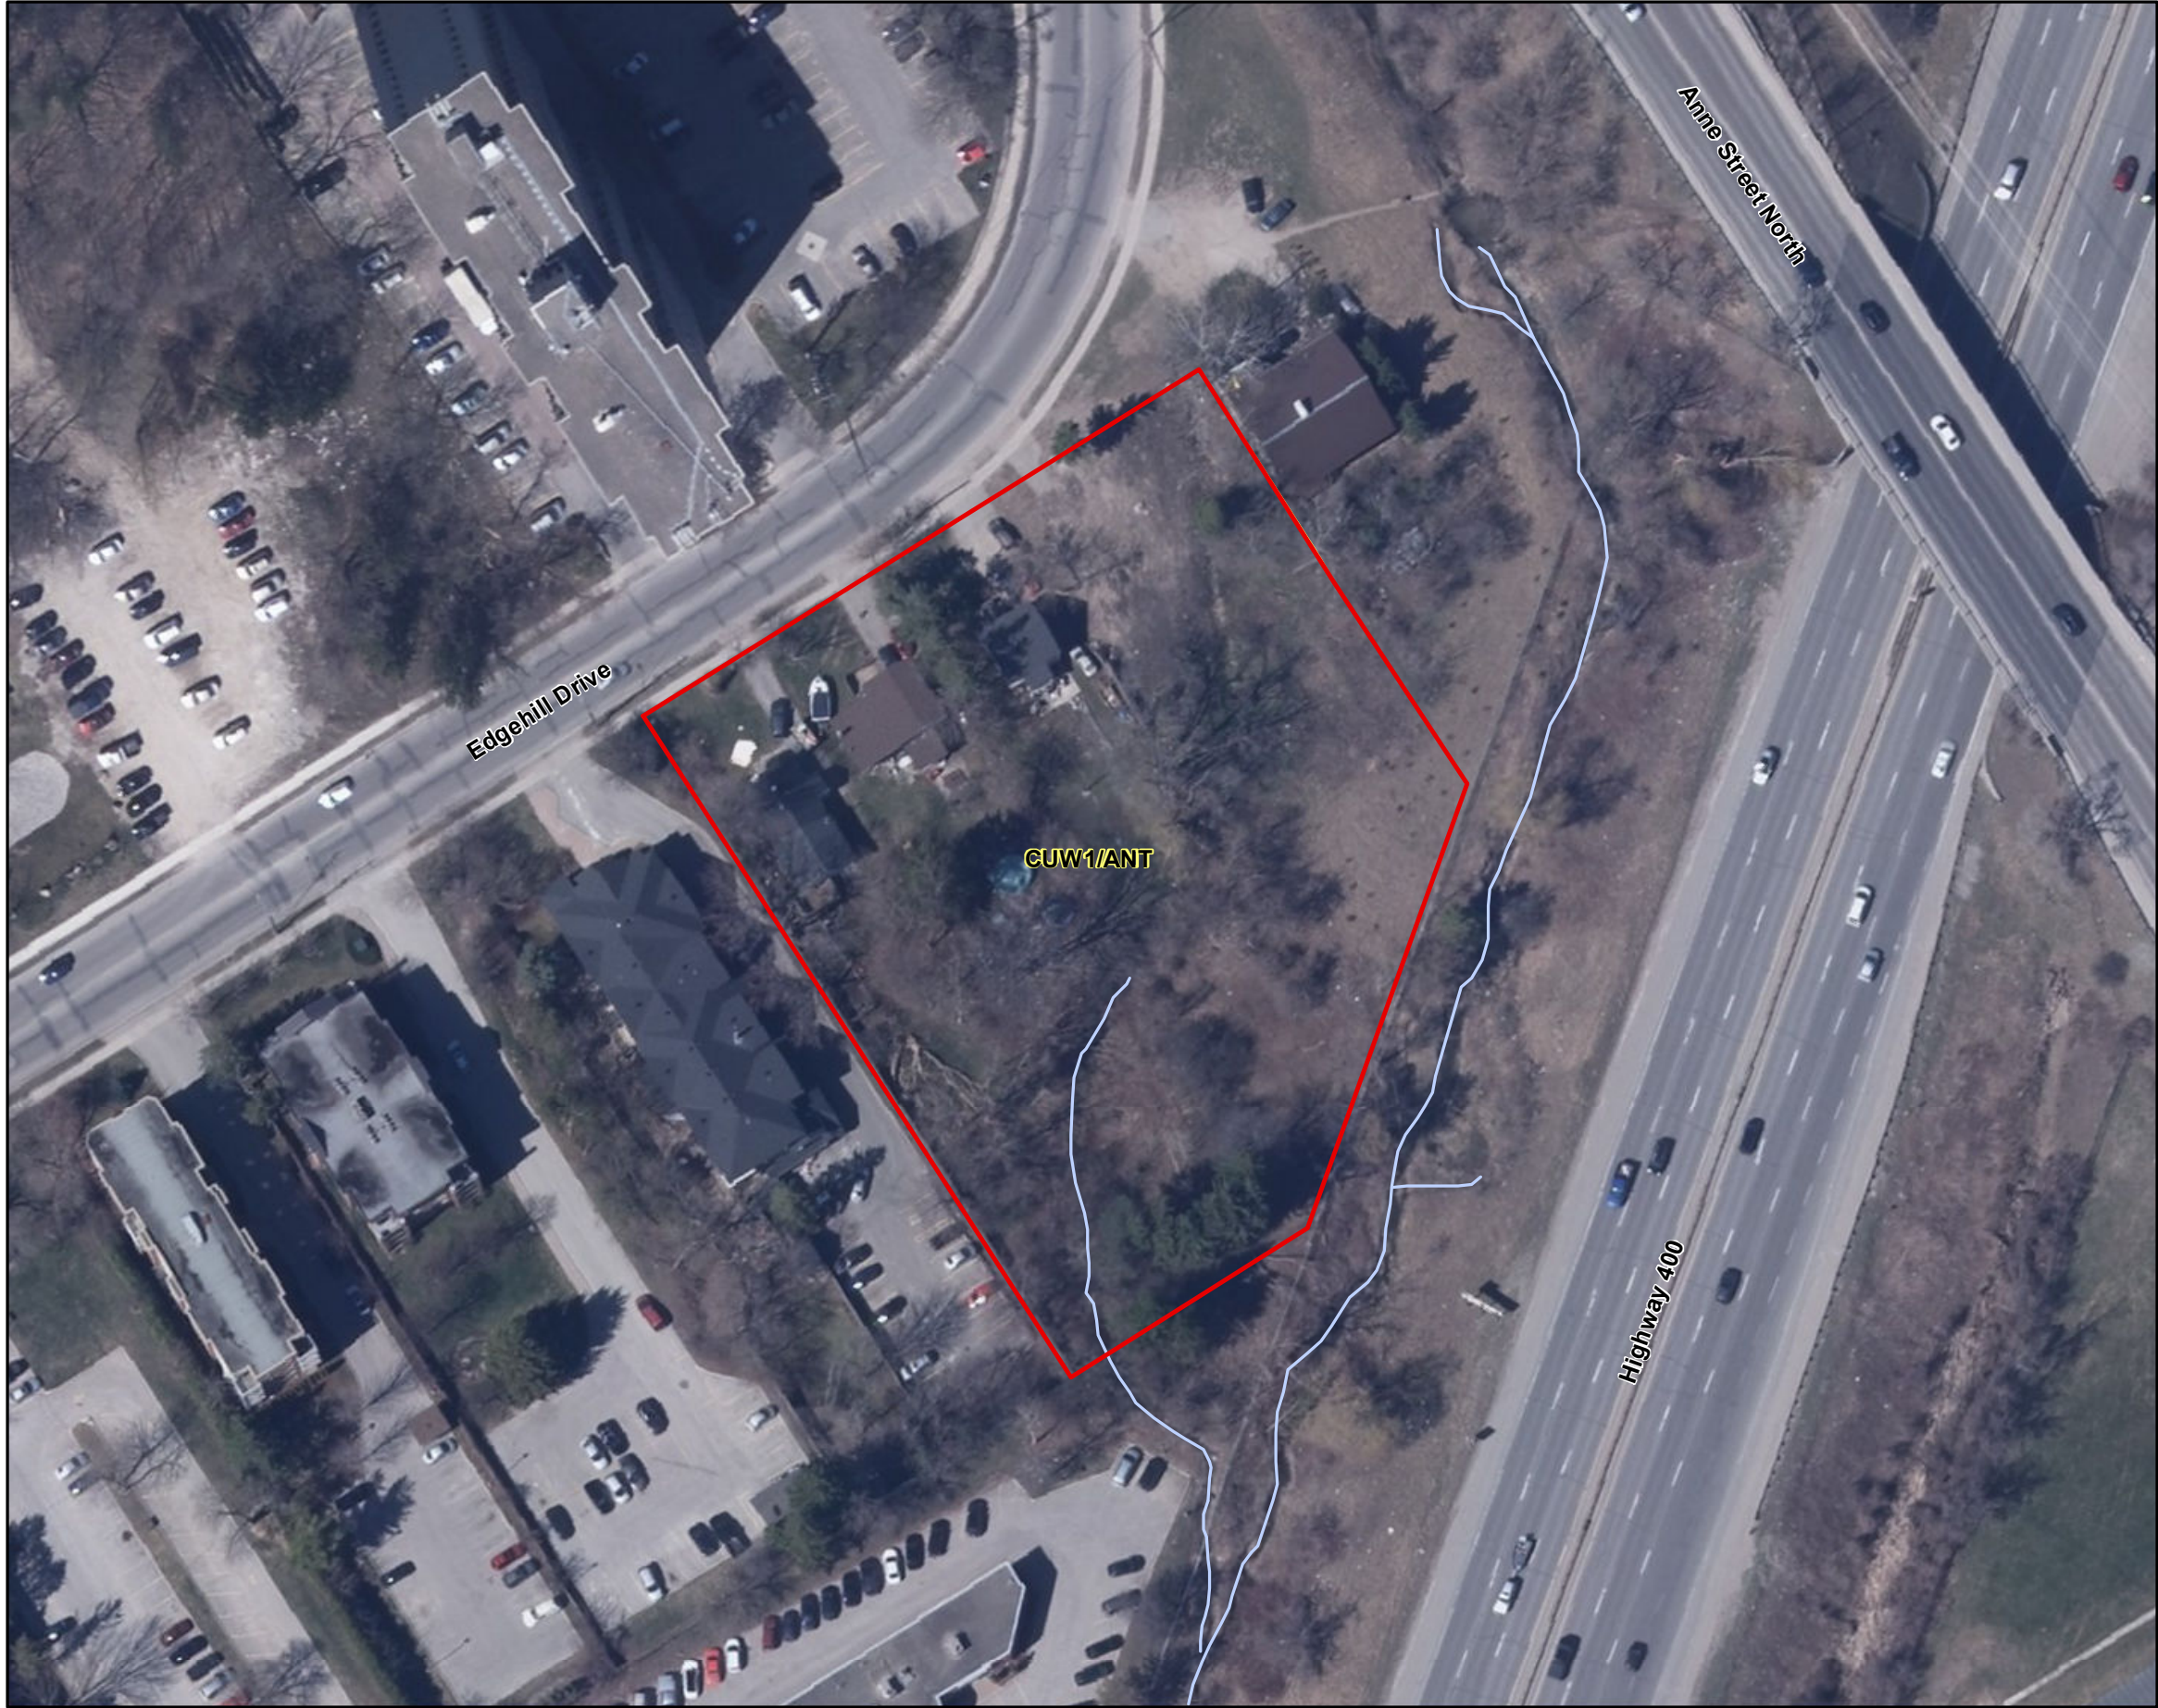
Figure 2

Existing Conditions

The entire subject property is a product of past disturbance having been residential properties for decades within the City of Barrie. The easterly lot has been more recently highly disturbed as the residence there was demolished several years ago. Existing conditions are illustrated on **Figure 2**.

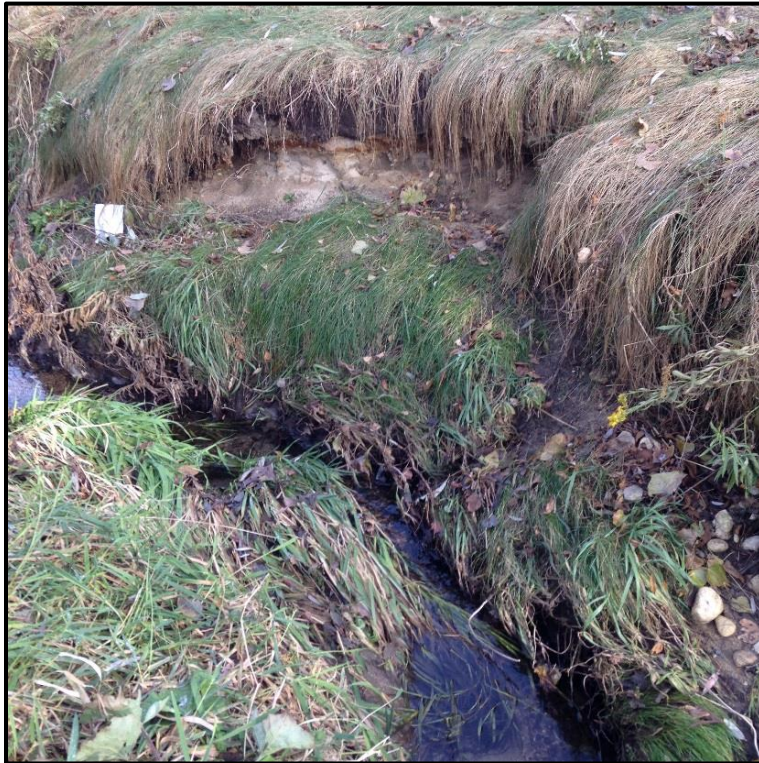
Photograph 1. View of Bunkers Creek Tributary East of Subject Property (Nov. 17, 2017).

The subject property is adjacent to the northern branch of Bunkers Creek. This branch is considered a cold water tributary (LSRCA 2012). The soils in the area consist of loamy sand with high infiltration rates (LSRCA 2012).

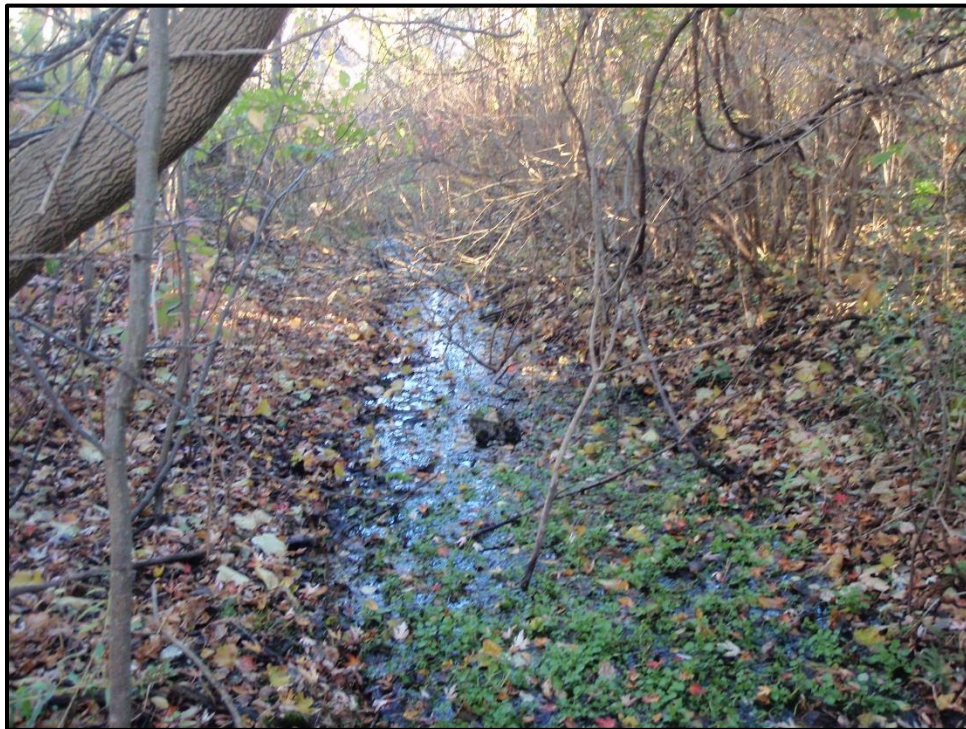
Photograph 2. View of Channelized Drainage Feature on Subject Property (Oct. 26, 2017).

Along the edges of the small watercourse (HDF) there is some Red-osier Dogwood (*Cornus sericea*), Bebb's Willow (*Salix bebbiana*) and Spotted Joe-pye Weed (*Eutrochium maculatum*) (**Photograph 2**).

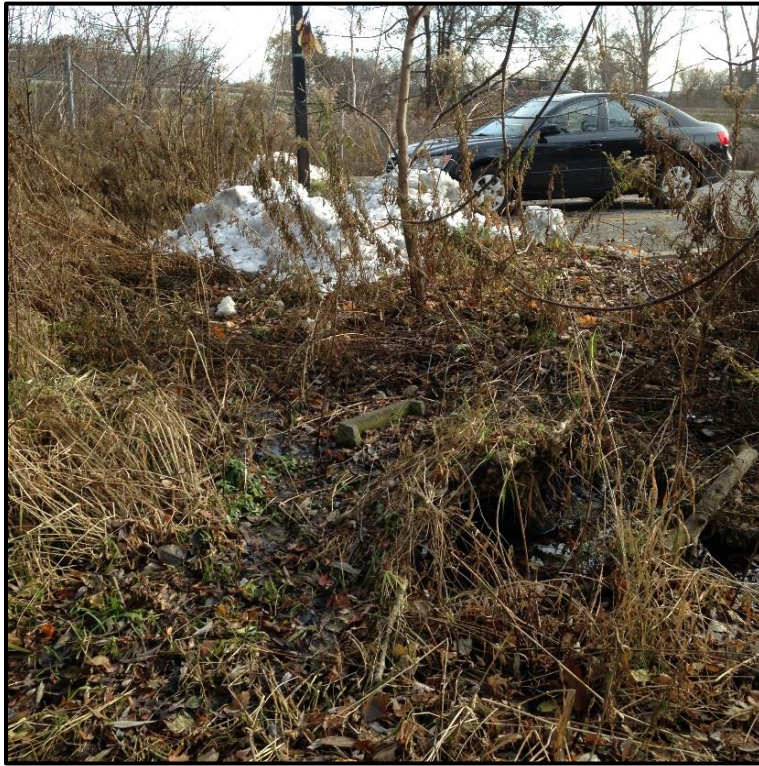
Photograph 3. View of Drainage Feature Where it Flows Past Edge of Parking Lot (Nov. 17, 2017).

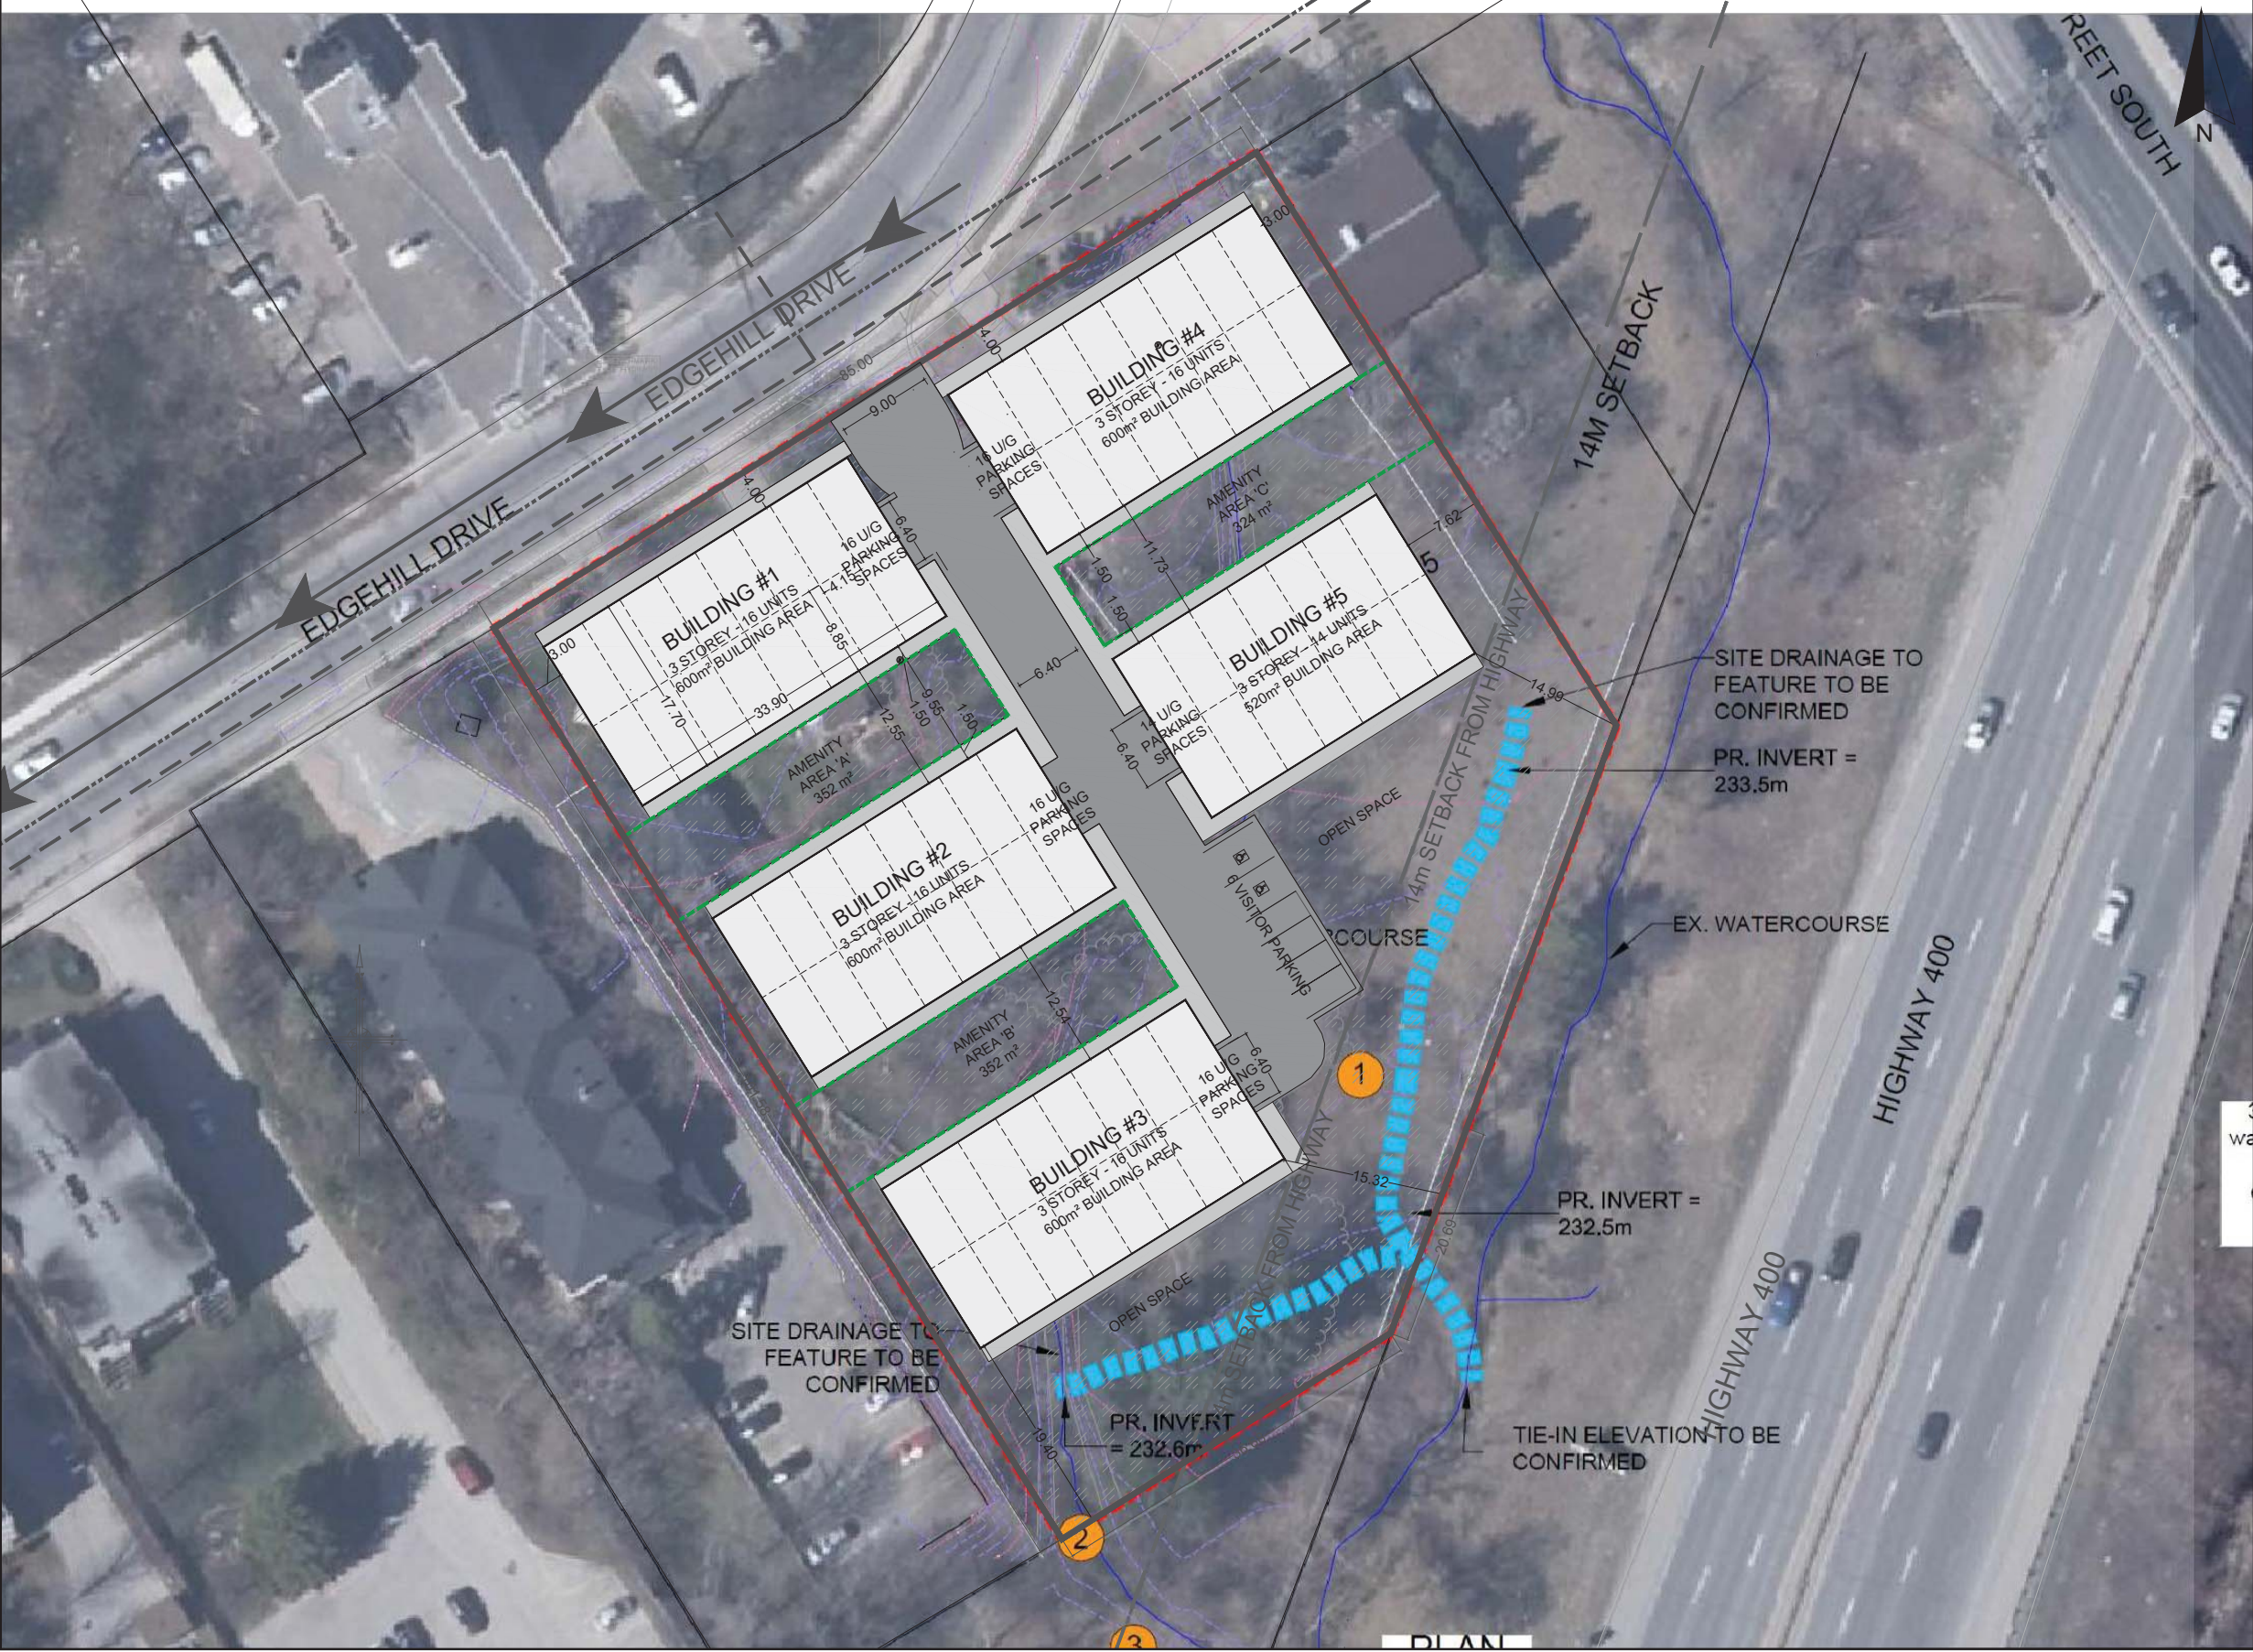
CONCEPTUAL SITE PLAN

105, 107, 109, 111 EDGEHILL DRIVE
IN THE
CITY OF BARRIE
COUNTY OF SIMCOE

The proposed grading includes swales along the perimeter of the subject property to capture external drainage and convey it and the internal drainage that is not infiltrated, to the south via the proposed relocated intermittent watercourse, then off property to the Bunkers Creek tributary. Final grading is to be determined and will be addressed when Beacon receives a grading plan, which is being prepared by others.

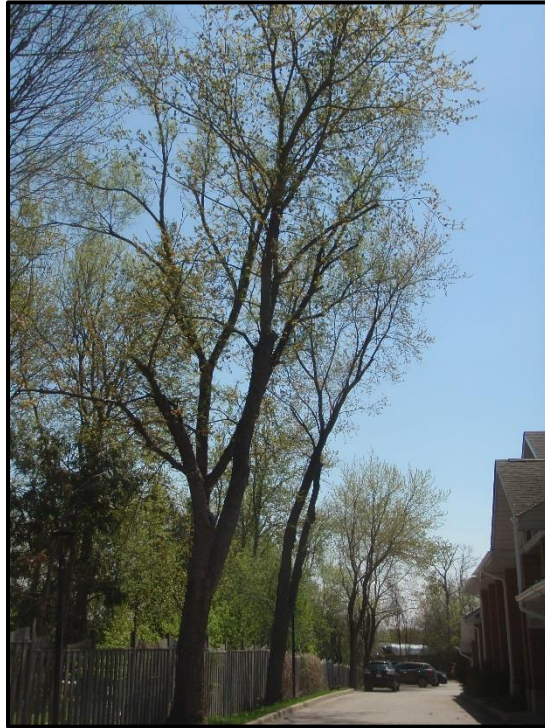
Photograph 1. Tree No. 308 to 311 on adjacent property (May 16, 2018).

Ten of the individually documented trees are located on adjacent properties. These include four Freeman’s Maple (#308 to 311) located on the property to the west that measure from 46 to 57 cm dbh and are in good to fair condition (**Photograph 1**). Tree #304, a White Poplar forked at base, measuring 60 and 61 cm dbh and in good to fair condition, and tree #305, a Manitoba Maple, also forked below dbh, measuring 25 and 33 cm dbh and in poor condition, are located adjacent to the northeast corner

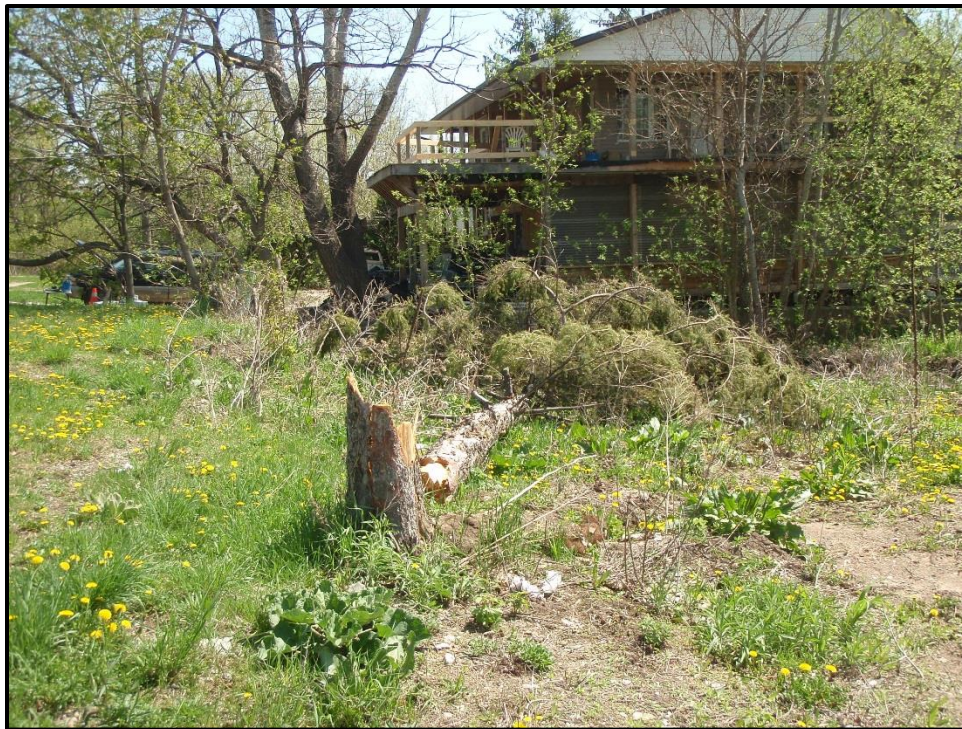
Photograph 2. Tree #314 and #315 in background to left of building (May 16, 2018).

of the subject property (**Photograph 2**). Tree #314 and #315, two Freeman's Maple measuring 28 and 30 cm dbh, in good to fair and good condition, respectively, are located adjacent the southern property boundary within the Highway 400 right of way, are not tagged in the field. There are two Norway Spruce, #185 and 186, measuring 39 and 31 cm dbh, respectively, are in good condition and located several meters beyond the southern property boundary.

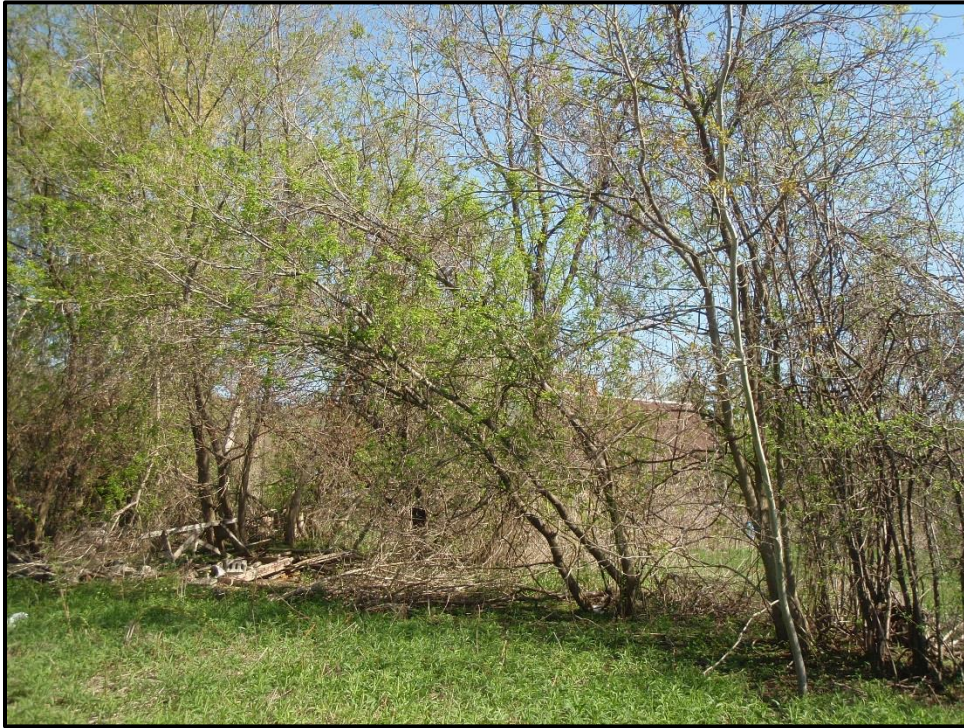
Photograph 3. View of part of tree Group A (May 16, 2018).

This tree group is located in the south-central portion of the subject property. The tree group is comprised of 15 Manitoba Maple, nine of which are less than 20cm dbh. The remaining six trees range in size from 20 to 25 cm dbh. All the trees in this group are in fair condition (**Photograph 3**).

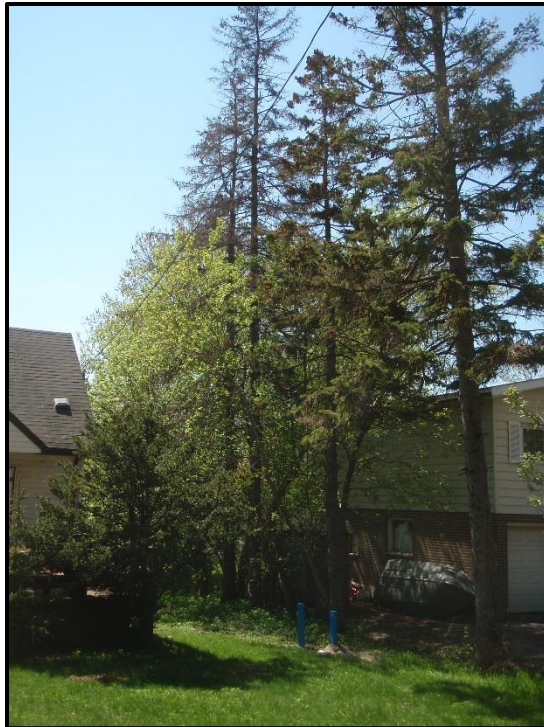
Photograph 4. Group C, with two dead Norway Spruce (May 16, 2018).

This tree group is a hedgerow along the property line between 107 and 109 Edgehill that consists of 15 trees in fair to poor condition, including two dead trees (**Photograph 4**). These include 10 Manitoba Maple (four trees ranging from 20 to 35 cm dbh and six measuring <20cm dbh), two dead Norway Spruce and three measuring 28, 32 and 38 cm dbh.
