ANALYTICAL REPORT

Part Two: Analysis of Historic Paints

Allandale Train Station,
Barrie, Ontario, Canada

January 18, 2011

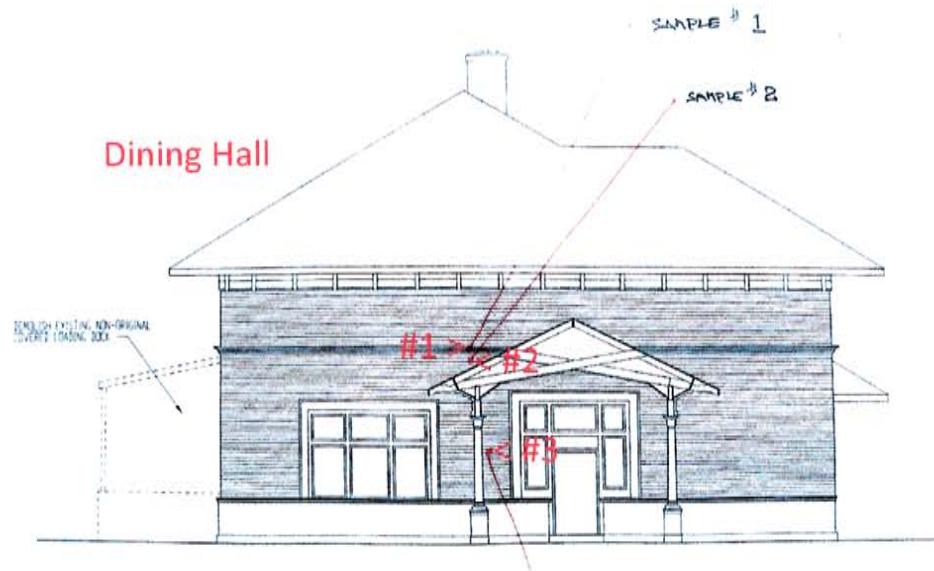
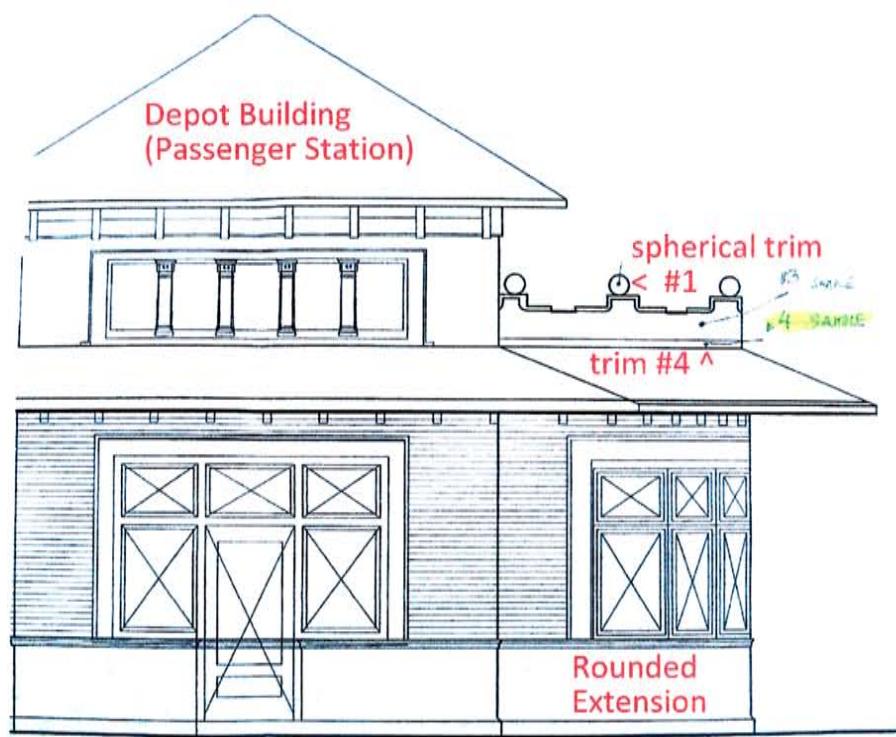
Sampling Locations

The samples were submitted as follows, and the locations are indicated on the architectural drawings below:

- Sample 1, Dining Hall, Trim
- Sample 2, Dining Hall, Cladding
- Sample 3, Dining Hall, Cladding
- Sample 1, Spherical Decoration on the rounded extension of the Depot Building (Passenger Station, east elevation)
- Sample 4, Trim on the rounded extension of the Depot Building (Passenger Station, east elevation).

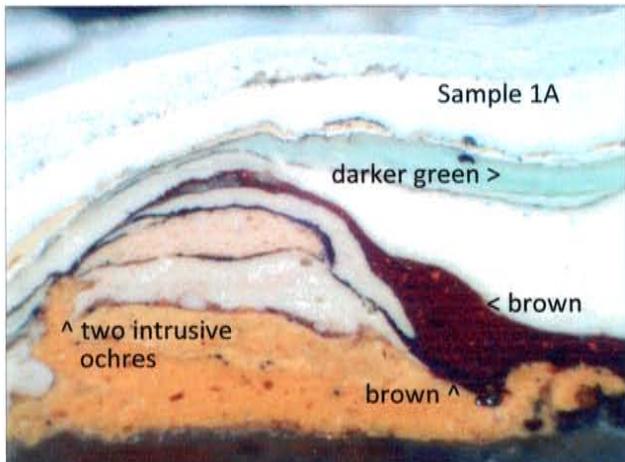
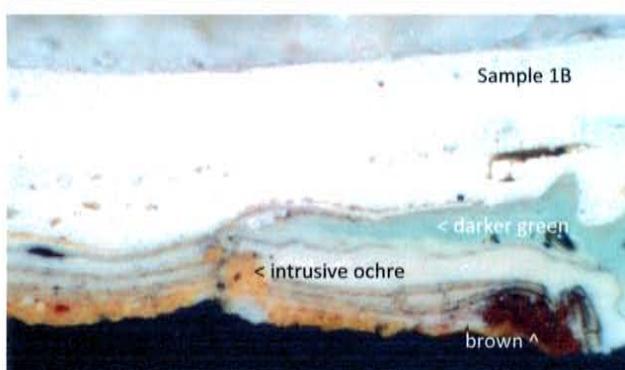
Sample 1: Dining Hall, Trim

The sample from the trim showed approximately 15 to 16 layers.

In the earliest layers of the cross-sections from this sample, there were some paints which were intrusive – that is, they were applied later but penetrated through cracks into and underneath the earlier layers. In this case, these are notably the yellow ochres and probably also the dark browns. The absence of upper layers with these same colours indicates that they have been lost or removed at a later date and thus are not represented in their proper position in the layer structure. In addition, the presence of some paints which occur only in part of the cross-sections (such as the darker green) suggests that the trim element may have been, at times, painted in more than one colour.

The area on the left of cross-section 1B (above) showed layers that were more regular in thickness, and the initial colours there were tones of beige and medium browns. The paints are thin and deteriorated, so the colour assignments are approximate. The first paint was a beige like HC-83, followed by a medium brown similar to HC-77. A pale beige (OC-48) and darker beige (HC-108) followed. An off-white like HC-174 and a pale green preceded a grey off-white and an orange/red ochre. There were about 5 or 6 white and off-white paints completing the sequence.

The Dining Hall was added around 1905. The samples from the cladding and trim showed 14 to 16 layers. However, patches of intrusive ochres and dark brown paint which show up in the cross-sections of samples from the trim suggest that some mid-level layers on this feature have been lost through deterioration or preparation for painting.

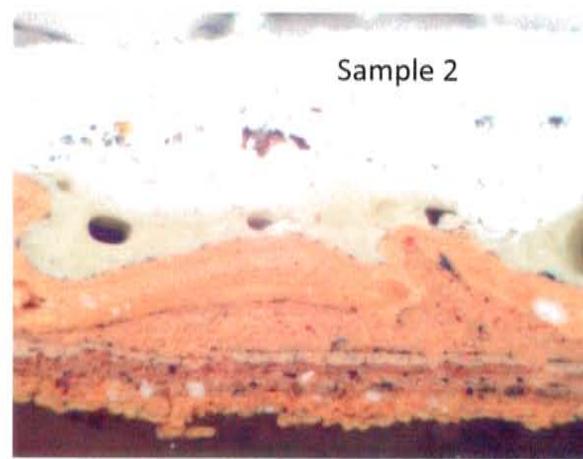
Sample 2

These two samples were similar and showed approximately 14 to 16 layers in total.

The initial colours were warm tones of ochre and browns.

In the early years, the cladding and trim on the Dining Hall were painted in contrast. The colours of the cladding were basically the same as those on the Depot Building. The first was a yellow ochre, followed by a red brown (possibly a paint/primer combination). The next three or four colours were various shades of brown. On the trim, the earliest paint was a light beige (a shade around HC-83) and this likely coordinated with the red brown (1210) of the cladding. Based on this combination, the second layer on the trim was a darker beige (like HC-77) which was contrasted with dark brown cladding (varying in colour around 2107-10). The third pairing comprised lighter colours, with pale beige (OC-48) on the trim and the cladding painted in a brown lighter than the previous one (HC-46). Subsequent combinations were grey beige with medium brown cladding, cream with red ochre cladding, and later, green colours were used in both areas (possibly two tones on the trim).

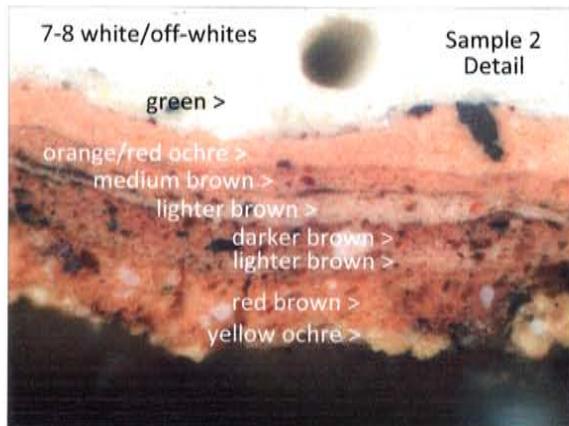
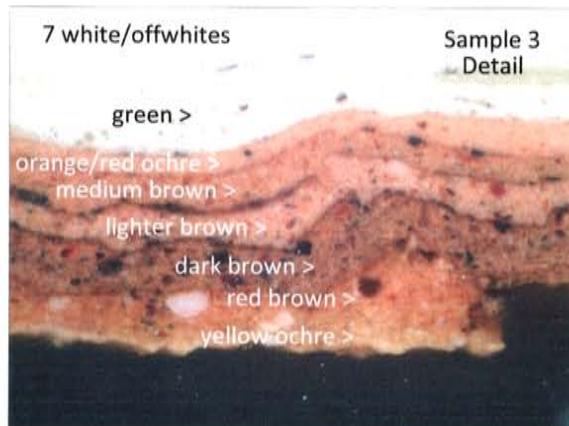
Sample 3
Detail

The first layer was a yellow ochre, which varied somewhat in colour but was generally most similar to R9935. Following this was a red brown closest to 1210. As there was no clear delineation between these layers, it is probable that they were applied close together in time, probably as a primer/sealer and paint combination. The next layer differed slightly between the samples, as there were two browns in Sample 2 (a lighter one similar to HC-73, followed by a darker one more like 2107-10) and a single brown in Sample 3 (in the range of 2107-10 to 2109-20). A lighter red brown like HC-46 followed in both cases. Dirt layers in these two samples were less consistently present than in the previous samples with similar layer structure (Samples 1 to 3 from the Depot Building).

The next three layers comprised a medium brown, an orange/red ochre and a pale green. The most recent layers were 7 or 8 white and off-white paints.

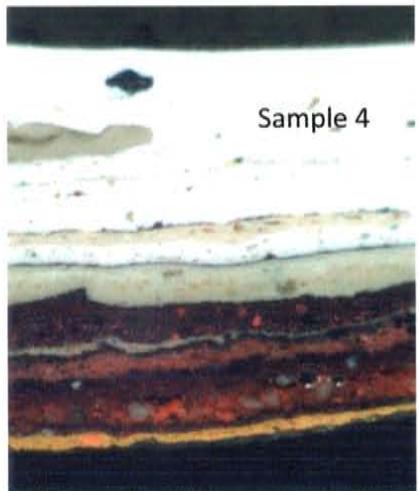
Sample 4

The samples from these features comprised 18 to 20 layers and had similar layer structures.

The first layer was a bright yellow similar to 2154-20. Above this was a dark brown like HC-70, which was followed by a coarsely ground red brown (overall colour approximately HC-49).

The subsequent four layers were shades of brown, and a beige/grey preceded the final dark brown. Green, white, orange/red ochre and 6-7 white and off-white layers completed the sequence.

The two samples from high trim features on the upper part of the rounded extension of the Depot Building showed identical layer structures and some colours which did not occur elsewhere. There were 18 to 20 layers in the cross-sections. The first paint was a bright yellow (2154-20), followed by a dark brown like HC-70 and a coarsely ground red brown with overall appearance similar to HC-49. The next two layers were very dark brown and nearly black.

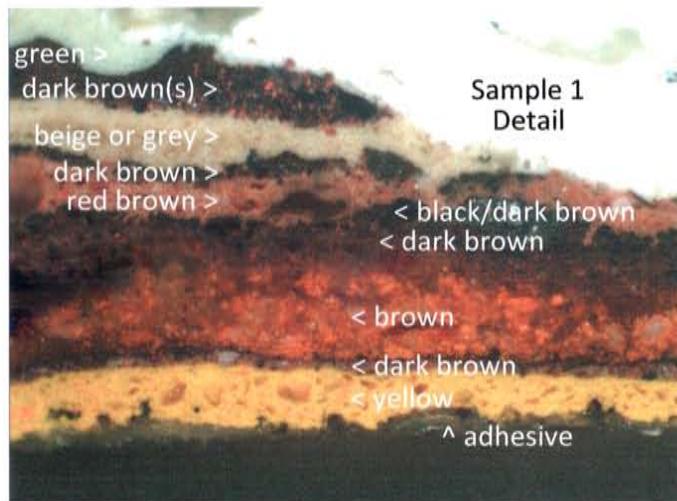
Sample 1
Detail

A millimetre-sized flake of gold paint was included with this sample – in cross-section this can be seen to be a layer of gold-coloured metallic flake paint on a grey or brown base (there was too little substrate attached to assess a colour).

A very tiny flake of gold paint included in the sample from the spherical decoration on the Depot Building was a single layer of gold-coloured metallic flake paint on a grey or brown base.

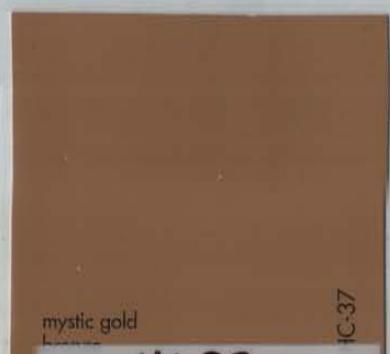
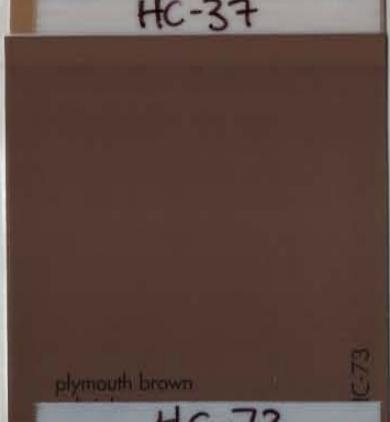
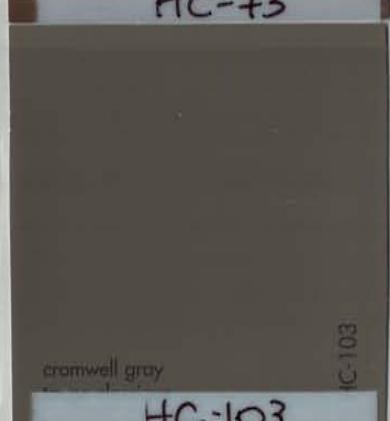
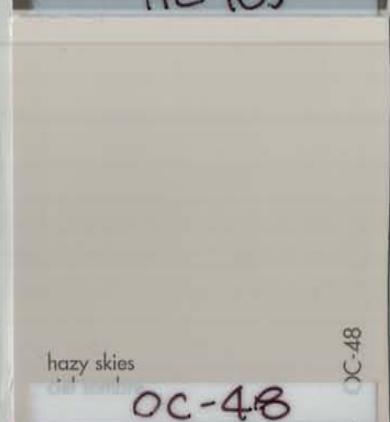
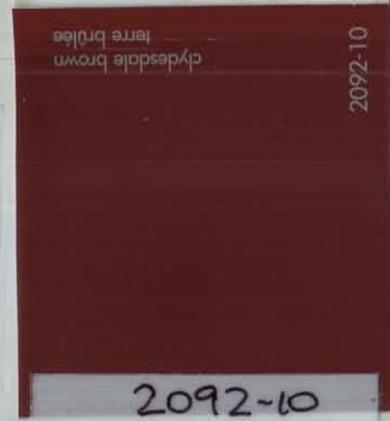
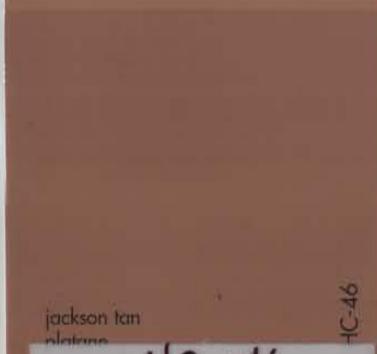
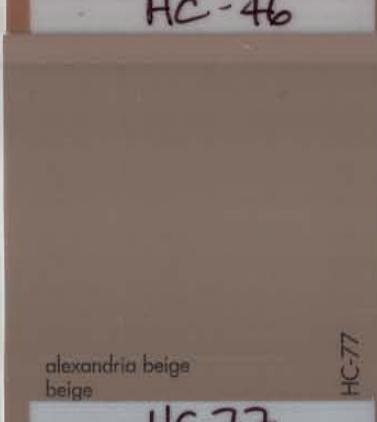
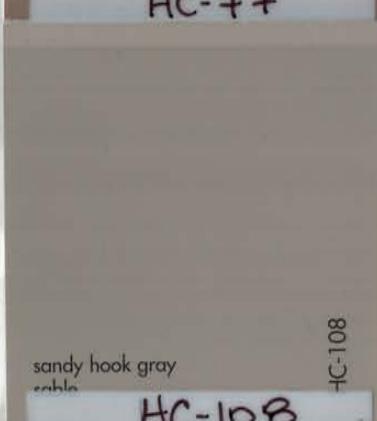
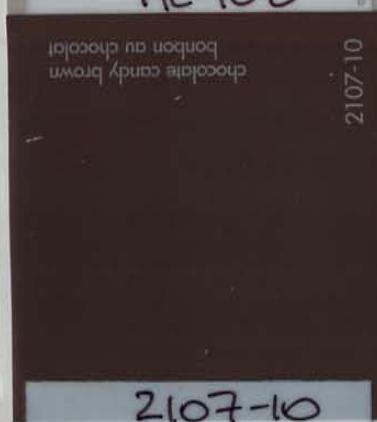
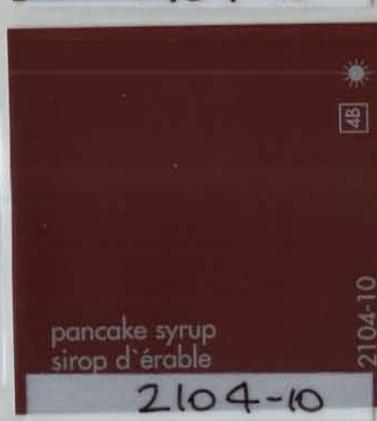
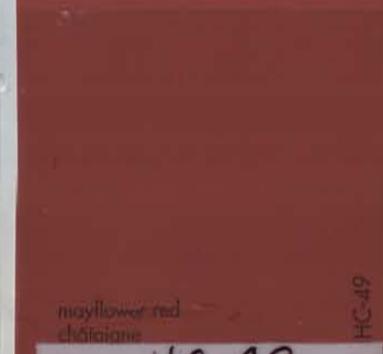
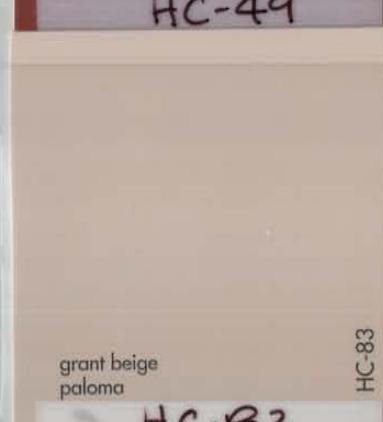
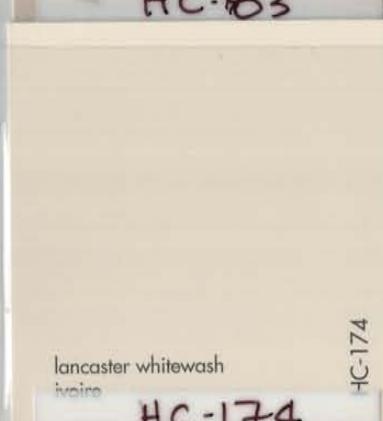
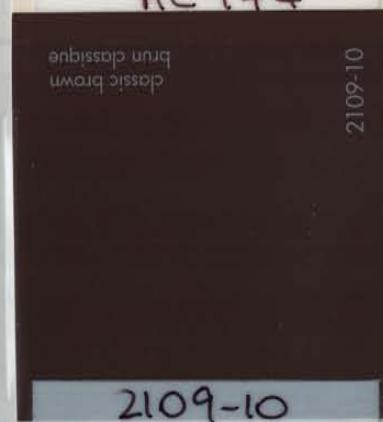
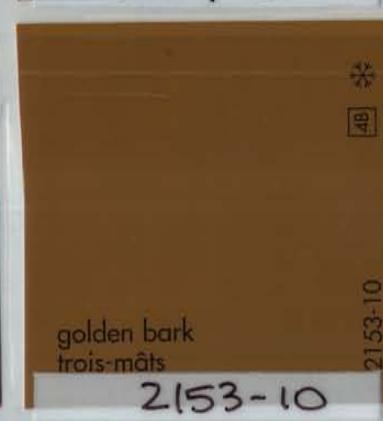
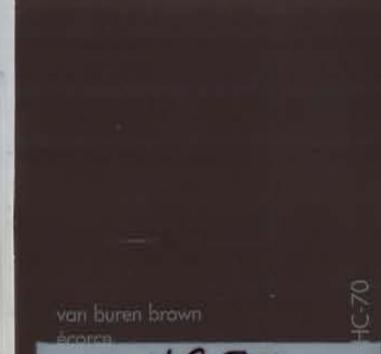
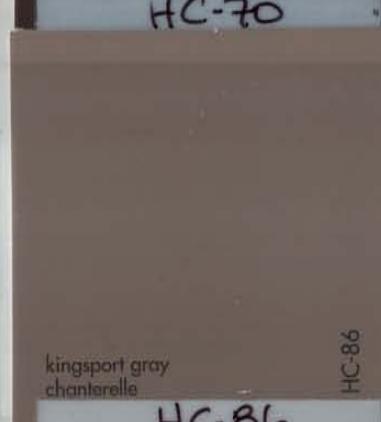
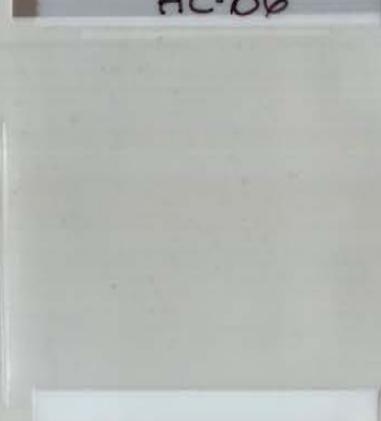
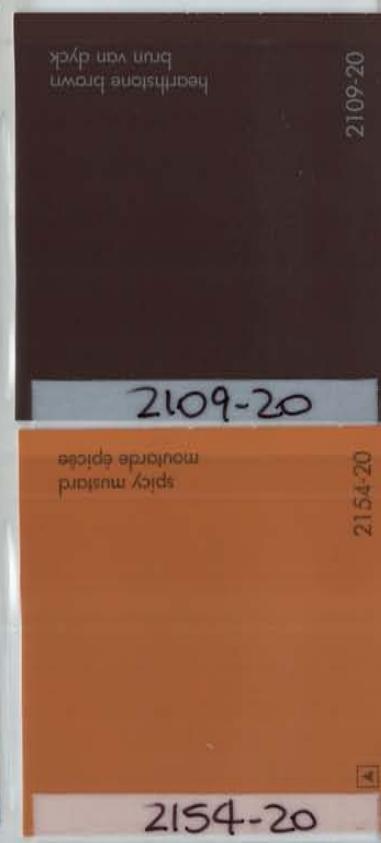
Appendix:
Colour Cards Corresponding
To Early Paint Colours

Note: Colour cards for the cladding of the Dining Hall are the same as for the Depot Building and the full set was provided with the previous report.
