# Phase One Environmental Site Assessment

109-129 Park Place Boulevard Barrie, Ontario

**North American Development Group**

December 23, 2021

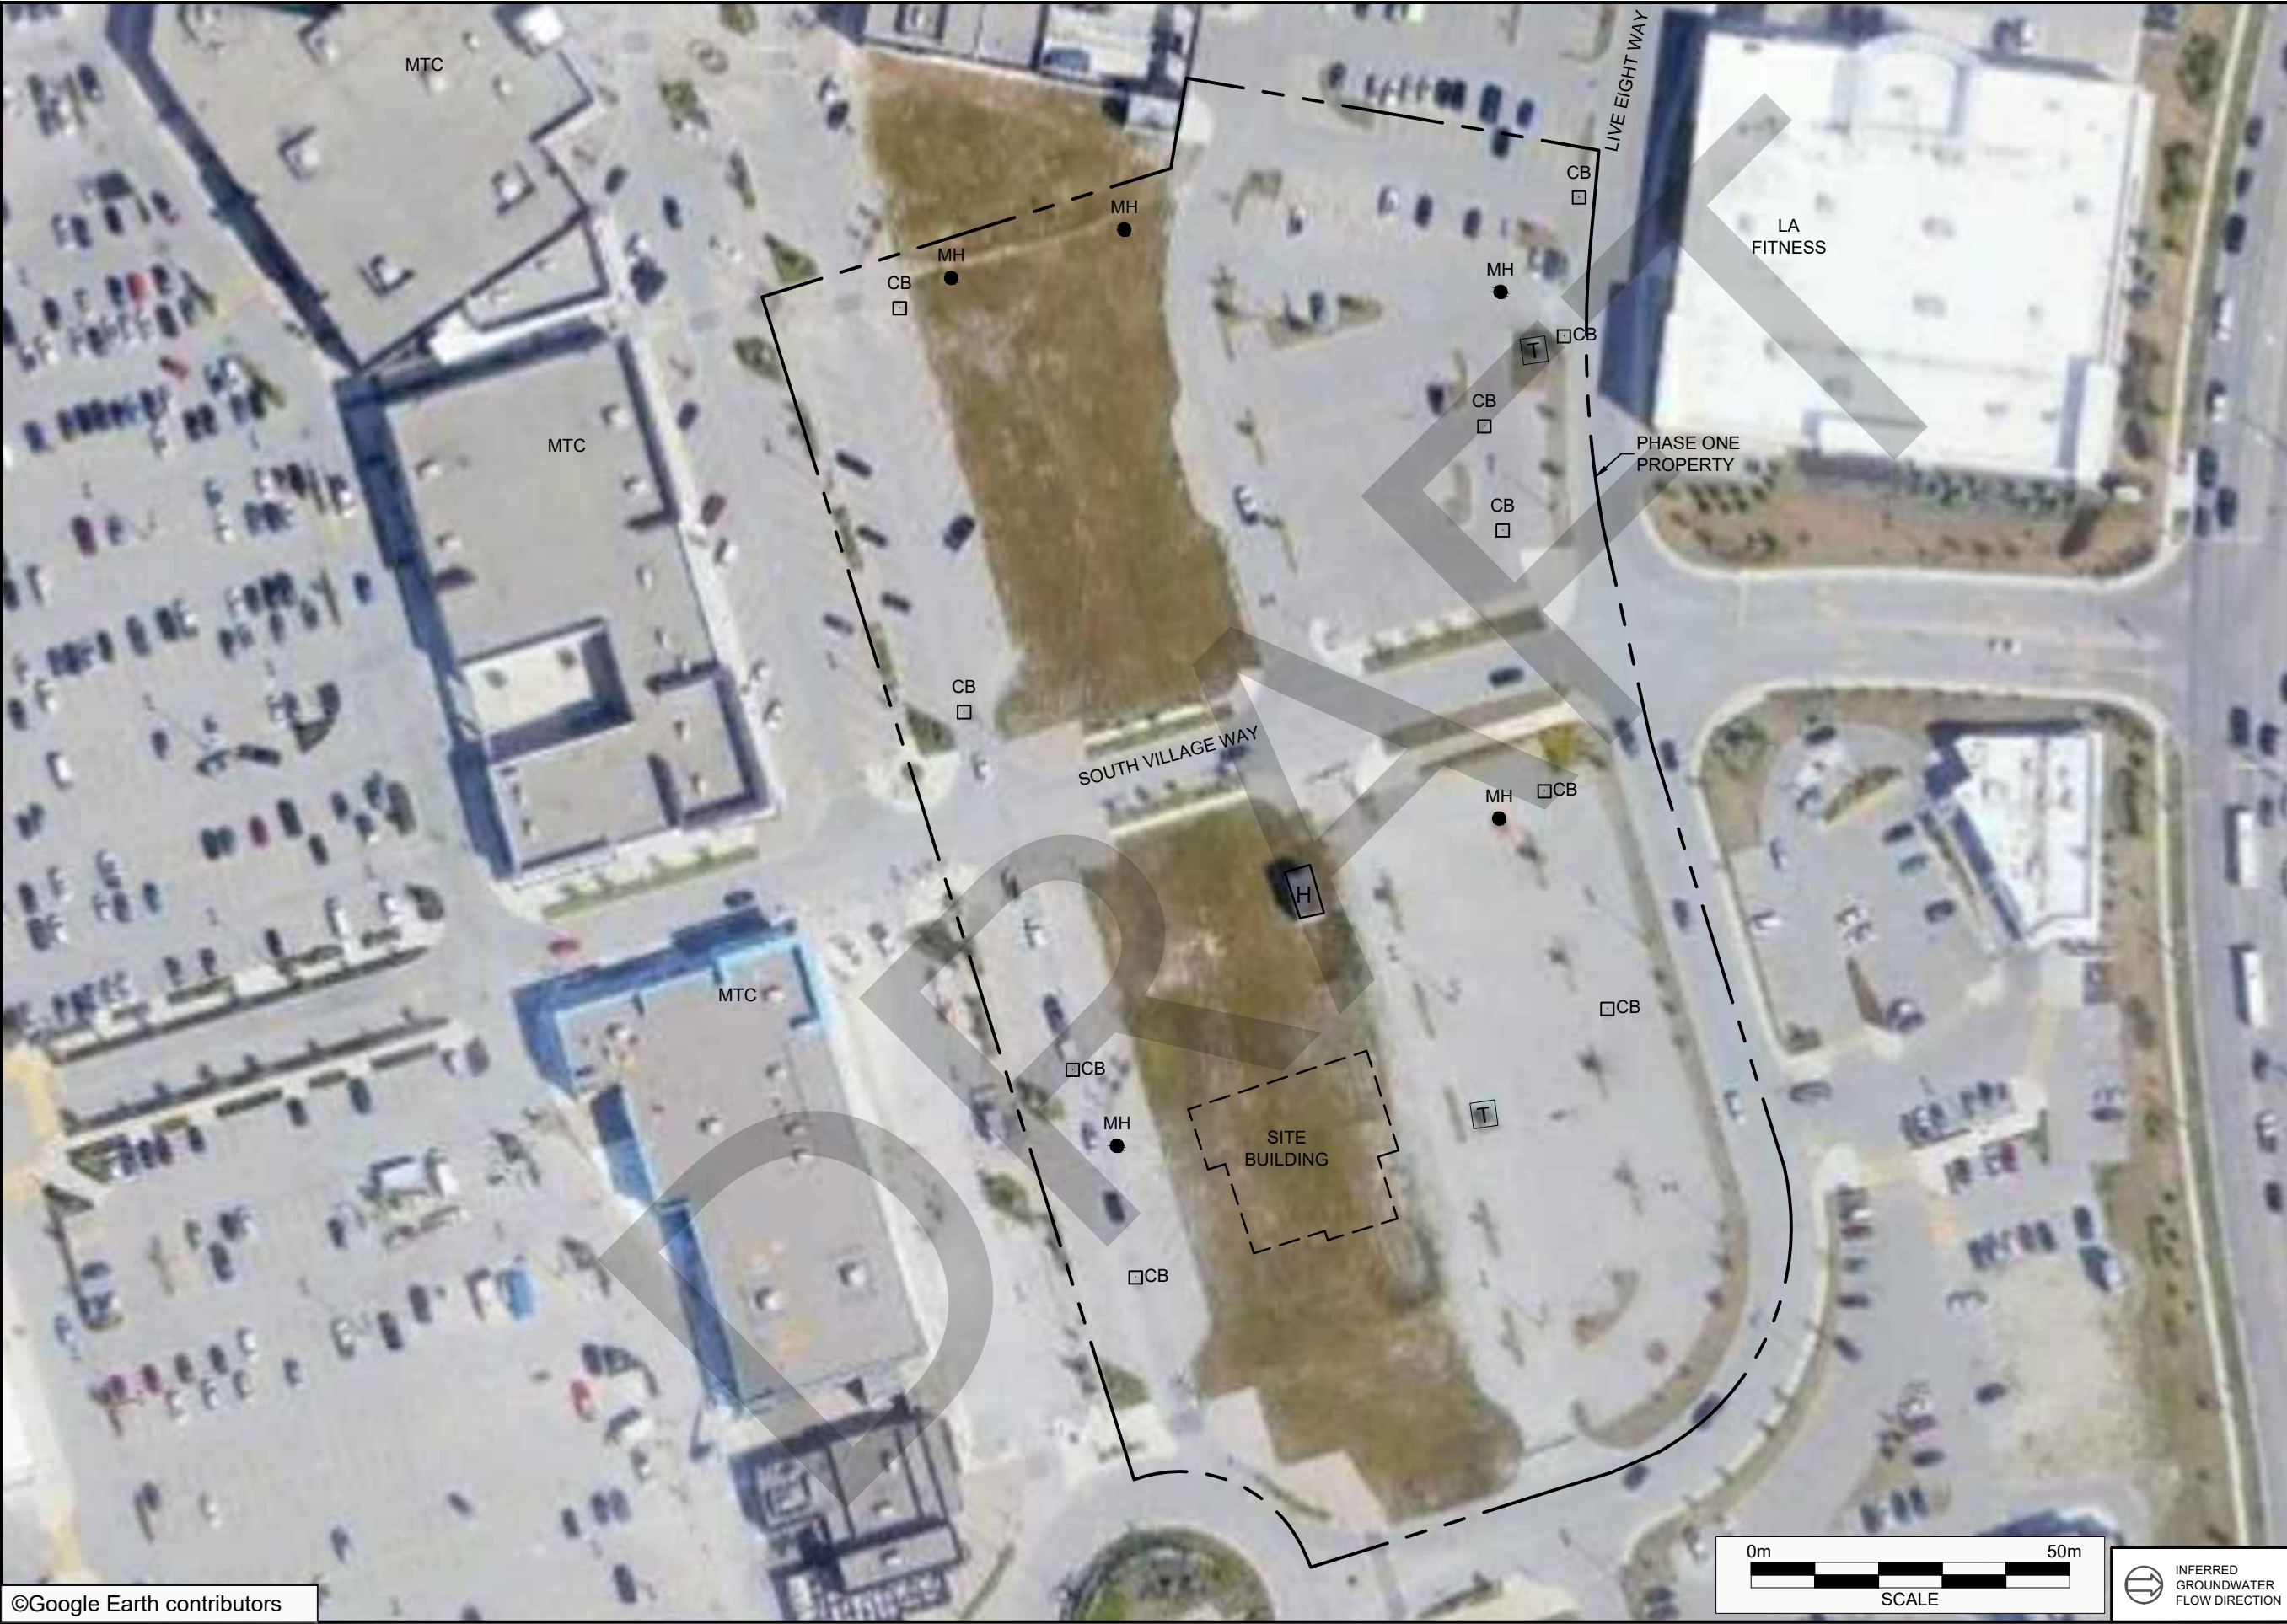
| DECEMBER 2021 | 2 |

INFERRED  
GROUNDWATER  
FLOW DIRECTION

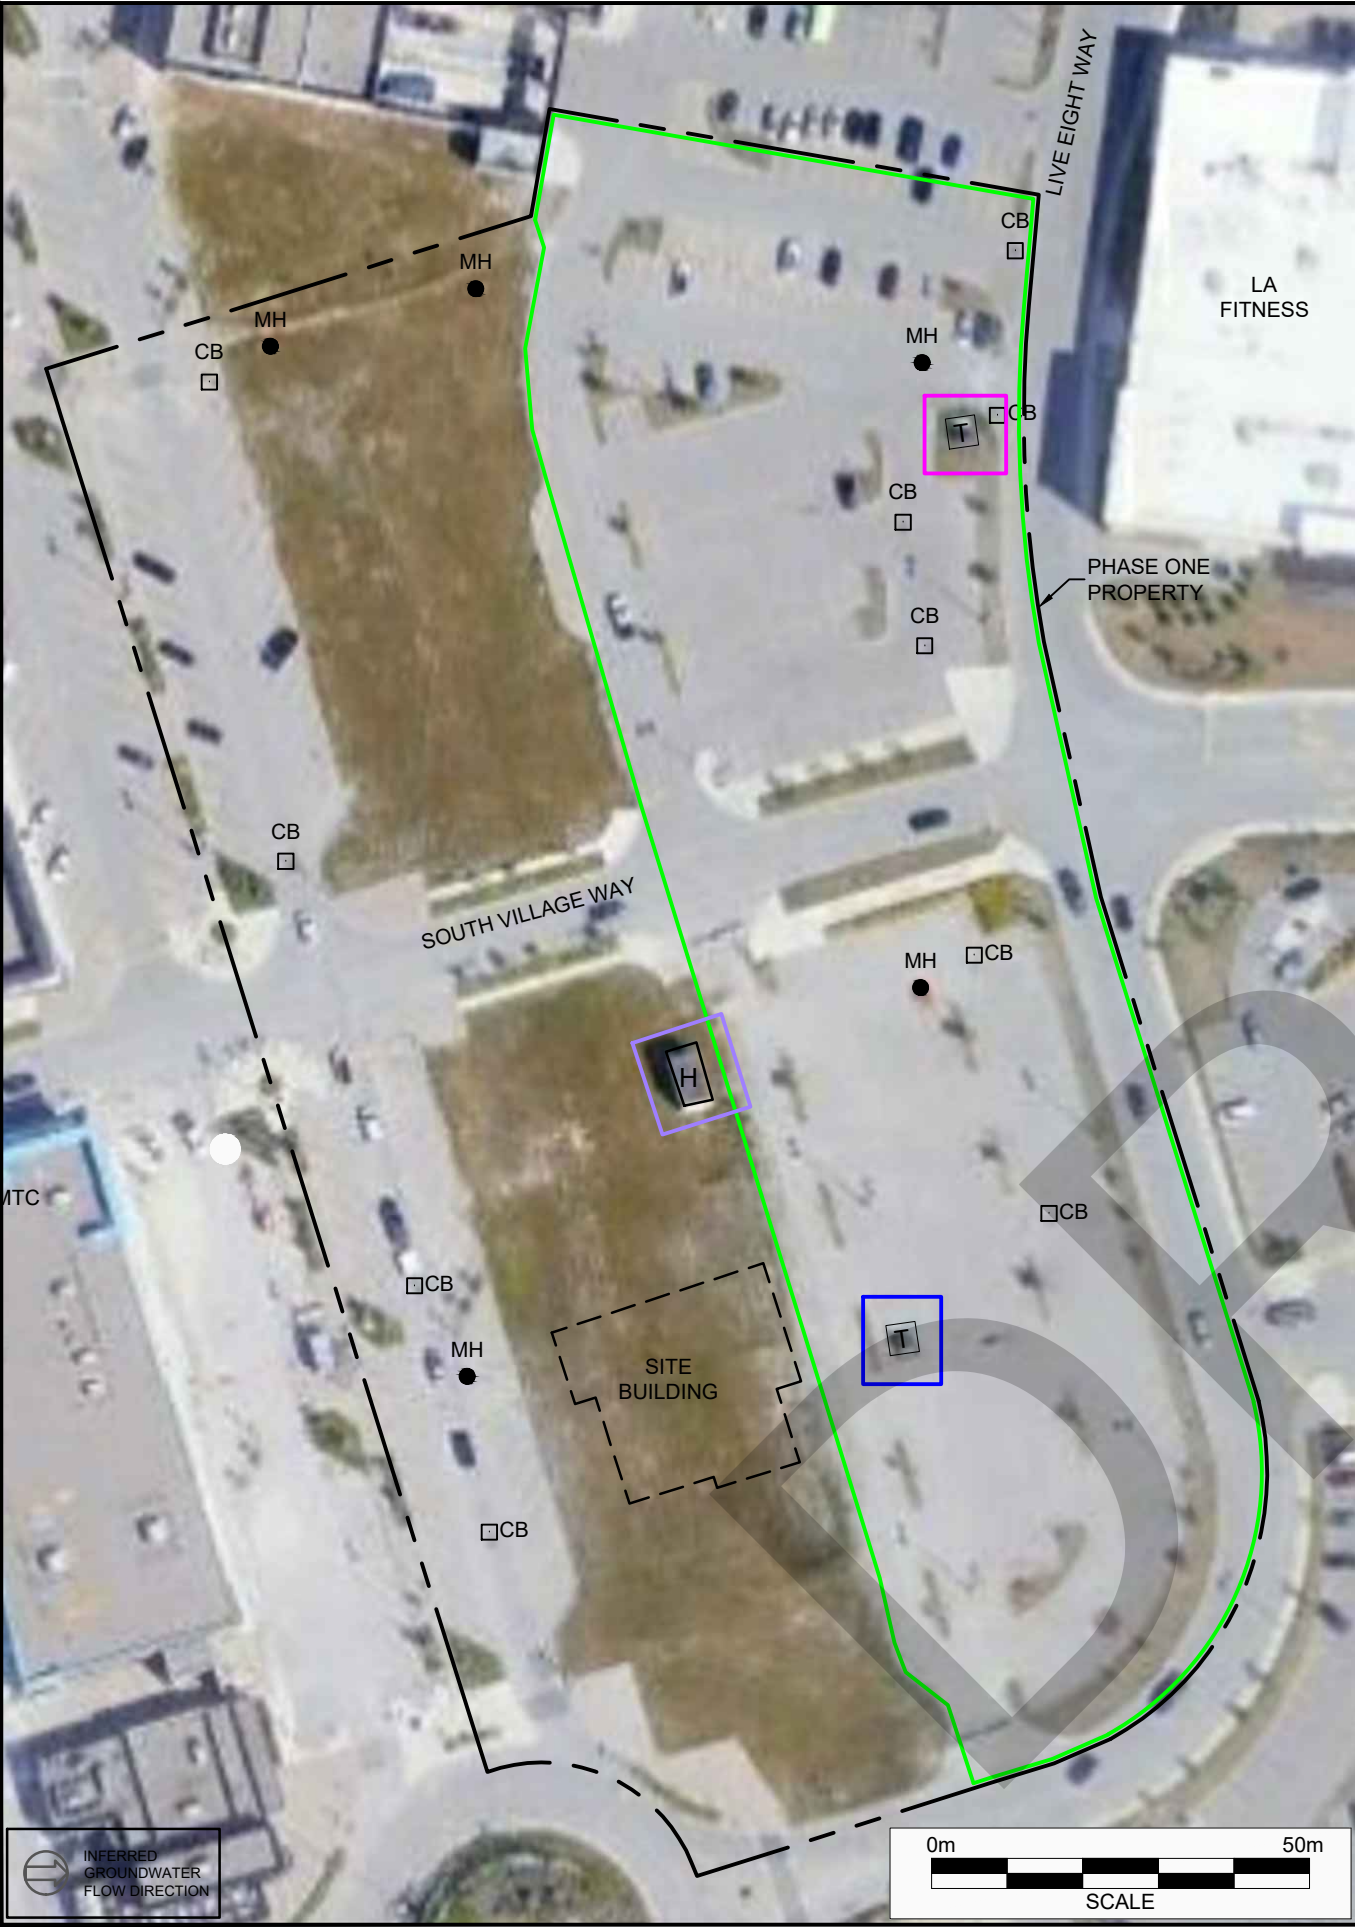
| Area of Potential Environmental Concern <sup>1</sup> | Location of Area of Potential Environmental Concern on Phase One Property | Potentially Contaminating Activity <sup>2</sup> | Location of PCA (On-Site or Off-Site) | Contaminants of Potential Concern <sup>3</sup> | Media Potentially Impacted (Ground Water, Soil and/or Sediment) |
|---|---|---|---|---|---|
| APEC-1 (hydro vault) | Central portion of the Phase One Property. | Item 55 - Transformer Manufacturing, Processing and Use | On-Site | PHCs<br>VOCs<br>PCBs | Soil |

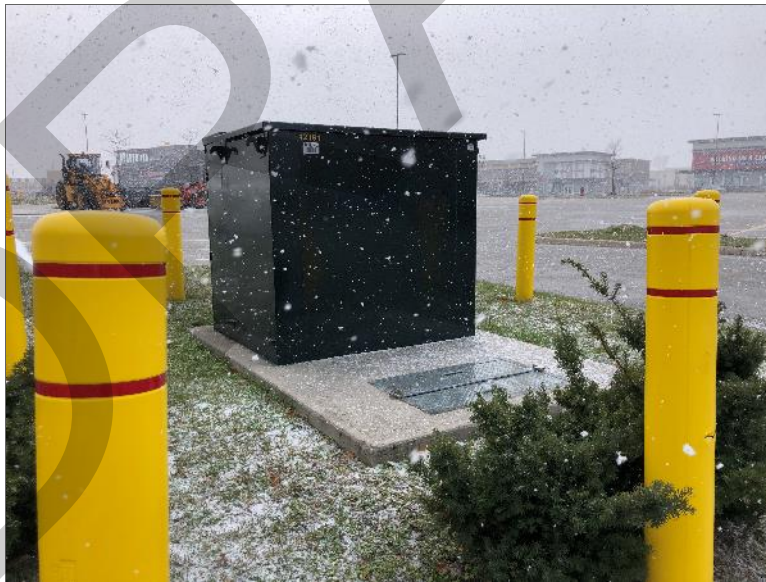
Photo 12 – Pad-mounted oil-cooled electrical transformer located in the northeastern portion of the Phase One Property, looking south.

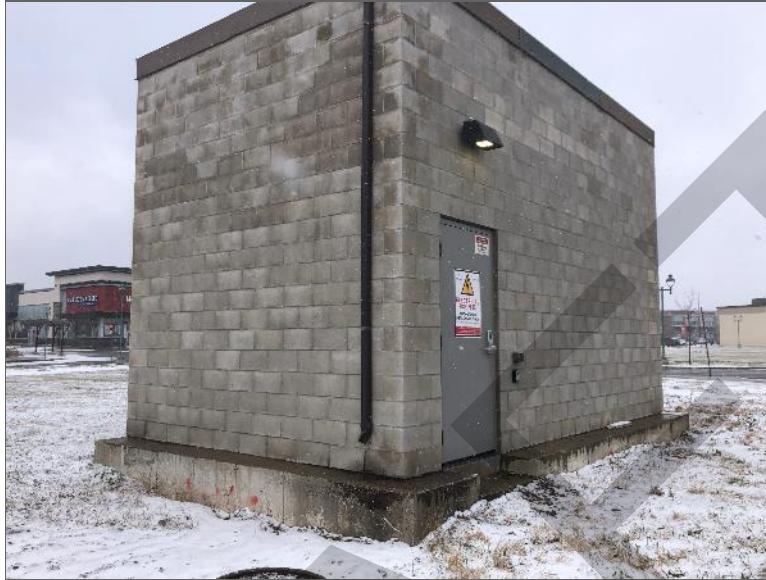
Photo 13 – Hydro vault located in the central portion of the Phase One Property, looking northwest.

During the Site reconnaissance, Pinchin observed two building/structures on the Phase One Property: a commercial building in the southwestern portion operating as a restaurant (Site Building), and a small hydro vault structure in the central portion. The Site Building consisted of a two-story slab-on-grade structure constructed between November 2020 and October 2021. The hydro vault was of concrete block and slab-on-grade construction. As noted above in Section 6.1, the presence of the on-Site hydro vault is considered a PCA.

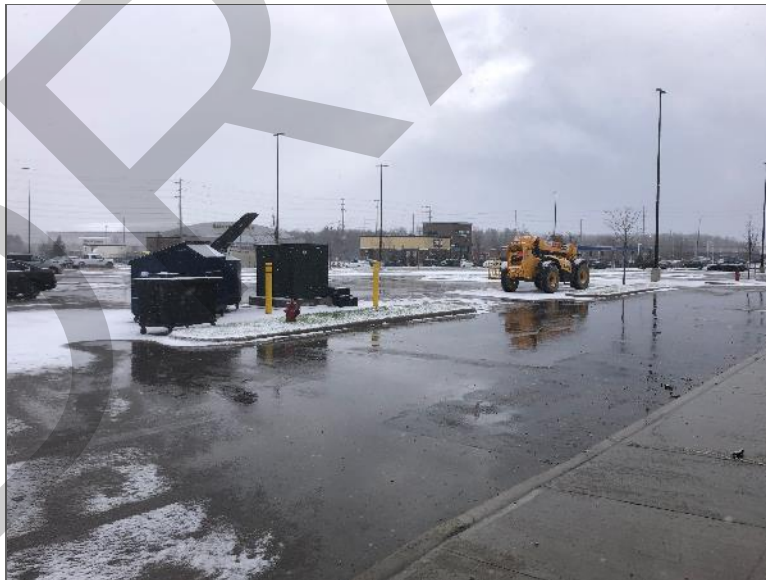
Photo 14 – Pad-mounted oil-cooled electrical transformer located in the south-central portion of the Phase One Property, looking southeast.

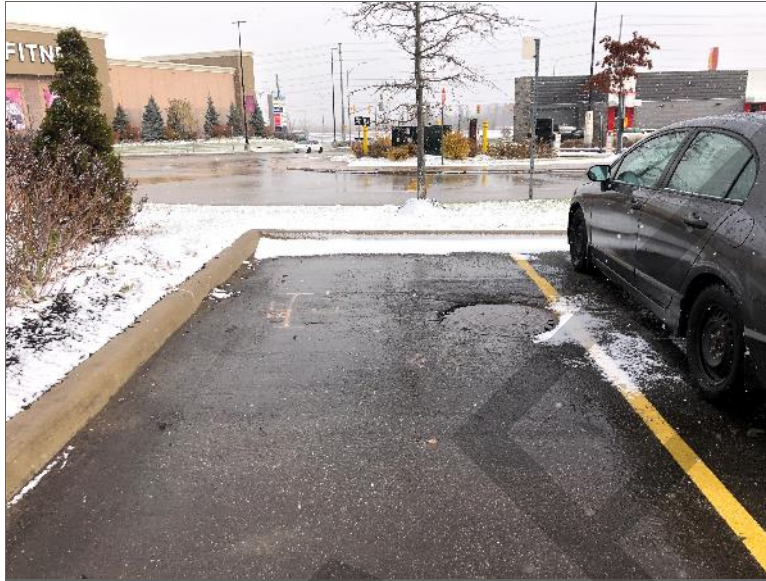
Photo 14 – Pad-mounted oil-cooled electrical transformer located approximately 20 m east of the Phase One Property, looking east.

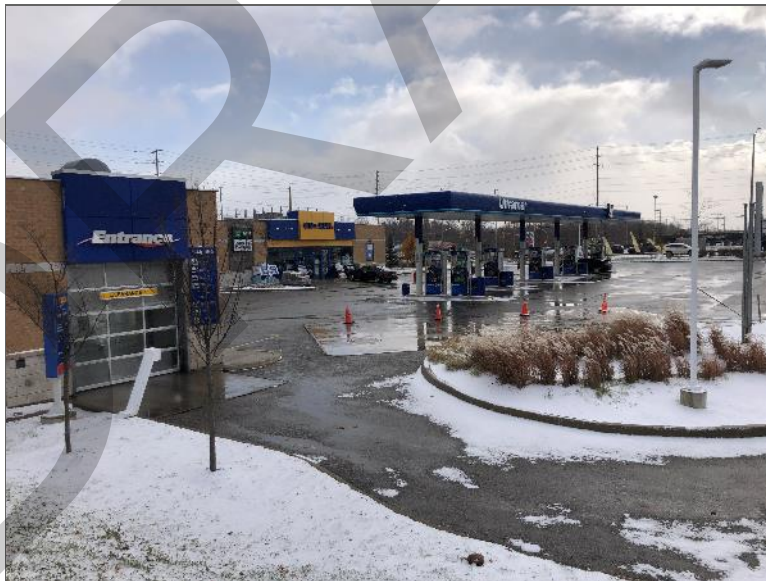
Photo 15 – Retail fuel outlet located at 90 Mapleview Drive East, looking south.
