NOTE:  
Vegetation inventory undertaken by Nate Torenvliet,  
ISA Certified Arborist (ON-1782A) on March 11th, 2019  
and updated on April 27th, 2020

CLIENT  
DMS Property Management Ltd.

PROJECT  
113 Bayfield Street

SHEET  
Vegetation  
Management Plan

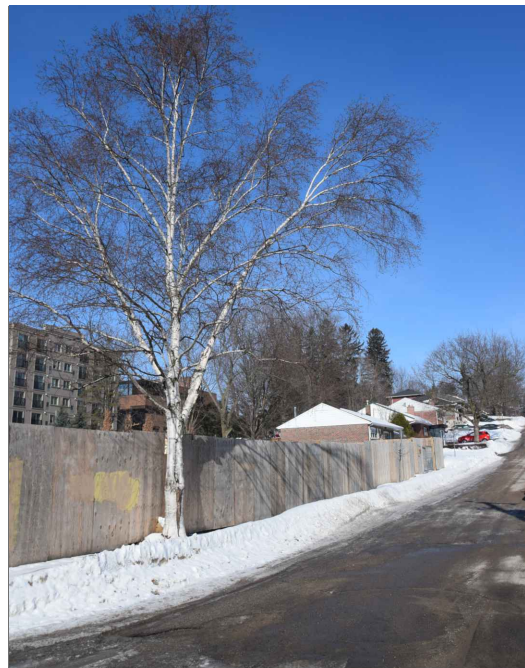
Tree #1 & 2

| TREE/UNIT NO. | SPECIES (COMMON NAME) | SPECIES (BOTANICAL NAME) | DBH (cm) | CROWN CLASS* | CONDITION | VEGETATION VALUE & PHYSICAL CONSTRAINTS | POTENTIAL IMPACTS FROM CONSTRUCTION | OWNERSHIP | RECOMMENDATION |
|---|---|---|---|---|---|---|---|---|---|
| 1 | Paper Birch | Betula papyrifera | 46 | D | Poor | Large scars on trunk, poor pruning breaks in canopy | Grading within roof zone due to proposed parking, poor quality | Private (on property) | REMOVE |
| 2 | Burr Oak | Quercus macrocarpa | 5 | D | Poor | Stunted growth | Conflict with proposed parking entrance, poor quality | Private (on property) | REMOVE |

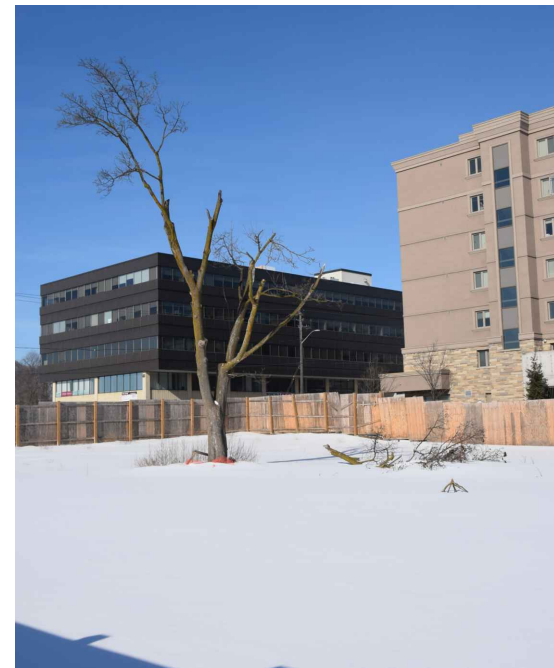
Tree #3

| TREE/UNIT NO. | SPECIES (COMMON NAME) | SPECIES (BOTANICAL NAME) | DBH (cm) | CROWN CLASS* | CONDITION | VEGETATION VALUE & PHYSICAL CONSTRAINTS | POTENTIAL IMPACTS FROM CONSTRUCTION | OWNERSHIP | RECOMMENDATION |
|---|---|---|---|---|---|---|---|---|---|
| 3 | Norway Maple | Acer platanoides | 50 | D | Poor | Significant decline, large broken limbs | Conflict with proposed building | Private (on property) | REMOVE |

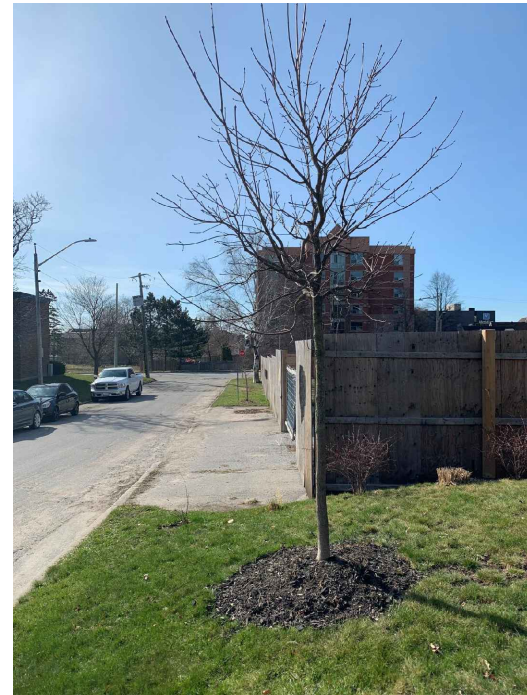
Tree #11

| TREE/UNIT NO. | SPECIES (COMMON NAME) | SPECIES (BOTANICAL NAME) | DBH (cm) | CROWN CLASS* | CONDITION | VEGETATION VALUE & PHYSICAL CONSTRAINTS | POTENTIAL IMPACTS FROM CONSTRUCTION | OWNERSHIP | RECOMMENDATION |
|---|---|---|---|---|---|---|---|---|---|
| 11 | Norway Maple | Acer platanoides | 7 | D | Good | | | City Property (ROW) | SAVE |

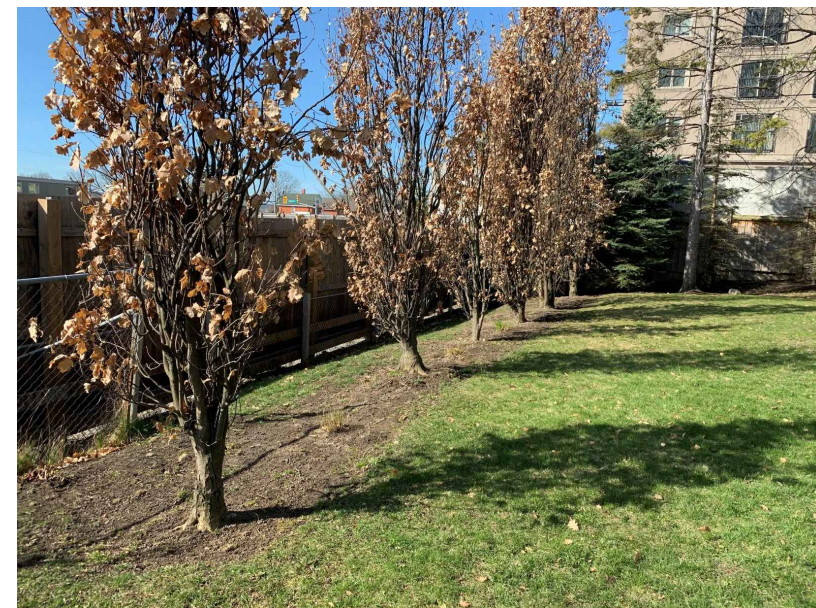
Tree #13 - 22

| TREE/UNIT NO. | SPECIES (COMMON NAME) | SPECIES (BOTANICAL NAME) | DBH (cm) | CROWN CLASS* | CONDITION | VEGETATION VALUE & PHYSICAL CONSTRAINTS | POTENTIAL IMPACTS FROM CONSTRUCTION | OWNERSHIP | RECOMMENDATION |
|---|---|---|---|---|---|---|---|---|---|
| 13 | Pyramidal English Oak | Quercus robur 'Fastigiata' | multi | D | Good | | | Private (off property) | SAVE |
| 14 | Pyramidal English Oak | Quercus robur 'Fastigiata' | multi | D | Good | | | Private (off property) | SAVE |
| 15 | Pyramidal English Oak | Quercus robur 'Fastigiata' | multi | D | Good | | | Private (off property) | SAVE |
| 16 | Pyramidal English Oak | Quercus robur 'Fastigiata' | multi | D | Good | | | Private (off property) | SAVE |
| 17 | Pyramidal English Oak | Quercus robur 'Fastigiata' | multi | D | Good | | | Private (off property) | SAVE |
| 18 | Pyramidal English Oak | Quercus robur 'Fastigiata' | multi | D | Good | | | Private (off property) | SAVE |
| 19 | Colorado Spruce | Picea pungens | 20 | C | Good | | | Private (off property) | SAVE |
| 20 | Colorado Spruce | Picea pungens | 13 | C | Fair | | | Private (off property) | SAVE |
| 21 | Colorado Spruce | Picea pungens | 20 | C | Fair | | | Private (off property) | SAVE |
| 22 | Colorado Spruce | Picea pungens | 15 | C | Fair | | | Private (off property) | SAVE |
