# **51, 53, 55 & 75 Bradford St. and 20 Checkley St., Barrie Geomorphic Assessment Bunker Creek Watershed, City of Barrie**

**Barrie Lakeshore Developments**

**Beacon Environmental Limited**

**August 2020    219403.2**

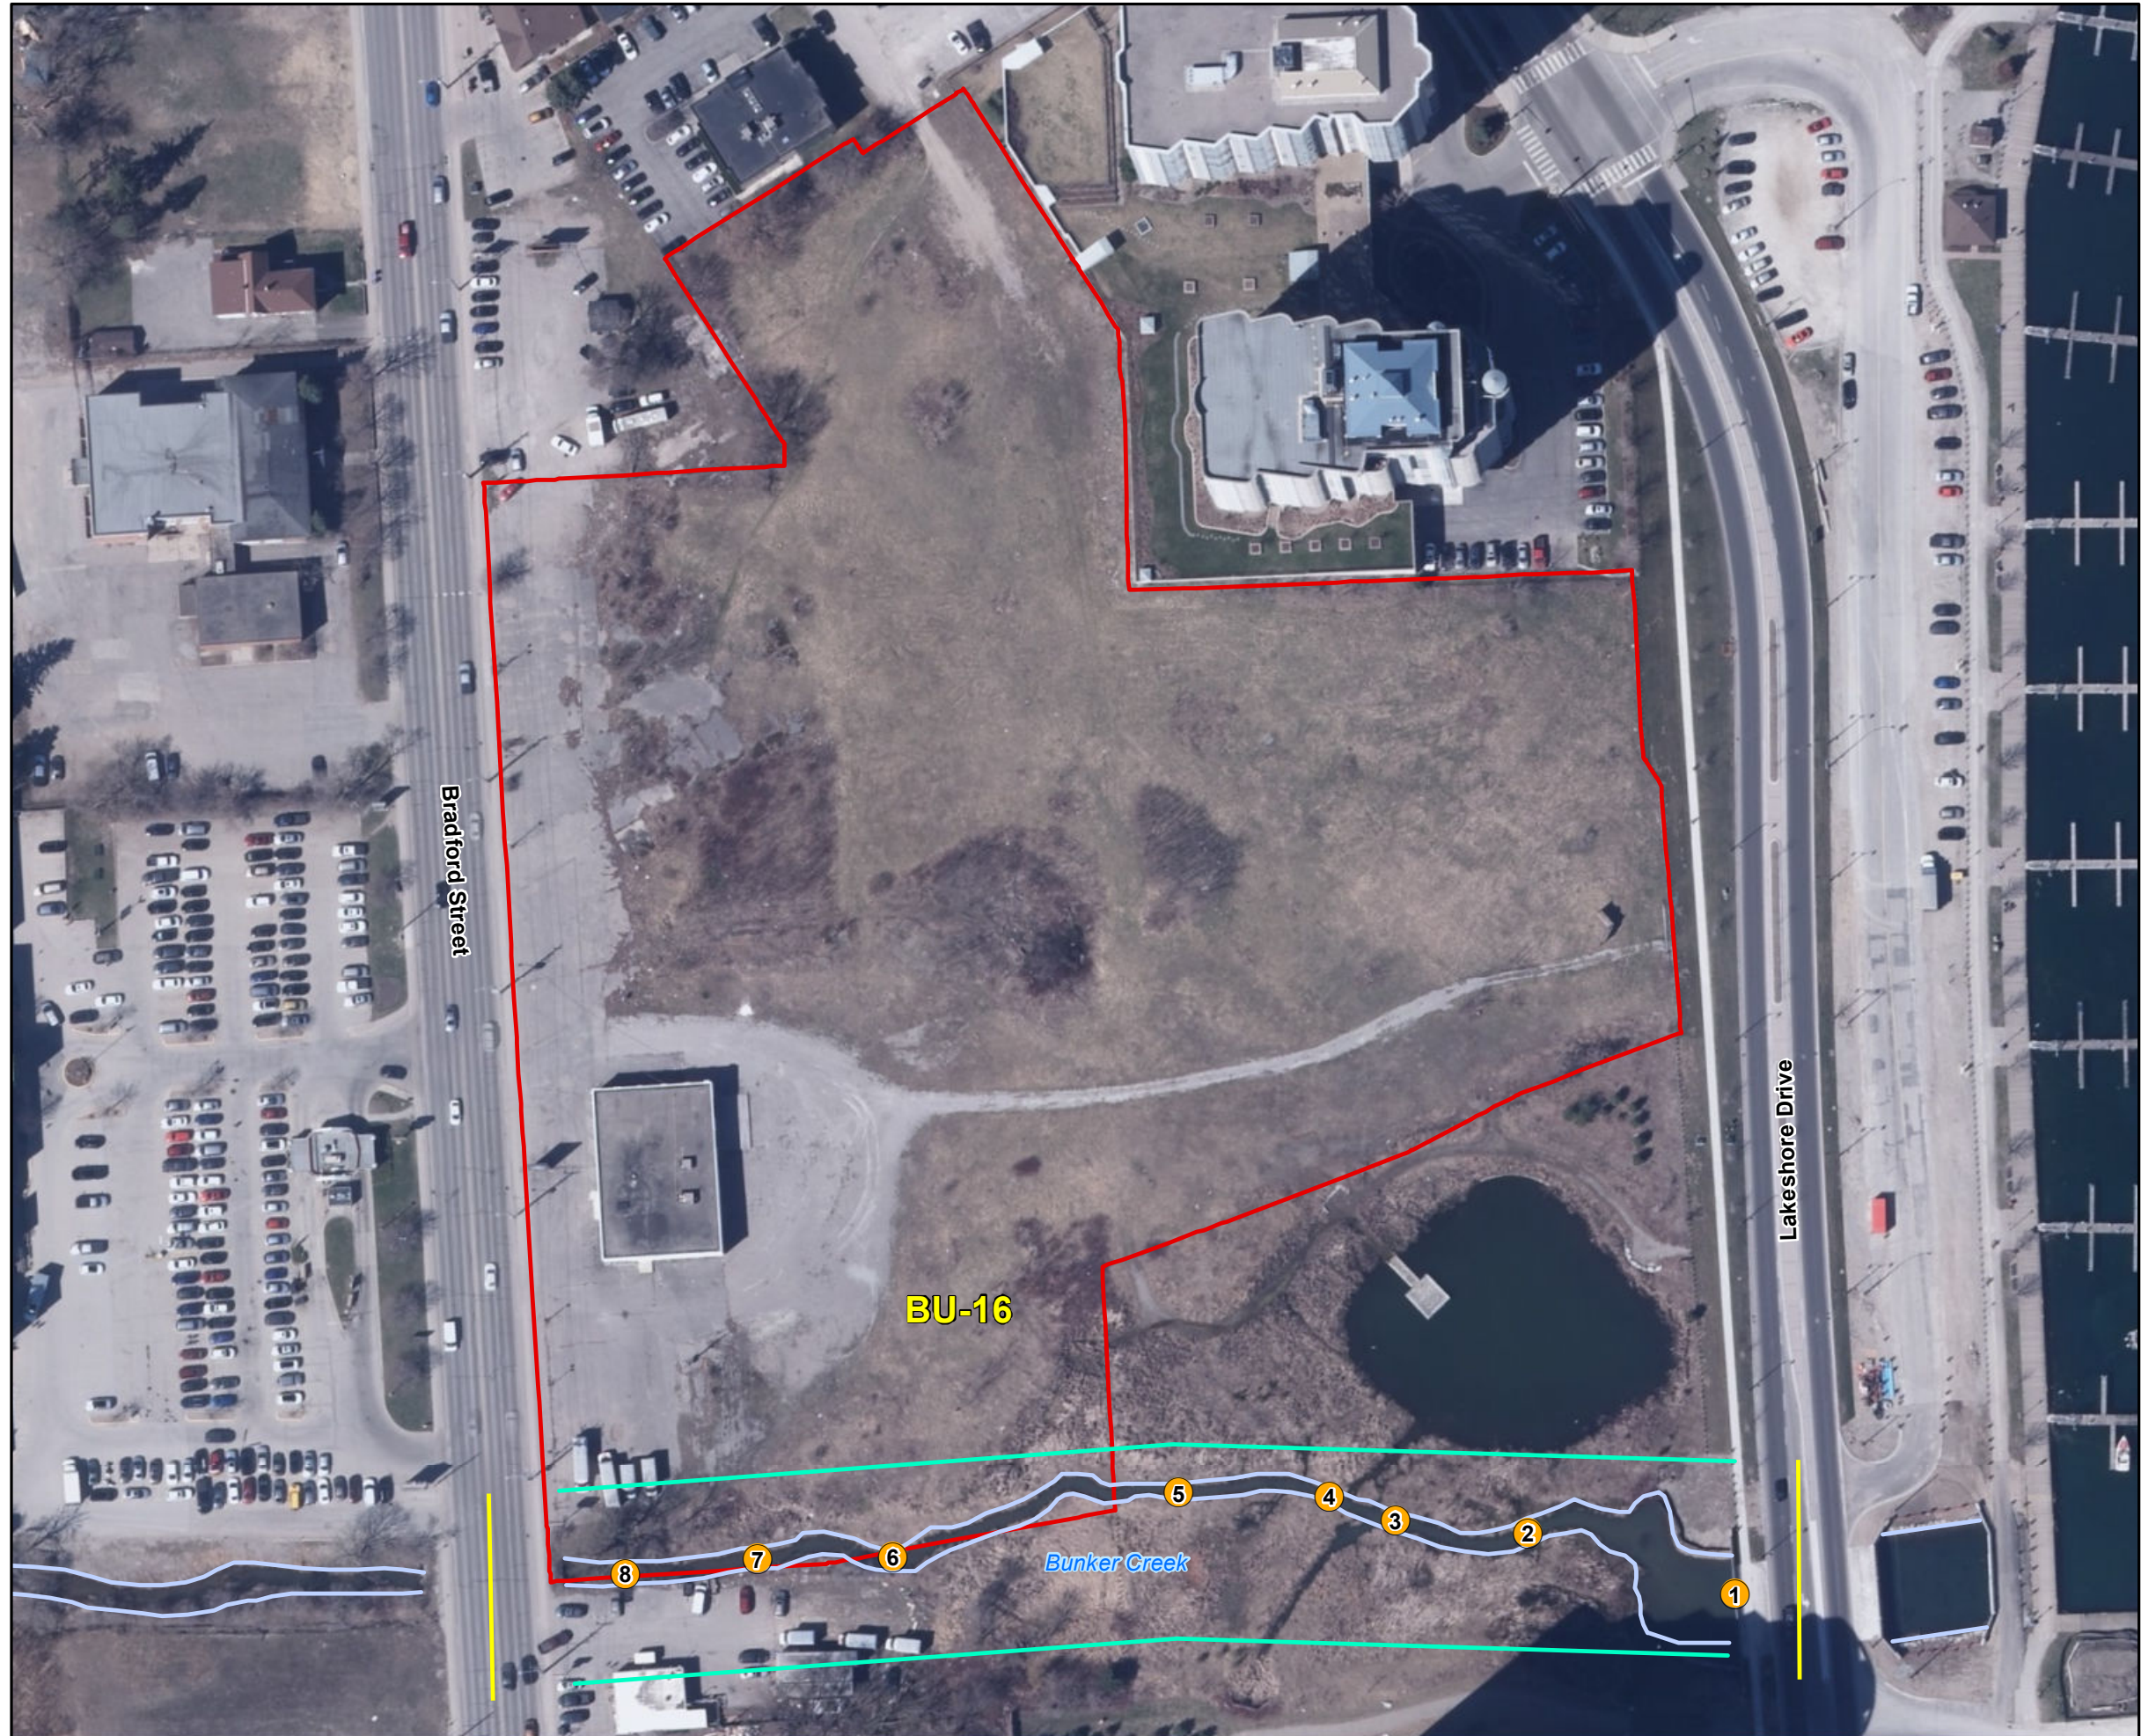
Figure 2

For the purposes of this study, the section of Bunkers Creek between Bradford Street to Lakeshore Drive was delineated as a single reach (Reach Bu-16; see **Figure 2**), in accordance with the Drainage Master Plan (Tatham 2019). The determination of reach extents was initially based on a desktop assessment of land use, riparian conditions and channel planform. Verification of reach extents was subsequently undertaken during the field assessment.

Reach Delineation, Photo Location and Meander Belt

Results of the empirical modelling analysis are summarized in **Table 4**. The resultant 35 m meander belt dimension was then reviewed relative to historical and recent aerial imagery, to ensure that the dimension was appropriate and captured current and historical channel locations. Meander belt limits are shown in **Figure 2**.

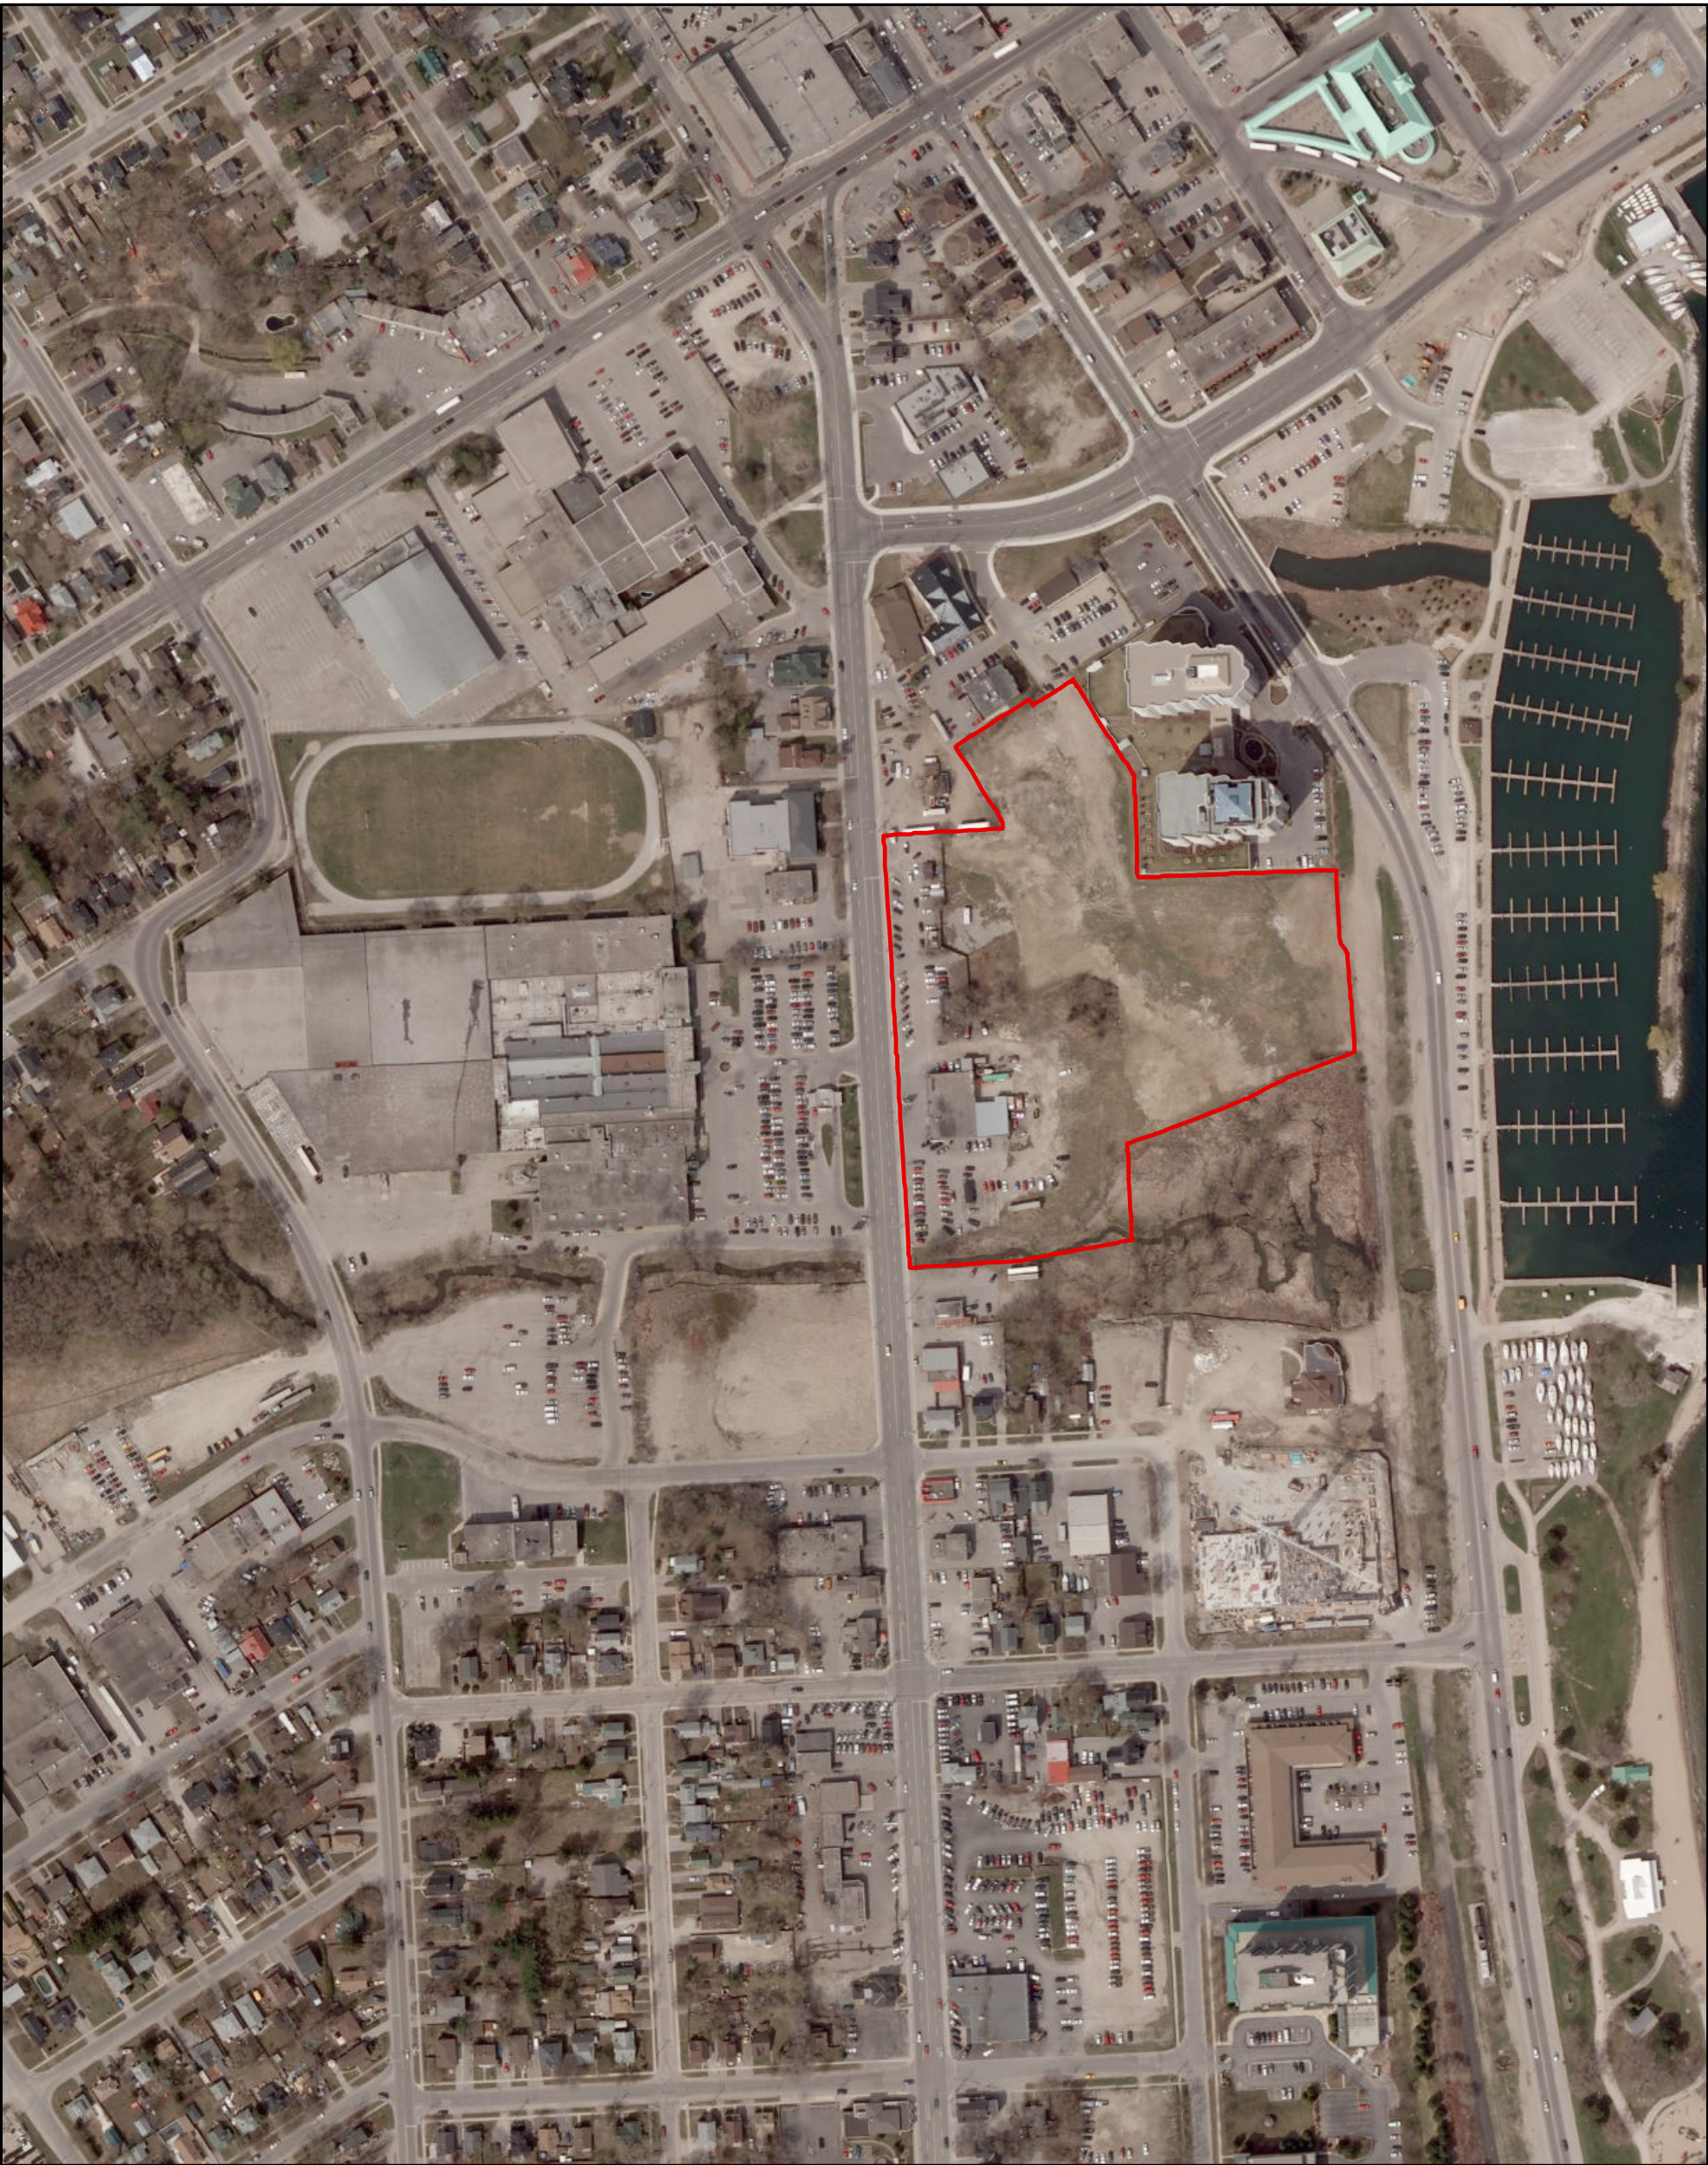
| Time Period | Scale, Source | Observations |
|---|---|---|
| 2008 | 1:3000, First Base Solutions | Land use remains unchanged within the areas within and surrounding the study area. Improvements along Lakeshore Drive could be observed, mainly through the realignment of the road towards Simcoe Street. The watercourse appears to be more discernible within the aerial photo. Riparian vegetation consisted mainly of tall grasses along the banks, with few mature trees. The ponding in the southeast remains present and remains vegetated by grass and few trees. |

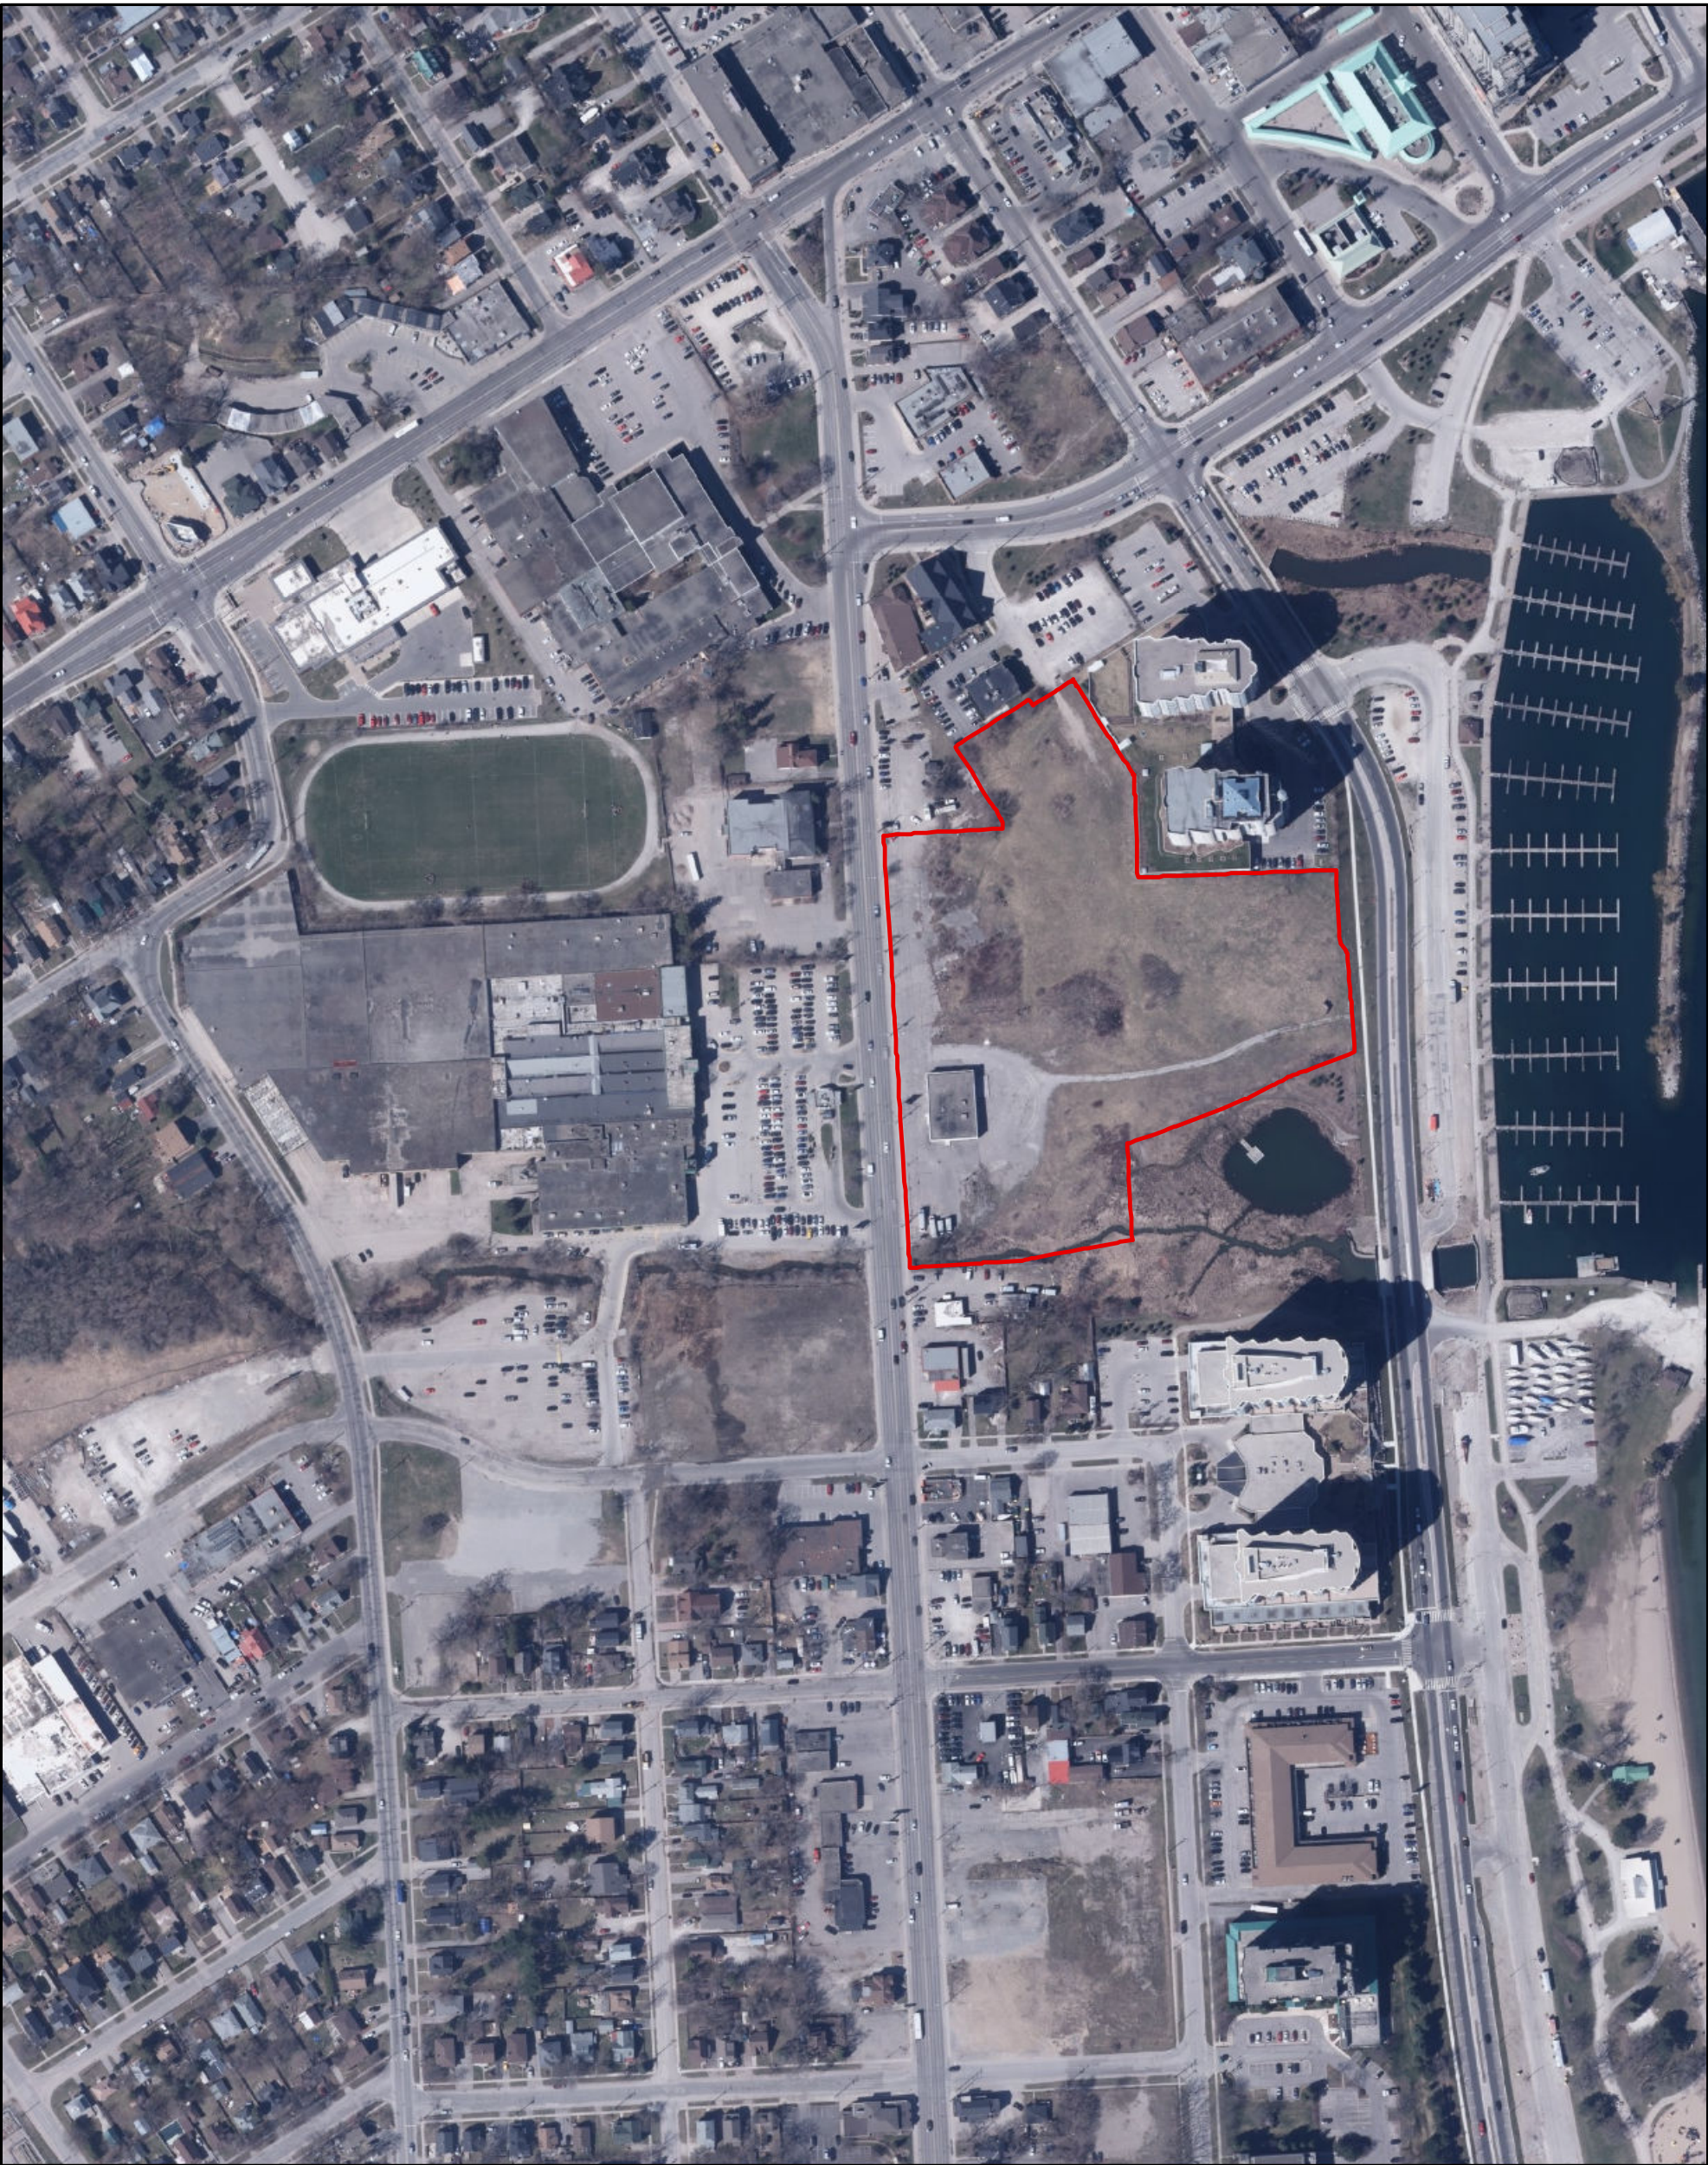
| <div>Legend</div> <div><div></div> Subject Property</div> | Historical Aerial Imagery | | 2016 |

| Time Period | Scale, Source | Observations |
|---|---|---|
| 2016 | 1:3000, First Base Solutions | Land use both on site and surrounding the subject property remains the same. However, further improvements could be seen along Lakeshore Drive, including the road widening and addition of a median between the northbound and southbound lanes, as well as the increase in parking space adjacent to the marina. |

| Time Period | Scale, Source | Observations |
|---|---|---|
| | | The watercourse is as discernible and vegetated as 2008, however the watercourse now flows underneath Lakeshore Drive through a series of new, larger culverts. There is also a water retention pond in the previous ponding location observed in 1986. |

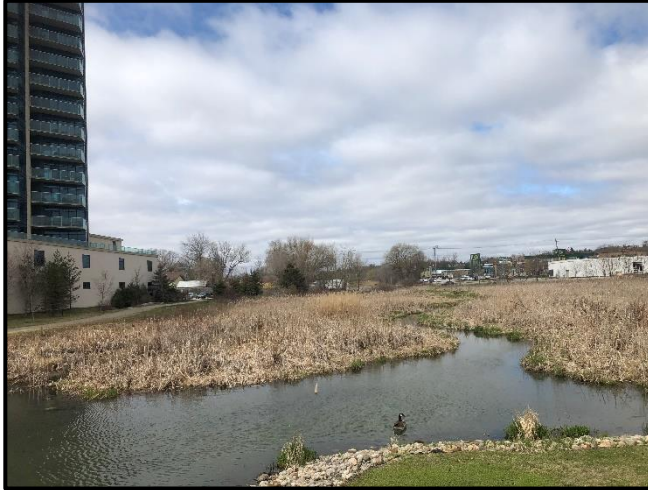
**Photograph 1. (Photo Location 1)**  
**Upstream view of from Lakeshore Drive crossing.**  
**Note: backwater influence associated with Lake levels.**

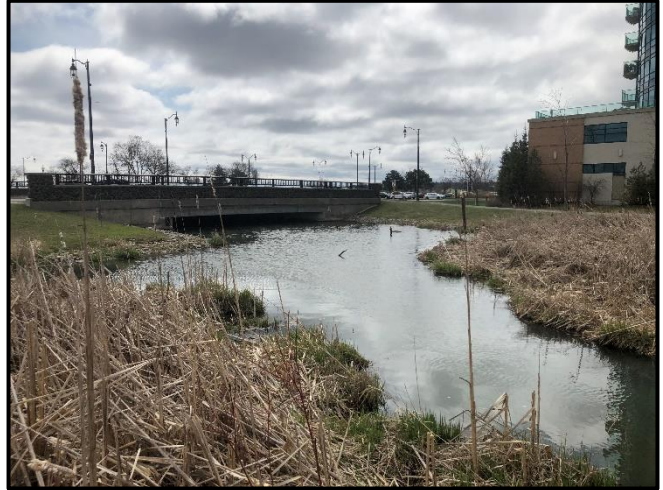
**Photograph 2. (Photo Location 2)**  
**Downstream view towards Lakeshore Drive crossing.**

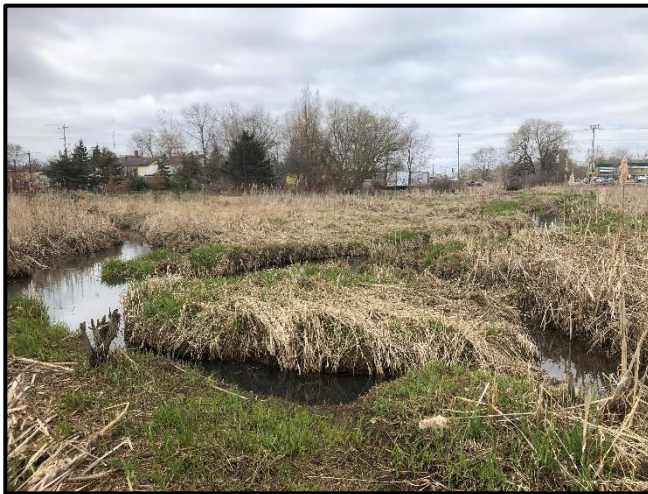
**Photograph 3. (Photo Location 3)**  
**Upstream view of island formation at offline pond outlet channel confluence with Bunkers Creek.**

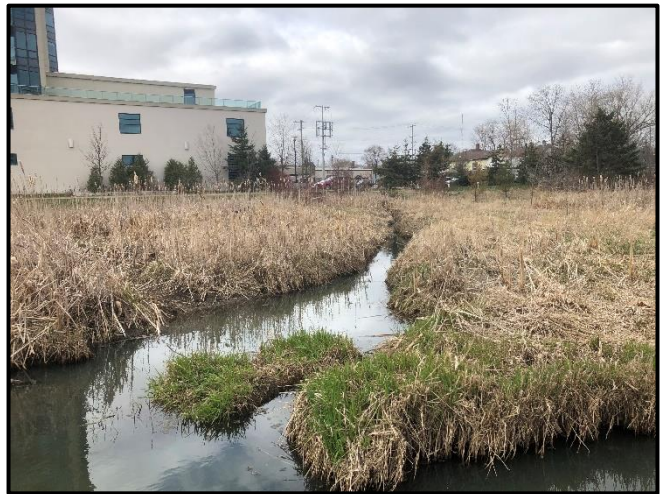
**Photograph 4. (Photo Location 3)**  
**Upstream view of stormwater outlet channel (south side of creek).**

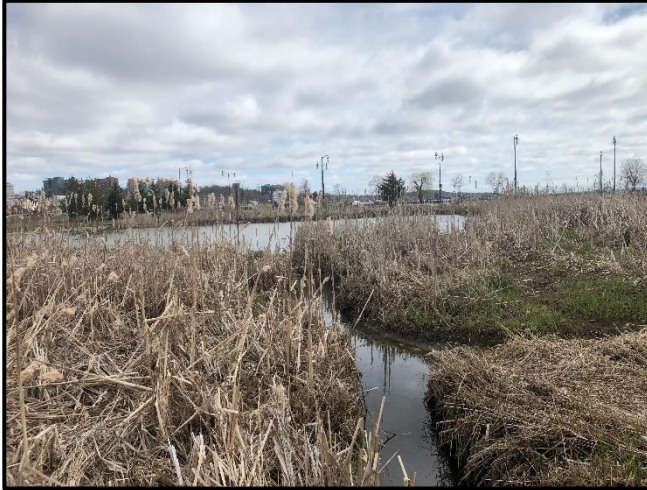
**Photograph 5. (Photo Location 4)**  
**View of offline pond and outlet channel (north side of creek).**

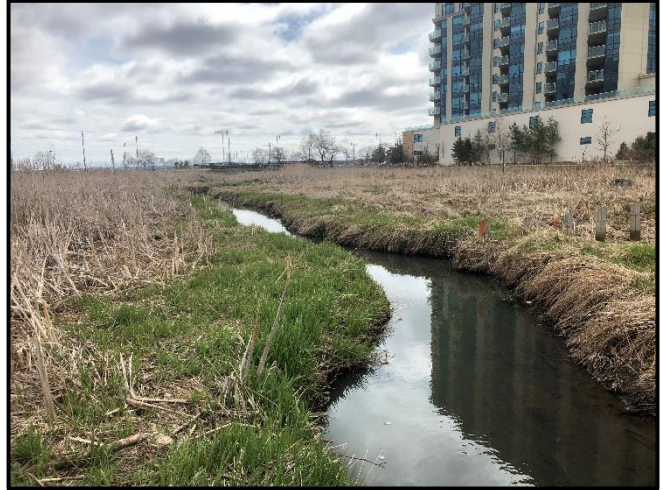
**Photograph 6. (Photo Location 5)**  
**Downstream facing view of general conditions downstream of subject property at limit of Lake influence.**

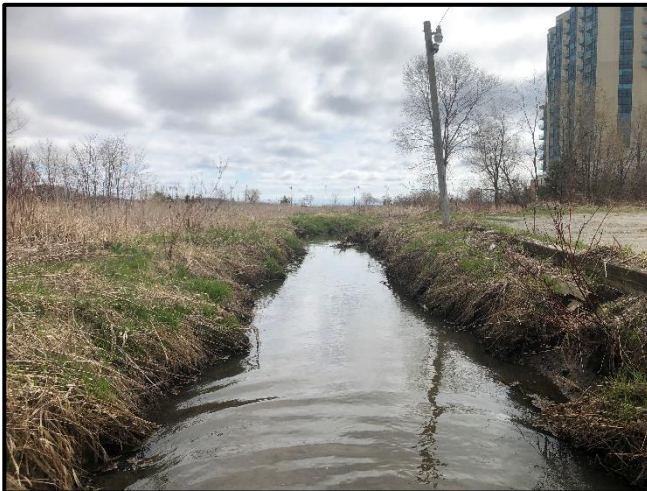
The RGA results indicated that Reach Bu-16 was stressed, or 'in transition, with a score of 0.39. Widening and degradation were identified as the primary modes of adjustment. Evidence supporting these processes included the prevalence of basal scour along channel banks, scour pool formation downstream of culverts/outfalls and undermining of bank protection measures. An RSAT score of 17 indicated that the reach displayed a 'fair' degree of stream health. Riparian habitat conditions were identified as the primary limiting factor. The Downs model classified this reach as e – 'enlarging' based on the presence of steep banks and evidence of downcutting.

**Photograph 7. (Photo Location 6)**  
**Downstream view of general conditions within corridor and evidence of active bank erosion (photo right).**

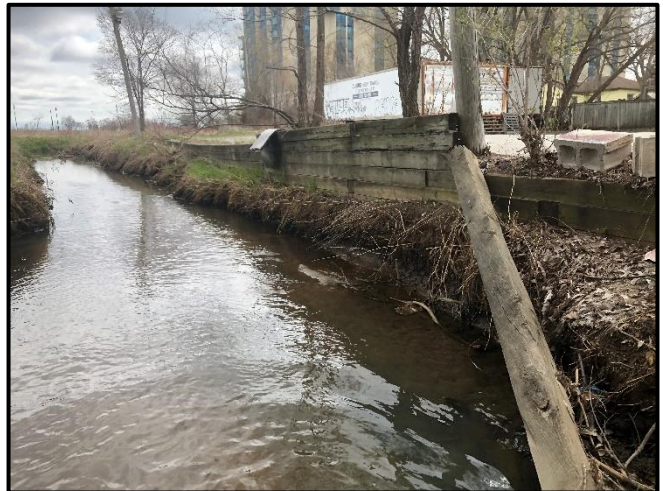
Existing channel disturbances included the Bradford Street and Lakeshore Drive road crossings, an off-property wooden retaining wall along the southern channel bank, as well as storm outfall and offline wetland outlet channels downstream of the subject property. Downstream of the subject property, the backwater influence of Lake Simcoe water levels was also observed as an influence on channel form.

**Photograph 8. (Photo Location 7)**  
**Downstream view of existing wooden retaining wall along southern channel bank (off property). Note: undermining of retaining wall and leaning hydro poles observed**

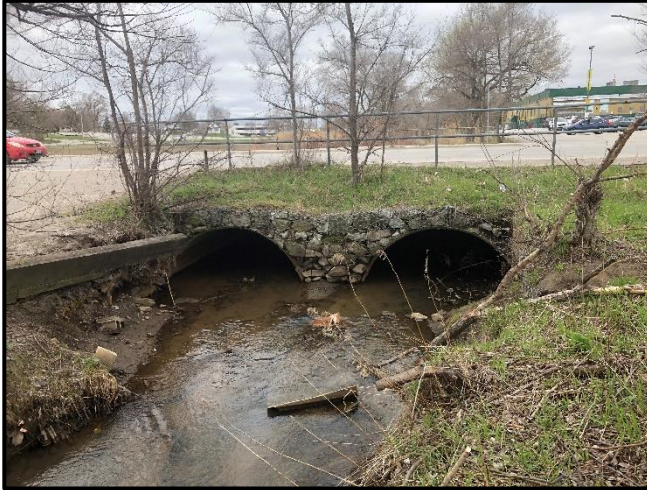
**Photograph 9. (Photo Location 8)  
Upstream view of Bradford Street crossing.**

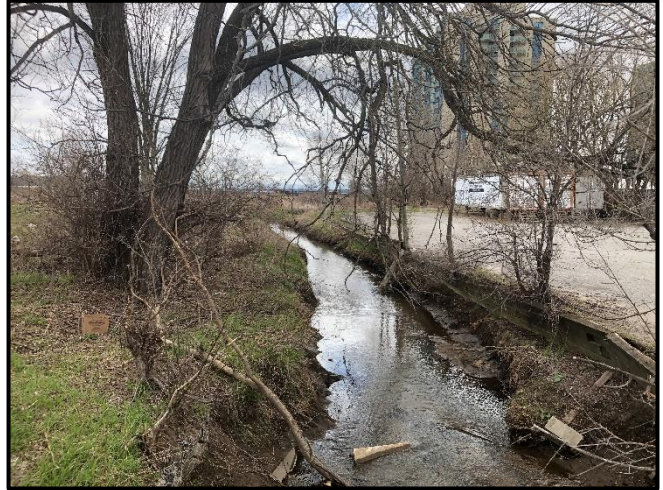
**Photograph 10. (Photo Location 8)  
Downstream view of general conditions from  
Bradford Street Crossing.**
