**PHASE ONE ENVIRONMENTAL SITE ASSESSMENT  
521 HURONIA ROAD  
BARRIE, ONTARIO**

**Prepared for:** **HURONIA BARRIE LAND INC.**  
590 ALDEN ROAD, SUITE 211  
MARKHAM, ONTARIO  
L3R 8N2

File No 3-19-0101-41  
October 21, 2019  
©**Terraprobe Inc.**

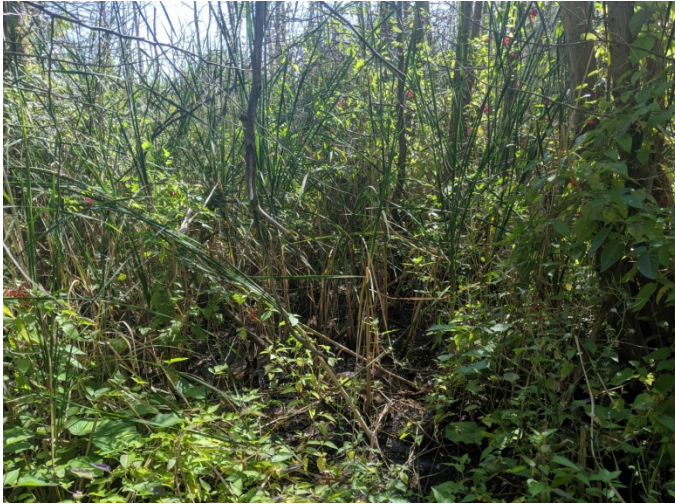
Photograph 1

Location: Phase One Property  
Viewing: South  
Description: View of Lovers Creek Swamp

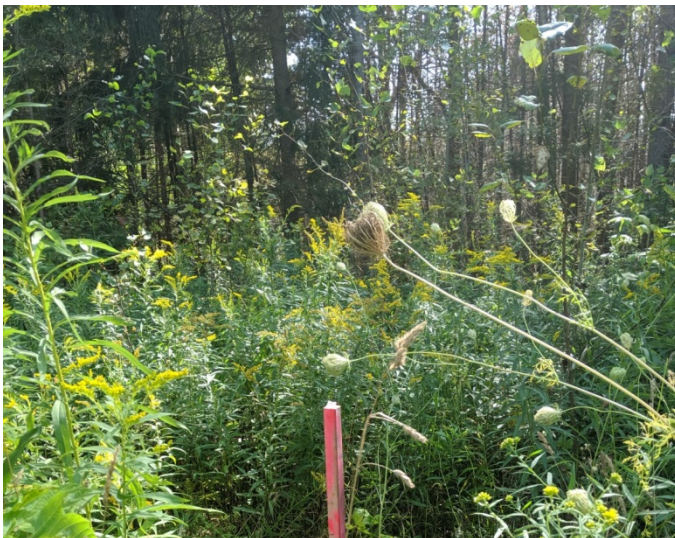
Photograph 2

Location: Phase One Property  
Viewing: South  
Description: View of Forested Area and Woodlands

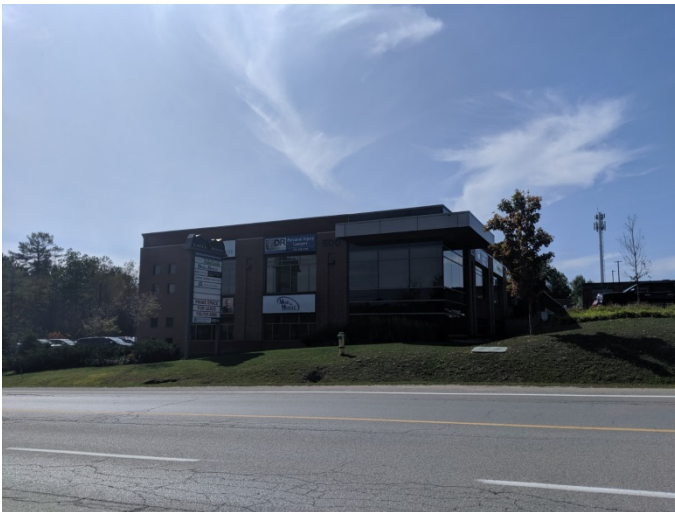
Photograph 3

Location: West of Phase One Property  
Viewing: West  
Description: View of adjacent light industrial land

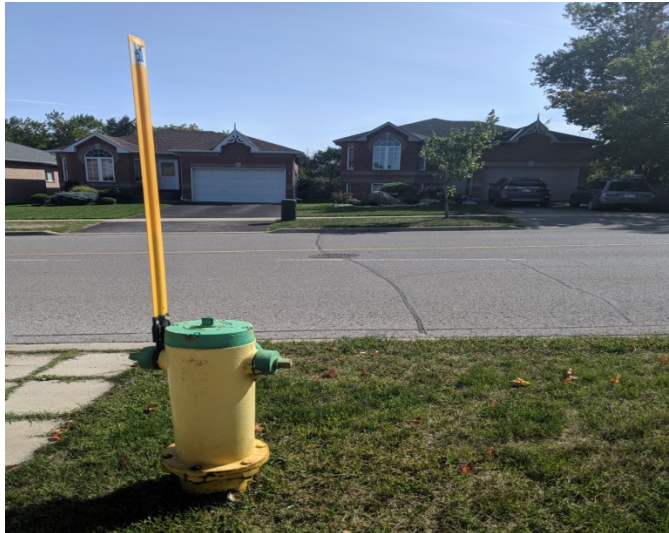
Photograph 4

Location: North of Phase One Property  
Viewing: South  
Description: View of fire hydrant, sanitary manhole and residential homes north of phase one property

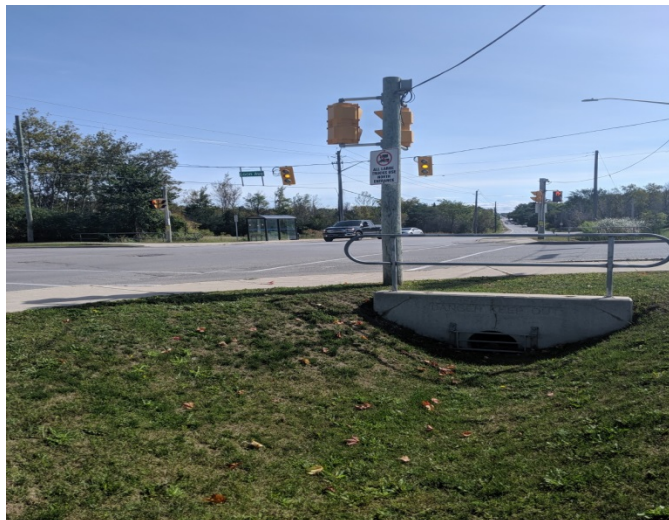
Photograph 5

Location: Northwest of Phase One Property  
Viewing: Southeast  
Description: View of Huronia Road and Loon Ave intersection. Also, along the west side of Huronia is a ditch/culvert.

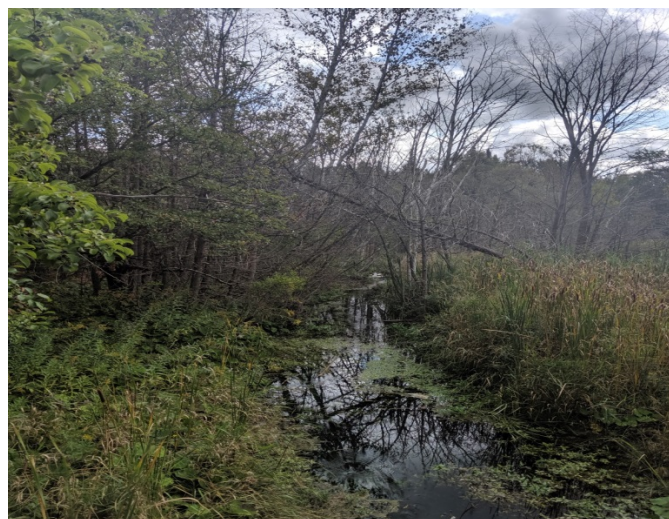
Photograph 6

| <b>Watercourses, Ditches or Standing Water</b> | Streams and wetlands were observed on the Property. Lovers Creek tributary (stream) was identified on the southwest portion of the Property. |

Location: Phase One Property  
Viewing: Southeast  
Description: Lovers creek stream trending west/east

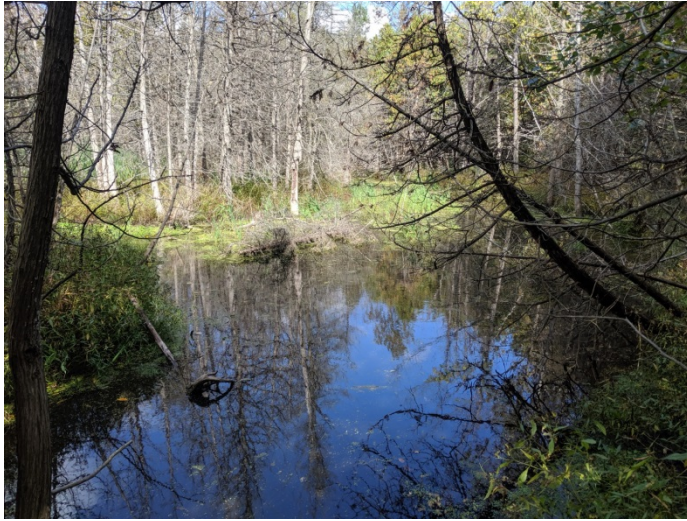
Photograph 7

Location: Phase One Property

Viewing: West

Description: View of wetland

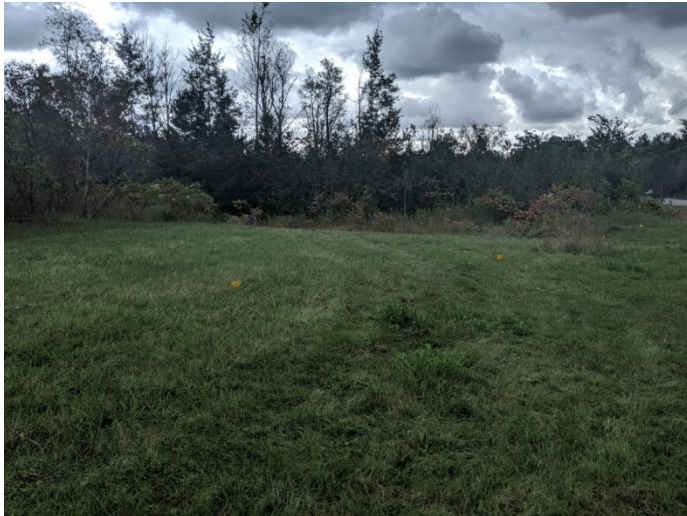
Photograph 8

Location: Phase One Property

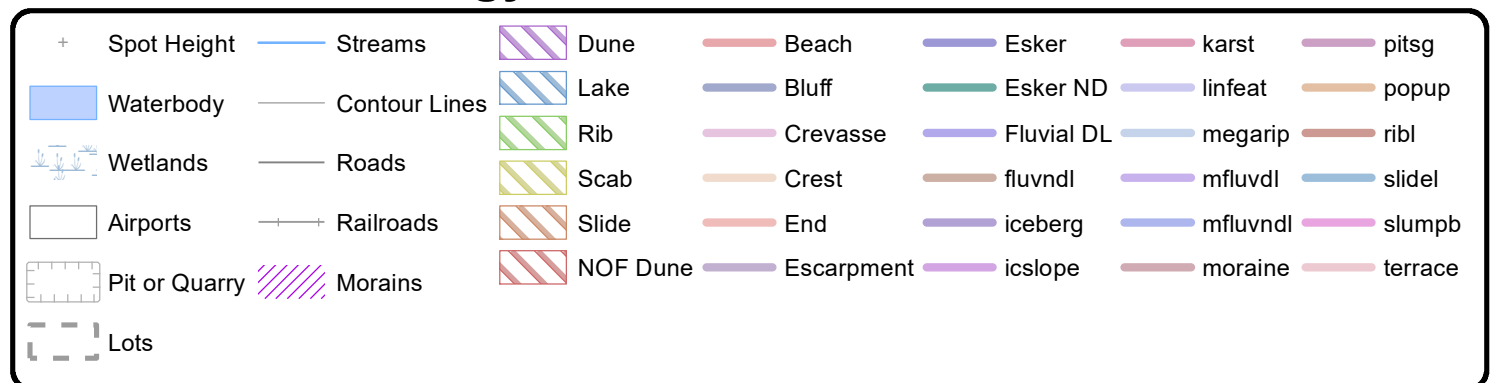
# The Surficial Geology of Southern Ontario Order No. 20190912190

**ID:** 81463 | **Unit Name:** Till |  
**Deposit Type Code:** 8 | **Deposit Age:** Pleistocene | **Map Number:** m2645 | **Map Name:** Barrie E | **Source Map Scale:** 1:50 000 |  
**Primary Material:** diamicton | **Primary Material Modifier:** silty sand to sand | **Secondary Material:** | **Primary General:** glacial |  
**Primary General Modifier:** | **Veneer:** | **Episode:** Wisconsin | **Sub Episode:** Michigan | **Phase:** | **Stratus Modifier:** Surface |  
**Provenance:** N | **Carbon Content:** | **Formation:** Newmarket Till | **Permeability:** Low-Medium | **Material Description:** Moderately stoney to stoney silty sand to sand till
