## 750 Maplevue Drive East, Barrie, Ontario

Proposed Development Complex

Hydrogeological Investigation and Water Balance Assessment

BRM-00604678-T0

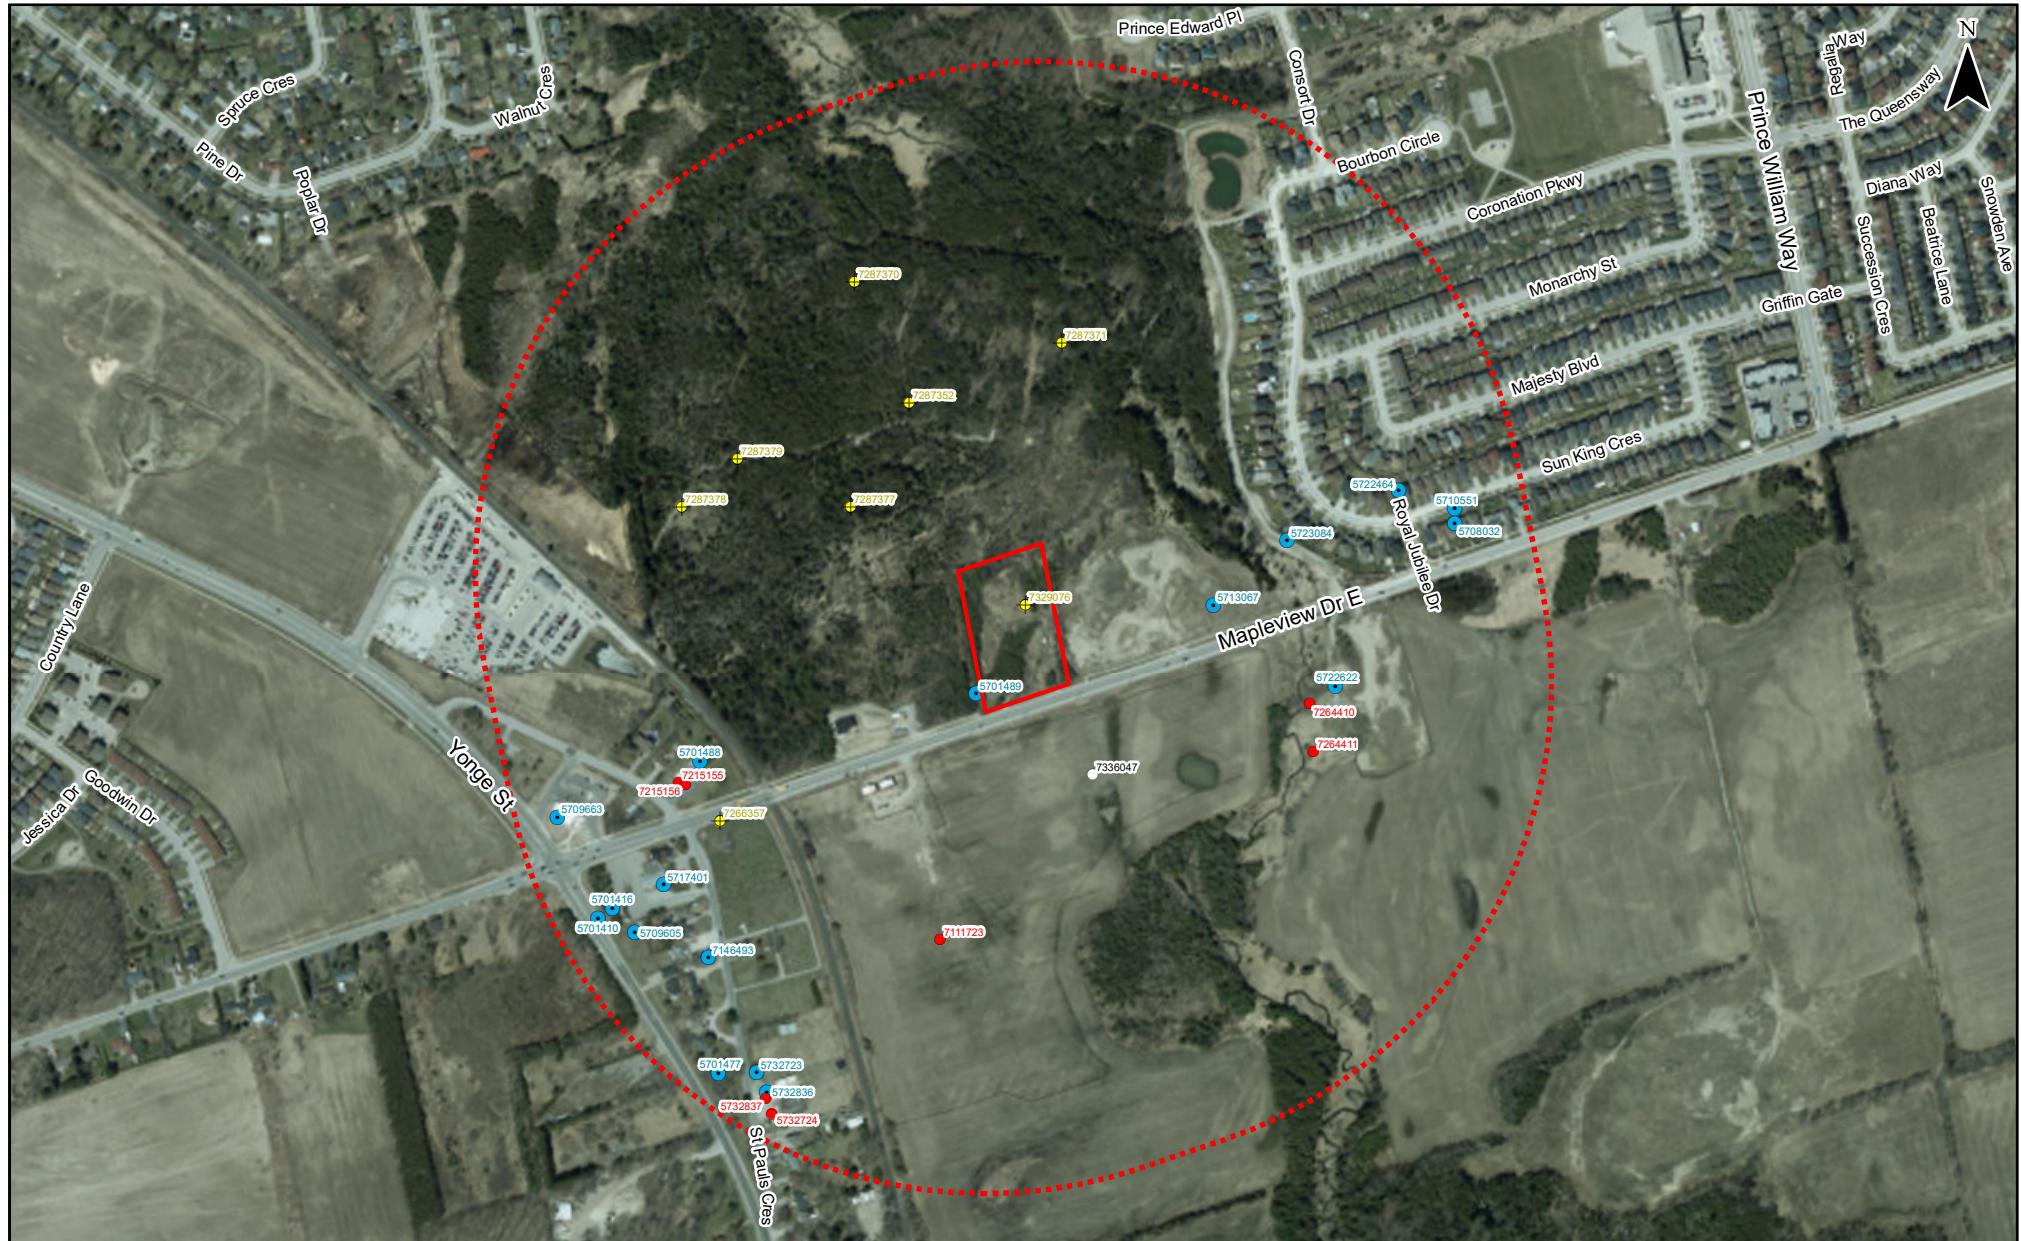
MECP WATER WELL RECORDS MAP	FIGURE: 3
HYDROGEOLOGICAL INVESTIGATION 750 MAPLEVIEW DRIVE EAST BARRIE, ONTARIO	
PROJECT NUMBER: BRM-00604678-T0	DATE: APRIL 2021

The MECP WWR database indicated total of thirty-three (33) WWRs in the 500 m zone. These included two (2) records of wells reportedly located on Site and thirty-one (31) off Site well records. From two (2) on Site wells, one (1) is reported as domestic water supply well (Well ID 5701489). The domestic wells were reportedly installed in 1967, with water found at depths of 3.7 m. The remaining on Site well was reported as a monitoring/ test hole installed in 2018.

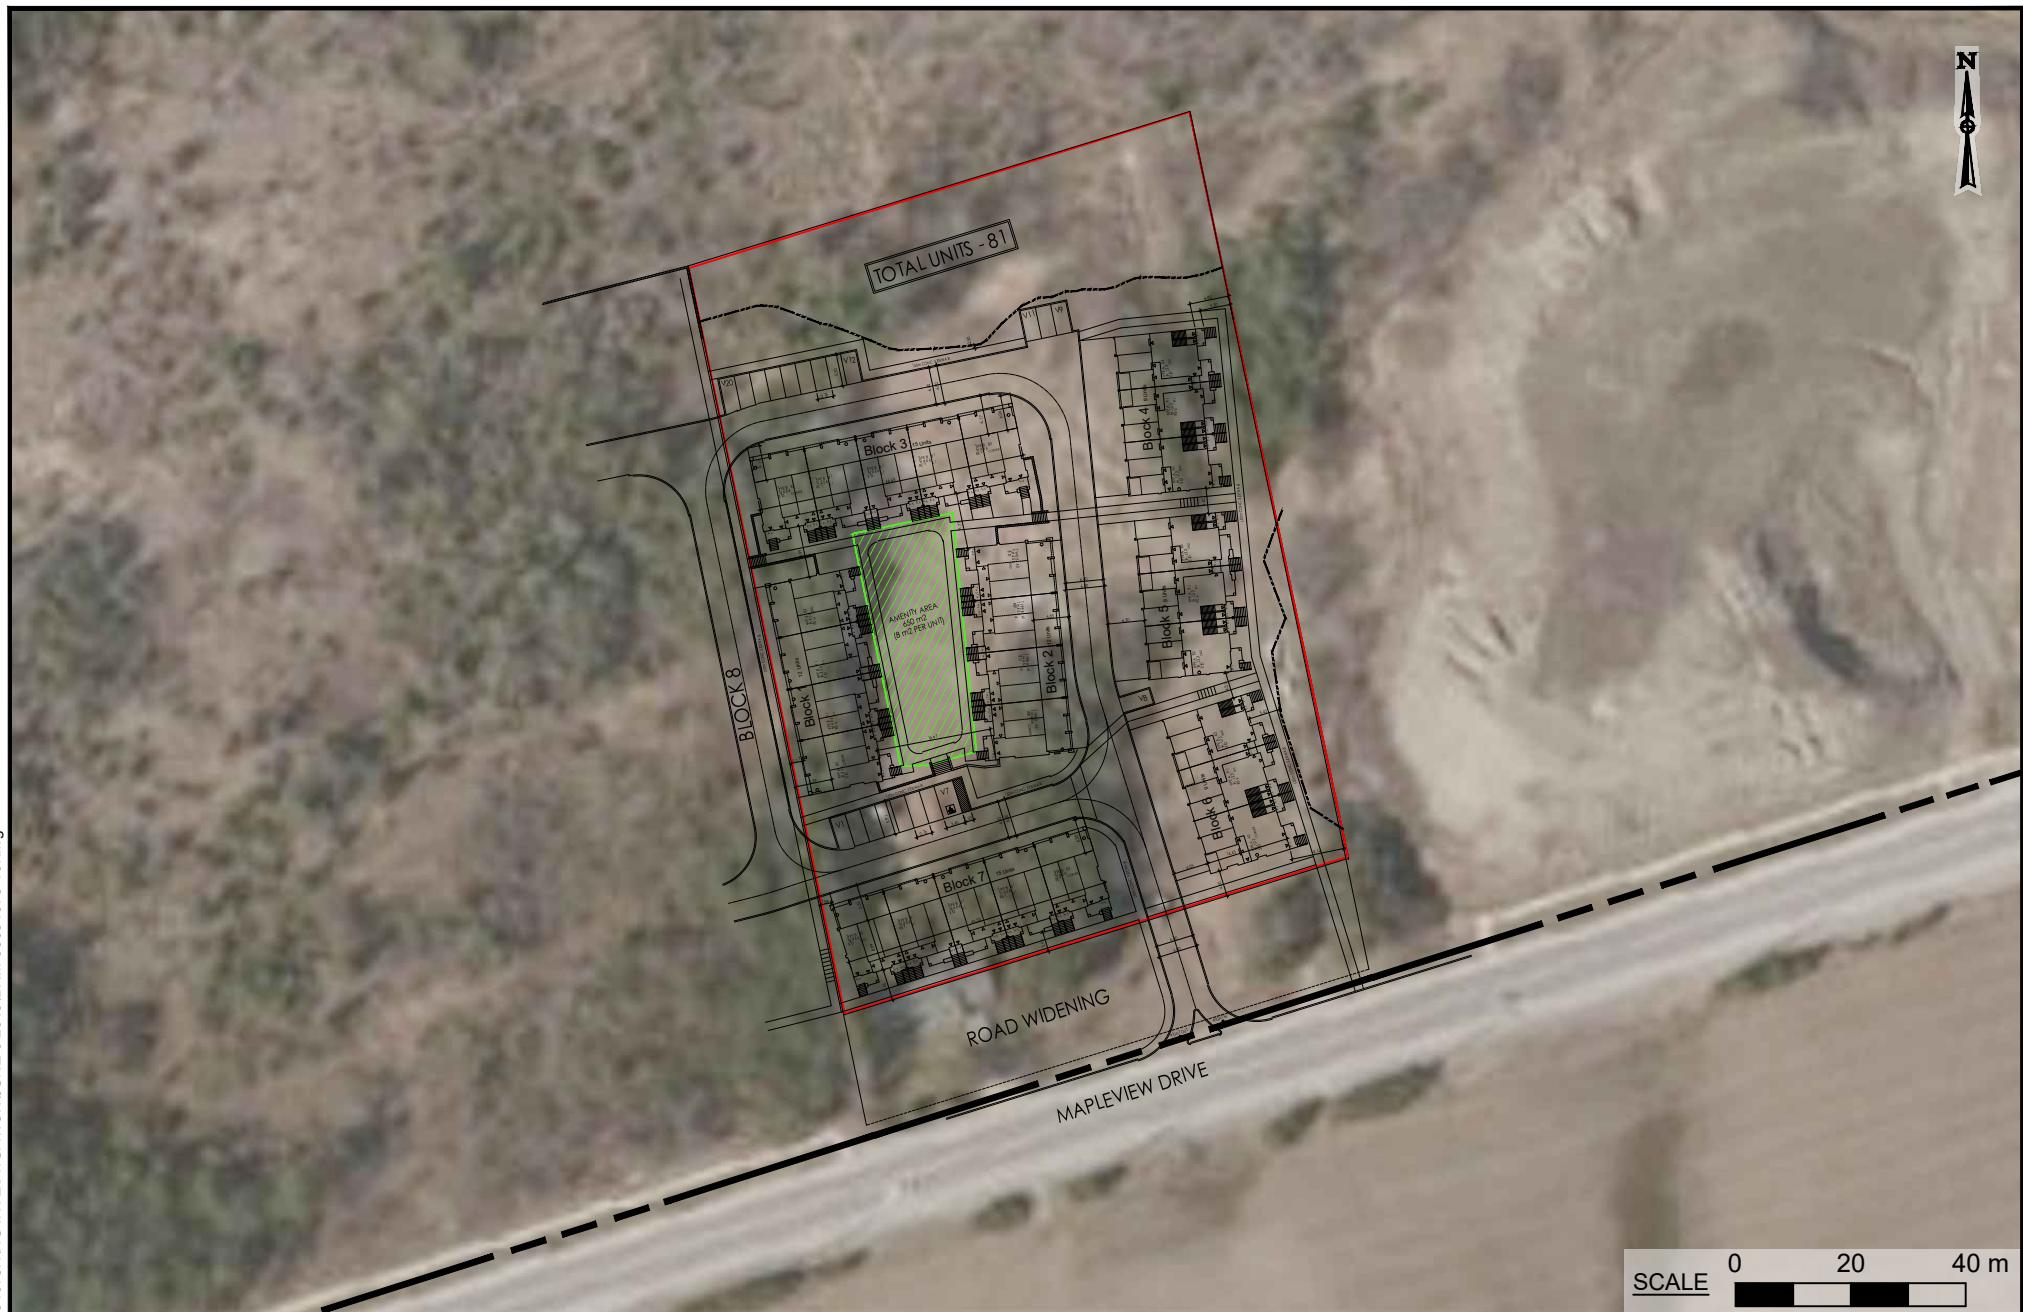
PROJECT NO.:	DWN.:
BRM-00604678-T0	WG
SCALE:	CK:
AS NOTED	NT
DATE:	FIG. NO.:
JUNE 2021	7

PROPOSED DEVELOPMENT PLAN  
HYDROGEOLOGICAL INVESTIGATION  
750 MAPLEVIEW DRIVE EAST,  
BARRIE, ONTARIO

Based on the proposed development plans, the total area of impervious surfaces under the post-development conditions is approximately 6,400 m<sup>2</sup> representing approximately 48% of the Site area (total area: 13,400 m<sup>2</sup>), (Table 4-2). The remaining 7,000 m<sup>2</sup> is available to contribute to infiltration during post development stage (52% of the total land area), not considering areas of shallow water table.
