October 7, 2020

**Re: Arborist Report and Tree Preservation Plan for 76 Bryne Drive, City of Barrie, Ontario
(Palmer #2004501)**

Palmer was retained by M-J-J-J Developments Inc. to complete this Arborist Report and Tree Preservation Plan for the proposed development of a new mixed commercial and residential building and associated parking area. The Subject Property is located at 76 Bryne Drive, City of Barrie, Ontario (**Figure 1**).

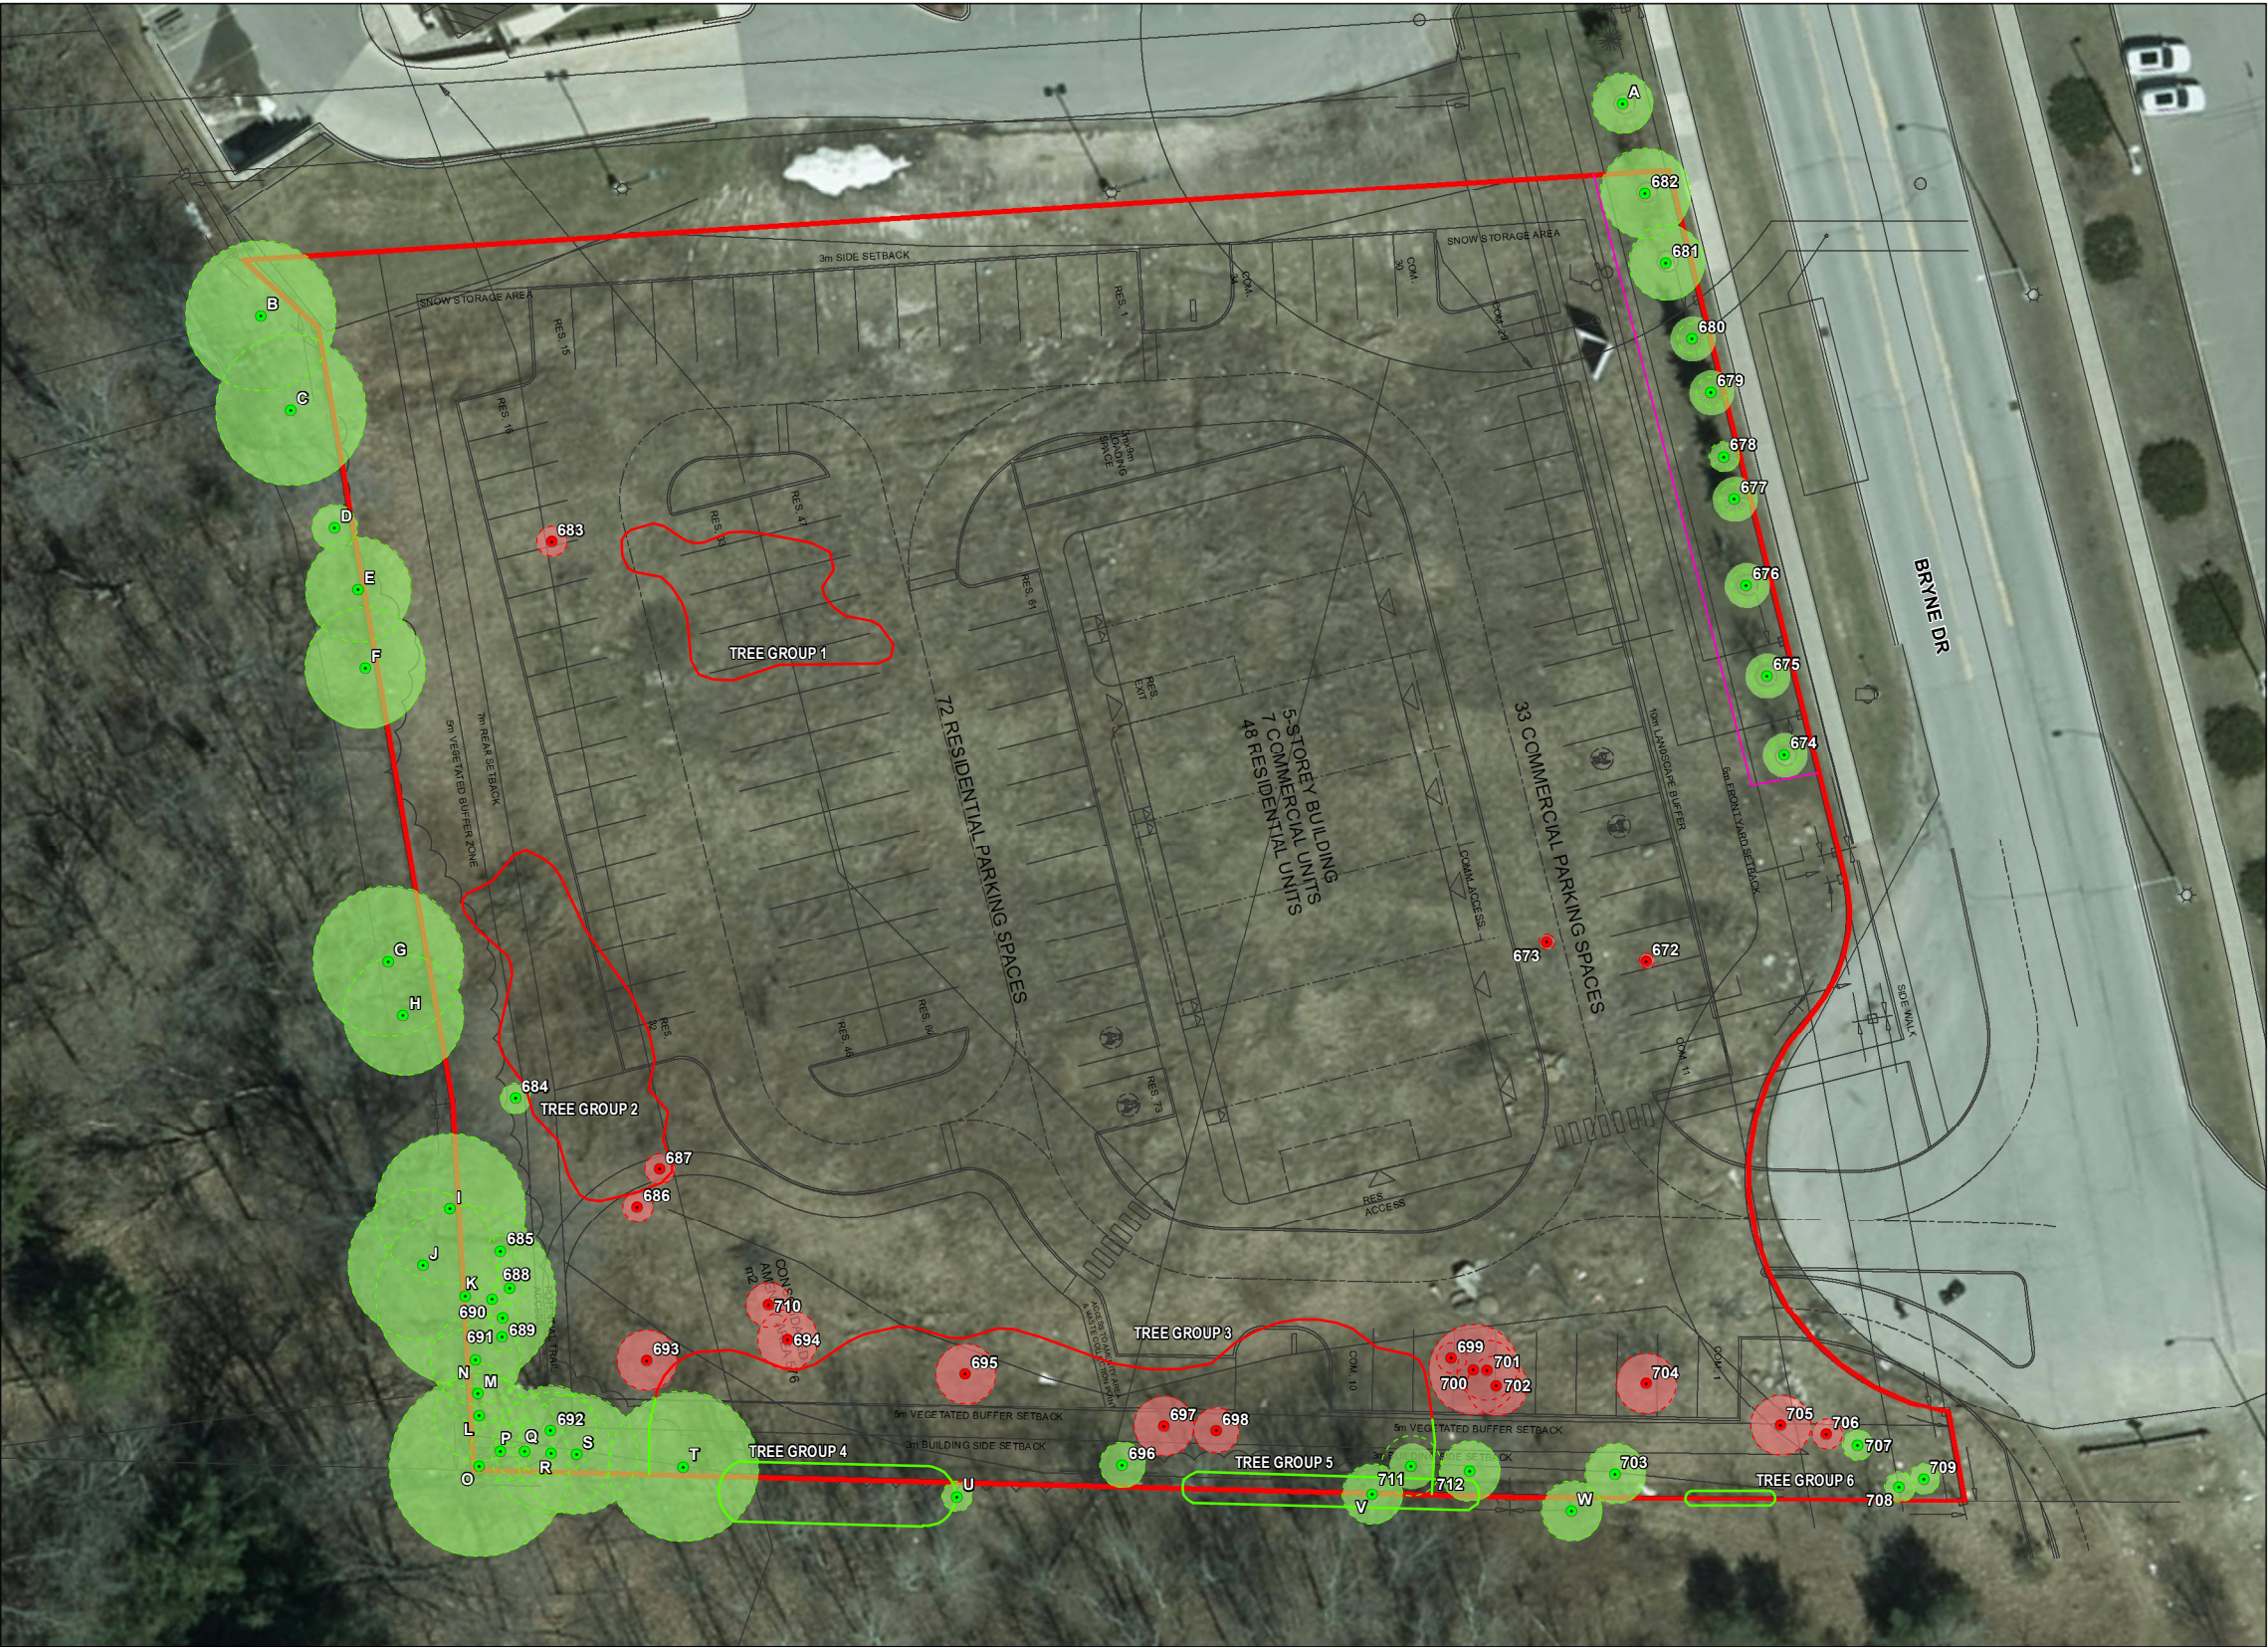
Figure 2

The tree inventory included a total of 64 individuals and six groupings (comprised of approximately 195 individuals, the majority having DBH's smaller than 5 cm) (**Figure 2**). The majority of the inventoried trees were native species (87%) (**Table 1**). Among the individual trees, Black Walnut (*Juglans nigra*) was the dominant tree species, followed by Manitoba Maple (*Acer negundo*). Among the tree groups, Meadow Willow (*Salix petiolaris*) was the dominant species (approximately 110 individuals), followed by Trembling Aspen (*Populus tremuloides*) (approximately 81 individuals). There were no Species at Risk (SAR) trees observed. The full tree inventory is provided in **Appendix A**.

**Tree Inventory
and Preservation Plan**

The specifications for tree protection are detailed below and illustrated on **Figure 2** with the location of required tree protection fencing. These standard mitigation measures are based on the Tree Protection Manual (City of Barrie, 2010).

Trees proposed for retention outside the 5 m Vegetated Buffer Zone, should be protected by installation of additional tree protection fencing. Fencing provides protection from potential damage during construction activities such as the use of machinery near trees and branches, and stockpiling of materials over the root zone. Tree protection fencing should be installed at the recommended Tree Protection Zone (TPZ) distance for each individual tree and tree group (**Table 4**). Based on the City of Barrie's guidelines, the minimum TPZs are based on the DBH of the tree, while the optimum TPZs are based on the tree's dripline. For this Tree Preservation Plan, the TPZ providing the greatest protection was applied to each tree.
